SUBJECT: Maintenance Worker Dies when He Falls into a Baling Machine that Bales Cardboard for Recycling

SUMMARY
California FACE Report #09CA005

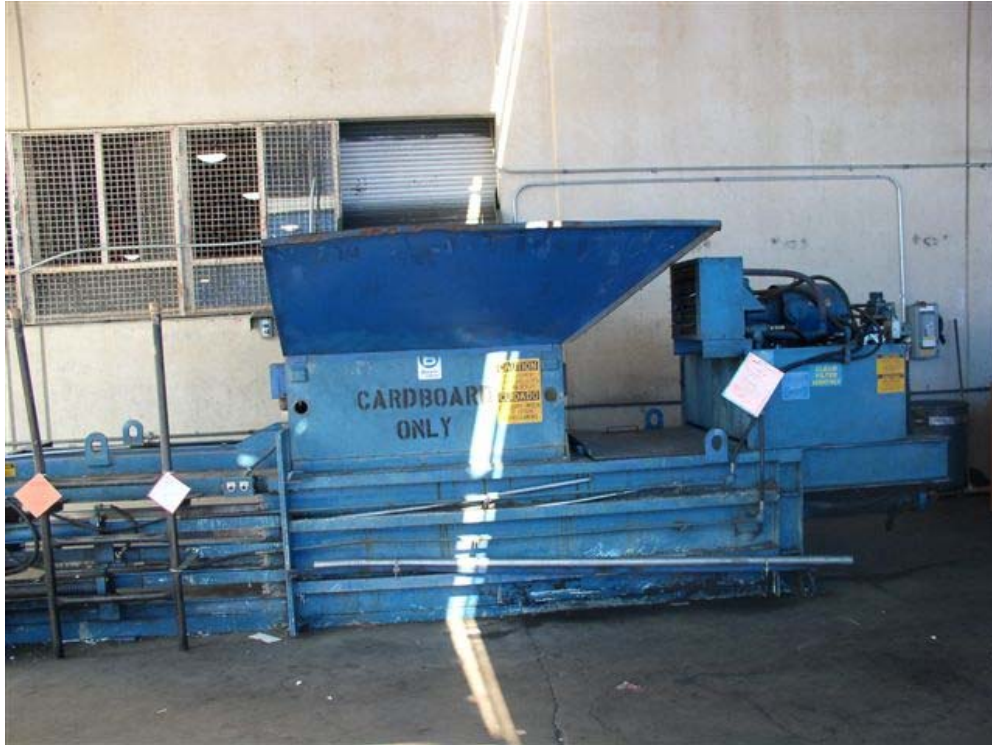
Exhibit 1. The cardboard baler machine involved in the incident.

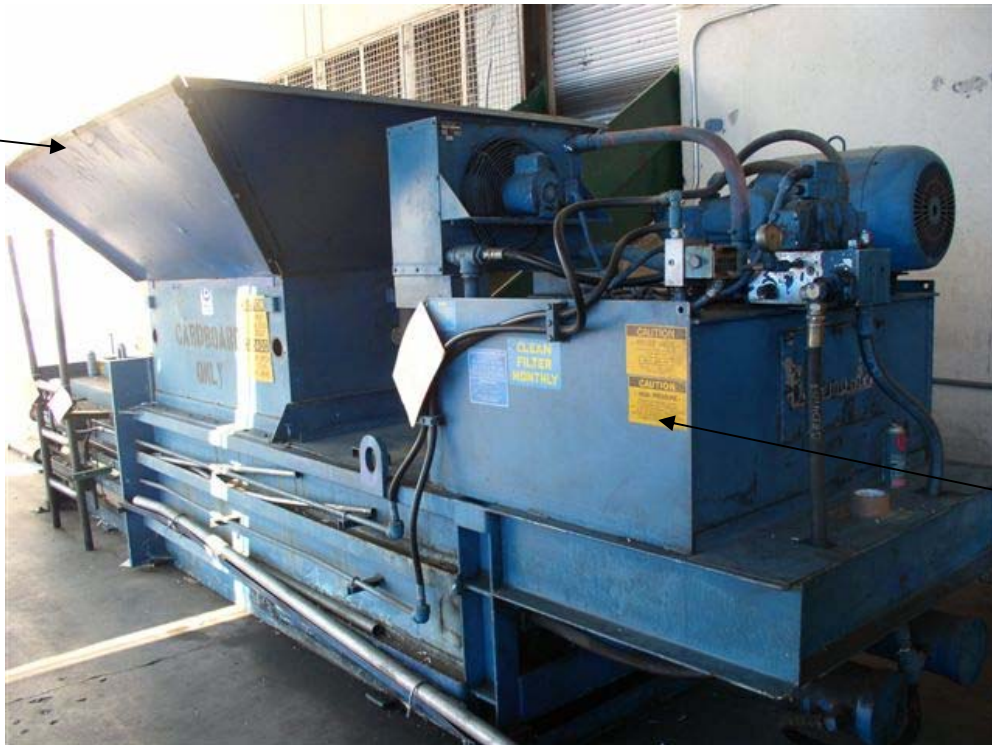
Exhibit 2. The cardboard baler showing the hydraulic system and feed chute.

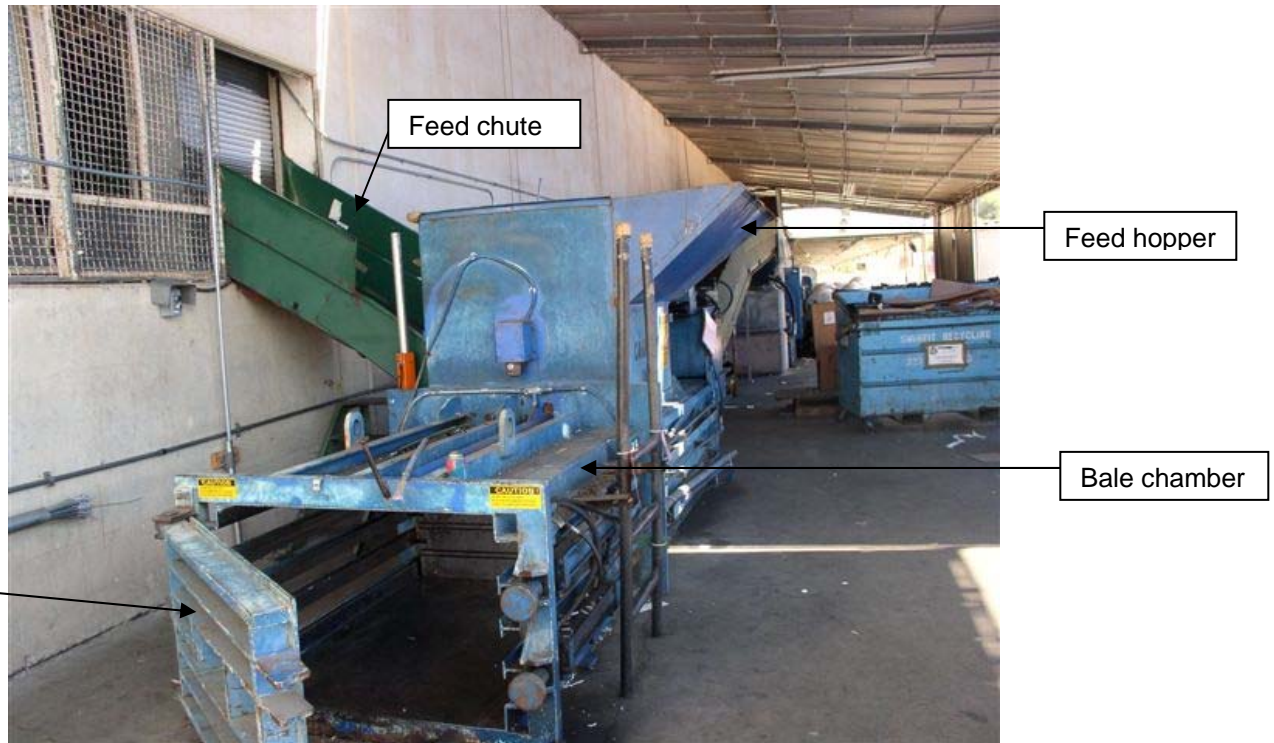
Exhibit 3. The cardboard baler showing the feed chute and chamber where the recycled bales of cardboard were formed.

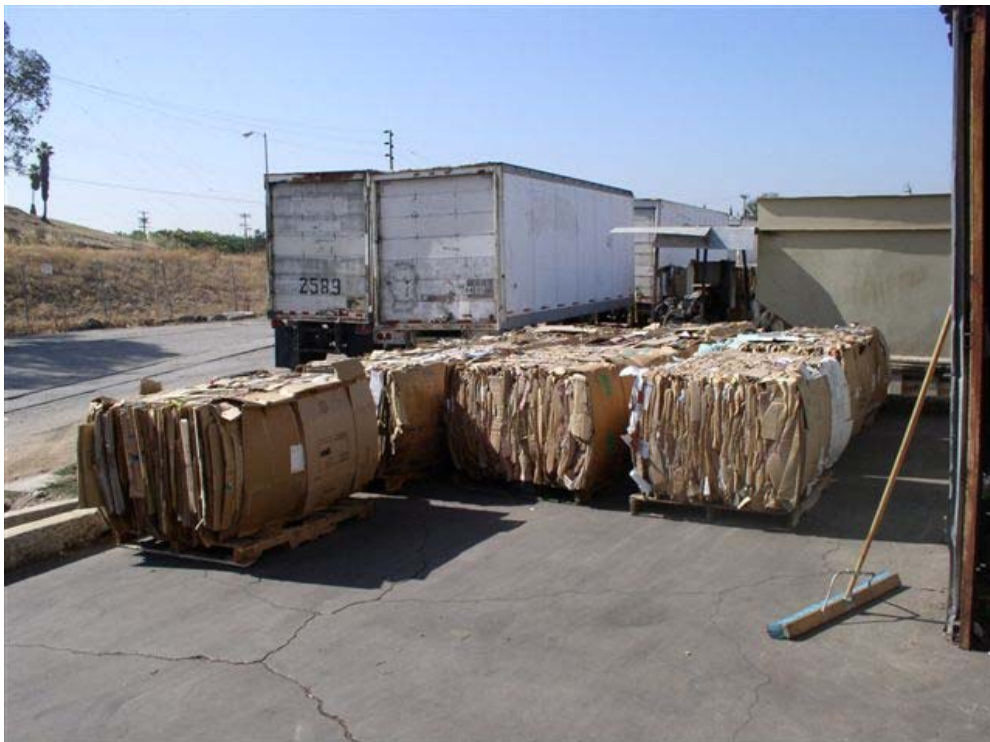
Exhibit 8. The bales of recycled cardboard produced by the machine involved in the incident.
