NASA-MSC-G-R-65-5
Supplemental Report 1

GEMINI AGENA TARGET VEHICLE 5002 SYSTEMS TEST EVALUATION (45 DAY REPORT)

This report, prepared by Lockheed Missiles & Space Company in compliance with Contract AF 04(695)-545, documents the flight performance evaluation and failure diagnostic analysis of Gemini Agena Target Vehicle 5002 launched from the Air Force Eastern Test Range on 25 October 1965.

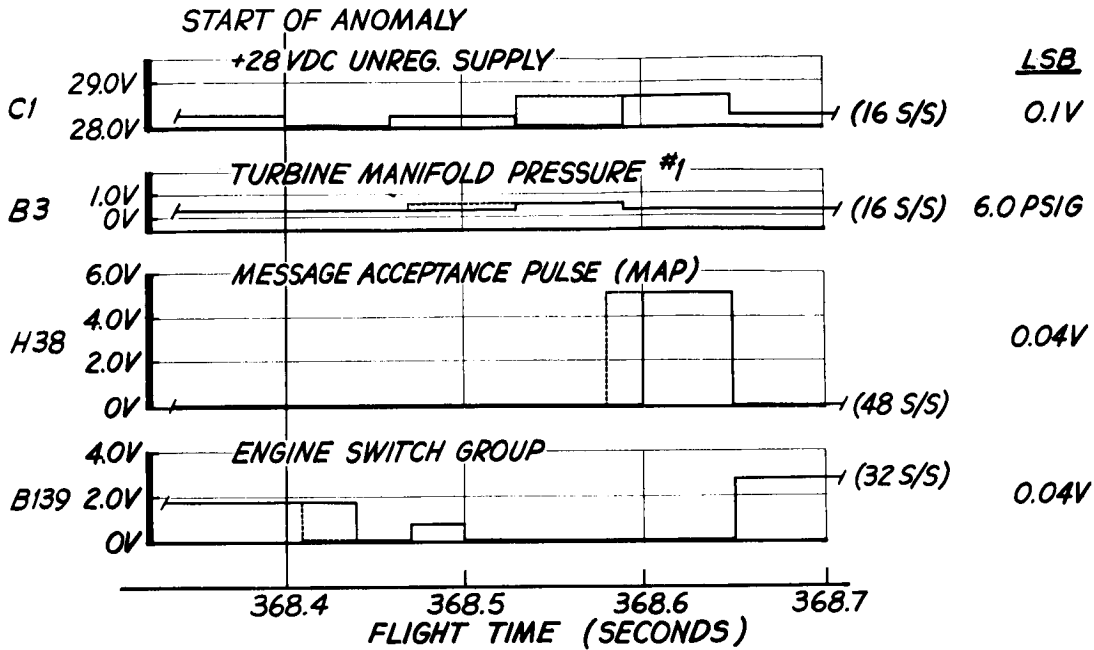
Fig. 3-2 Message Acceptance Pulse Anomaly

The most reasonable explanation of the spurious MAP pulse is that, during the severe mechanical shock, a short-duration short circuit occurred. This happened during the severing of the electrical harnessing, which in turn, caused a fast rise-time transient to be coupled from the adjacent wiring into the MAP pulse generation circuit.

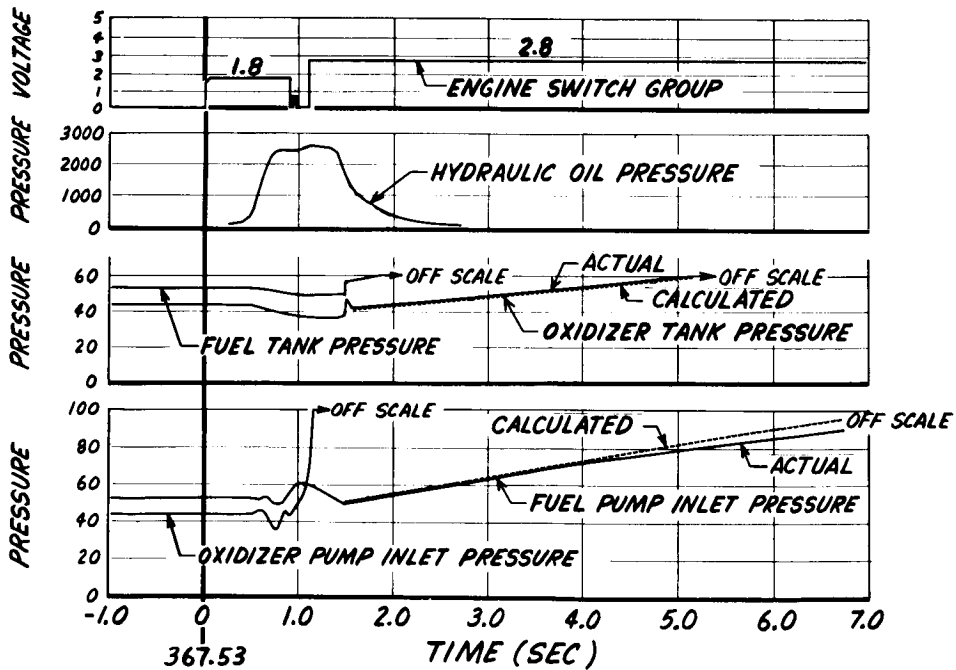
Fig. 3-5 Engine Switch Group and Hydraulic-Oil, Propellant-Tank, Pump-Inlet Pressures

- c. B9, "Fuel Tank Pressure" Measurement (Fig. 3-5). B9, at 54.4 psi, began to decrease at 368.12 sec. At 368.61 sec, it showed 50.4 psi, a loss of 4.0 psi due to fuel being withdrawn from the tank. B9 then remained constant until 369.01 sec, increased to 57.5 psi at 369.07 sec (pyrotechnic helium-control-valve operation) and finally increased to 60.4 psi (out of band) during the 0.30-sec time interval to 369.37 sec. The data after 368.61 sec indicate that fuel is not being withdrawn from the tank at a normal rate.

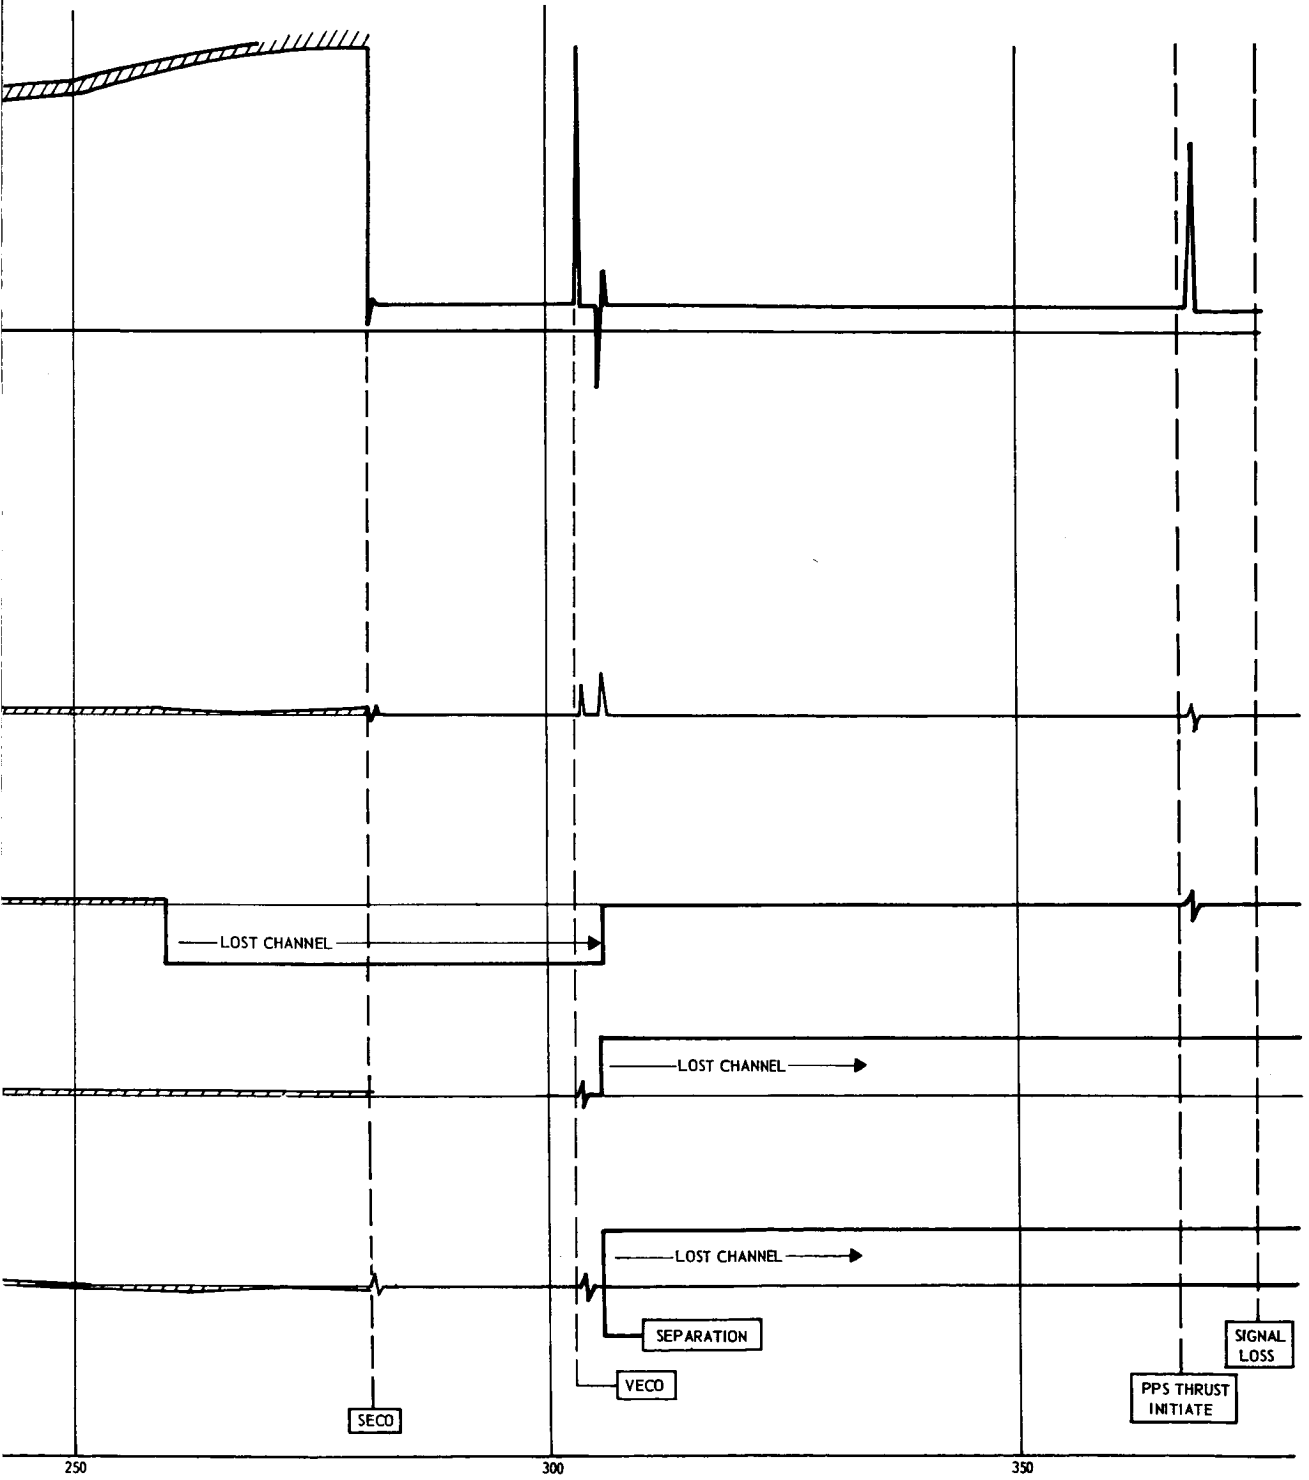
Fig. 3- 20 Accelerometer Status Time History

As illustrated in Fig. 3-20, three accelerometers exhibited partial or complete failures during various stages of flight. The TDA Z-axis accelerometer (A523) was intermittent but operation otherwise appeared normal. The two accelerometers (A5 and A522) mounted in the engine cone were lost completely during the pyrotechnic separation event. The loss of A5 and A522 appears to be a clearcut case of pyrotechnic shock at separation.

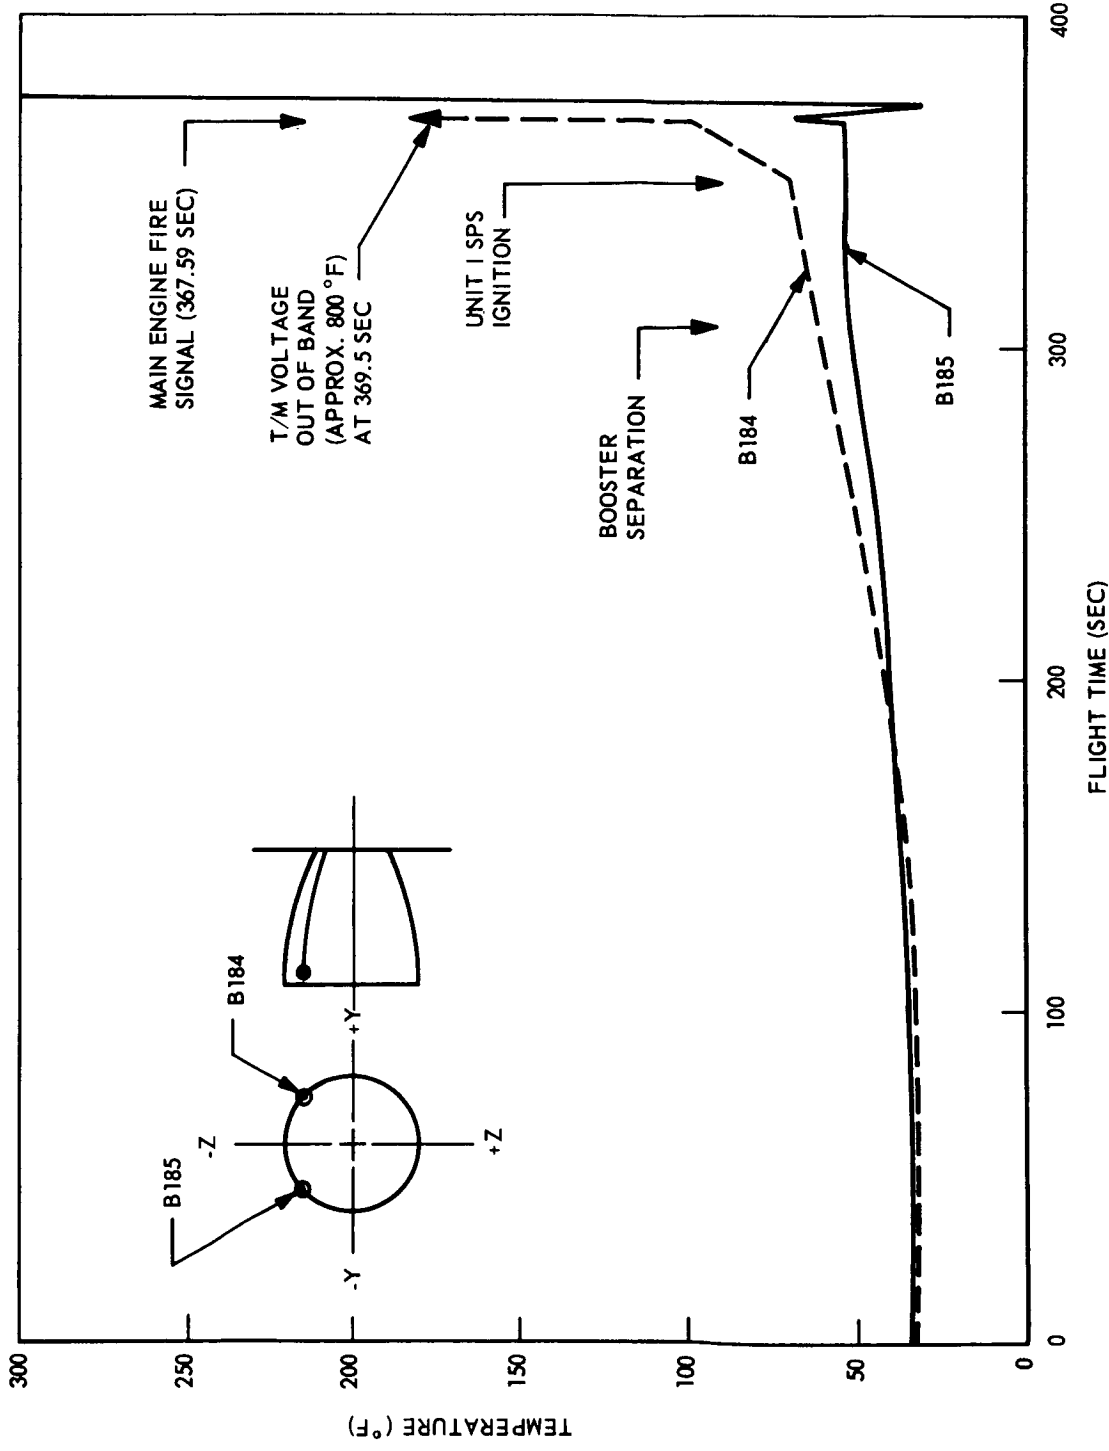
Fig. 3-40 Nozzle Extension (B184 and B185) Temperatures

The effect of the SPS burn was observed on the nozzle extension (B184), where the temperature increased from 70°F to 103°F because of radiation from the SPS nozzle and from exhaust plume impingement (Fig. 3-40). Sensor B184 is approximately 2 ft aft of the Unit I nozzle exit plane and at approximately the same angle as the nozzle from the vehicle vertical (Z) axis.

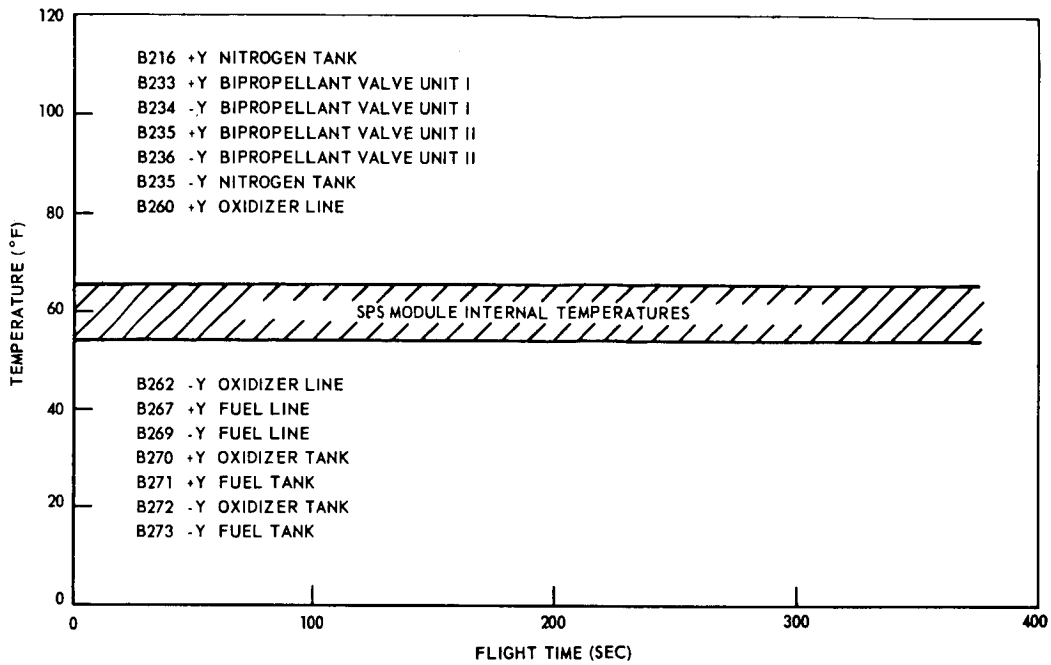
Fig. 3-41 SPS Module Component Internal Temperatures (B216, B233, B234, B235, B236, B253, B260, B262, B267, B269, B270, B271, B272, and B273)

It was postulated that such rapid temperature drops could only result from the high-heat transfer coefficients commonly associated with boiling or flashing liquids, where the change in phase from liquid to vapor involves considerable energy exchange. Leaking propellants were ~~immediately~~ suspected, and investigation of the thermodynamic properties of the propellants was undertaken. It was determined that the thermodynamic properties were indeed in the proper ranges to produce the indicated phenomenon.

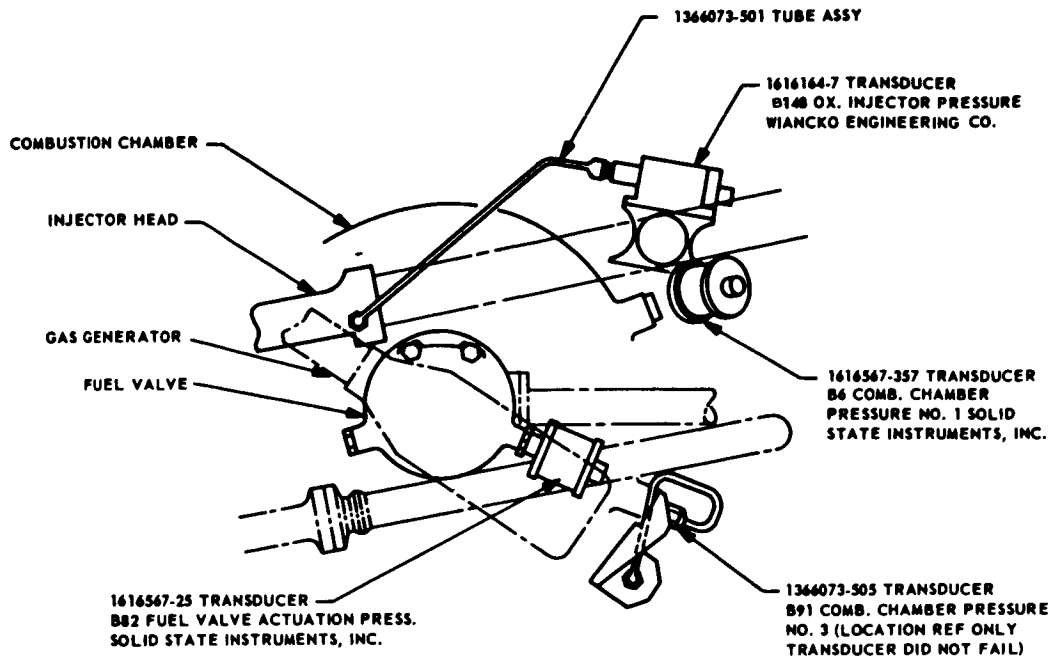
Fig. C-5 Location of Failed Transducers

11. Measurement read zero until +150 sec then drifts to 42 psig by 187 sec. Does not change at engine firing - should follow measurement B132. Reading indicates a failure in the electronics package of the transducer. Failure of transducer then becomes intermittent. Failure is attributed to excessive pressure surge on element.
