**AIRTRANS URBAN TECHNOLOGY PROGRAM
PHASE II**

**IRAN PROGRAM
Inspect, Repair As Necessary
on the
AIRTRANS AGT Vehicle**

AUGUST 1978

TOPICAL REPORT

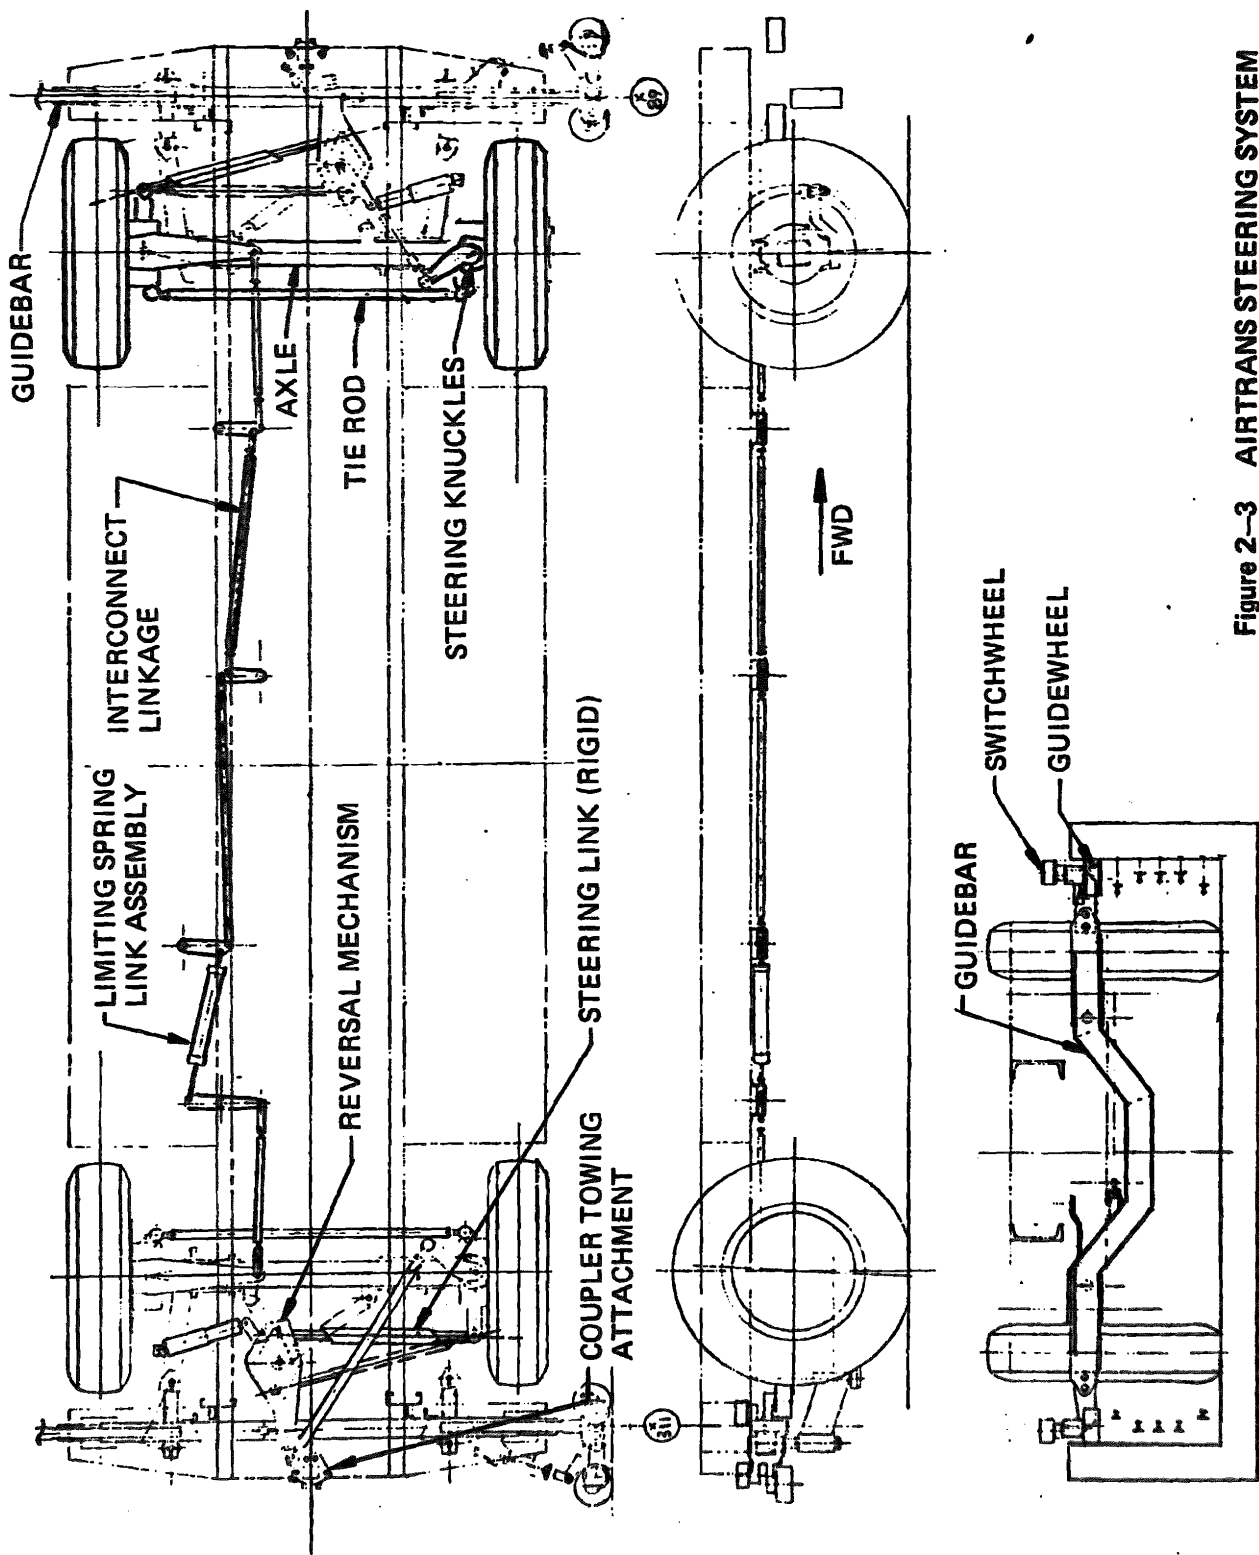
Figure 2-3 AIRTRANS STEERING SYSTEM

The steering system had the most wear of all systems examined. This can be anticipated since it is a relatively complex system, required because all wheels are steerable and the vehicle is capable of travel in either direction. Additionally, steering is required when the vehicle is removed from the guideway for maintenance. Figure 2-3 shows the steering system arrangement. Each of the components within the system will be addressed individually.

The guidebar bushing which interfaces with the left-hand pivot fitting of the hanger assembly exceeded the wear tolerances, and was replaced.

The hanger assemblies displayed the most wear of the components inspected. This wear was primarily associated with the bearings, which were rough and rusted. The lower bearings had more severe wear than the upper bearings. All bearings and shafts were replaced. Excessive high pressure lubrication of these bearings has the potential to damage the seals associated with the bearings. As seal damage occurs, water and moisture are allowed to penetrate the bearings and cause rust and wear.

The preliminary inspection of the actuator revealed moderate looseness and wear. The actuator was disassembled for a detailed inspection.

The steering-rod-end bearing within the actuator was loose within the rod end. Investigation revealed that the staking points had broken. The bearing was restaked, which eliminated the looseness.

The steering reversal actuator lug was worn, and the sleeve insert was loose. The lug hole was slightly elongated. A repair was made by line reaming the hole to eliminate the elongation and press fitting a steel bushing into the hole. The bushing hole diameter was then reamed to the correct size.

The lock, ring arm and key parts were worn to the extent that the actuator would not lock into position. These parts were removed and replaced with new parts.

The guide bars, after being repaired, were phosphate treated, primed and painted.

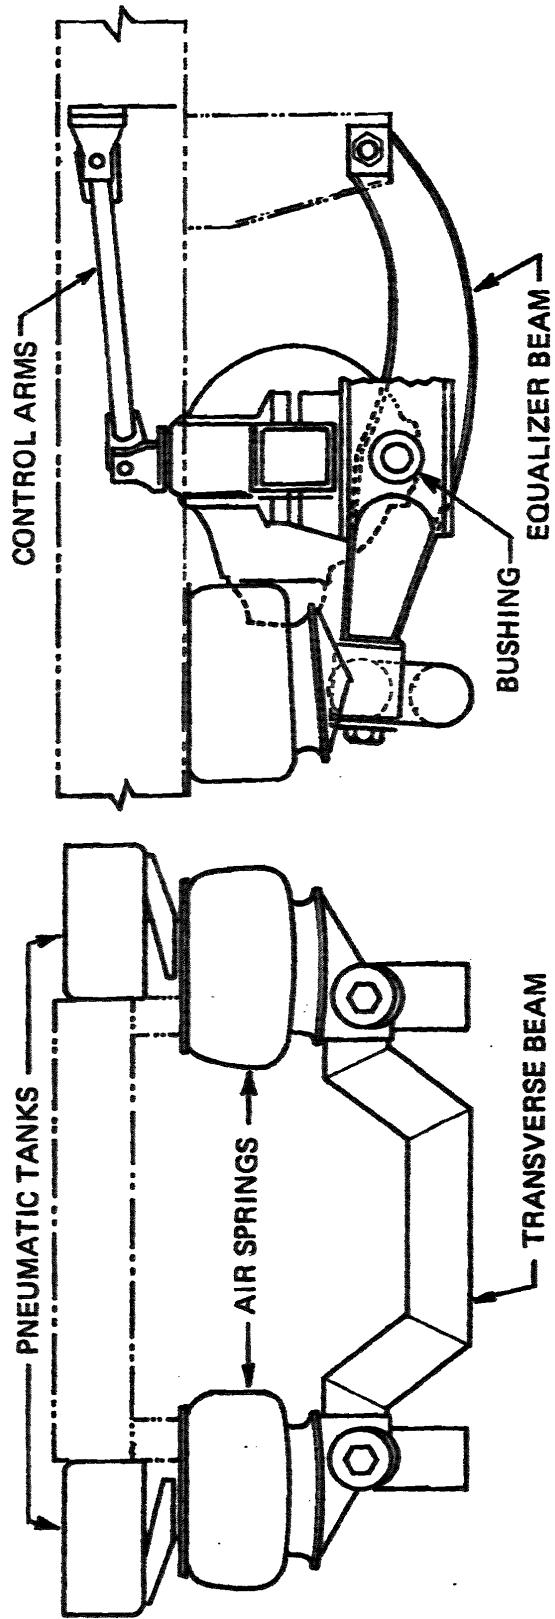
Figure 2-4 SUSPENSION SYSTEM DIAGRAM

The suspension system was disassembled and each component inspected. Figure 2-4 illustrates the suspension system arrangement.

The control arms were removed and inspected. Bearing wear was apparent due to considerable fore- and aft-movement. Also, the pins were worn four to five-thousandths of an inch, which contributed to the motion. All control arms and pins were replaced.

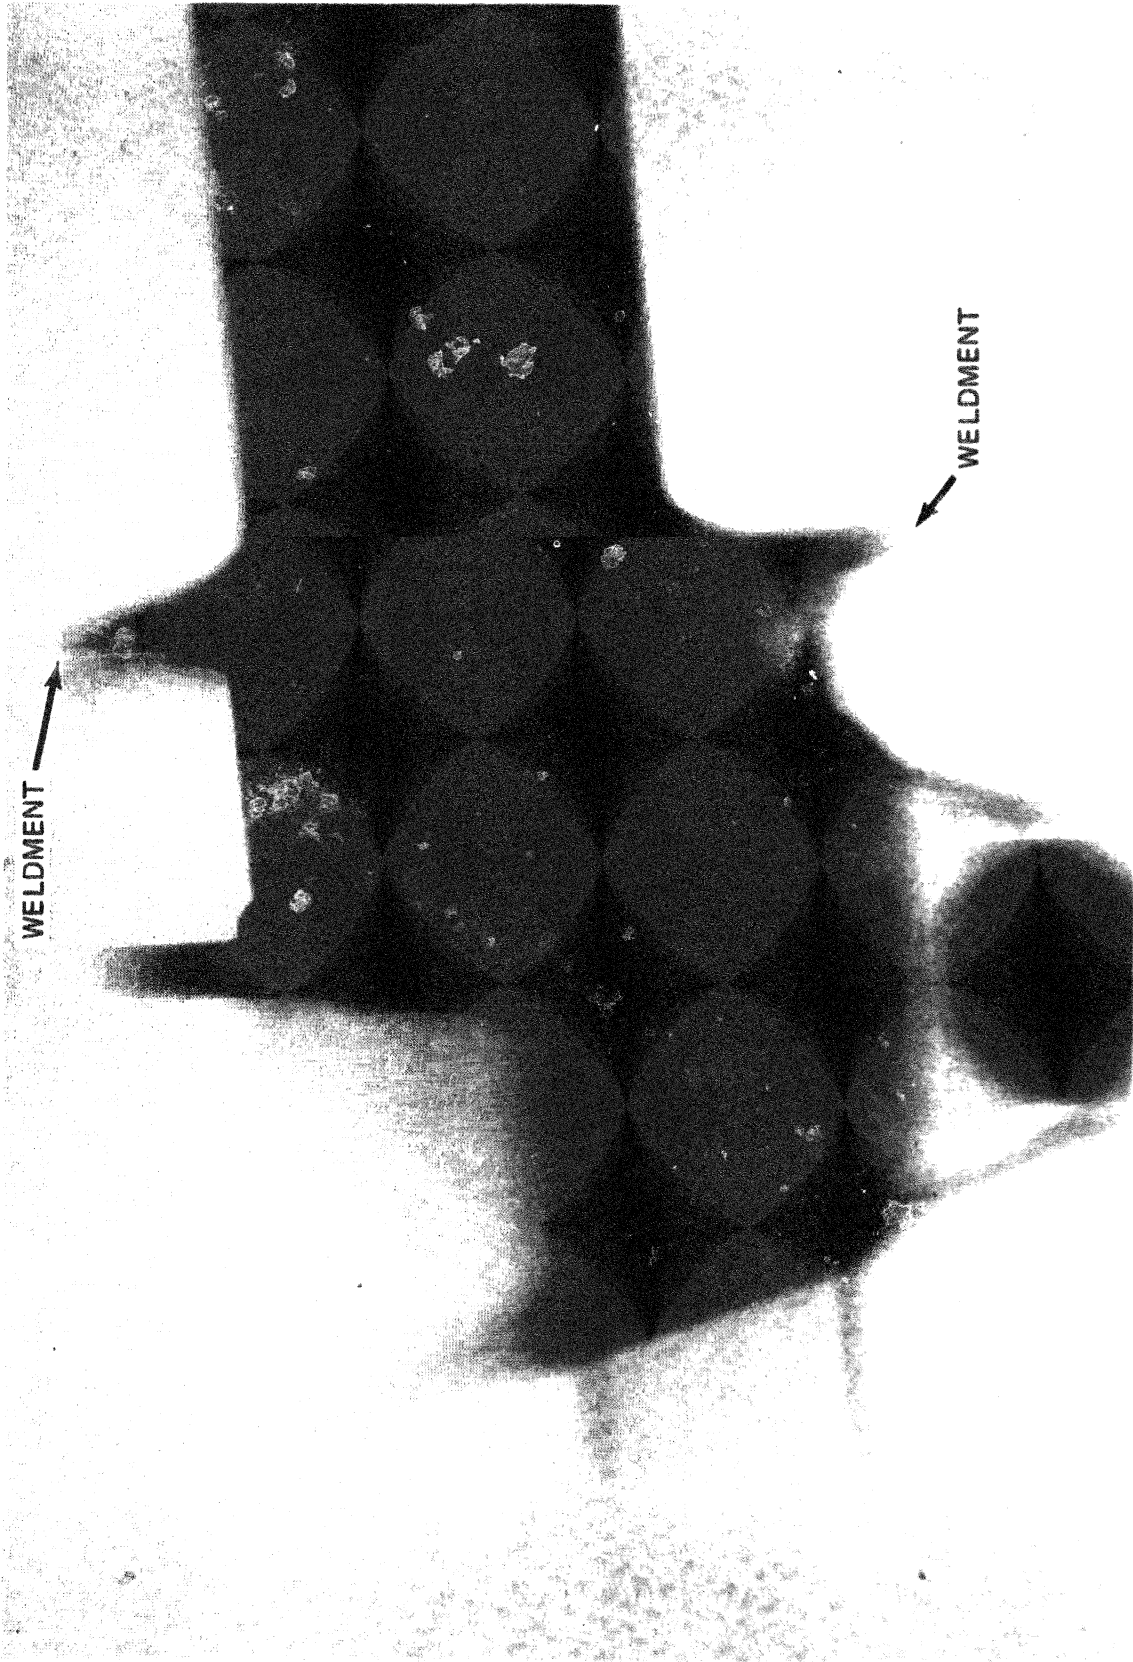
Figure 2-5 EQUALIZER BEAM X-RAY

The equalizer beam assemblies were disassembled and examined for condition. There was moderate to heavy corrosion on the steel bushing within the rubber bushing. This condition is not hazardous or considered dangerous. The design of the assembly allows moisture to enter the area between the inner and outer rubber bushings to form rust. The bushings were cleaned and a zinc chromate primer applied to prevent the corrosion. The beams were inspected visually and with dye penetrant process to locate any cracking within the welds. No evidence of cracks was found. This process has been successfully used to determine cracks in the structure on other vehicles. One beam, selected at random, was subjected to a radiographic inspection. Each end and the center section were x-rayed to verify the other inspection procedures. Figure 2-5 shows an x-ray view of one end of the beam which attaches to the transverse beam. This area is of particular interest since a few beams have experienced some cracks.

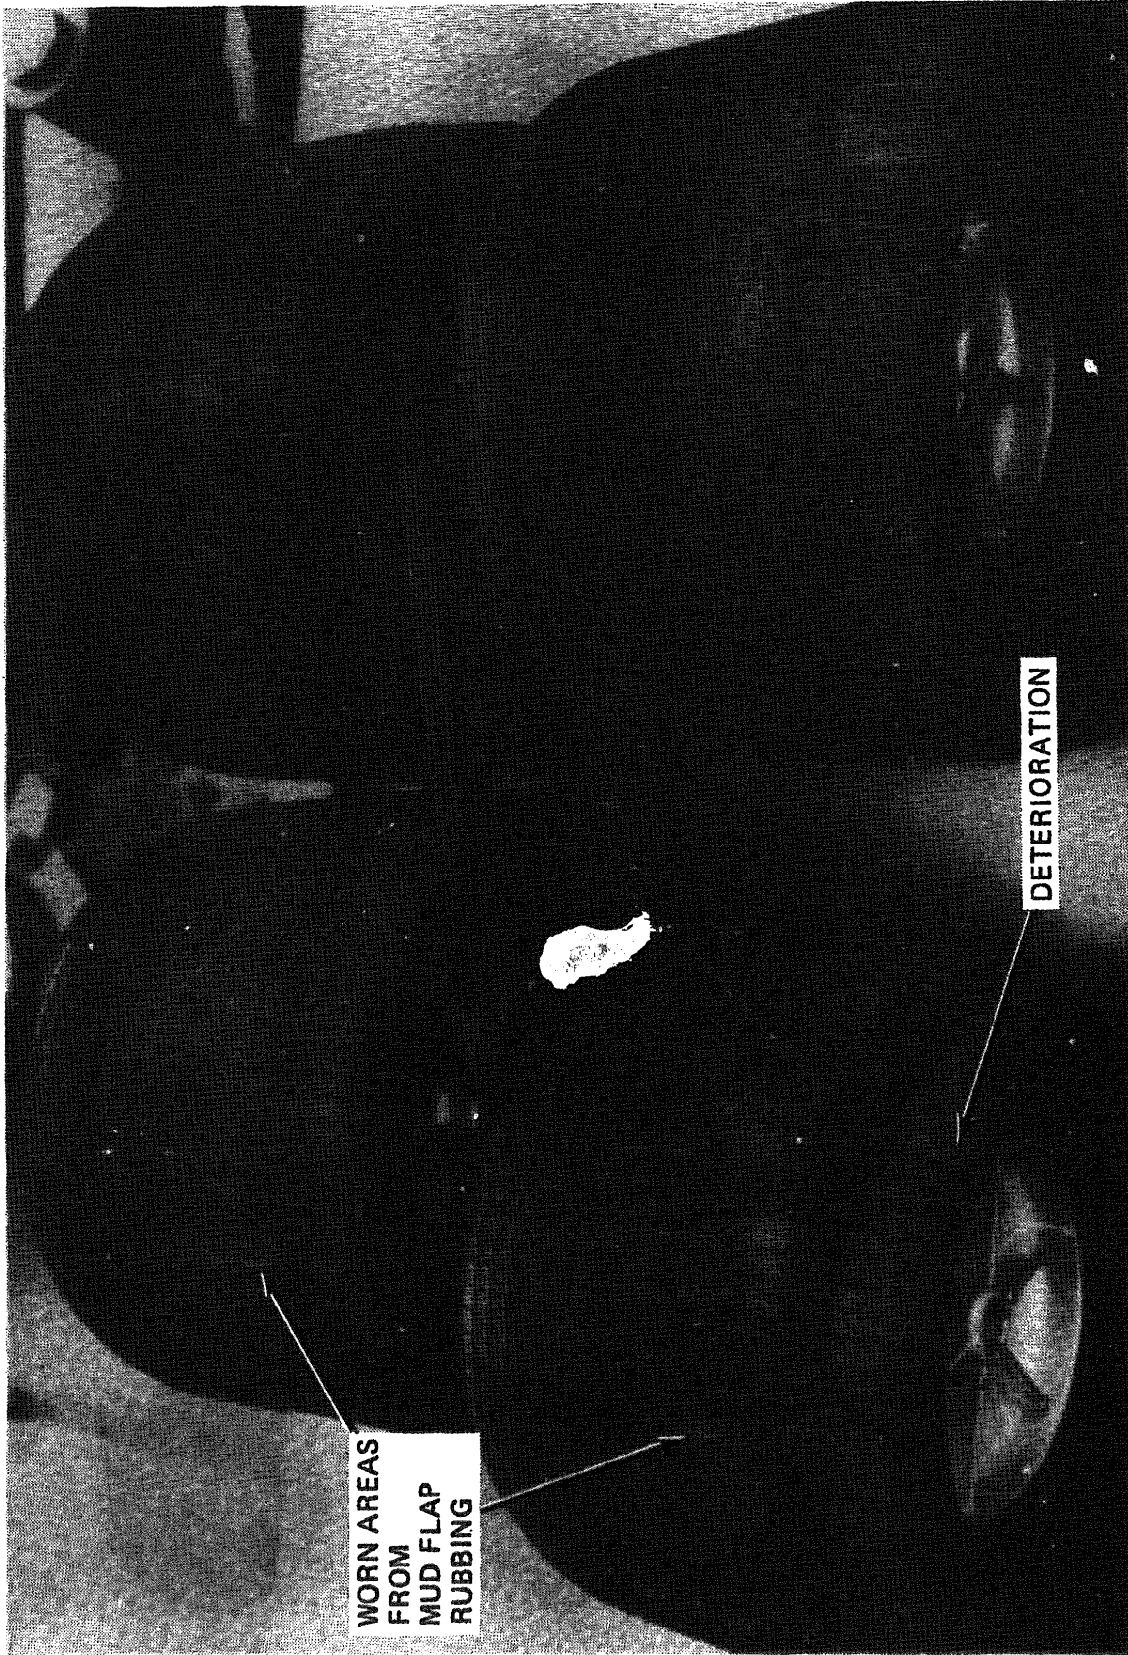
Figure 2-6 AIR SPRINGS

The air springs were inspected visually for cracking and deterioration. These air springs which are cylindrical in form and constructed of rubber did display a moderate amount of cracking and deterioration, particularly on the lower end where the attachment to the transverse beam is located. Further examination revealed a wear area on the side of the spring. This wear, a vertical line approximately three (3) inches long and one-fourth (1/4) inch wide, cut a groove in the spring through the fabric and into the second ply of the construction. This wear was created by the vehicle tire mud flap rubbing with the spring. As the vehicle moved vertically up and down to accommodate loads and station alignment, the wear would occur. The mud flaps were secured to the vertical structure of the pneumatic compressor/alternator compartment and the AC/DC panel boxes. The other two mud flaps were cut and trimmed locally to preclude the interaction of the air spring and flap. The wear on the air spring is shown in Figure 2-6. All air springs were replaced to preclude an air spring failure.
