# WARFIGHTER SUPPORT

## Independent Expert Assessment of Army Body Armor Test Results and Procedures Needed Before Fielding

Highlights of [GAO-10-119](#), a report to congressional requesters

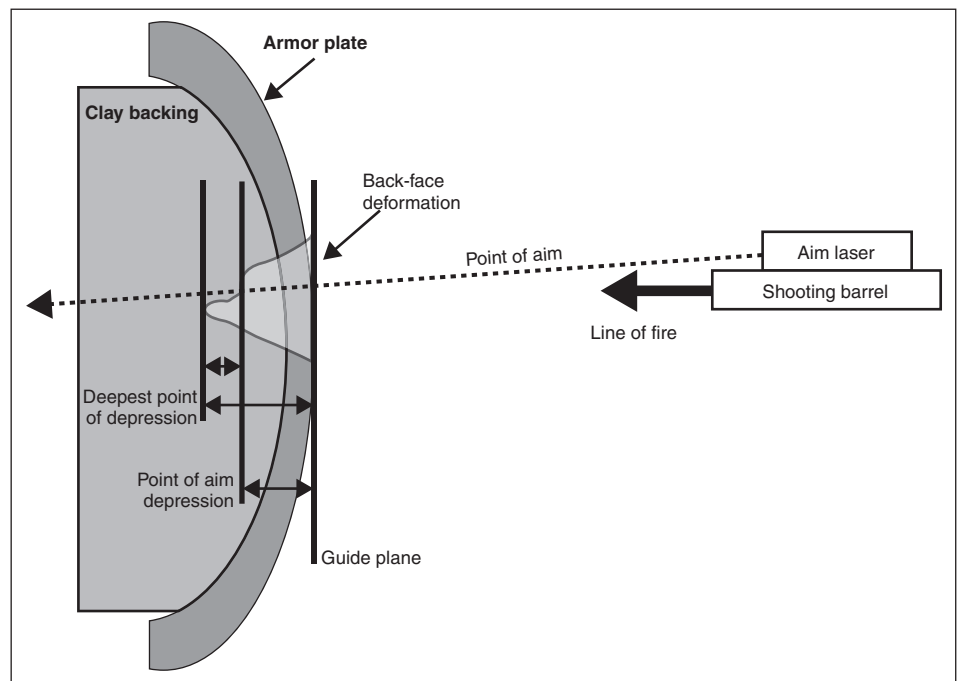
During Preliminary Design Model testing the Army took significant steps to run a controlled test and maintain consistency throughout the process, but the Army did not always follow established testing protocols and, as a result, did not achieve its intended test objective of determining as a basis for awarding contracts which designs met performance requirements. In the most consequential of the Army's deviations from testing protocols, the Army testers incorrectly measured the amount of force absorbed by the plate designs by measuring back-face deformation in the clay backing at the point of aim rather than at the deepest point of depression. The graphic below depicts the difference between the point of aim and the deepest point.

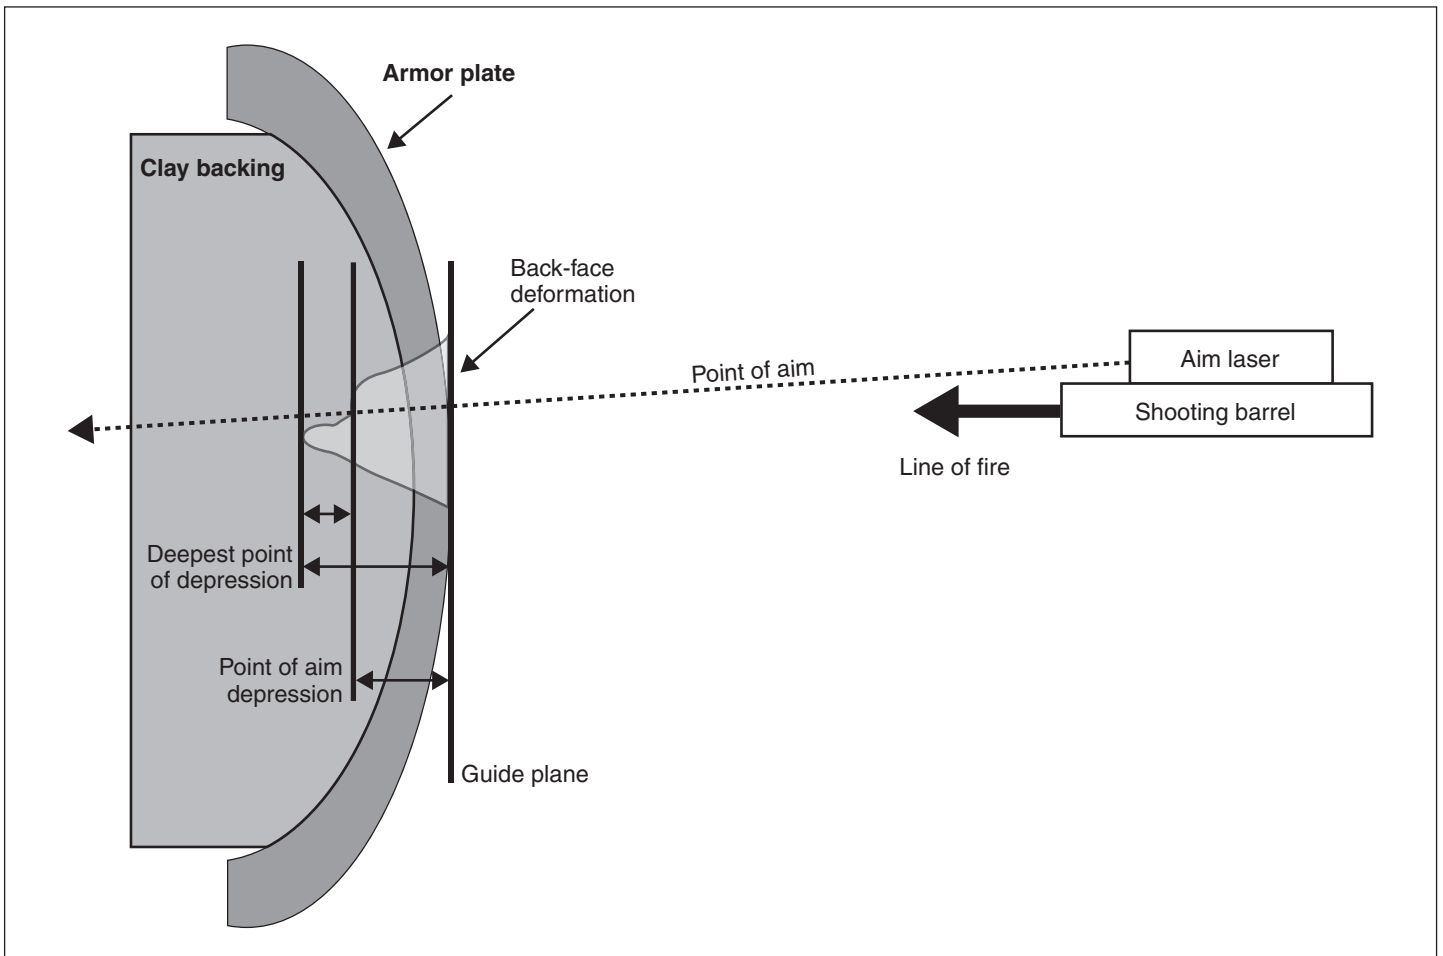
Figure 4: Graphic Representation of the Difference between the Point of Aim and the Deepest Point

The most consequential of the deviations from testing protocols we observed involved the measurement of back-face deformation, which did affect final test results. According to testing protocol, back-face

When members of the Integrated Product Team overseeing the testing were made aware of this error, the Integrated Product Team decided to begin measuring at the deepest point of depression. When senior Army leadership was made aware of this error, testing was halted for 2 weeks while Army leadership considered the situation. Army leadership developed many courses of action, including restarting the entire Preliminary Design Model testing with new armor plate submissions, but ultimately decided to continue measuring and scoring officially at the point of aim, since this would not disadvantage any vendors. The Army then changed the test plans and modified the contract solicitation to call for measuring at the point of aim. The Army also decided to collect deepest point of depression measurements for all shots from that point forward, but only as a government reference. During the second two-thirds of testing, we observed significant differences between the measurements taken at the point of aim and those taken at the deepest point, as much as a 10-millimeter difference between measurements. As a result, at least two of the eight designs that passed Preliminary Design Model testing and were awarded contracts would have failed if the deepest point of depression measurement had been used. Figures 4 and 5 illustrate the difference between the point of aim and the deepest point.

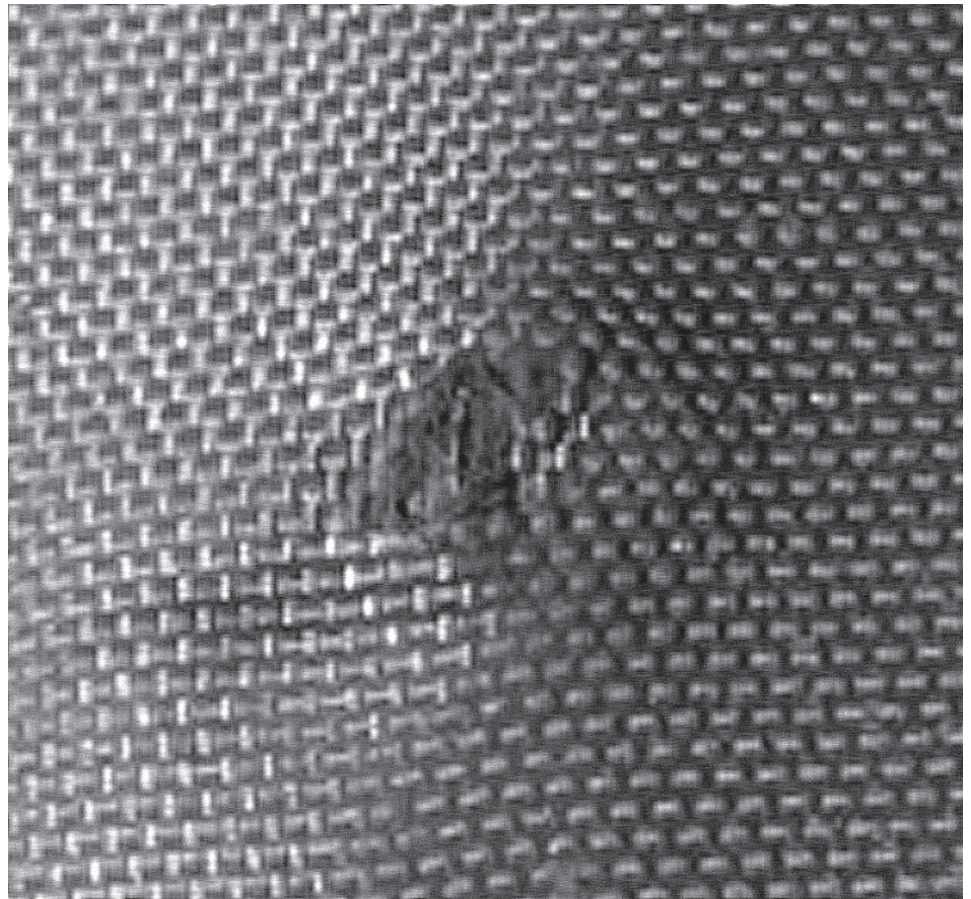
**Figure 6: Tears in Kevlar Backing Material after a Penetration of the Plate**

Although we did not observe problems in the Army's determination of penetration results during Preliminary Design Model testing, during First Article Testing we observed that the Army did not consistently follow its testing protocols in determining whether a shot was a partial or a complete penetration. Army testing protocols require that penalty points be awarded when any fragment of the armor material is imbedded or passes into the soft under garment used behind the plate; however, the Army did not score the penetration of small debris through a plate as a complete penetration of the plate in at least one case that we observed. In this instance, we observed small fragments from the armor three layers deep inside the Kevlar backing behind the plate. This shot should have resulted in the armor's receiving 1.5 penalty points, which would have caused the design to fail First Article Testing.<sup>40</sup> Army officials said that testers counted the shot as only a partial penetration of the plate because it was determined that fibers of the Kevlar backing placed behind the plate were not broken,<sup>41</sup> which they stated was a requirement for the shot to be counted as a complete penetration of the plate. This determination was made with the agreement of an Army subject-matter expert from PEO-Soldier present on the lane. However, the requirement for broken fibers is inconsistent with the written testing protocols. Army officials acknowledged that the requirement for broken fibers was not described in

the testing protocols or otherwise documented but said that Army testers discussed this before First Article Testing began. Figure 6 shows the tear in the fibers of the rear of the plate in question.

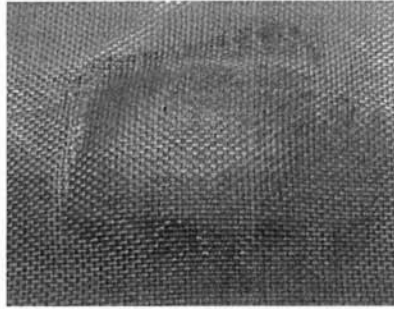
Figure 6. Front face of shoot pack for the test in question.

**Response:** This information appends that provided in the earlier discussion of this issue. While Figure 6 of the GAO report appears to show evidence of a perforation on the rear of the test plate in question, by the definition in the Purchase Description, a complete perforation is scored based upon the damage to the soft armor shoot pack directly behind the ballistic test plate. The front (face immediately behind the plate under test) of the shoot pack in question is shown in Figure 6 of this response, located below. Though deformed, the damage does not constitute a complete perforation of the plate according to the definition in the Purchase Description.
