CHAPTER 4: ENGINEERING FOR WATER TRANSPORTATION

EARTHQUAKE DAMAGE TO SEA HARBOR WHARVES AND SHORE SLOPES

Meng Zhaohua and Ye Borong*

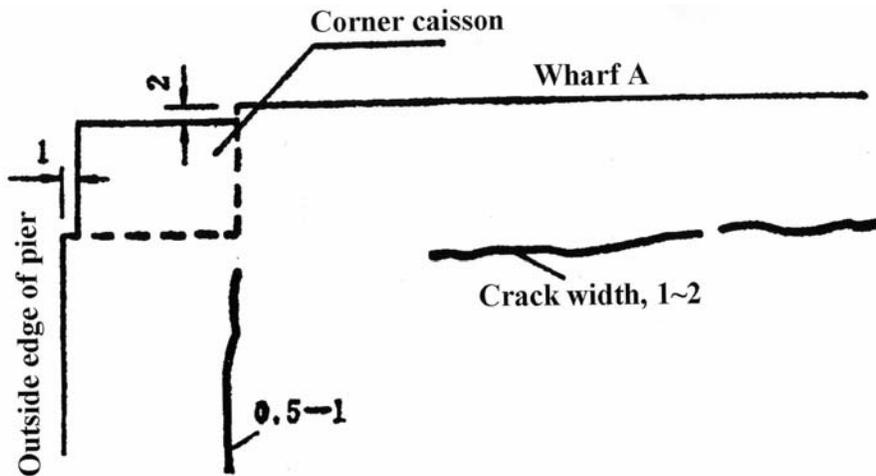
Figure 3. A sketched plan of cracks and dislocations at the corner of wharf A (in cm).

At the front part of the pier on the concrete surface there was a crack about 0.5-1.0 cm wide on the west side along the edge of the caisson and a crack 1-2 cm wide on the north side. There was a dislocation of about 2 cm between the wharf front of Pier A and the outer edge of the corner caisson, and a dislocation of 1 cm between the outside edge of the pier and corner caisson (Fig. 3).

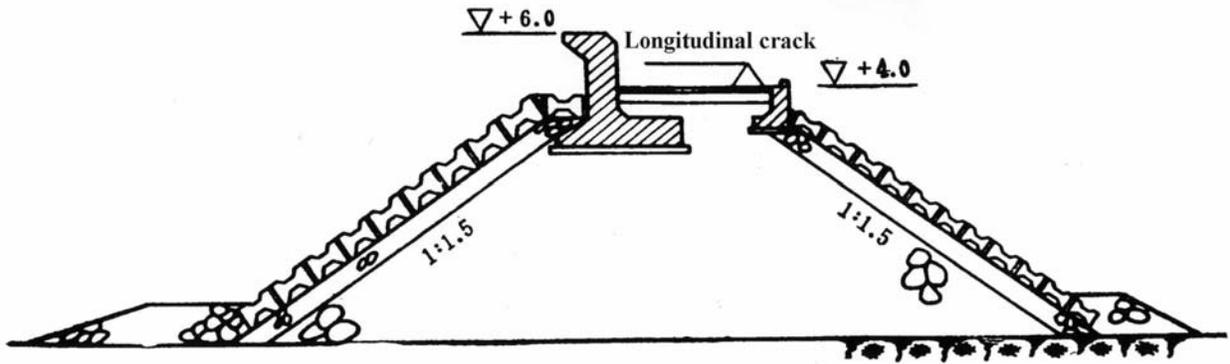
Figure 4. A sketch of the pavement structure of the mound approach dike and position of the cracks. The first stage project of the Crude Oil Pier.

The mound approach dike was built in 1974 at a total length of 746.7 m. The width of the dike top is 6 m, the bottom elevation is -5 m to -5.6 m, the elevation of the dike top is +4 m; the obliquity of both side slopes is 1:1.5 and they are protected with a slope pavement of hollow concrete blocks 1-2 tons in weight. After the earthquake, at the top of the dike at a distance of 180 m from the root of the dike two longitudinal cracks occurred about 4 cm wide and 520 meters long running south to north (Fig. 4).

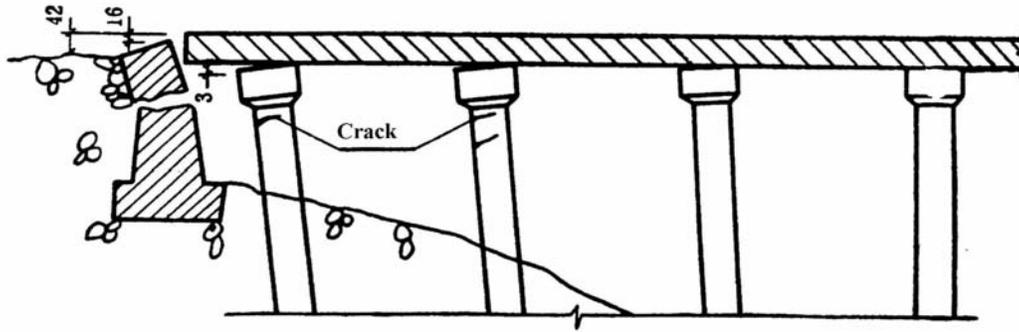
Figure 13. A sketch of a map showing damage to the retaining wall of the No. 20 berth at the New Port of Tianjin (in cm).

The retaining wall at the north end of the No. 20 berth was built on a rubble-mound. After the earthquake the retaining wall settled about 42 cm and slipped forward and pressed against the rear platform resulting in a break in the retaining wall with a breach 12 cm wide and dislocation of 18 cm. Simultaneously 4 surfaces in contact with the vertical pile caps under the rear platform with the beam were opened and the opening facing the bank reached 3 cm. The vertical piles inclined backward and several cracks appeared on the pile shaft (Fig. 13).

(b) If the bank slope and retaining wall moved forward the vertical pile near the bank slope under the rear platform cracked (Fig. 13).

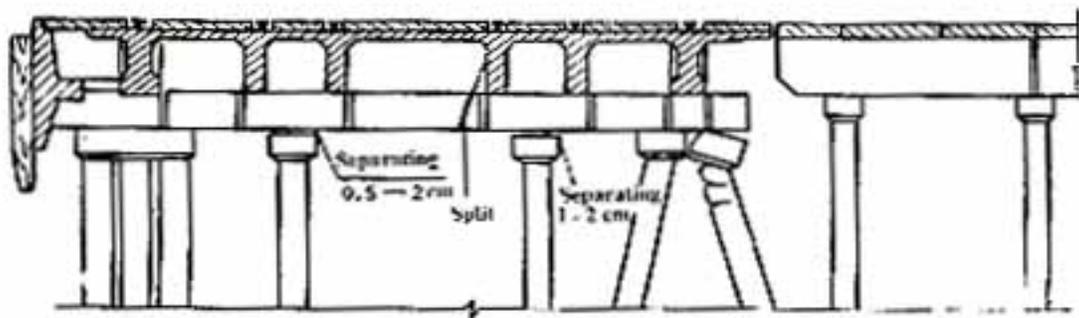
Figure 15. A sketch showing damage to a crossbeam of the No. 14 and No. 15 berths at the New Port of Tianjin.

Because the concrete pile cap of the crossing pile broke (the reinforcements still connected), the batter piles inclined forward and pushed up the crossbeam, which made the two pile caps of the vertical pile in the middle of the crossbeam separate from the crossbeam. The crossbeam span increased and the crossbeam cracked at the middle of the span (Fig. 15). The investigation showed that there were 28 crossbeams that separated from pile caps and 12 crossbeams that cracked.

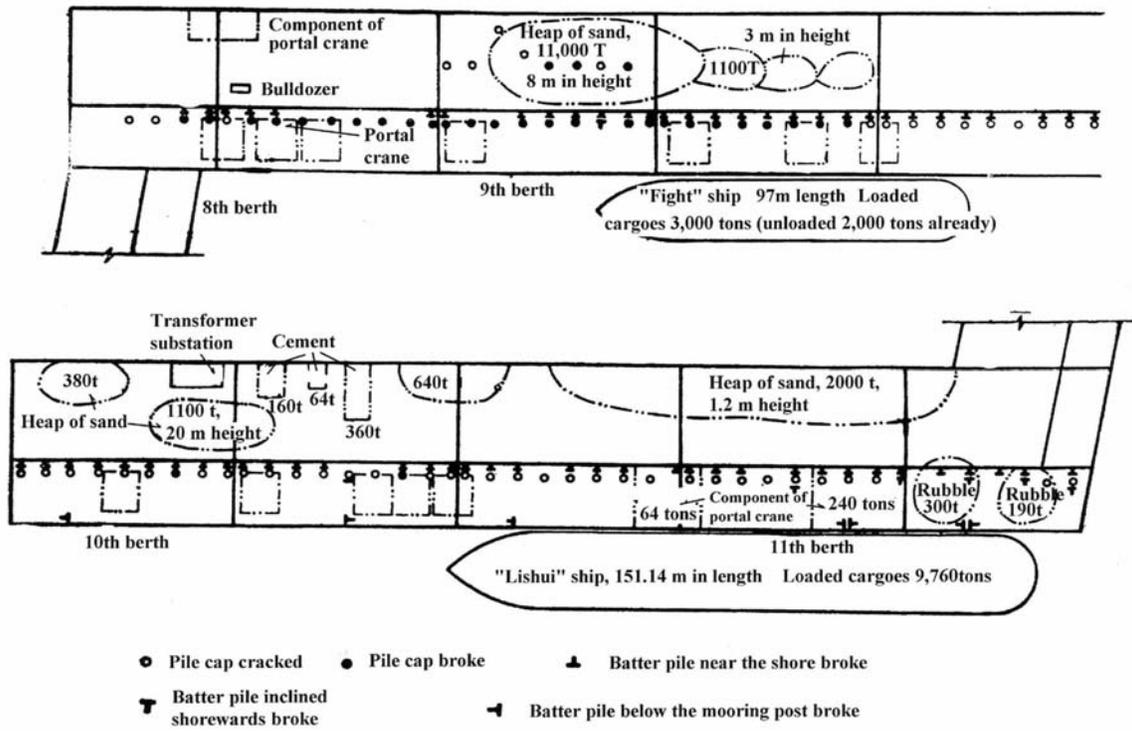
Figure 16. A sketch showing the load and damage to a pile foundation investigation for the No. 9 to No. 11 berths.

Bulk cargoes on the wharf surface had a direct influence on damage to the crossing piles below the front platform. Big bulk cargoes seriously damaged the structure. The load of stacked cargo on the platform increased the horizontal earthquake force, which was transmitted to the front platform and thus intensified the damage to the crossing piles. Under the rear platform there were all vertical piles and the beam and slab were simply-supported on the cap of the vertical pile. At points of overload of stacking cargo the pile caps were damaged, however the pile shafts above the seabed were intact. For pile shafts under the seabed two vertical piles had been checked with a drill hole and submerged television and no cracks were found. For example, at the 9th berth the stacked sand was 8 m in height, the average load was 6-7 t/m² (the largest reached 10 t/m²); and at the 18th berth the stacked salt was about 7-8 m in height, the average load was 3 t/m² (the largest reached 6 t/m²). The pile foundation under the front platform of these two berths was seriously damaged. The results of the investigation of stacked load distribution during the earthquake and damage to the pile foundation of the 9th to 11th berths are shown in Fig. 16.

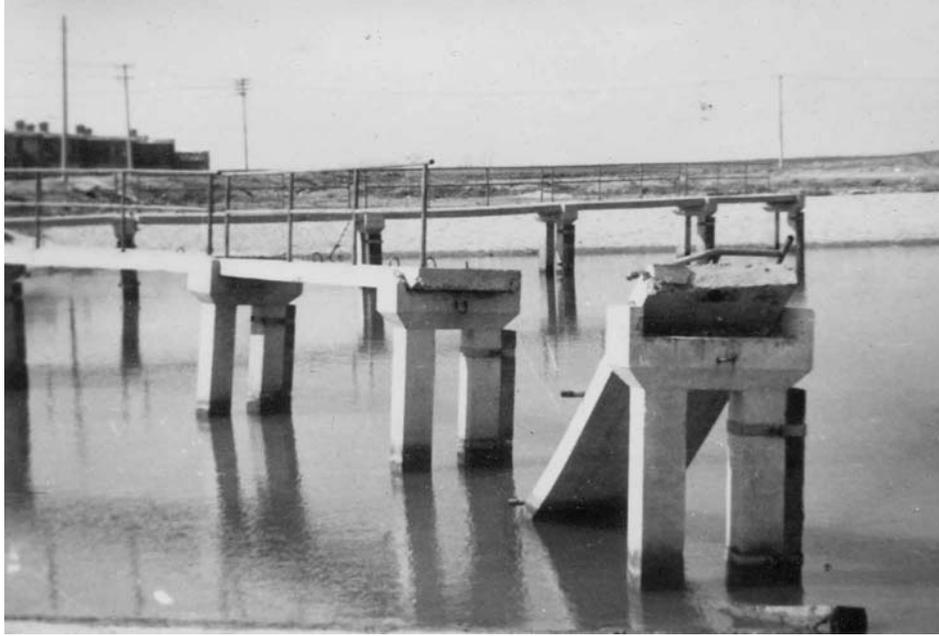
Photo 1. Damage to the upper guiding frame at the Beitang shiplock.

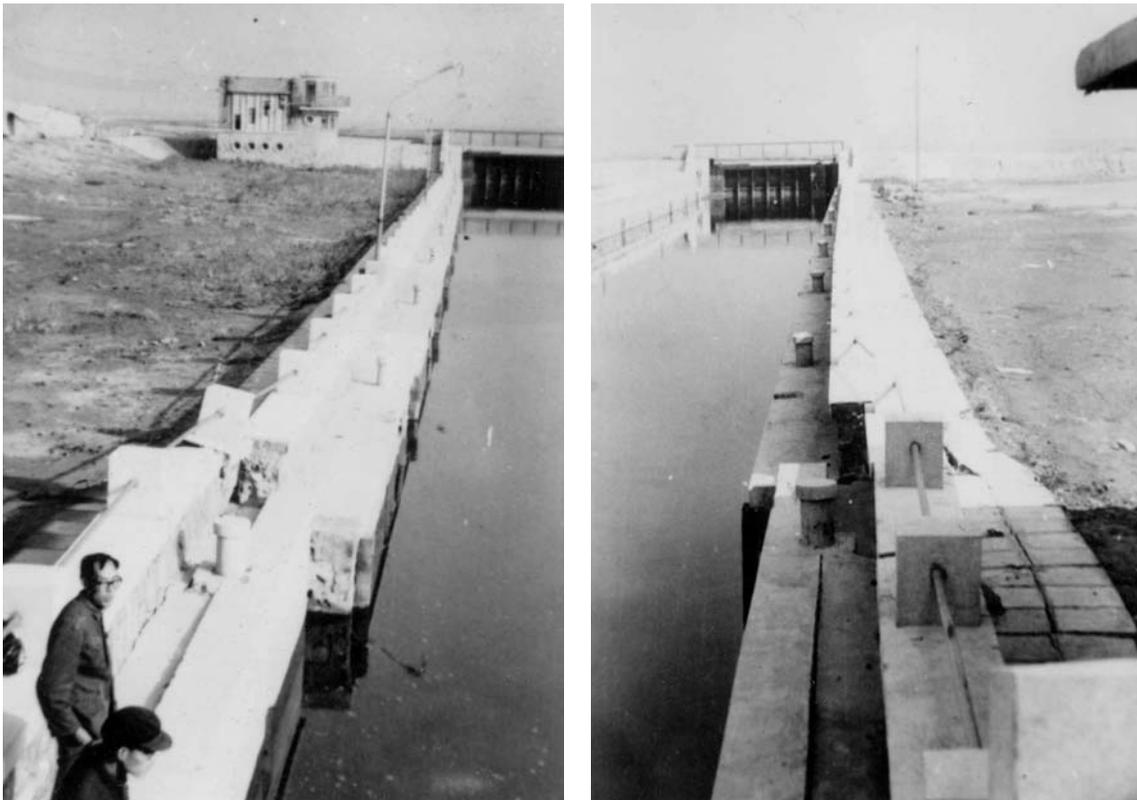
Photo 2. The chamber wall of the Beitang shiplock displaced and became oblique.

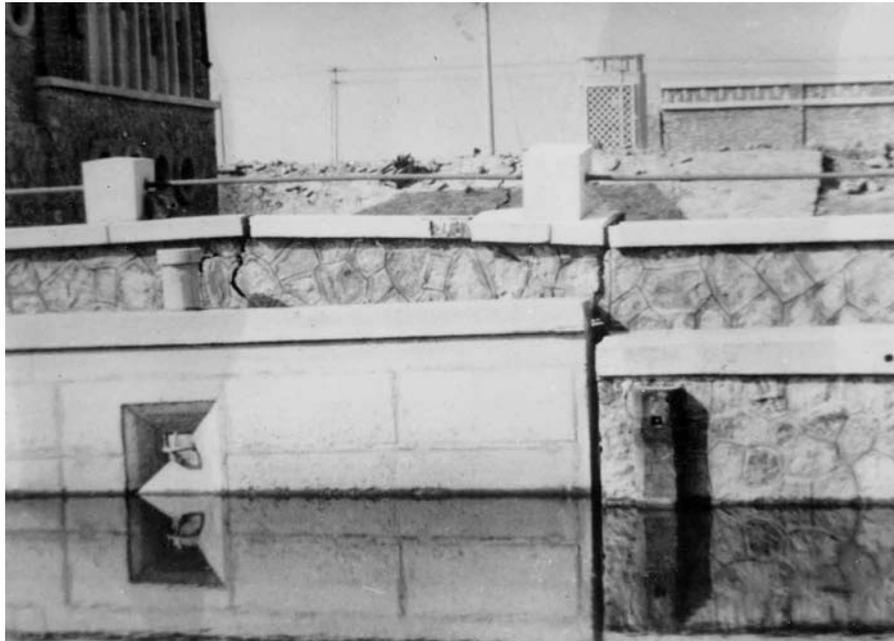
Photo 3. Two sections of the masonry retaining wall and reinforced concrete chamber, having a seam at the center of the floor, dislocated at the Beitang shiplock chamber.

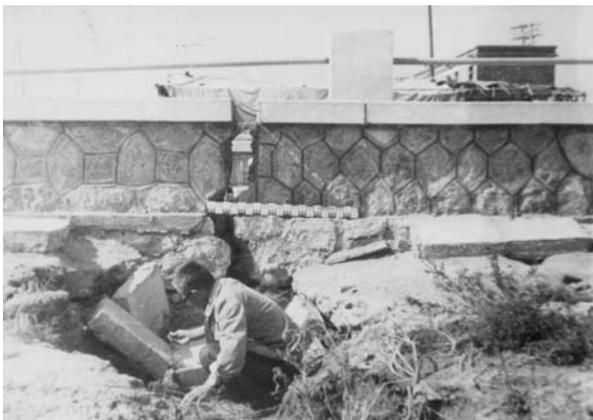
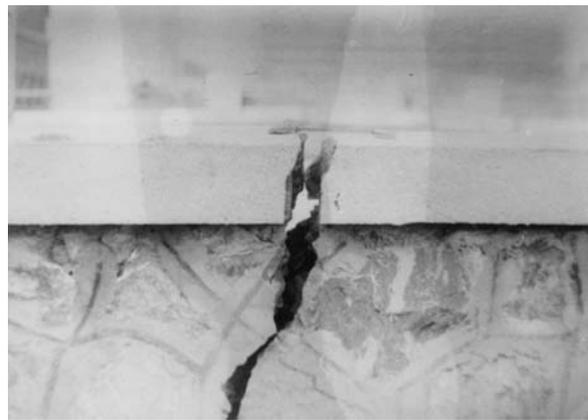
Photo 4. Damage to the guard wall of the Beitang shiplock chamber.

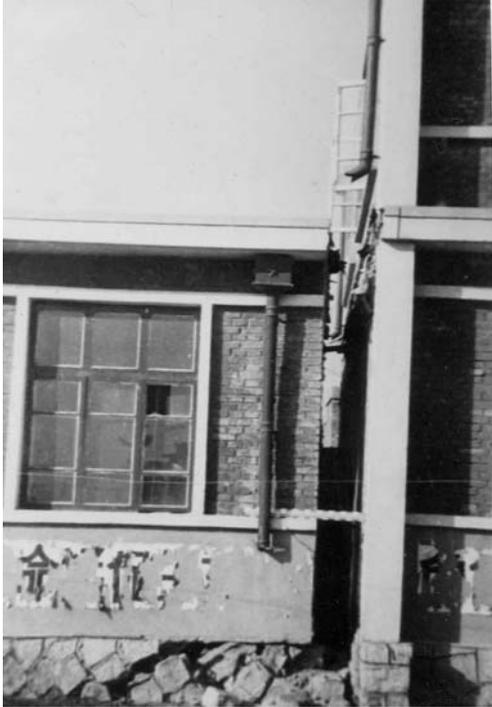
Photo 5. The Beitang shiplock office building was separated by the earthquake.

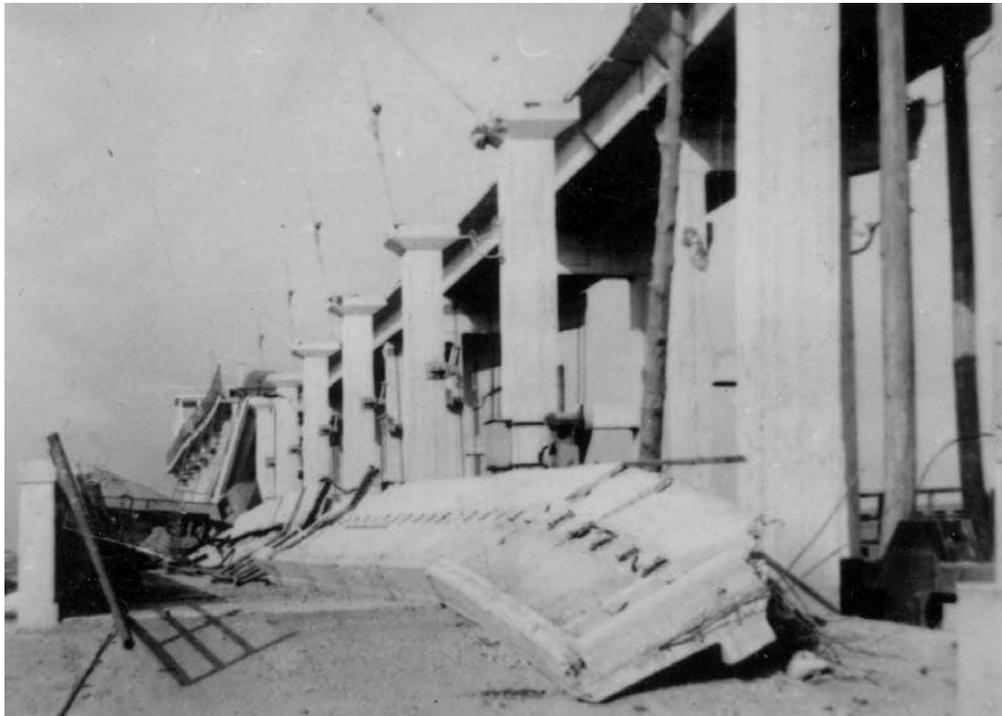
Photo 7. The hoisting frame and equipment on the working bridge collapsed on the sluice of the Beitang project.

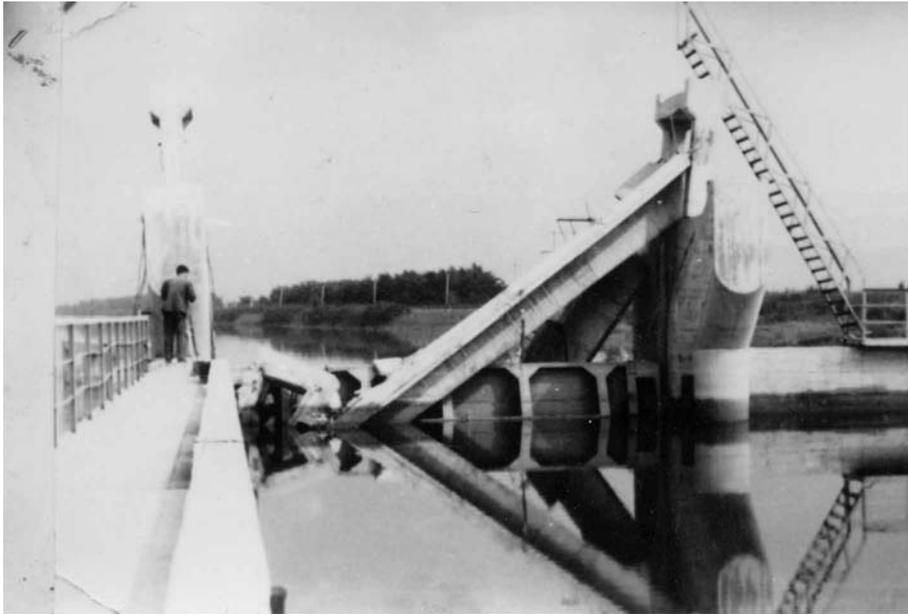
Photo 8. The upper lock head of the Peizhuang shiplock collapsed.

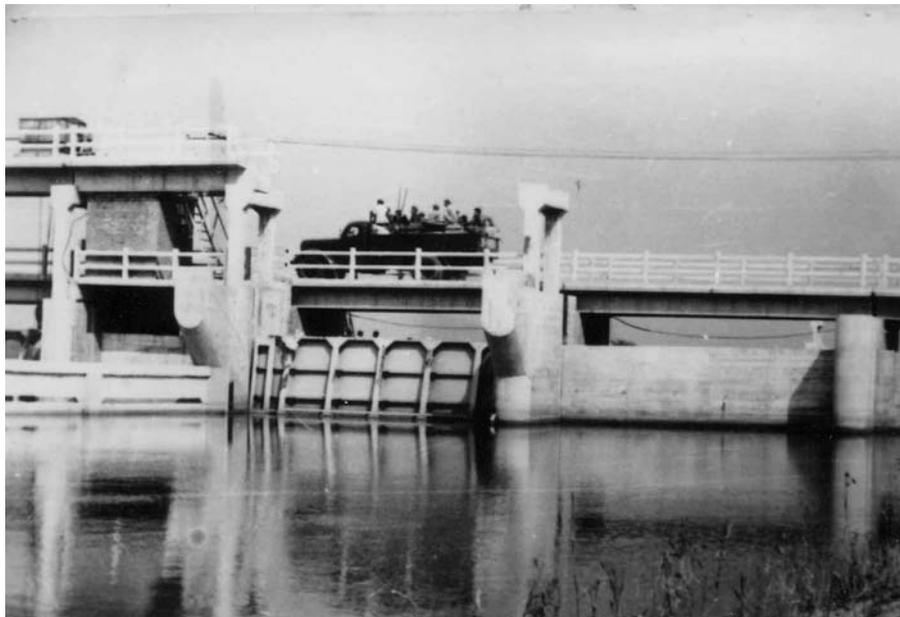
Photo 9. The down lock head of the Peizhuang shiplock collapsed.

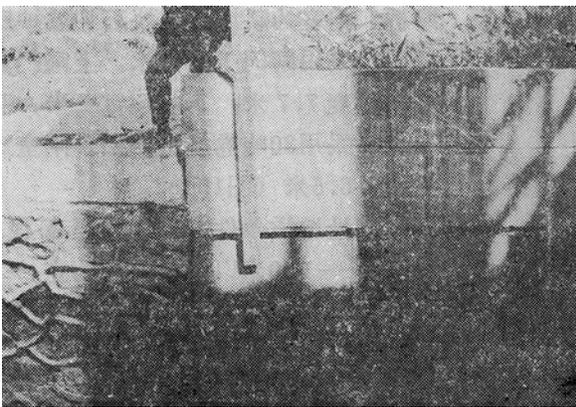
Photo 11. The Π frame column of the lock pier cracked at the Yonghe Shiplock.

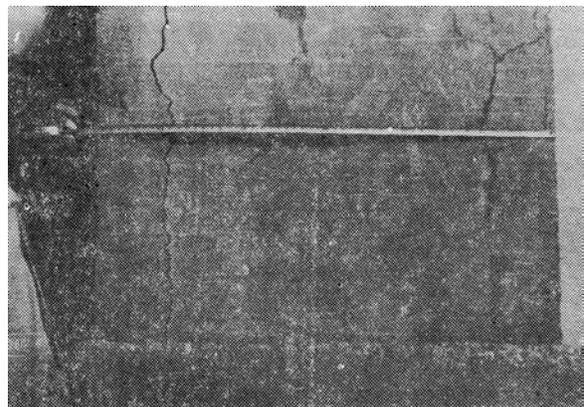
Photo 12. The left lock pier cracked at the Yonghe Shiplock.

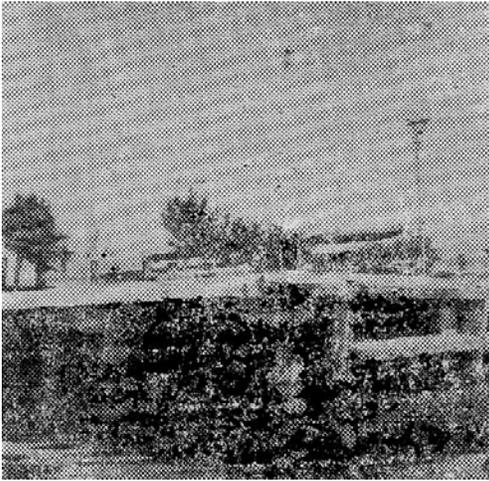
Photo 1. The upstream part of the wharf displaced forward and inclined at the Yujiapu Terminal.

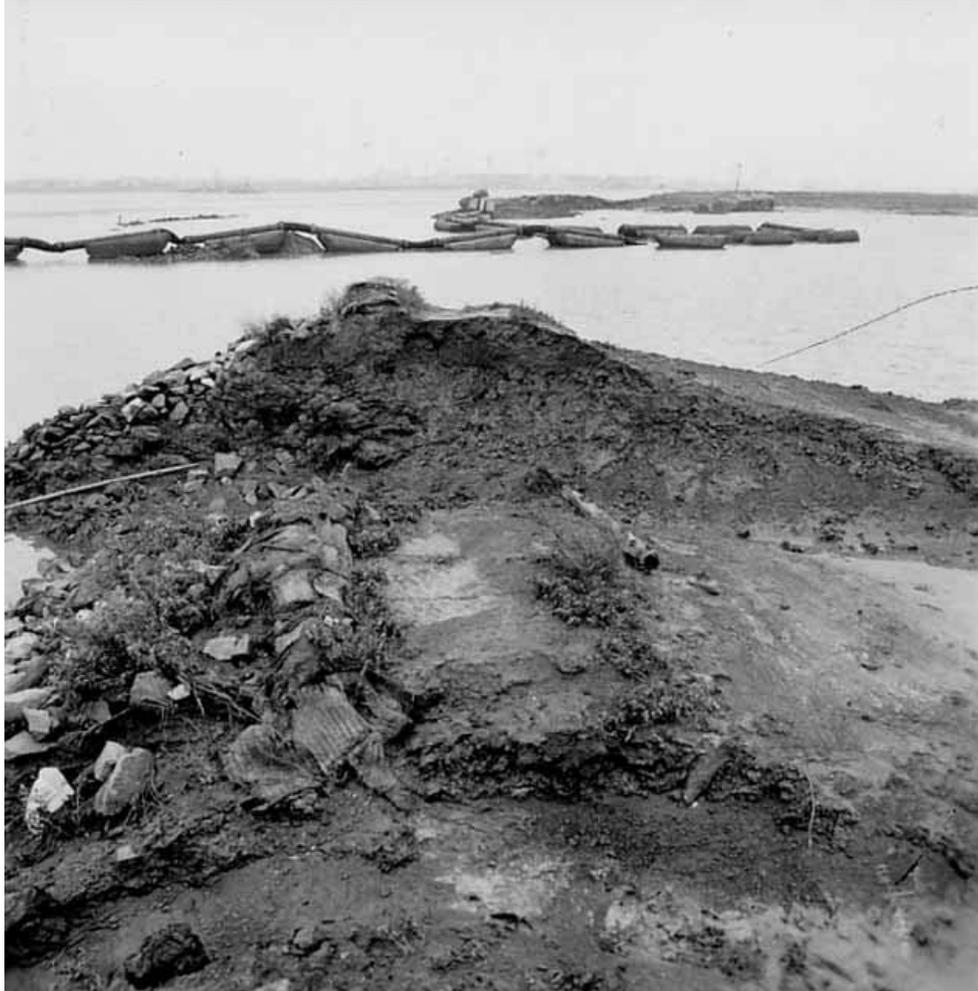
Photo 1. Sliding of the enclosure wall and foundation pit of the dock at the Marine Petroleum Exploration Bureau after the earthquake.
