NATIONAL TRANSPORTATION SAFETY BOARD
Office of Aviation Safety
Washington, DC 20594

Interim Factual Report

NTSB Case Number: DCA13IA037
Location: Boston, Massachusetts
Date: January 7, 2013
Aircraft/Operator: Boeing 787-8, JA829J, Japan Airlines

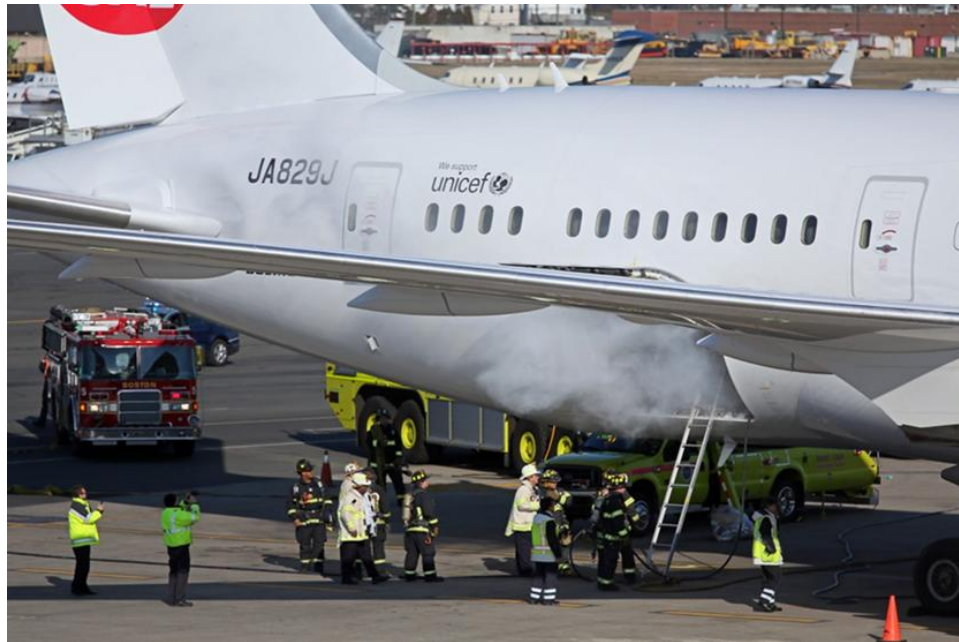
The JAL mechanic advised ARFF personnel that the fire was in the aft E/E bay and led a firefighter to the aft E/E bay door. The firefighter reported that, after entering the compartment, “a white glow about the size of a softball” could be seen on a hand-held thermal imaging camera¹⁸ and that he applied “a shot” of Halotron (a clean fire-extinguishing agent)¹⁹ to try to knock down the fire.²⁰ The thermal imaging camera showed that the white glow was still present but was less than before. The airport security camera video showed smoke coming out of the airplane, as shown in figure 1, at 1040:26.

Figure 1. Smoke emanating from the aft electronic equipment bay.

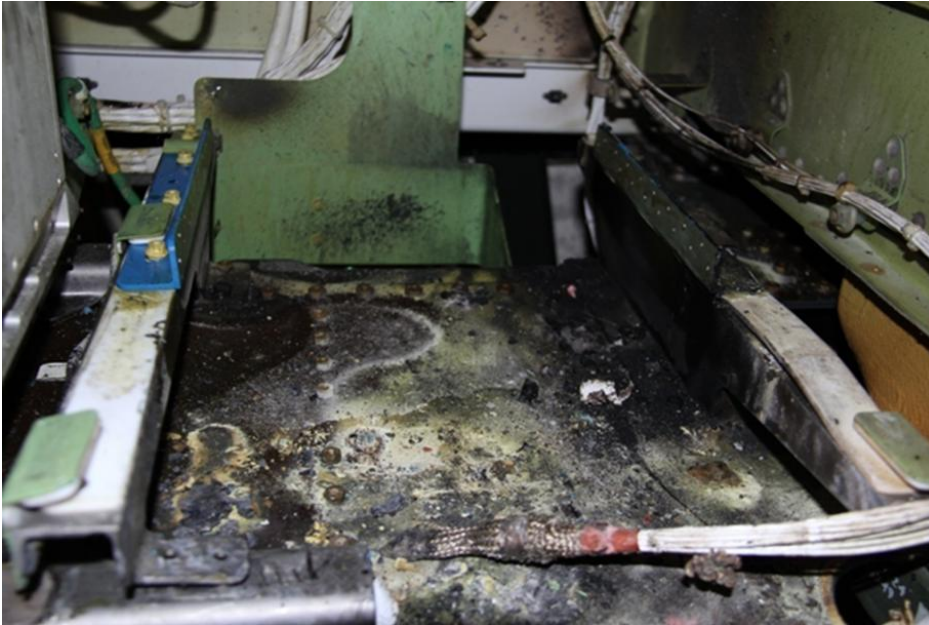
The APU battery installation location showed damage consistent with (1) heat generated from the APU battery and (2) smoke, hot gases, and electrolyte discharged from the battery, as shown in figure 5. Evidence of material expelled from the battery was seen in the areas behind the battery in the form of residue and thermal damage. The extent of thermal damage was confined to within about 20 inches from the battery installation. No primary structure (that is, those associated with airplane flight loads) was found damaged; secondary structure—specifically, the avionics rack²⁷ and the floor panel—exhibited thermal damage near where the APU battery had been installed.

Figure 5. Auxiliary power unit installation location with battery removed.

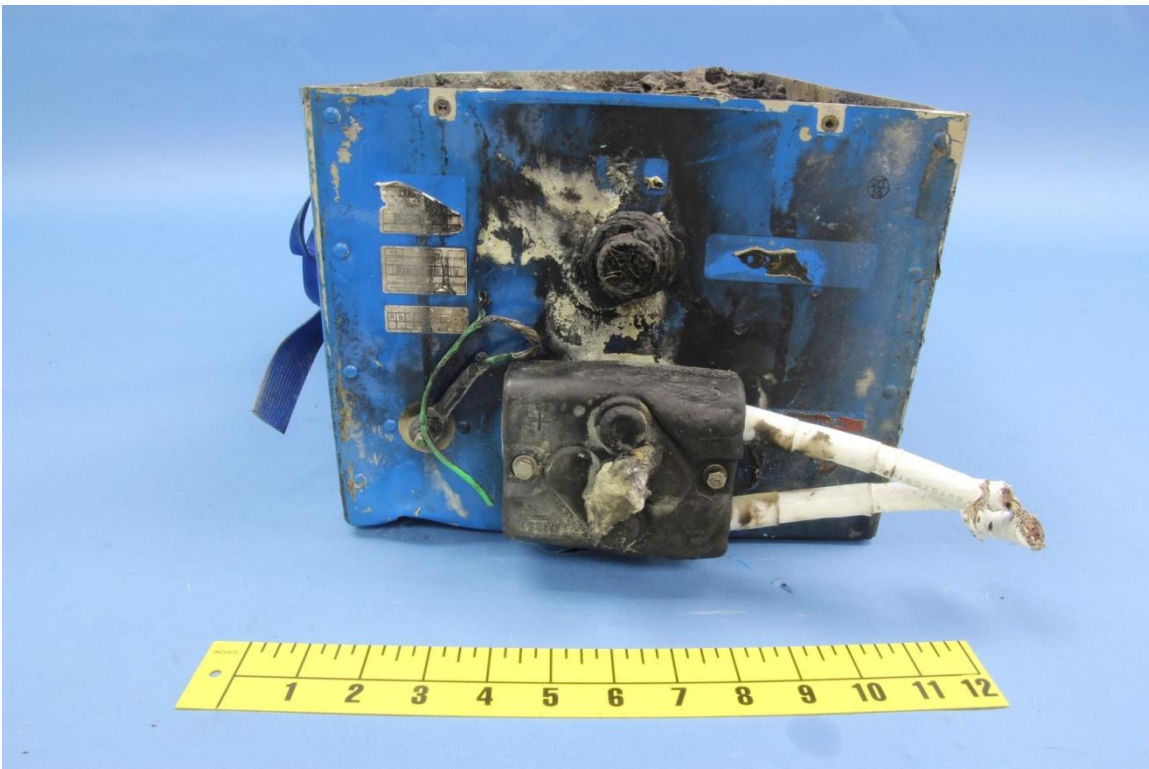
Side 1 of the battery case exhibited black residue and white powdery material on the exterior surface, which were consistent with the flames reported at the J1 and J3 connectors and the application of a dry chemical fire-extinguishing agent by the JAL mechanic. Additionally, on the lower edge of side 1, there was damage caused by a prying tool used by ARFF personnel in their efforts to remove the battery from the airplane. Side 2 of the battery case appeared to have the least visible damage of the four battery sides, with some soot residue observed and an area of bulking and a missing battery case attachment bracket associated with the battery's removal from the airplane. Sides 1 and 2 of the battery case are shown in figures 6 and 7, respectively.

Figure 6. Side 1 (forward face) of the battery case.

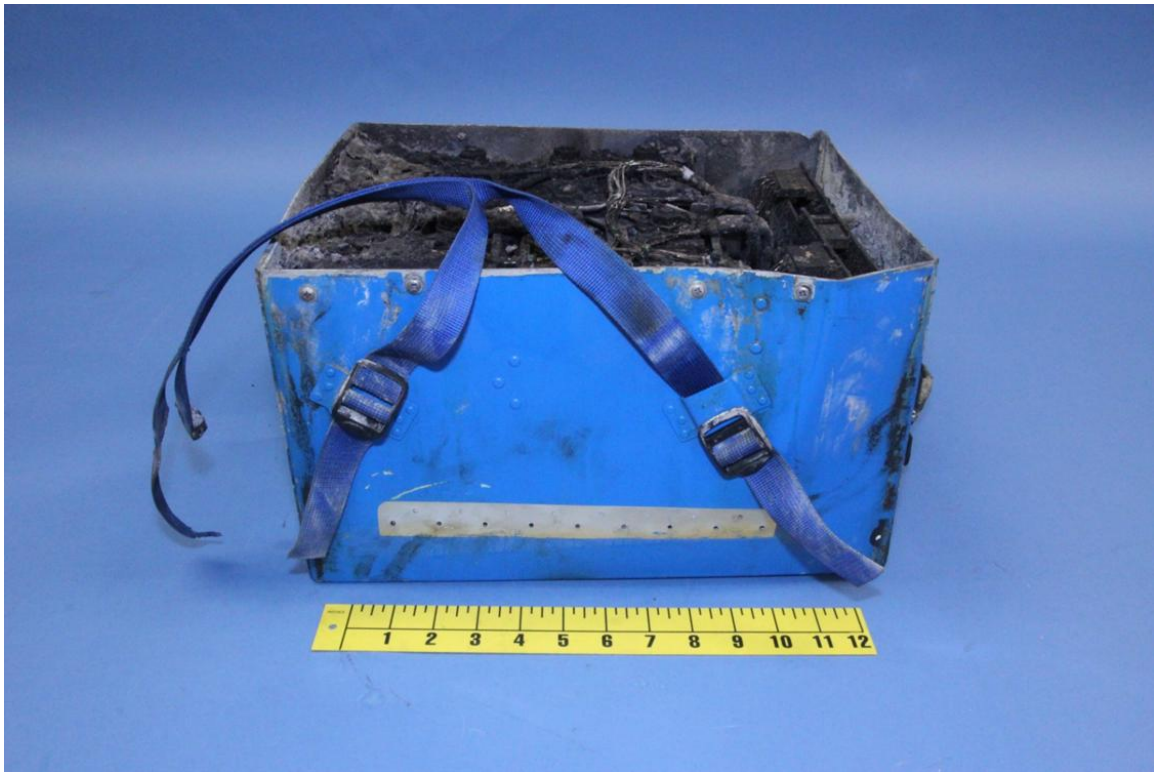
Figure 7. Side 2 (left side) of the battery case.

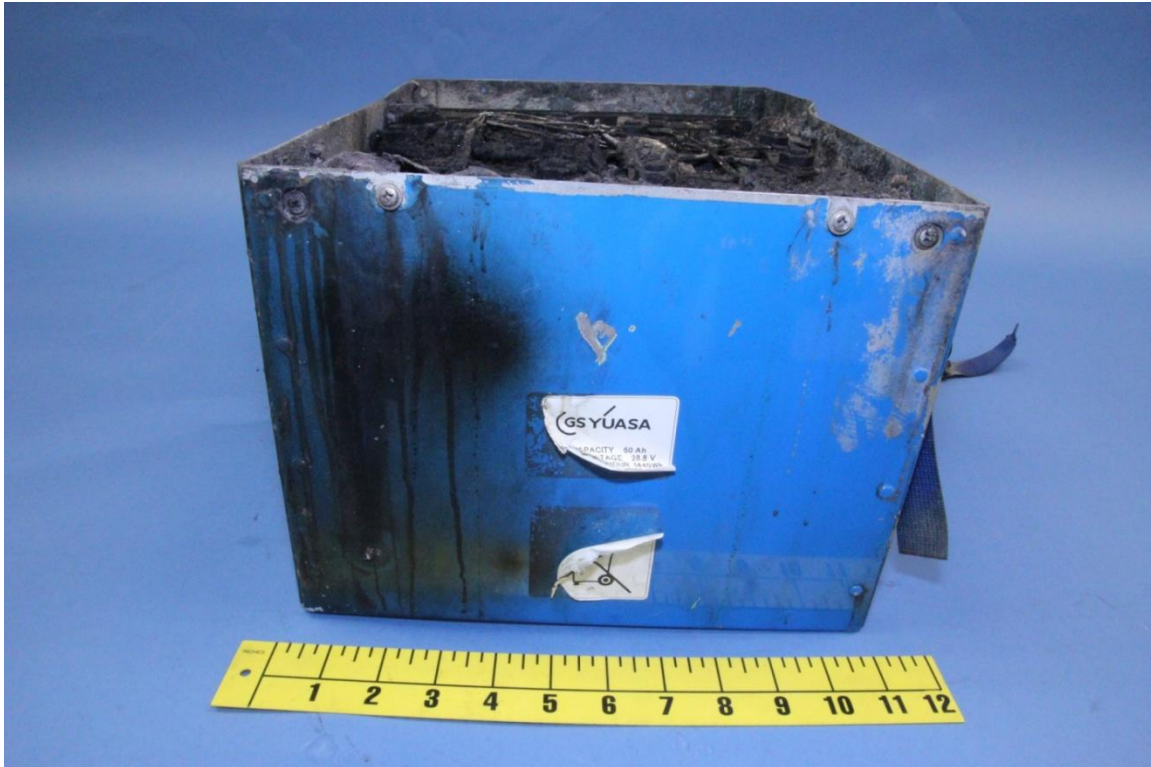
Side 3 of the battery case appeared to be minimally damaged near side 2 but was more heavily damaged near side 4. Vertical black streaks, which were consistent with residue from dripping liquid, were observed toward side 4 in a location that corresponded to the damaged corner of the battery lid. A roughly oval deposit of black residue covered the side 3 upper face near the side 4 edge. Side 3 had a mostly circular distortion—a paint discoloration about 1 inch in diameter with a 0.25-inch-wide nodular protrusion in the middle—near the lower corner adjoining sides 3 and 4. The protrusion was located about 1.5 inches from the bottom and 1.5 inches from the left edge. Side 3 of the battery case is shown in figure 8.

Figure 8. Side 3 (aft face) of the battery case.

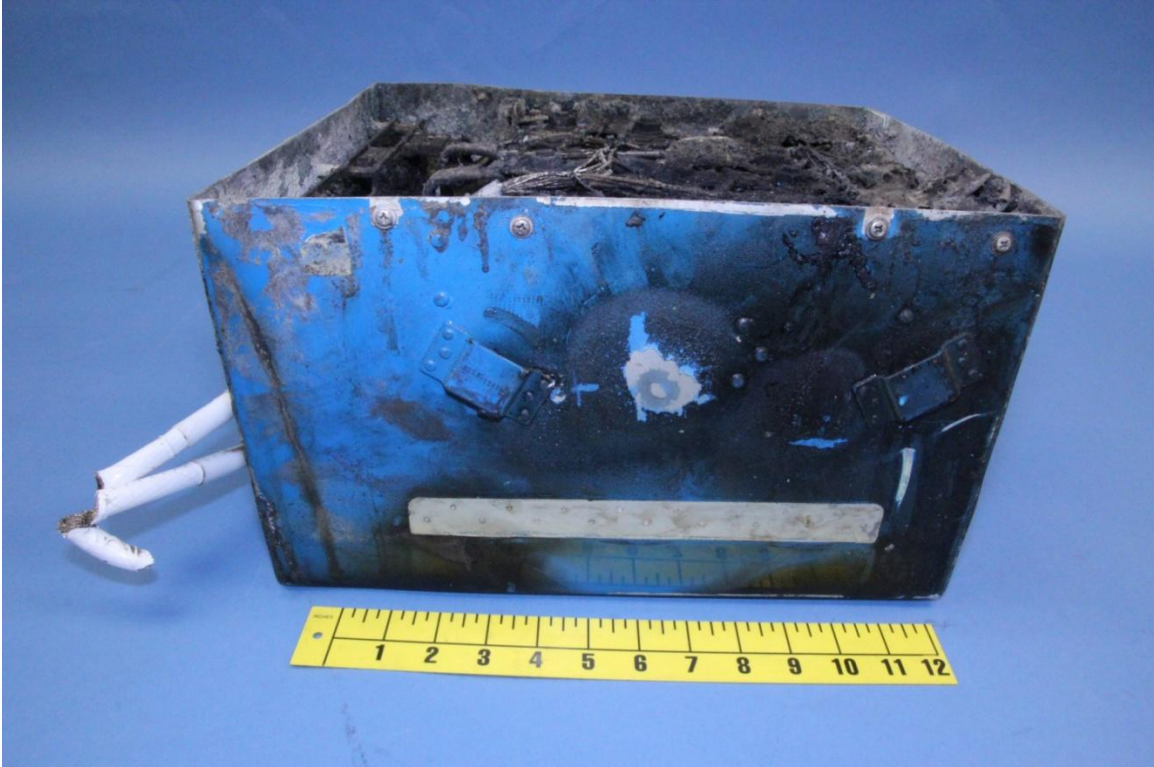
Side 4 of the battery case appeared to have the most extensive damage of the four battery sides. The exterior was heavily coated with black residue that was concentrated near side 3. Thicker black deposits were visible on the right side near the battery lid. Large, mostly circular areas of thermal damage to the paint were located at the same elevation as the battery cell vent discs,³² as viewed from the exterior. A distortion and an area of missing paint were adjacent to and opposite of the cell 7 vent disc. An area of thermal damage to the paint was adjacent to and opposite the cell 6 vent disc. In both of these vent disc locations, the black residue that remained had a different appearance than the surrounding residue. For the cell 7 vent disc location, the soot and paint had disbonded, leaving a relatively concentric appearance. Paint discolorations were also visible at the cell 5 and 8 locations. The battery case attachment bracket was missing from this side, which was consistent with the removal of the battery from the airplane by ARFF personnel. Side 4 of the battery case is shown in figure 9.

Figure 9. Side 4 (right side) of the battery case.

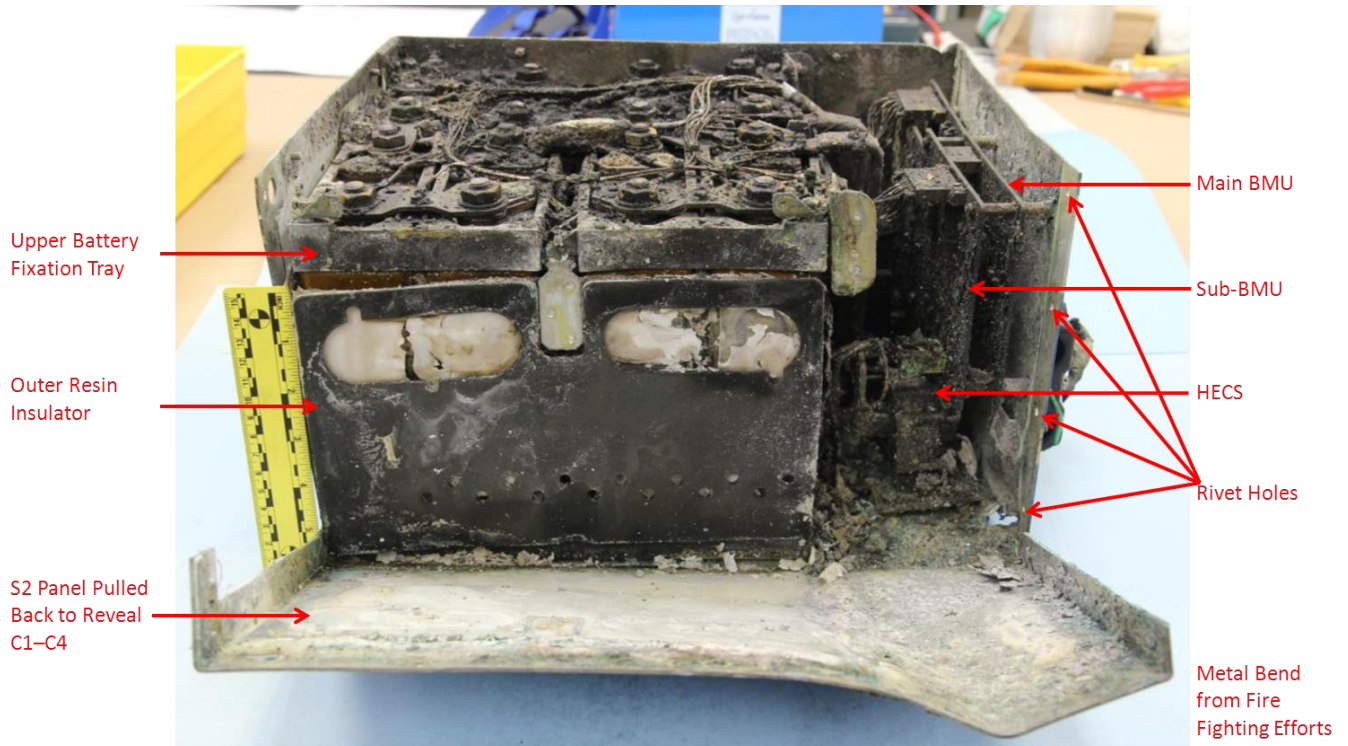
The battery was disassembled so that the internal components could be examined. Side 2 of the battery case was folded down to reveal cells 1 through 4, as shown in figure 10. The insulation sheet remained in place adjacent to the battery cells. Behind the insulation, a portion of the insulation sheet was visible but was missing some sections. Although the insulation between cells 1 through 4 was damaged, the material was distinguishable from other thermally damaged material in the battery case. The interior surface of folded-down side 2 had a clean area with a similar outline to that of the insulation sheet. The rest of the interior surface of side 2 was coated with residue.

Figure 10. Battery case with side 2 folded down.

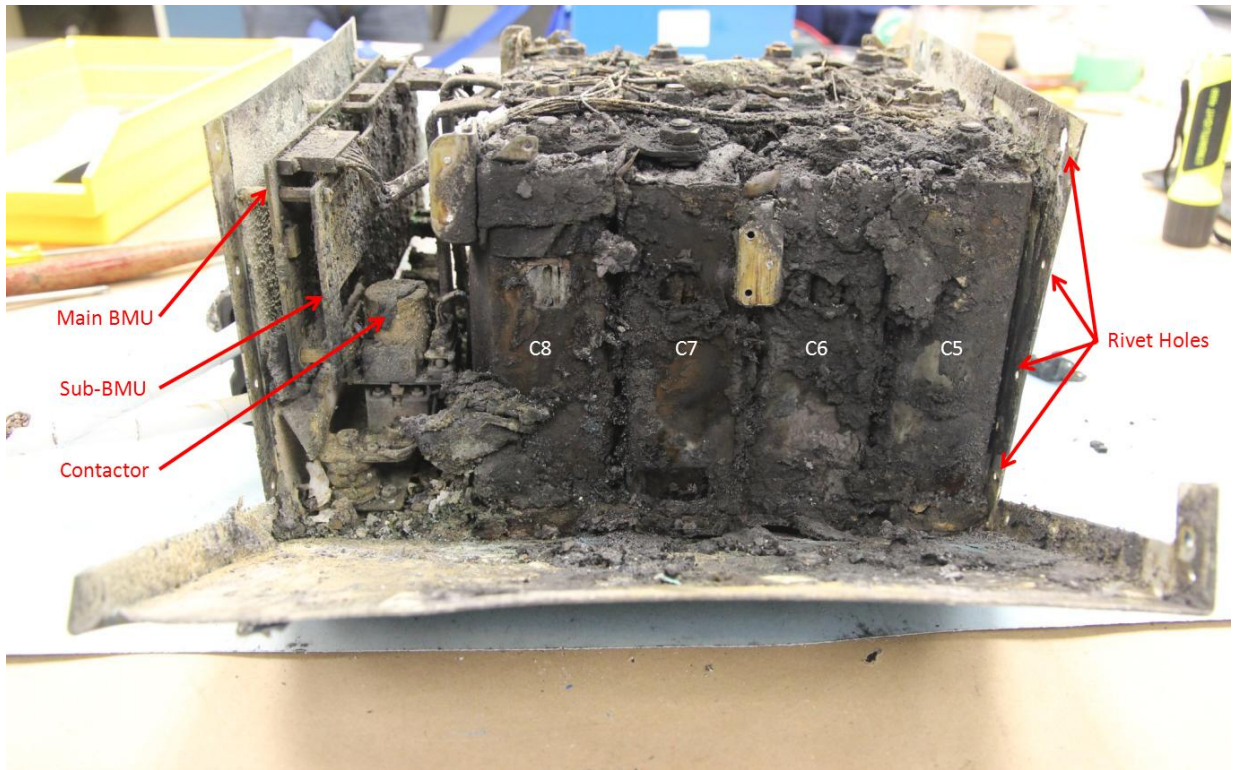
Battery case side 4 was folded down to reveal the position of cells 5 through 8, as shown in figure 11. The cells exhibited a darkened, charred appearance. The insulation sheets were completely charred and were indistinguishable from each other and other thermally damaged material in the battery case, and portions of the charred insulation adhered to the cells. The interior surface of folded-down side 4 had portions of the charred insulation adhering to areas where the insulation sheets contacted the interior surface. The rest of the interior surface of side 4 was coated with residue.

Figure 11. Battery case with side 4 folded down.

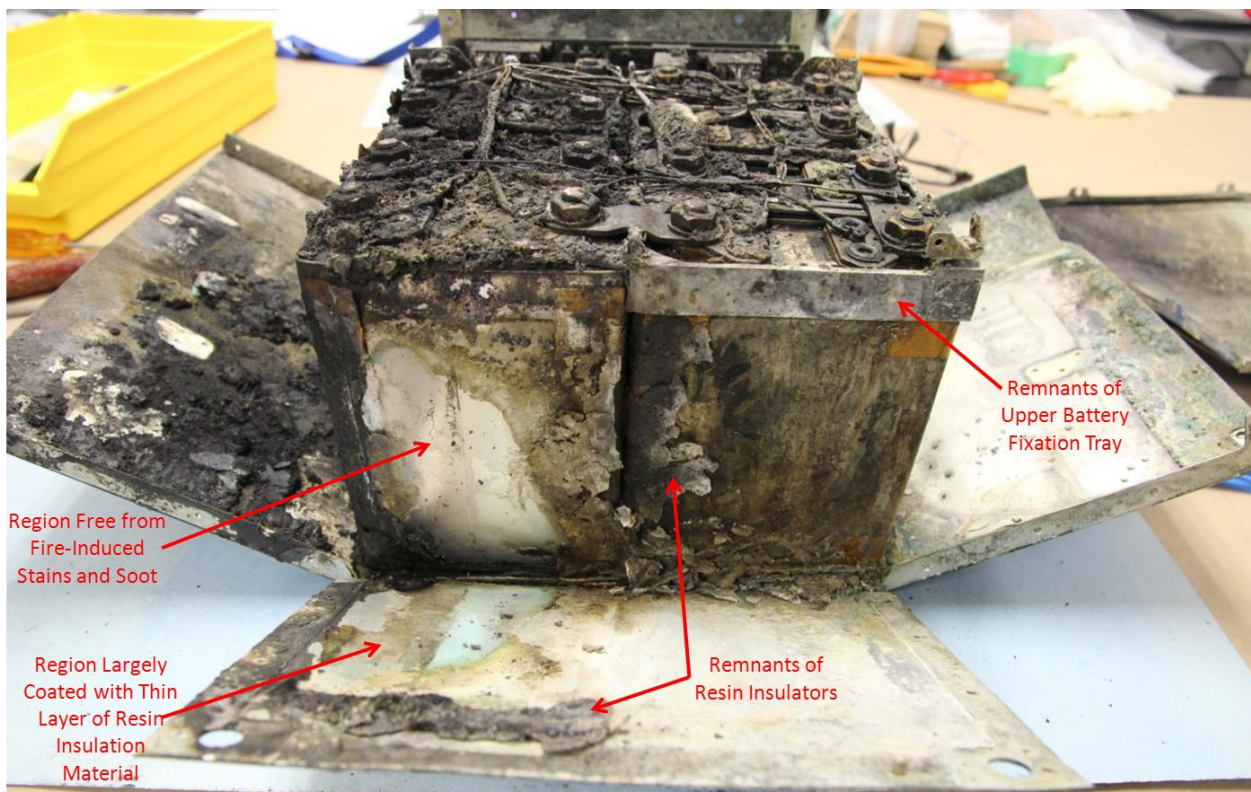
Side 3 of the battery case was folded down to reveal the sides of cells 4 and 5, as shown in figure 12. The side of cell 4 had staining that resembled a flowing residue. The side of cell 5 had similar staining but also had a clean area on the cell case. The corresponding area on the interior surface of folded-down side 3 had large portions of insulation adhering to it. The insulation along side 3 was thermally degraded and fragmented, and the portions of the insulation adhering to the battery case directly behind cell 5 exhibited some thinning. The damage in the area of the nodular protrusion that was observed on the side 3 battery case corresponded with damage to the cell 5 case, as discussed in section 1.5.3.

Figure 12. Battery case with side 3 folded down.

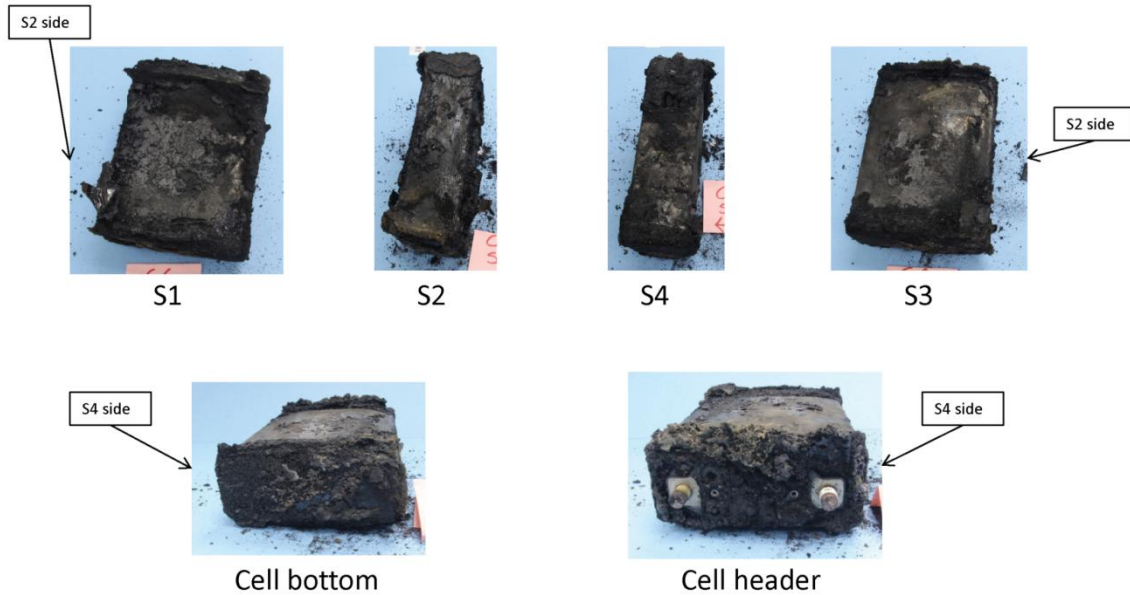
Figure 13. Views of cell 6.

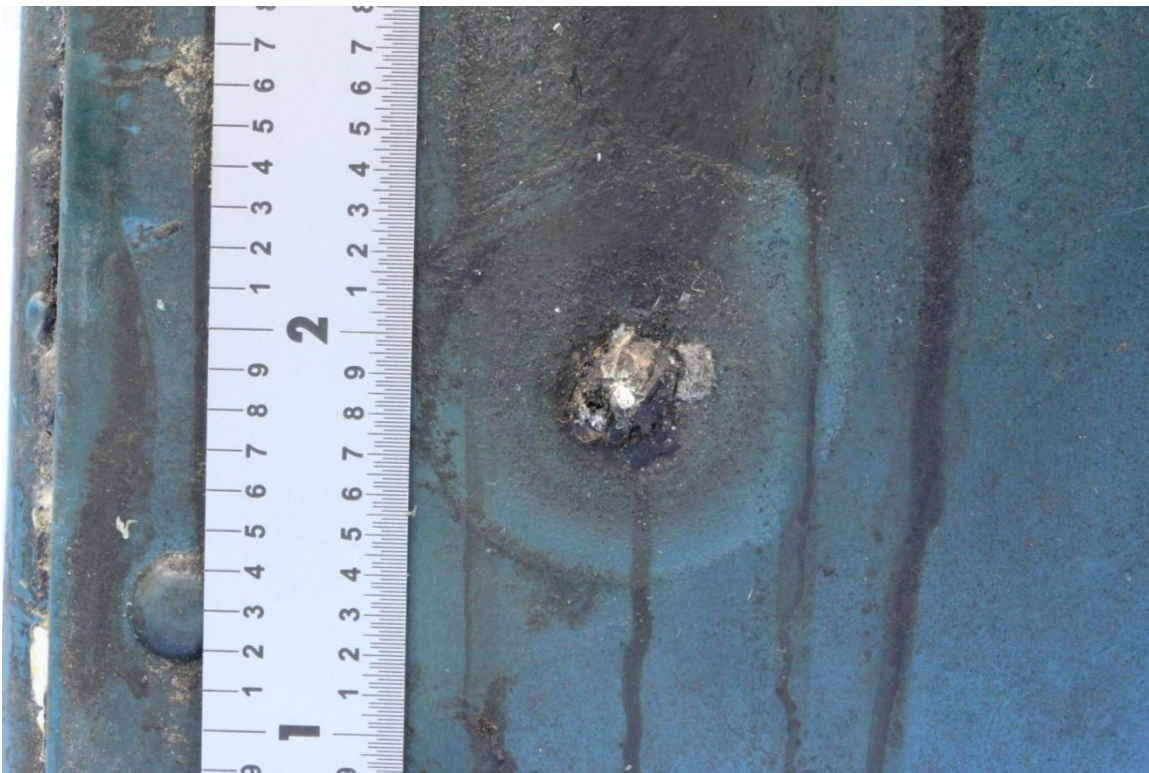
As previously stated, the battery case exhibited a 0.25-inch-wide nodular protrusion on the lower left of side 3, as shown in figure 14. The protrusion extended about 0.12 inch from the case. Two concentric rings surrounding the protrusion corresponded with the discoloration of the exterior paint. (The protrusion appeared metallic and was absent of paint.) Deposits consistent with thermally degraded materials were observed on and near the protrusion, and at least three holes in the battery case and on the periphery of the protrusion were identified. The largest of these holes was elliptical in shape, with its longest dimension measuring 0.080 inch. The two other holes, which were similar in size, measured about 0.004 inch. Most of the interior side of the protrusion contained dull gray flakey material that was consistent with spatter and shiny black material that was consistent with charred plastics and tars.

Figure 14. Protrusion on the lower left of battery cases side 3.

The side of the cell 5 case that faced side 3 of the battery case had been heavily damaged, especially on its periphery. Four holes measuring between 0.005 and 0.050 inch were identified on the lower portions of this side of the cell case, all of which exhibited large amounts of dark, rough-appearing features consistent with decomposition products. The largest hole (in terms of size and amount of decomposition products) corresponded with the location of the protrusion on the battery case.

The protrusion was inspected using a scanning electron microscope (SEM) and energy dispersive x-ray spectroscopy (EDS). The inspections determined that arc damage occurred from contact between the cell 5 case and the battery case.³⁴ Evidence of material transfer between the cases was only found on the interior surface of the battery case and exterior surface of the cell case. The case for cell 5 is located about 0.2 inch from the battery case. The battery case exhibited no inward deformation at the protrusion, whereas the cell case exhibited outward expansion. These features are indicative of arc damage between the cases after expansion of cell 5. SEM and EDS inspections also showed that all the holes on the cell 5 case exhibited various compounds and alloys that were not part of the cell case material, and inspection by EDS showed that this material was consistent with the battery case material.

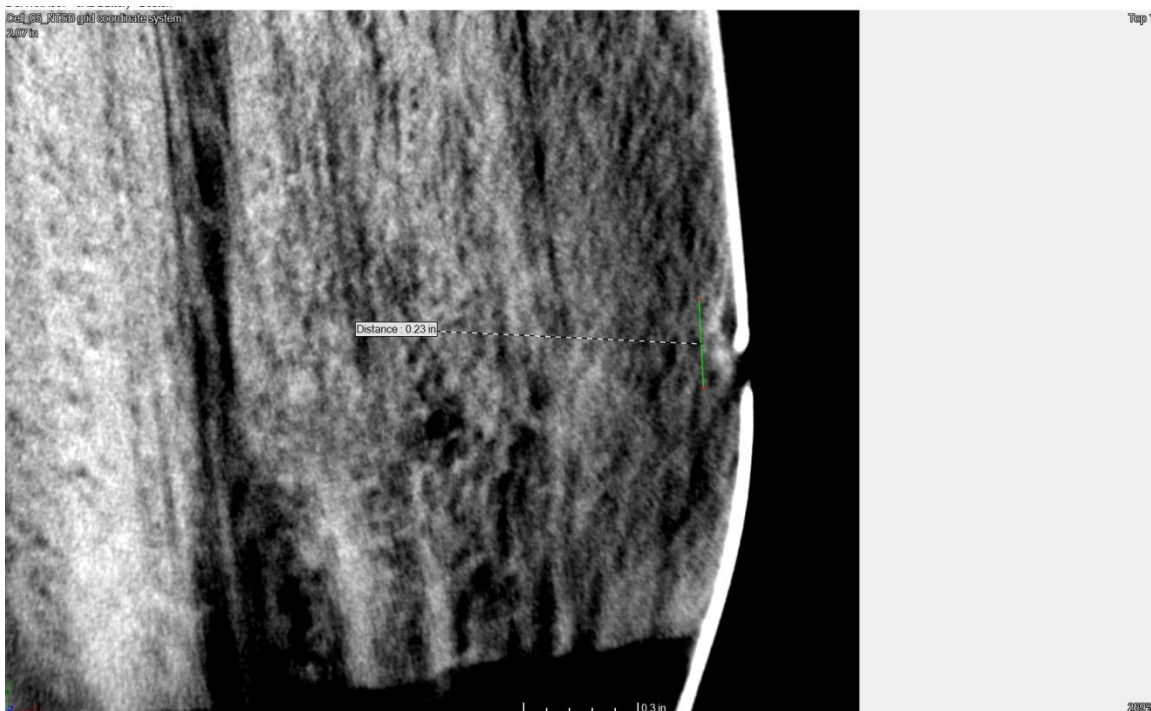
- There were two cell wall breaches in separate locations identified during the radiographic examination.³⁷ The larger of the two breaches appeared to consist of separate smaller holes, as shown in figure 16. The smaller breach appeared to consist of a single hole with some material missing from the outer cell wall around the hole. There were some anomalies inside the cell near the breaches; these areas differed from the general appearance of the cell.

- Two of the six aluminum (cathode) current collector fingers had breaks that appeared to have rounded material on the ends. The breaks also appeared to go all the way through the fingers. The copper (anode) current collectors were intact.
- Some high-density areas were noted within the electrode assembly generally along the edges and next to the cell wall.

Figure 16. Top view of cell 5 showing cell wall breach.

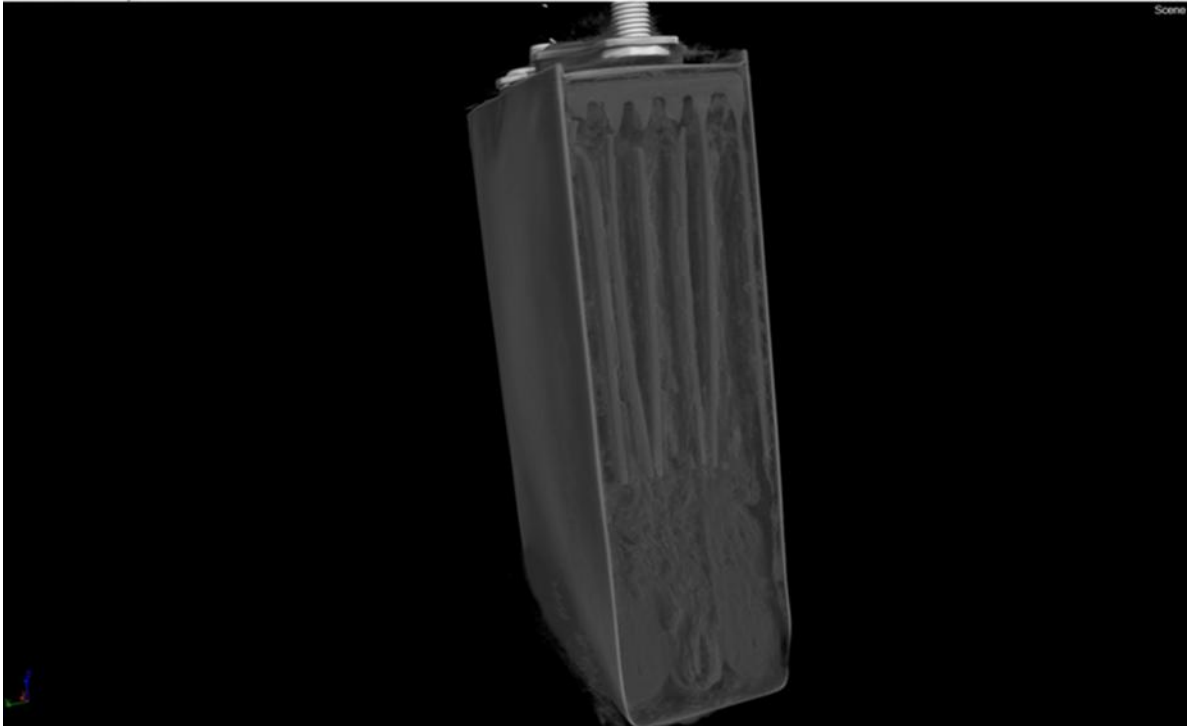
- Four of the six aluminum (cathode) current collector fingers had breaks, as shown in figure 17, including one that had multiple breaks and one that was missing more material in its break than the other current collector fingers with breaks. The gap in missing material measured about 0.15 inch. The copper (anode) current collectors were intact.
- There were a number of locations where a lump of medium-radiodensity material appeared to have flowed outside of the electrode assembly. In general, a small ribbon of material connected the lump with the rest of the electrode assembly.

Figure 17. Three-dimensional view of aluminum current collectors in cell 6.

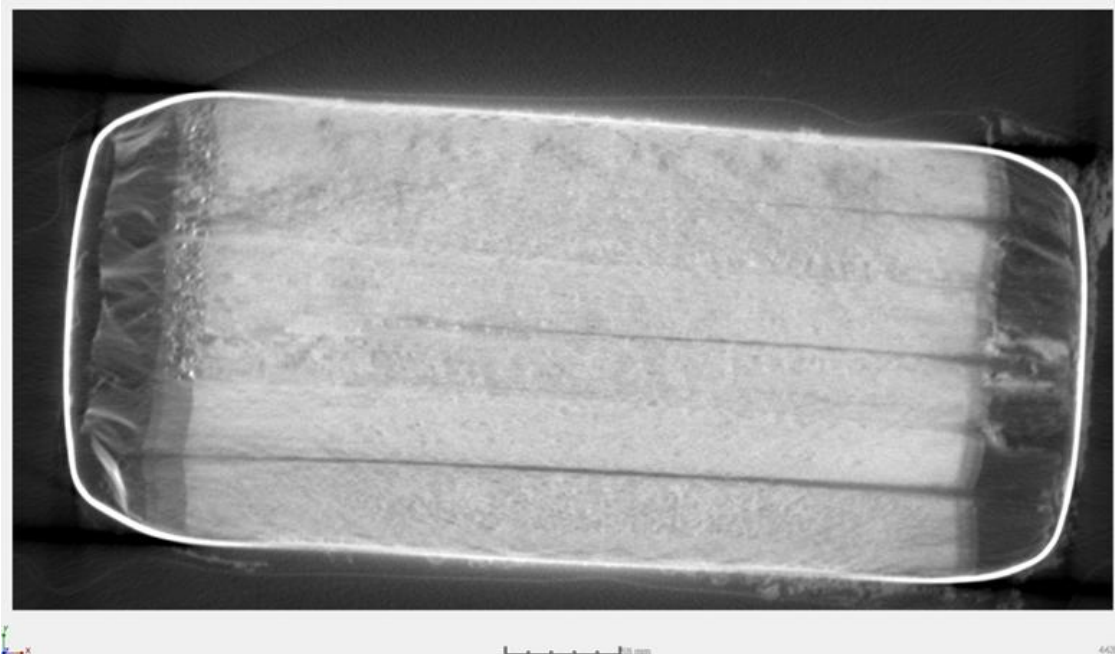
- A possible low-radiodensity area was noted at the top of the cell between the electrodes, and a distinct high-radiodensity region was noted in the cell wall.
- Four of the six aluminum (cathode) current collector fingers had breaks, including one that had multiple breaks. All six fingers appeared to be displaced from their original positions. The copper (anode) current collectors were intact.
- There were some variations in the appearance of the electrode assembly throughout the cell. In particular, the electrode assembly in one location appeared to be more granular than other areas in the cell, as shown in figure 18.

Figure 18. Granularity noted in top view of cell 7.

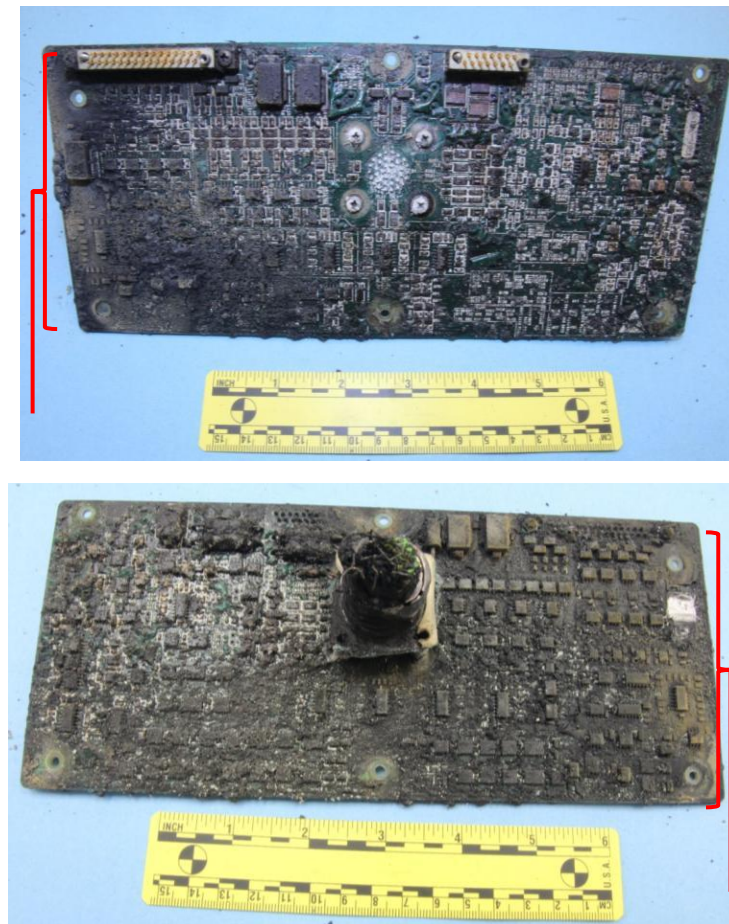
The BMU main circuit card and sub-circuit card were visually inspected before functional testing began. The visual inspections found thermal damage to various components, including the printed wiring boards⁴⁰; the damage to the BMU main board is shown in figure 19. The thermal damage precluded the ATP from being performed. (The ATPs for the BMU main circuit card and sub-circuit card were completed successfully during the manufacturing process in May and June 2012, respectively.)

Figure 19. Battery monitoring unit main board.

One of the transient voltage suppressors mounted on the main BMU circuit card was found detached from the circuit card. (A transient voltage suppressor is designed to protect an electronic circuit from a sudden or momentary overvoltage condition.) The BMU and suppressor had passed manufacturing quality tests and would have logged a failure if the suppressor had detached before the incident. The melting point of the solder (which attached components to the circuit board) was below that of the maximum heat within the battery during the incident. The two suppressors that were part of the circuit containing the detached suppressor were functionally checked on test equipment using a multimeter, and the components measured nominally. The suppressor that was found detached was further tested using a variable DC power supply, and the component operated per specification.
