Offshore Petroleum Safety Regulation

Varanus Island
Incident Investigation

by
Kym Bills and David Agostini
June 2009

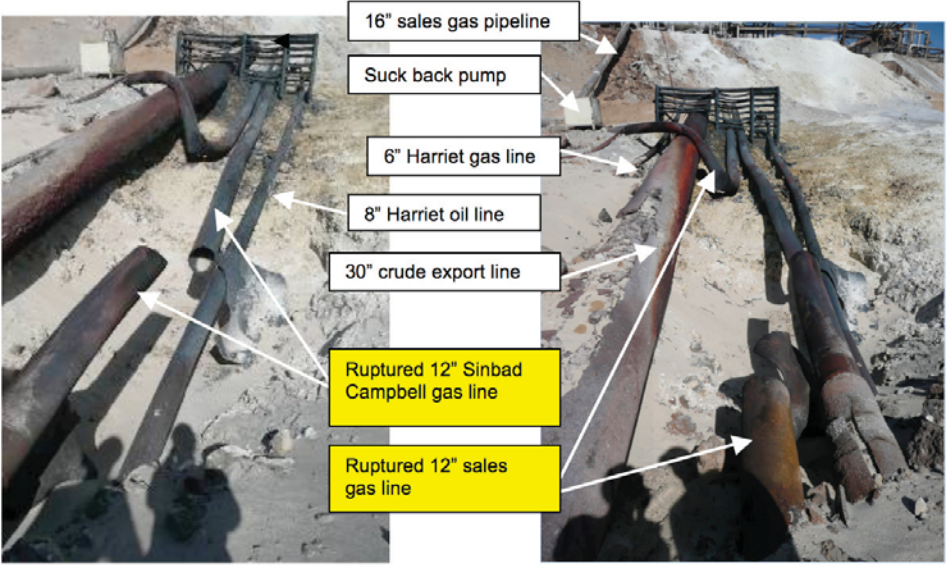
Photo 4 a) & b) – Ruptured 12" pipelines

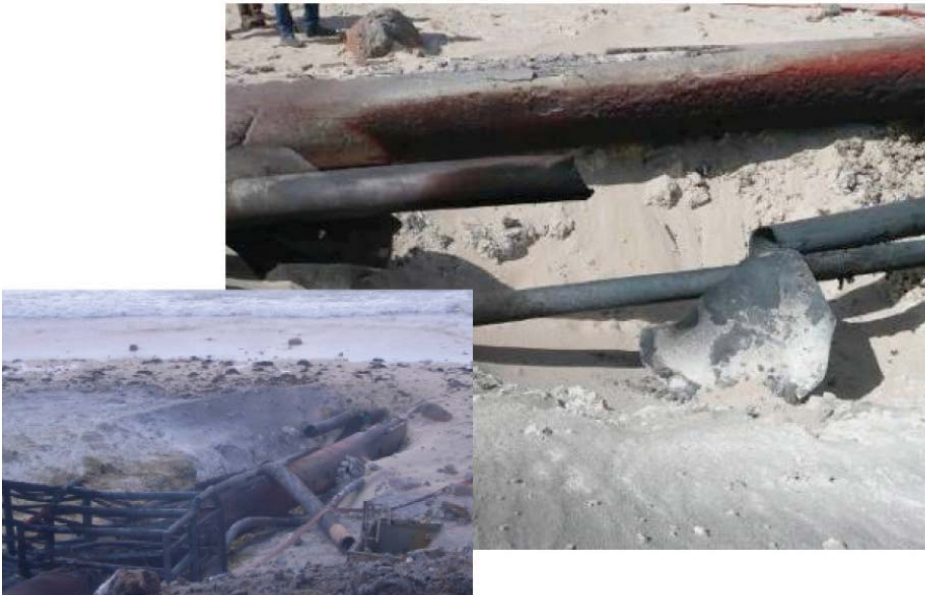
Photo 5 – Explosion crater

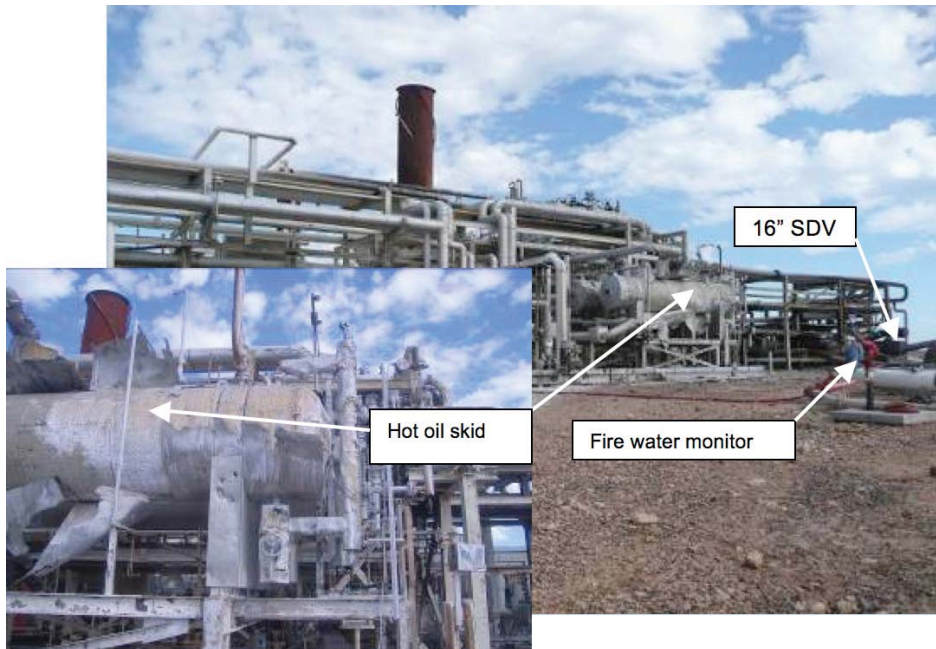
Photo 8 – Damaged gas plant

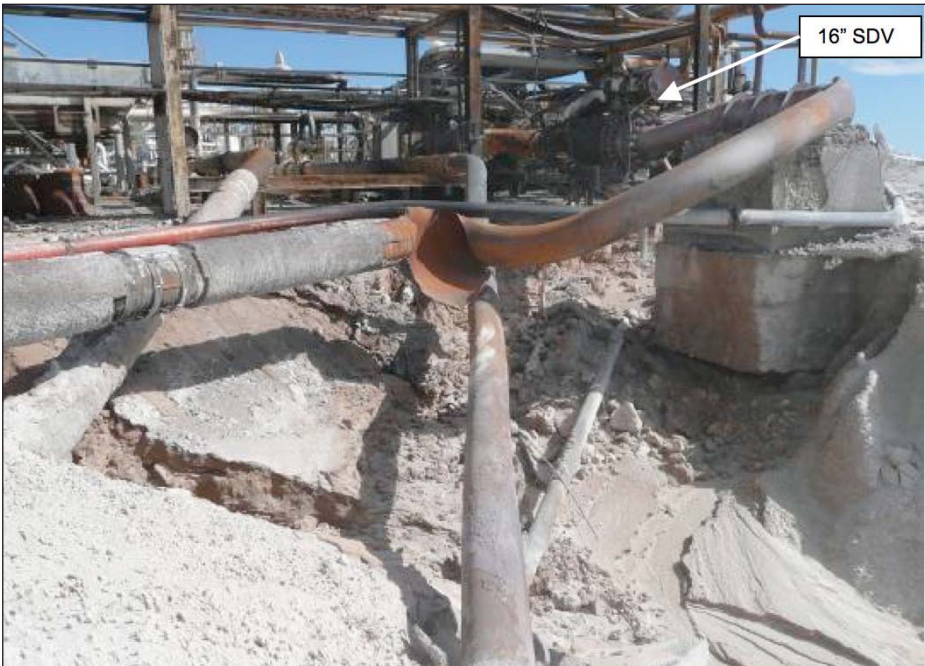
Photo 10 – Ruptured 16” sales gas line

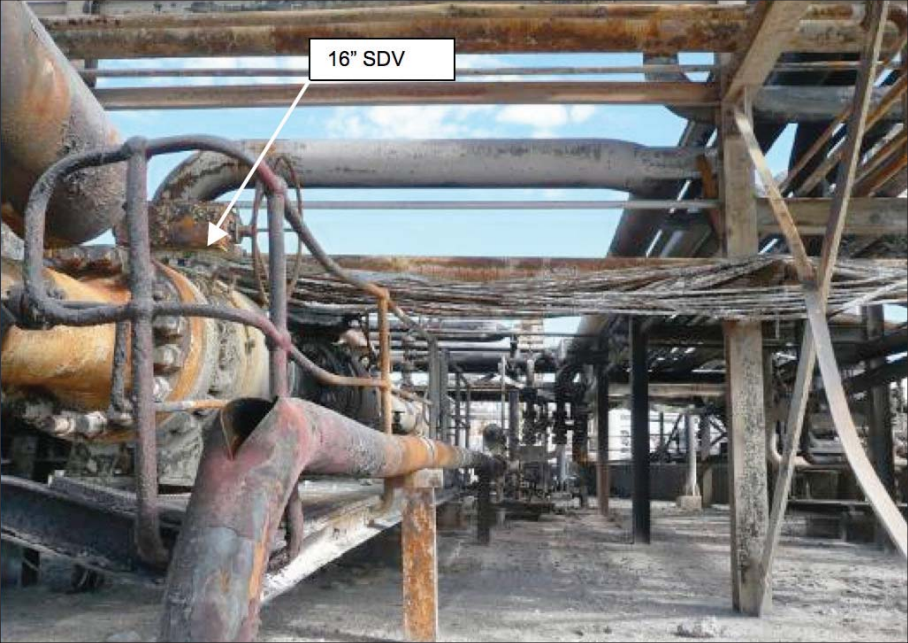
Photo 11 – Ruptured 6” Harriet gas line

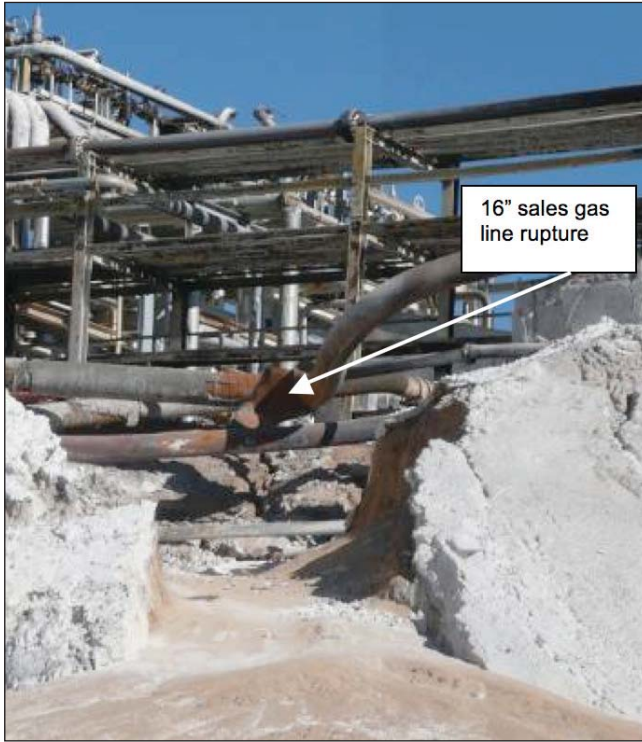
Photo 13 – Seawall banking water and jet fire erosion

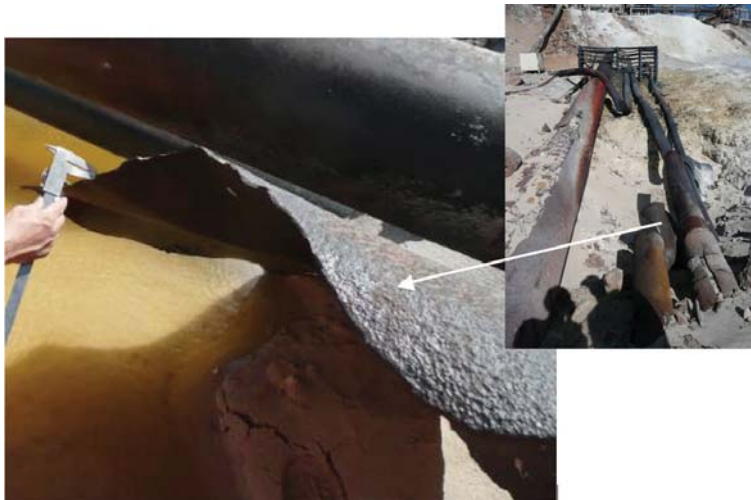
Photo 14 – Ruptured section 12" sales gas line, external corrosion and wall thinning

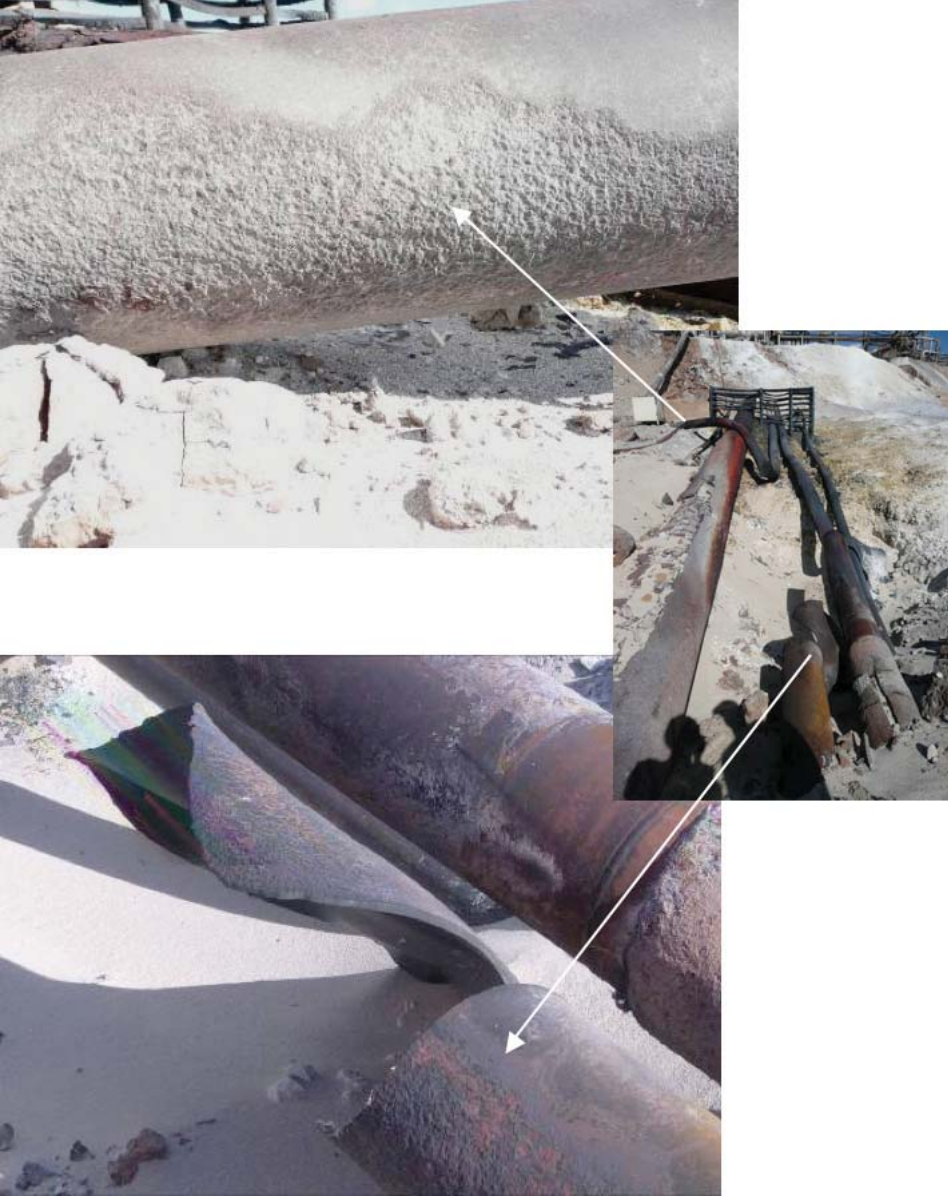
Photo 15 - Ruptured section 12" sales gas line external corrosion

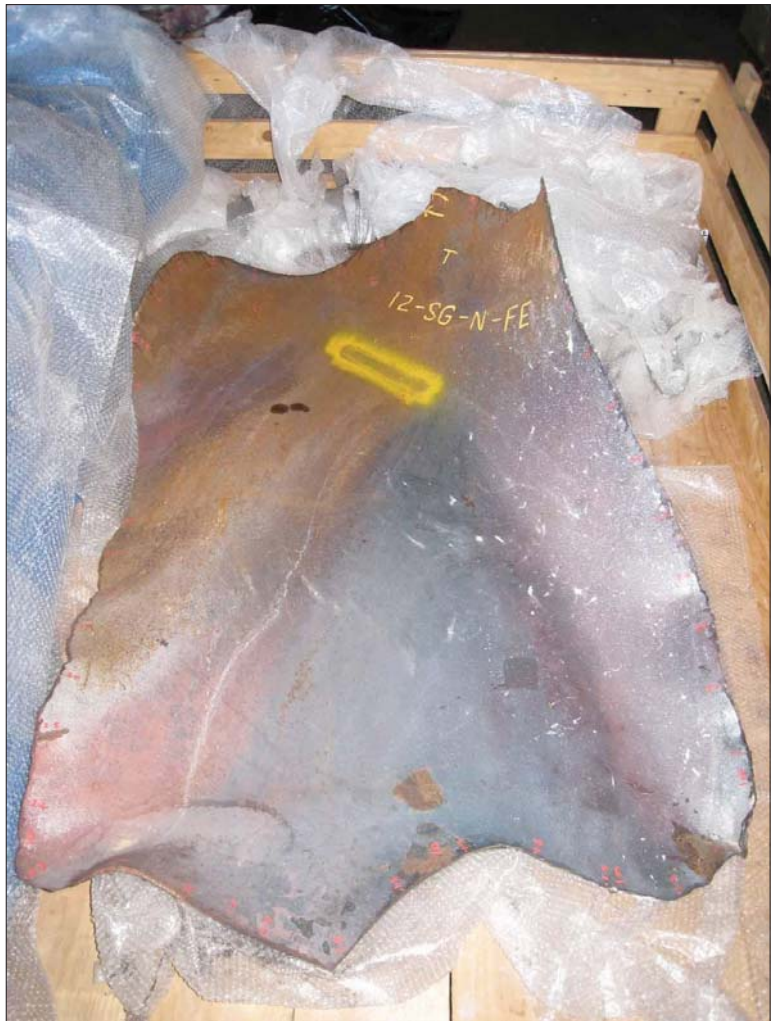
Figure 3.1.1
General view of the inner surface of the 12-SG-N-FE piece of pipe, unwrapped by bursting

The once cylindrical length of pipe had been unwrapped and flattened by bursting to become a sheet of pipe steel.

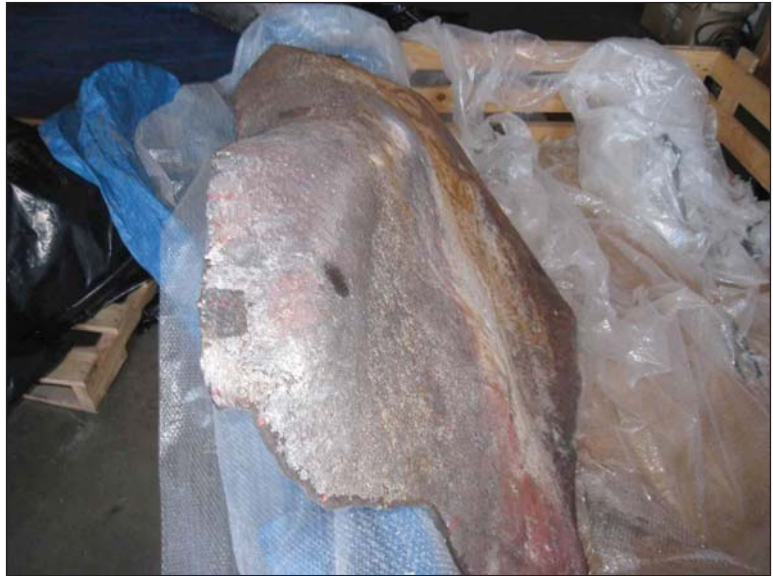
Figure 3.1.3
External surface of 12-SG-N-FE

Surface roughness characteristic of long term corrosion was observed in a band approximately one third of the width of the sample adjacent to the left hand edge visible in figure 3.1.3. A similar band was observed adjacent to the right hand edge. The colour of the products of corrosion formed by the longer term corrosion were dark brown.

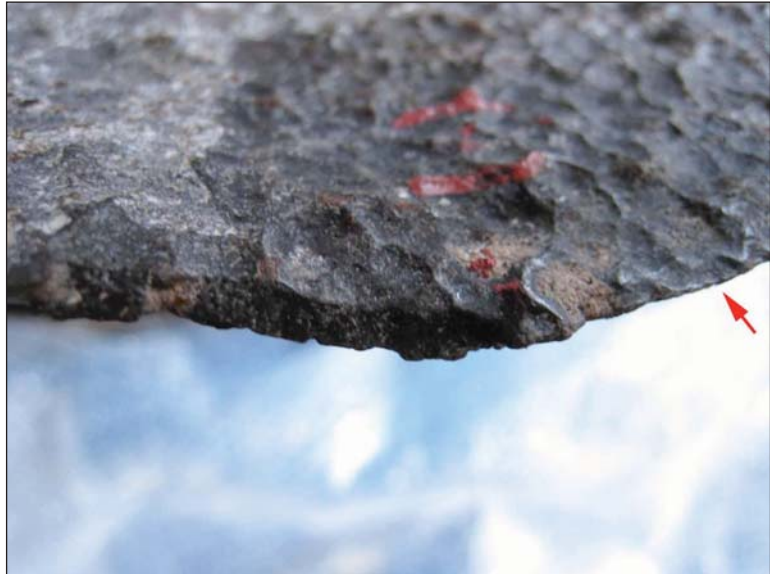
Close up view of part of the left hand edge showing corrosion pits and a chisel edge at the arrow, adjacent to the position marked 1.1 in red

The fracture surface chisel edge thickness, measured by steel tape, was of the order of 1 mm.

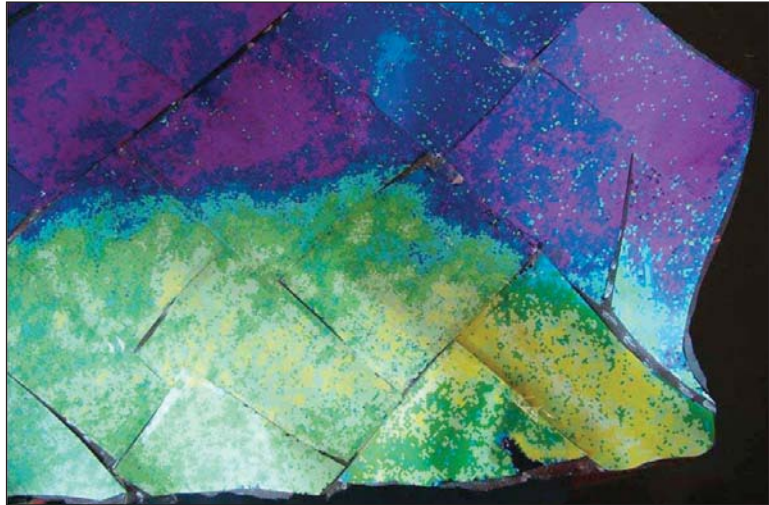
Colour prints of a set of μ maps attached to the surface of the 12-SG-N-FE pipe piece

The thinnest positions in yellow can be seen towards the bottom right of the photograph.

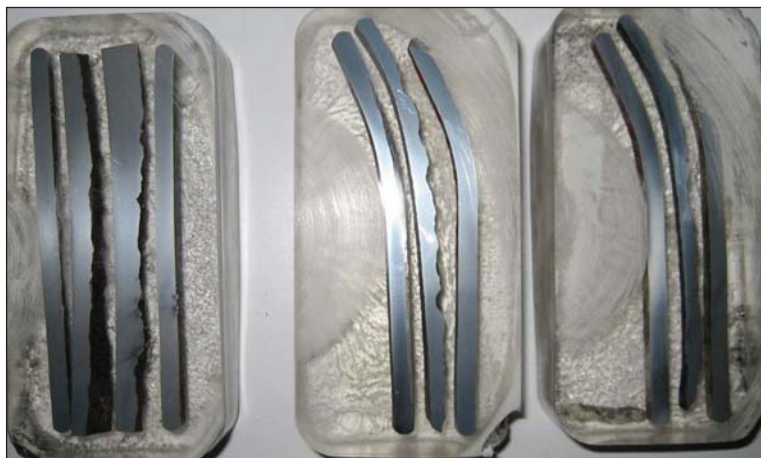
Examples of full wall thickness metallographic macro sections cut from the 12-SG-N-FE piece of pipe.

A visual indication of the loss by corrosion can be obtained by comparison with the least corroded top end thickness of the third sample from the left.

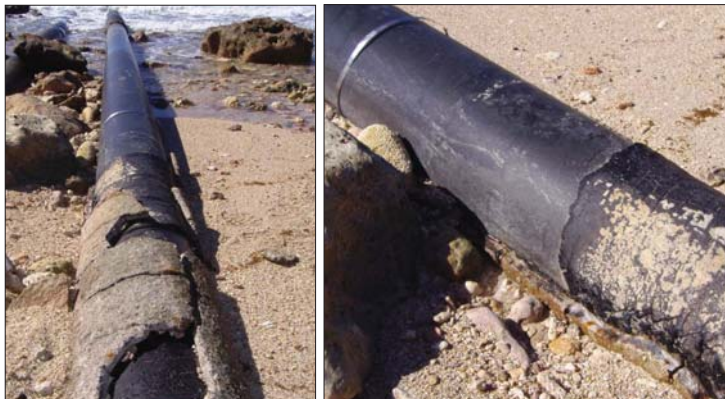
- d) The report indicates that there was a 2m section of missing weight coat. Photos taken subsequent to the rupture indicate that as well as the weight coat the anti-corrosion asphalt enamel coating was probably missing as well.

The photograph on the right is from Photograph A52741 and shows the end of the asphalt enamel. The asphalt enamel is to the right and the bare pipe (or primer only coated pipe) to the left. The photograph on the left is from Photograph A52742 and shows the end of the asphalt enamel on the close side of the stainless steel strap, and how the lack of asphalt enamel extends to the remote concrete weight coat near the water.

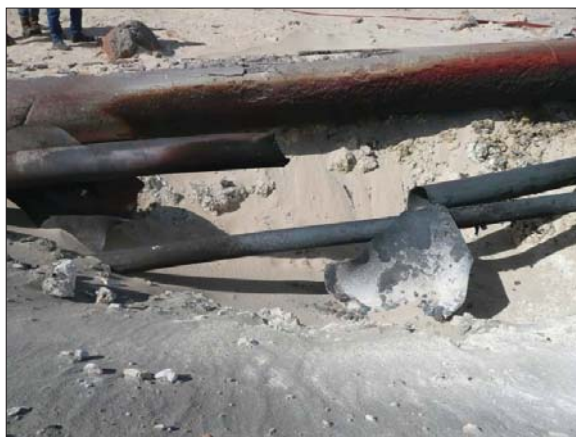
The photograph below is Photograph P1010253 and shows the sand environment at the rupture site.

To allow for the effect of environment resistivity on CP, CP standards require that the CP potential be measured with a technique that allows for this phenomenon. For example AS2885.3:2001 calls up the CP criteria in accordance with AS/NZS2832.1:2004 which, in Clause 2.2.2.1, says that the criteria apply providing that there is not a significant voltage gradient in the electrolyte between the structure and the reference electrode. Then in Appendices B and C it gives a number of ways of carrying out the measurement when the voltage gradient is significant. These alternative techniques do not appear to have been carried out on VI.

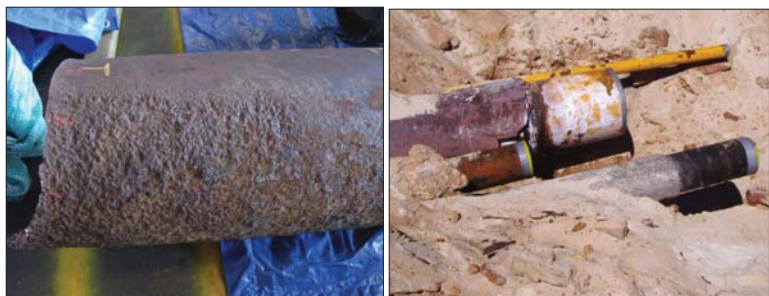
For corrosion to occur the coating must have failed. Where the coating failed is obvious from the pipeline samples at Pearlstreet. The photograph below left shows the areas of substantial corrosion penetration where the coating failed, and the areas of zero corrosion where the coating remained intact. There was approximately 7m of the 12" Sales Gas Pipeline at Pearlstreet, most of which had areas of substantial corrosion penetration. The photograph below right shows the VI cut back end of the pipeline indicating that it is also uncoated and rusty. The adjacent 12" Campbell – Sinbad line can be seen as having intact coating, and the pipe samples at Pearlstreet indicated minimal corrosion compared with the 12" Sales Gas Line.

The Photographs in Section 3.3.2 above show corrosion coating failure of the 12" Sales Gas Pipeline near the beach crossing and intact coating on the 12" Campbell – Sinbad Line. It is evident that the coating on the 12" Sales Gas Line had failed on VI and that the coating on the adjacent 12" Campbell – Sinbad Line, which was constructed at the same time, was in a significantly better condition.

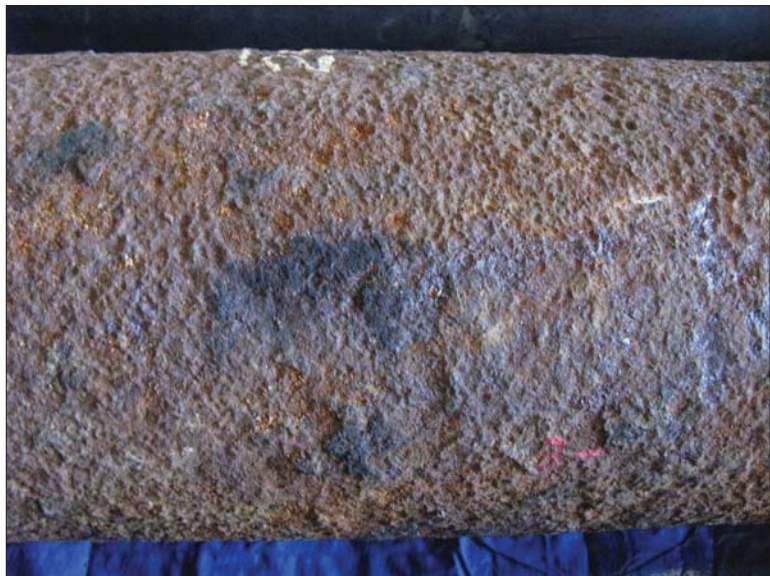
The following photographs taken at the Pearlstreet inspection indicate the severity of the corrosion:

The above photograph was taken near the rupture site on the beach side of the rupture. It shows the substantial corrosion that has occurred since the coating failure.

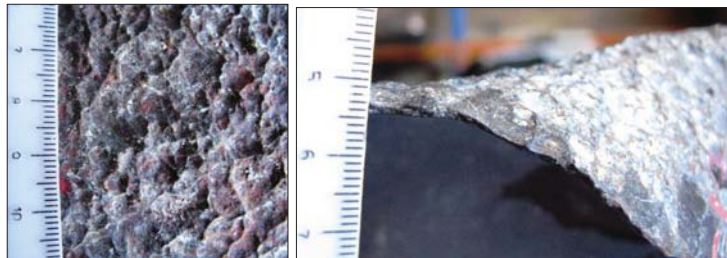
The two photographs below show the corrosion adjacent to the rupture edge with a mm ruler to show scale. The photograph on the right shows that the remaining wall thickness at the rupture was of the order of one or two mm at this location. That represents a corrosion penetration of approximately 10 mm since the coating failure.

A 10 mm corrosion penetration, if the coating failure occurred during construction, represents a rate of corrosion of 0.7 mm/year over the 15 years since construction. The typical maximum corrosion rates for steel subject to crevice corrosion are similar to the typical maximum corrosion rate for steel subject to intermittent immersion in sea water. That rate of corrosion is of the order of 0.5 mm/year, but at a temperature of 66°C would be expected to be higher. Therefore it is likely that the coating failure was present at pipeline installation or very soon thereafter.
