# Summary of Air Traffic Hijack Events

September 11, 2001

SOURCE: AAT-20

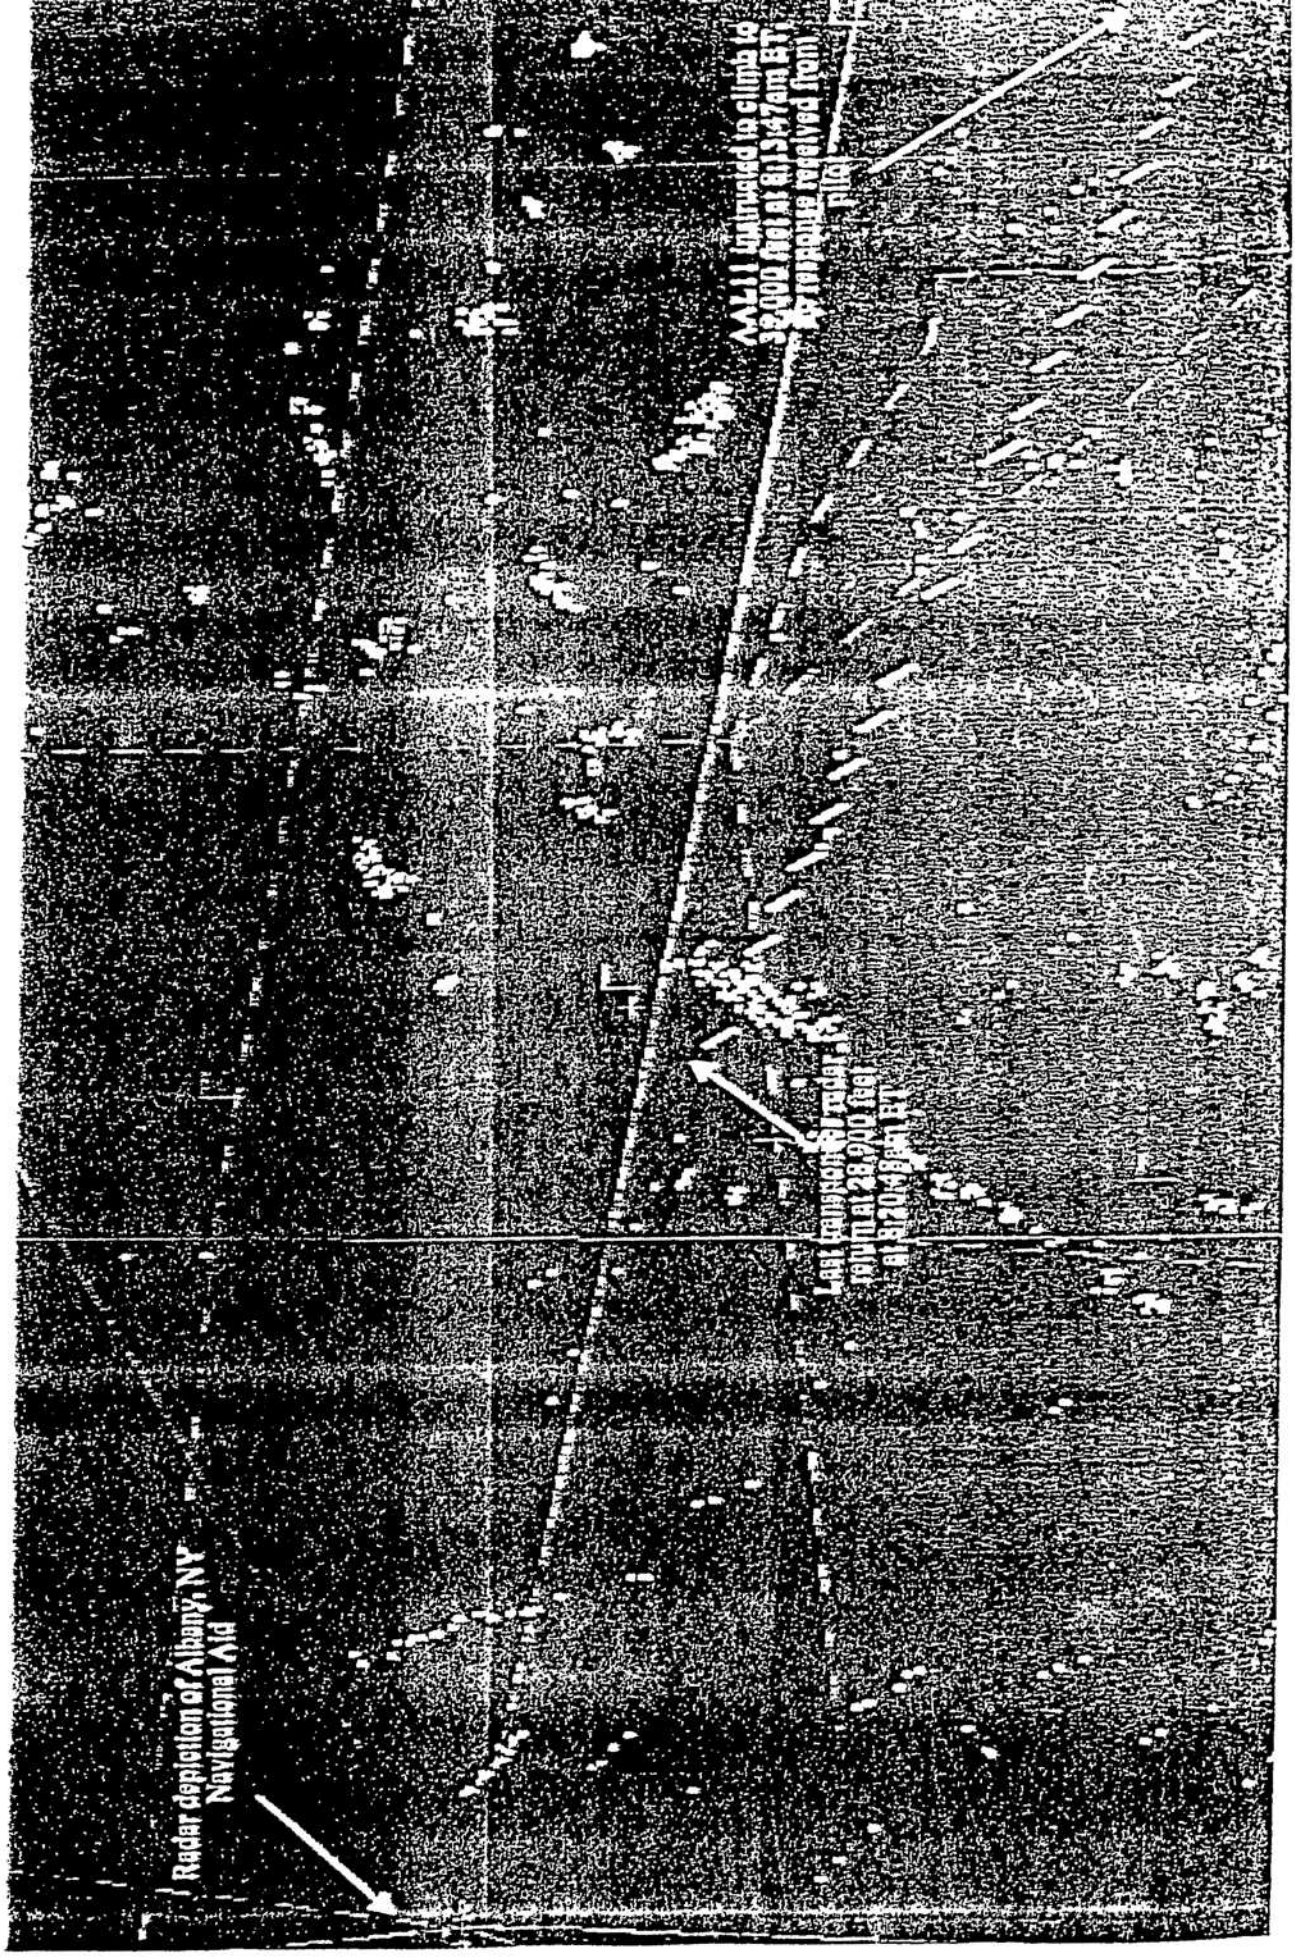
AA11, Boeing 767-300ER, Radar Track  
By the Boston ARTC on Long Range Radar  
September 11, 2001, 8:46:55am EDT  
Prepared by AA11-091-0060

0846:31  
Primary radar tracking of AAL11 was lost.

0846:35  
Impact at the World Trade Center.

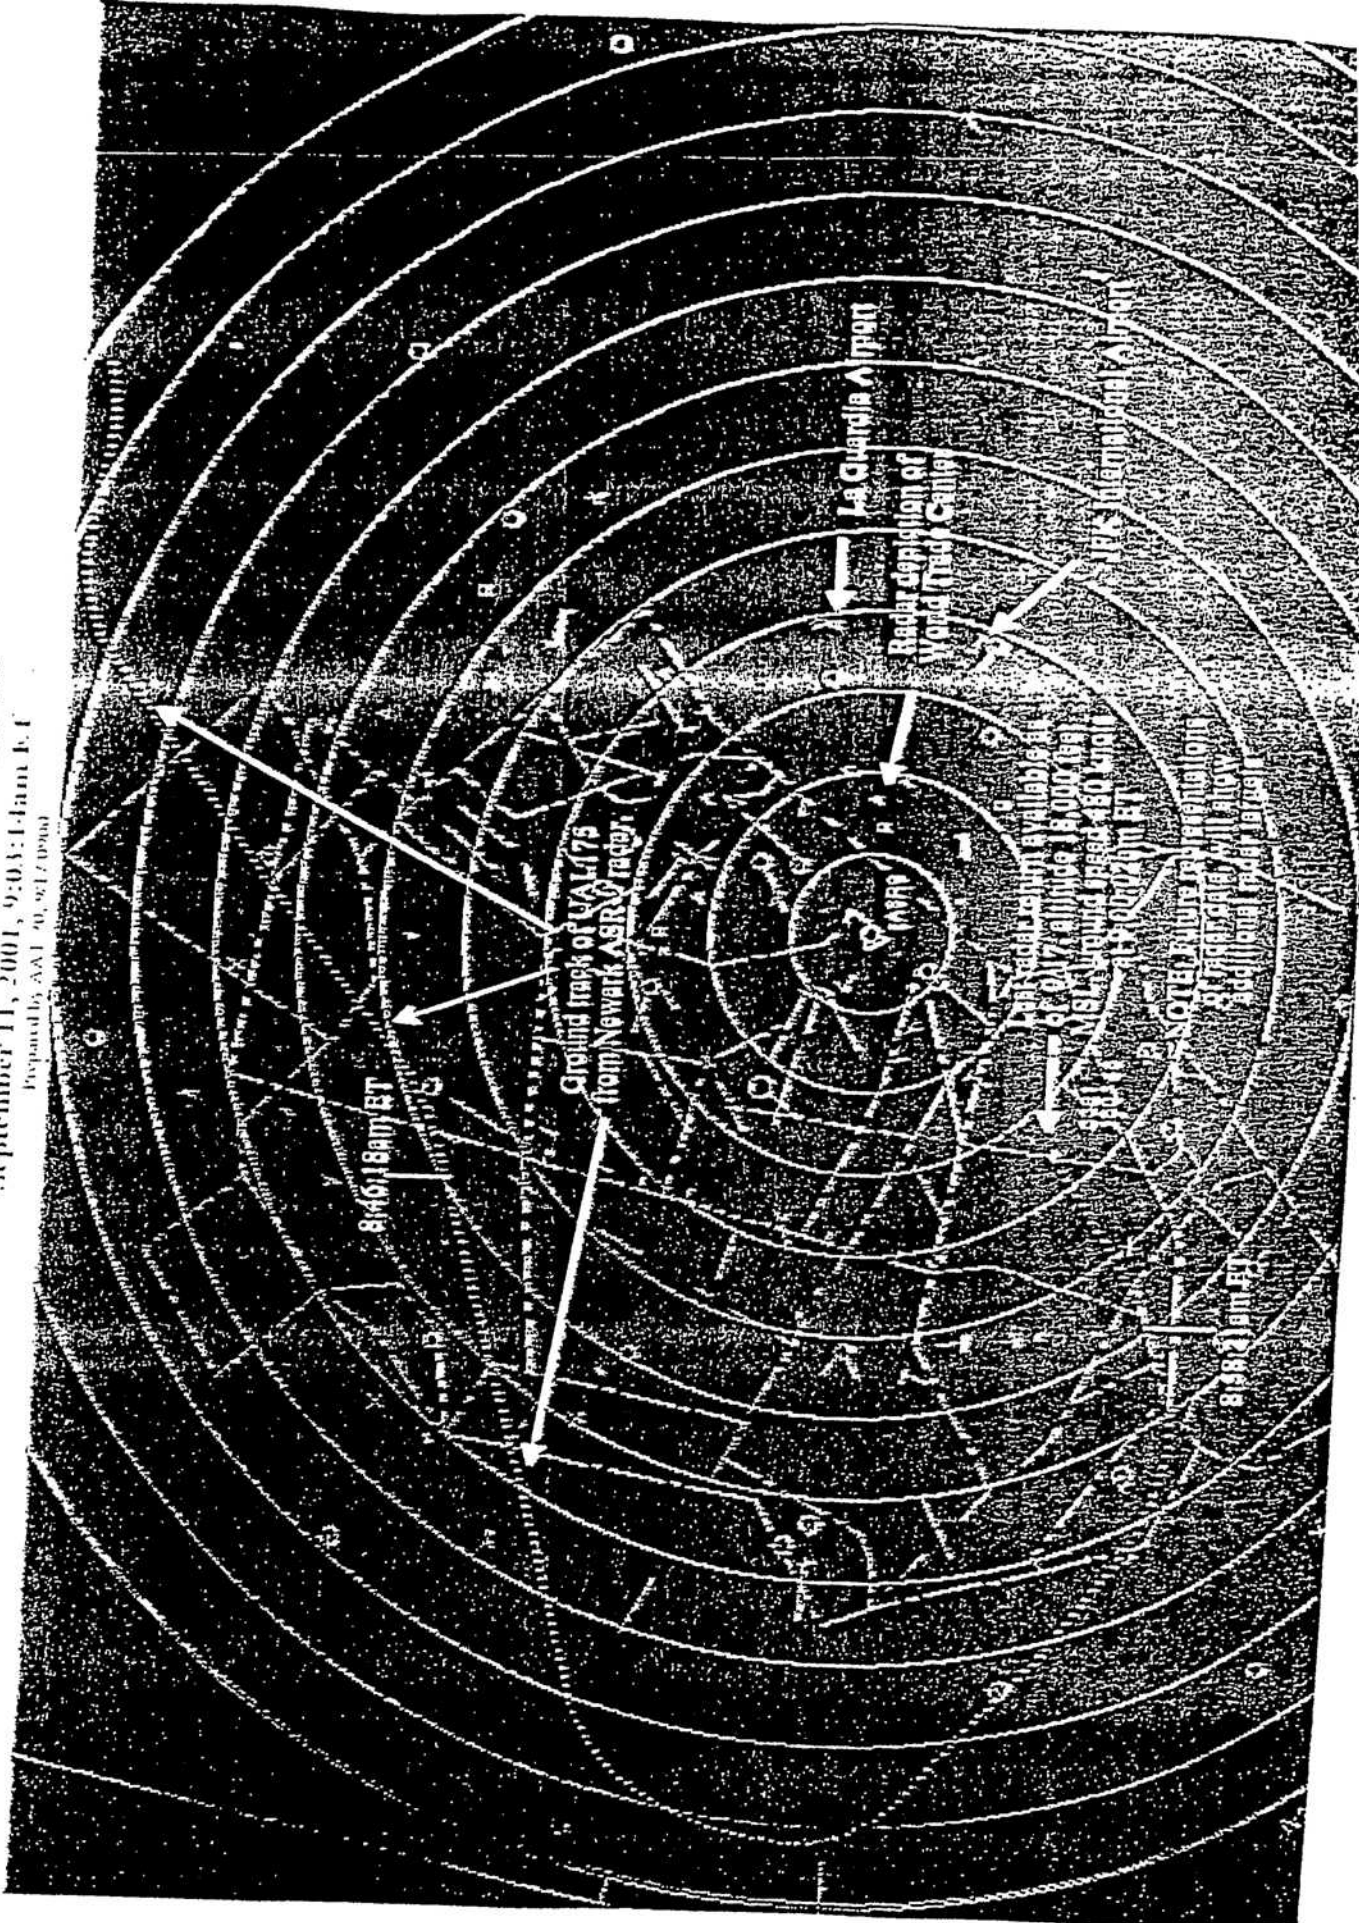
UAL175 Boeing 737-400 Radar Track  
By Newark Airport ASR-9 Radar Antenna  
September 11, 2001, 9:03:14am EDT  
Prepared by AAI 20 09170900

- 0900:00 *This time is approximate based on personnel statements from New York Terminal Radar Approach Control (N90). N90 controller stated "at approximately 9:00, I observed an unknown aircraft south of the Newark, New Jersey Airport, northeast bound and descending out of twelve thousand nine hundred feet in a rapid rate of descent, the radar target terminated at the World Trade Center."*
- 0903:14 Second Impact at World Trade Center.
- 0905:00 North East Air Defense Sector (NEADS) logs indicate they were notified by the Federal Aviation Administration of the events concerning UAL175.
- 0905:00 N90 received notification from the Newark Airport Traffic Control Tower of a second aircraft striking the World Trade Center.

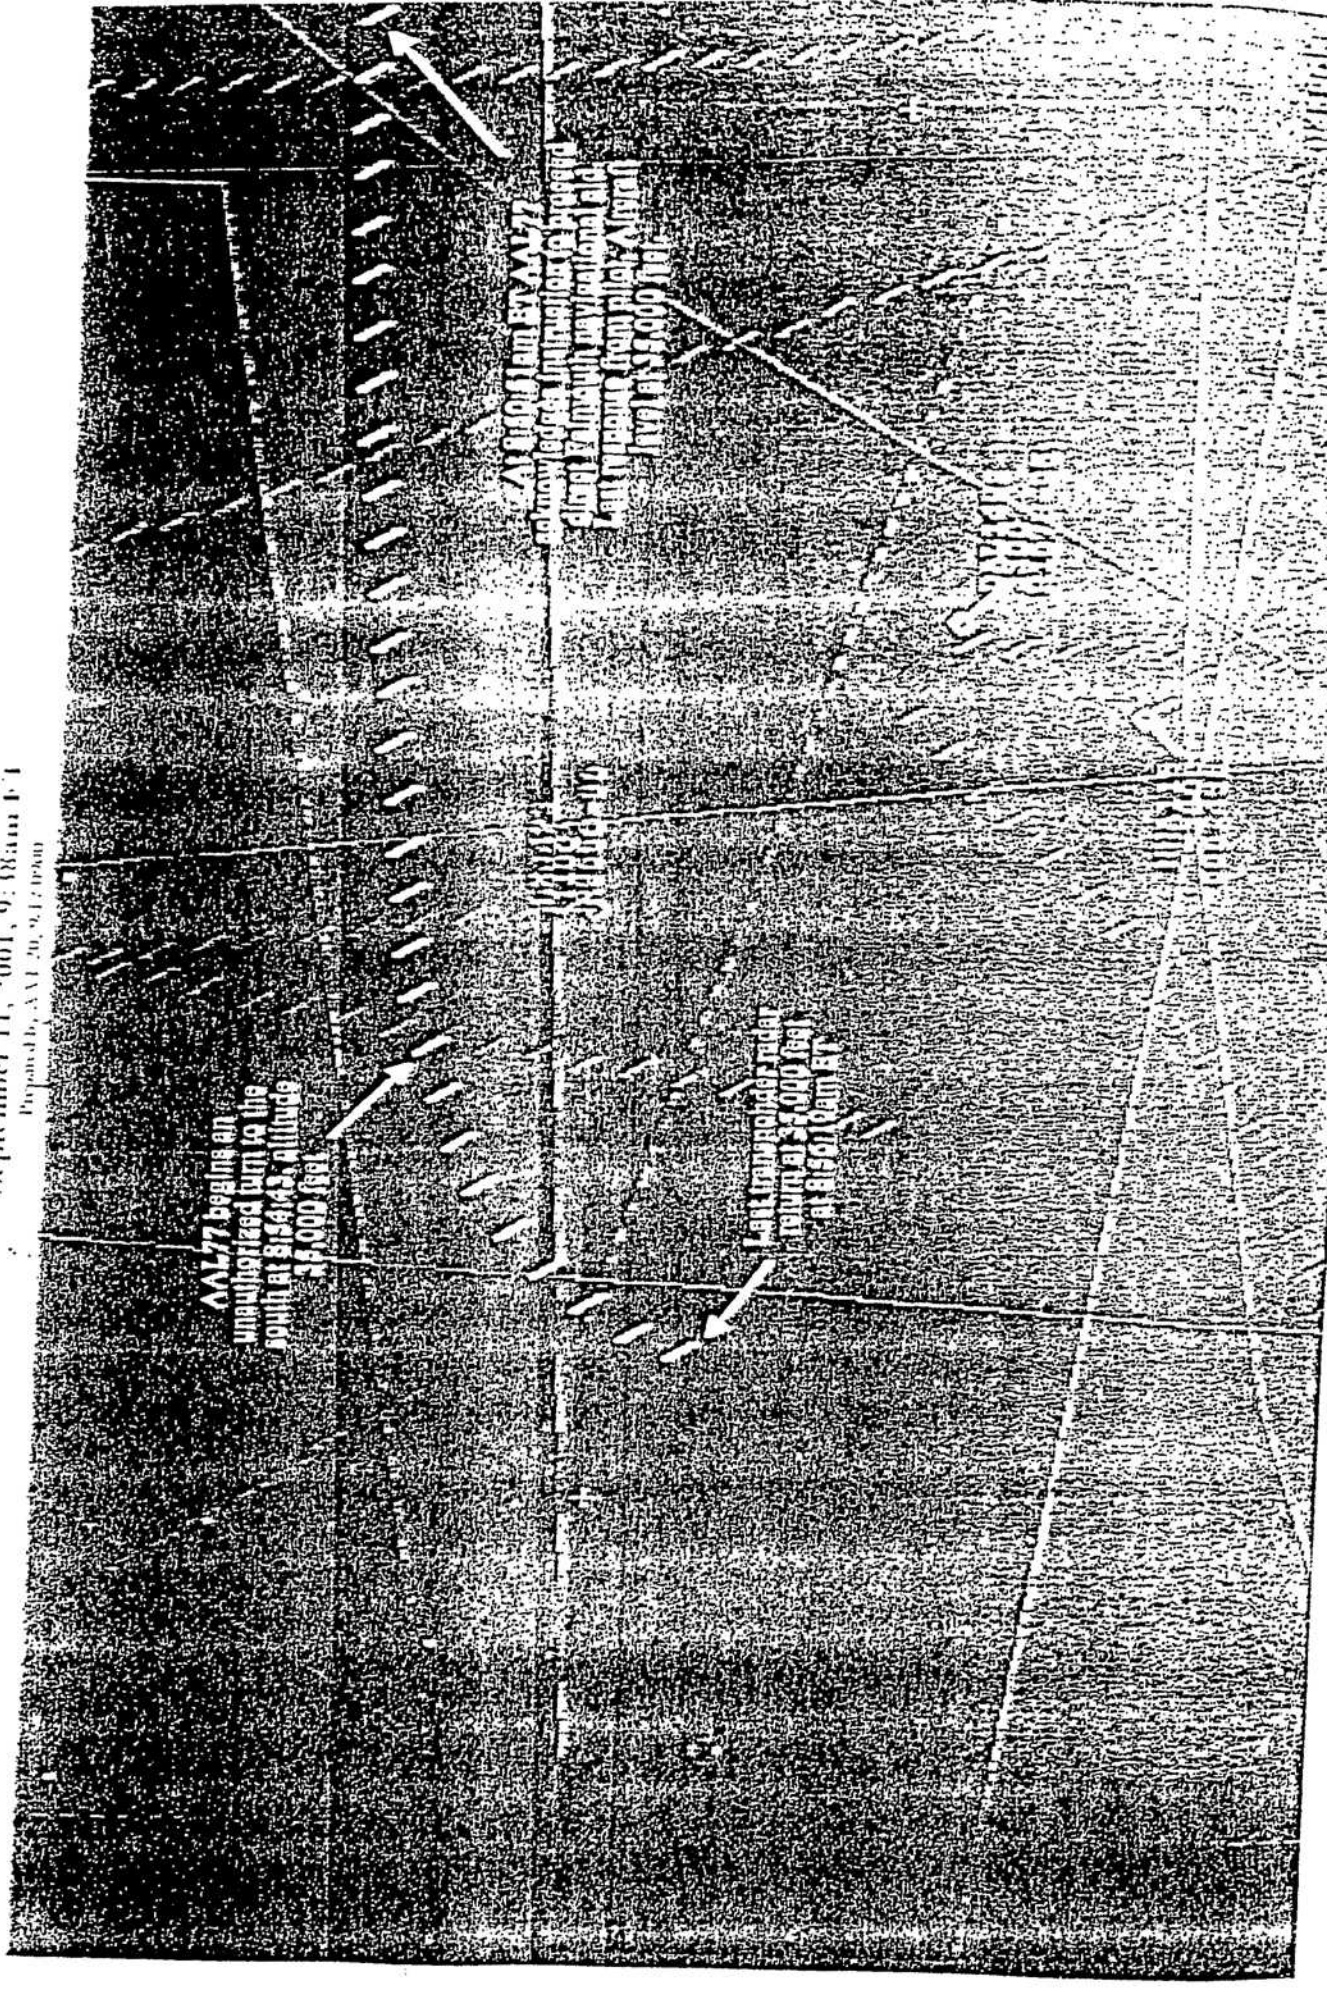
NAVY, Boeing Co. Radar Craft  
By the Indianapolis AFCC Four Range Radar  
September 11, 1944, 9:38am PT  
Report by NAV 26, 9-11-44

AA-77 begins an  
unauthorized turn to the  
south at 8,500 feet. Altitude  
35,000 feet

AA-77 begins an  
unauthorized turn  
at 35,000 feet
