The Pentagon Event: The Honegger Hypothesis Refuted

Victoria Ashley, David Chandler, Jonathan H. Cole, Jim Hoffman,

April, 2016

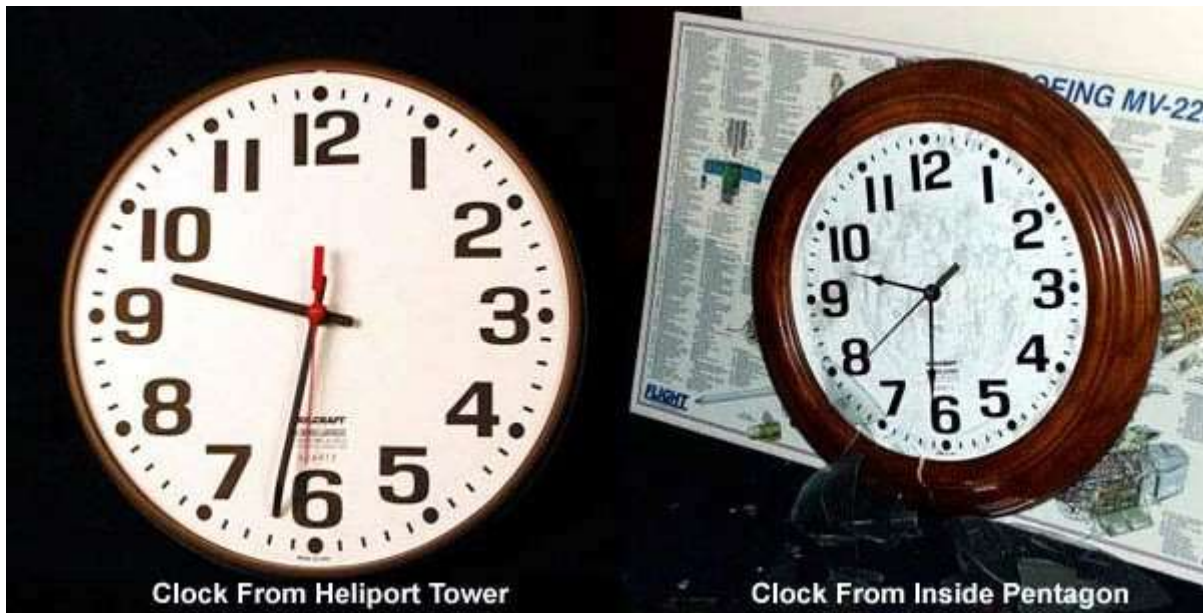
Figure E-1: Pentagon wall clocks cited by Honegger and others
Left: Heliport clock, 9:32:30. Right: Navy Area clock, 9:31:40

The essential problem with the clocks is that, for wristwatches and wall clocks, there is no way to verify that they were initially set at the correct time or were synchronized with standard time. Moreover, for the fallen clocks, it has been established by experiment⁴⁸ that the hands of clocks identical to the Heliport clock can move back if the clock falls and hits the ground. Depending on its orientation when hitting the ground, the backward movement of the minute hand can be zero, a few minutes or as much as 17 minutes. These clocks are battery operated and, as observed experimentally, the batteries can dislodge when the clock is dropped. This dislodgement stops the clock. The conclusion is that the earlier event time evidence based solely from fallen clocks and wristwatches is untrustworthy, unprovable and therefore seriously flawed. Furthermore, Honegger has excluded from consideration two other Pentagon clocks⁴⁹ whose hands stopped at approximately 9:36:27 and 9:37 or a little later. These clocks are shown in Figure E-2 and may have fallen in such a way that there was little or no hand movement. Or they may have read a time later than 9:37 am, but fell in such a way that the minute hand moved back. In either case, the clock readings cannot be deemed reliable.⁵⁰

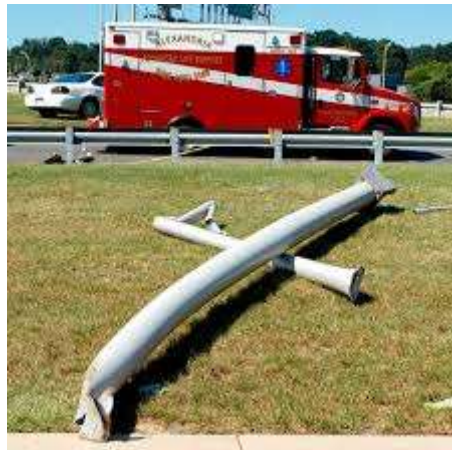
Figure F-2 – Downed light pole sections

The two pieces appear to be the result of the pole being sliced in two.

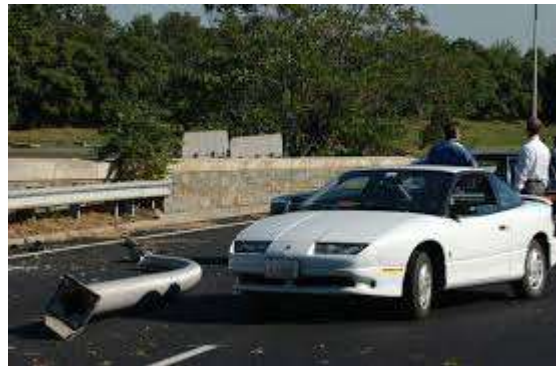
Figure F-3 – Pole that entered Loyde England's taxi cab

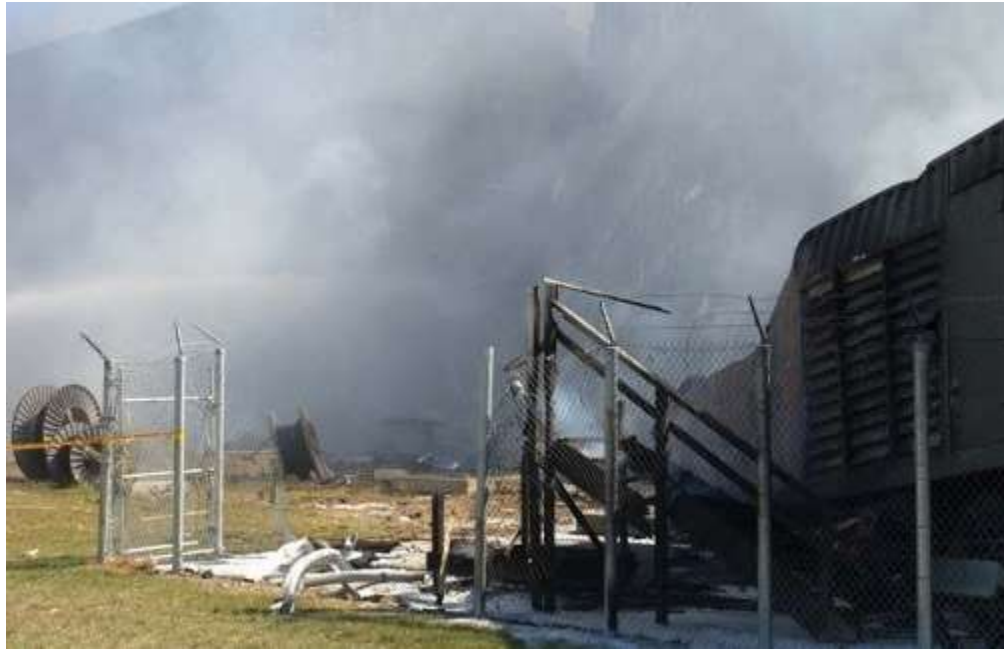
Eyewitnesses⁶⁶ such as Bruce Elliott, Jerry Henson, Don Mason⁶⁷ and Frank Probst testified to seeing the generator trailer struck by the plane's right wing or engine. After first striking the fence, the engine struck the north end of the heavy generator trailer at a point approximately 5 to 8 feet from the ground, creating a large gouge as shown in Figure F-4.

Figure F-4 Generator trailer and fence
The north end of the trailer is gouged

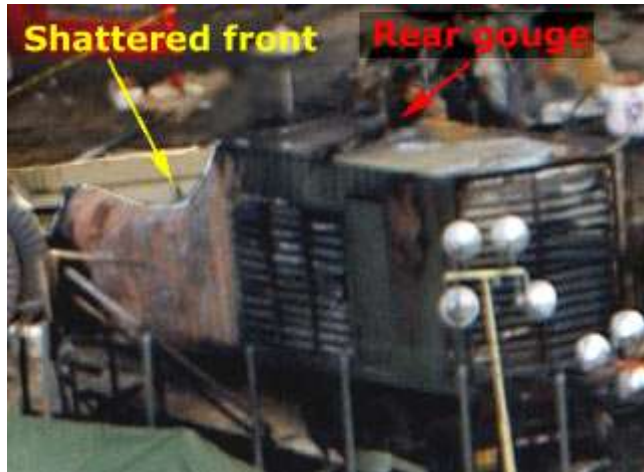
Figure F-5 Generator trailer with gouge

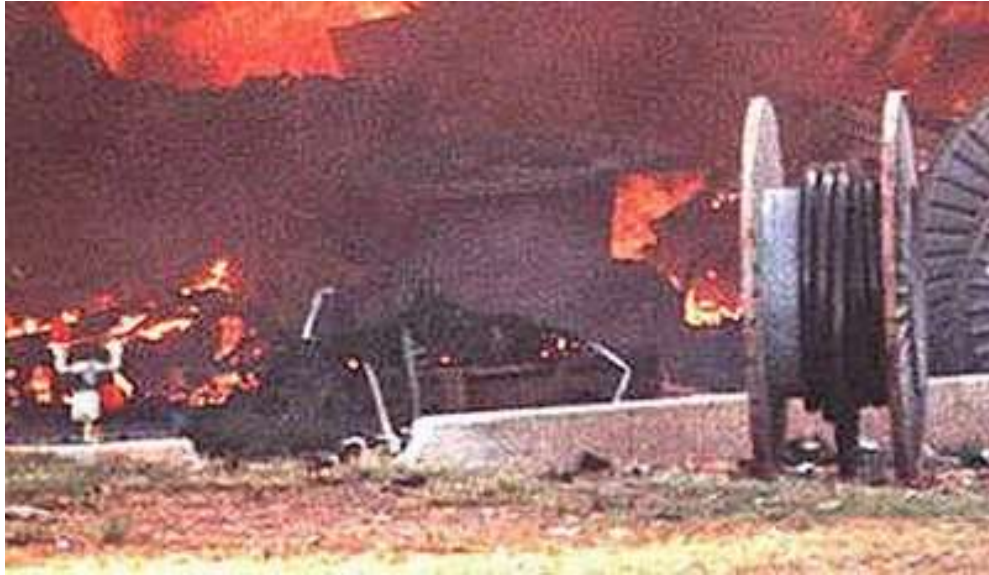
Figure F-6 Low concrete wall gouge

The gouge indicates that the left engine was very close to the ground at this point. However, as shown in Figures F-9 and F-11 and in these photographs, the ground slopes up as one approaches the concrete wall from the highway and from the generator trailer and then slopes down toward the Pentagon west wall. Thus the left engine did not gouge the lawn as it was just above ground level at a high point. The two red lights to the left of the gouge are warning lights.

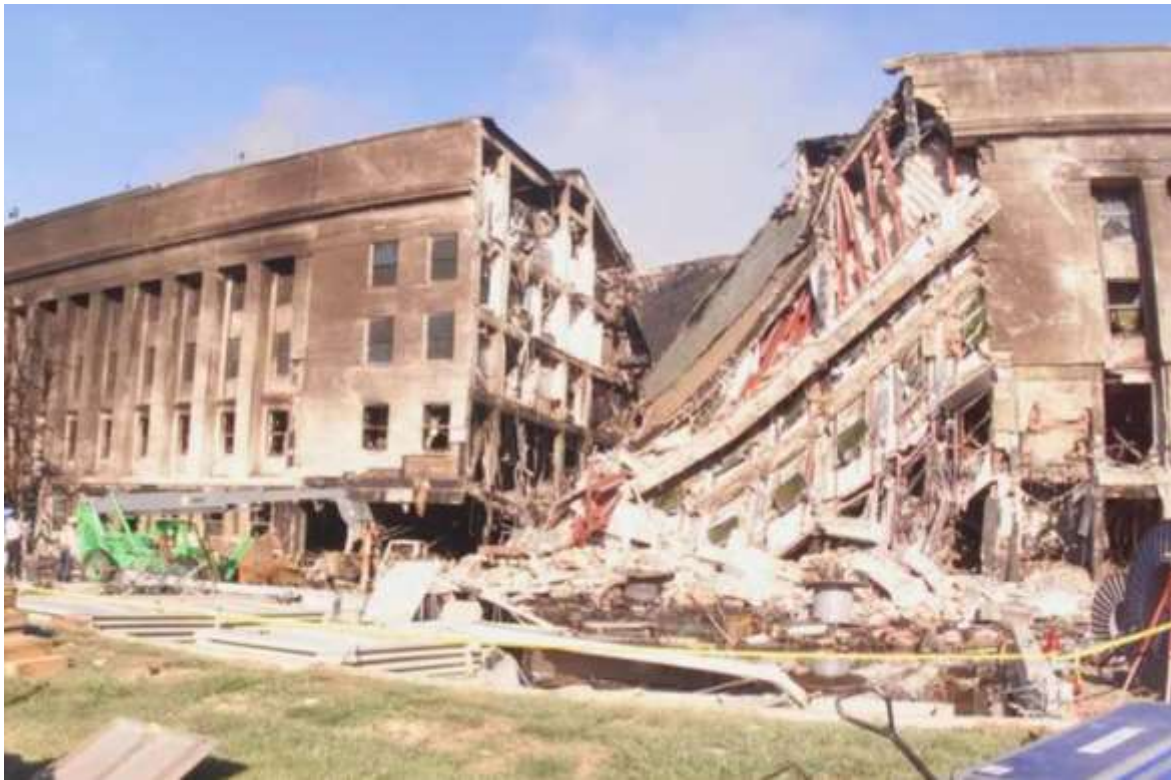
It has been suggested that the plane's engine did not create the gouge in the low concrete wall because, if it had done so, the warning lights (red on a white stand – possibly aviation lights but not confirmed as such) would have been knocked down. This notion arises from an examination only of photographs that do not indicate the depth of the lights behind the wall. Figure F-8 together with Figure F-6 shows that the lights are in the corner where two sides of the low concrete wall meet at a right angle and therefore were not in the path of the left engine.

Figure F-8 Warning lights and collapsed section (see red lights at bottom right)

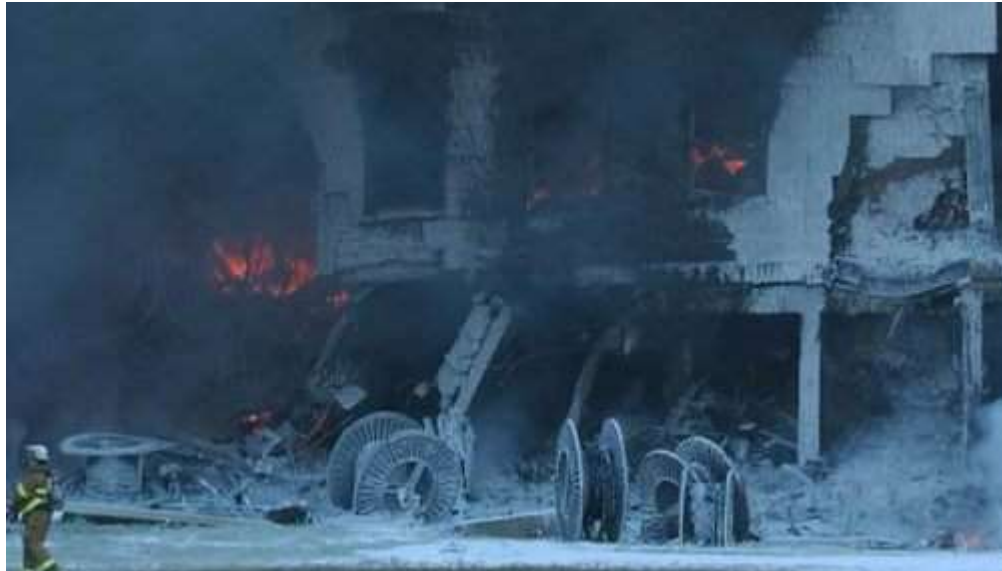
Figure F-14. Honegger's chief claim here is that columns 15, 16 and 17 are "bowed out," not in, as would be expected from the impact of the large plane and its right engine. See also Figure F-15.

Figure F-14 Façade damage with some fire
Taken at a less oblique angle facing the façade

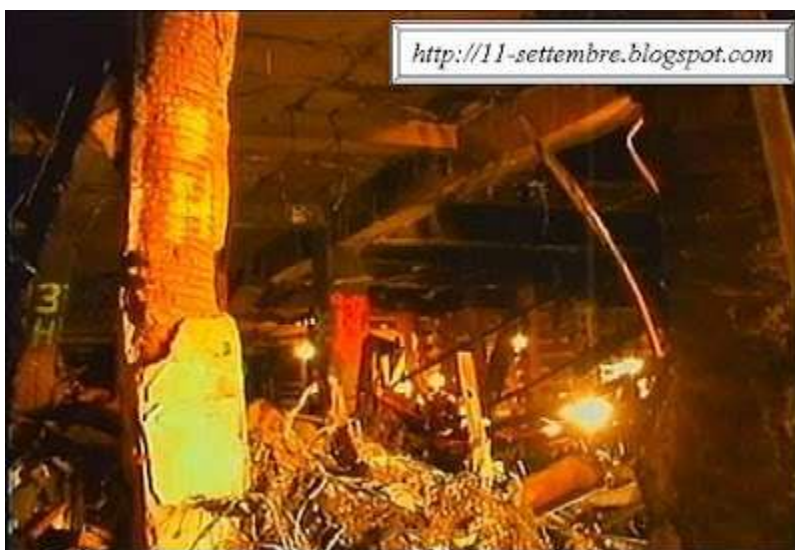
Figure G-1 Curved and abraded column

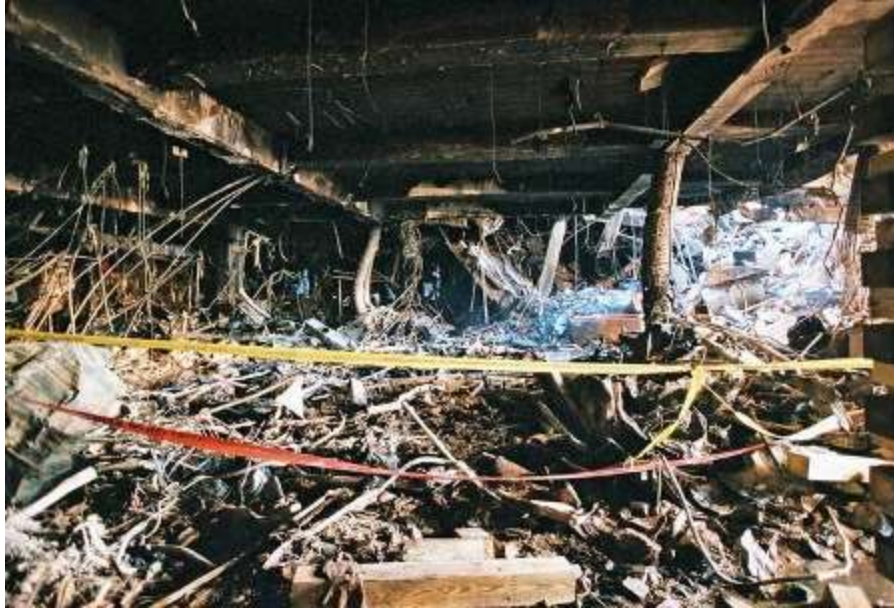
Photographs of the interior of the Pentagon first floor area reveal widespread debris as seen in Figures G-3 and G-4. Note the curved and abraded columns indicating the high-speed flow of thousands of pieces of plane debris. Note also the intact ceilings – a bomb would have also damaged or collapsed the ceiling, but instead the debris and damage indicate a horizontal force or flow of material.

Figure G-3 Internal debris and curved columns

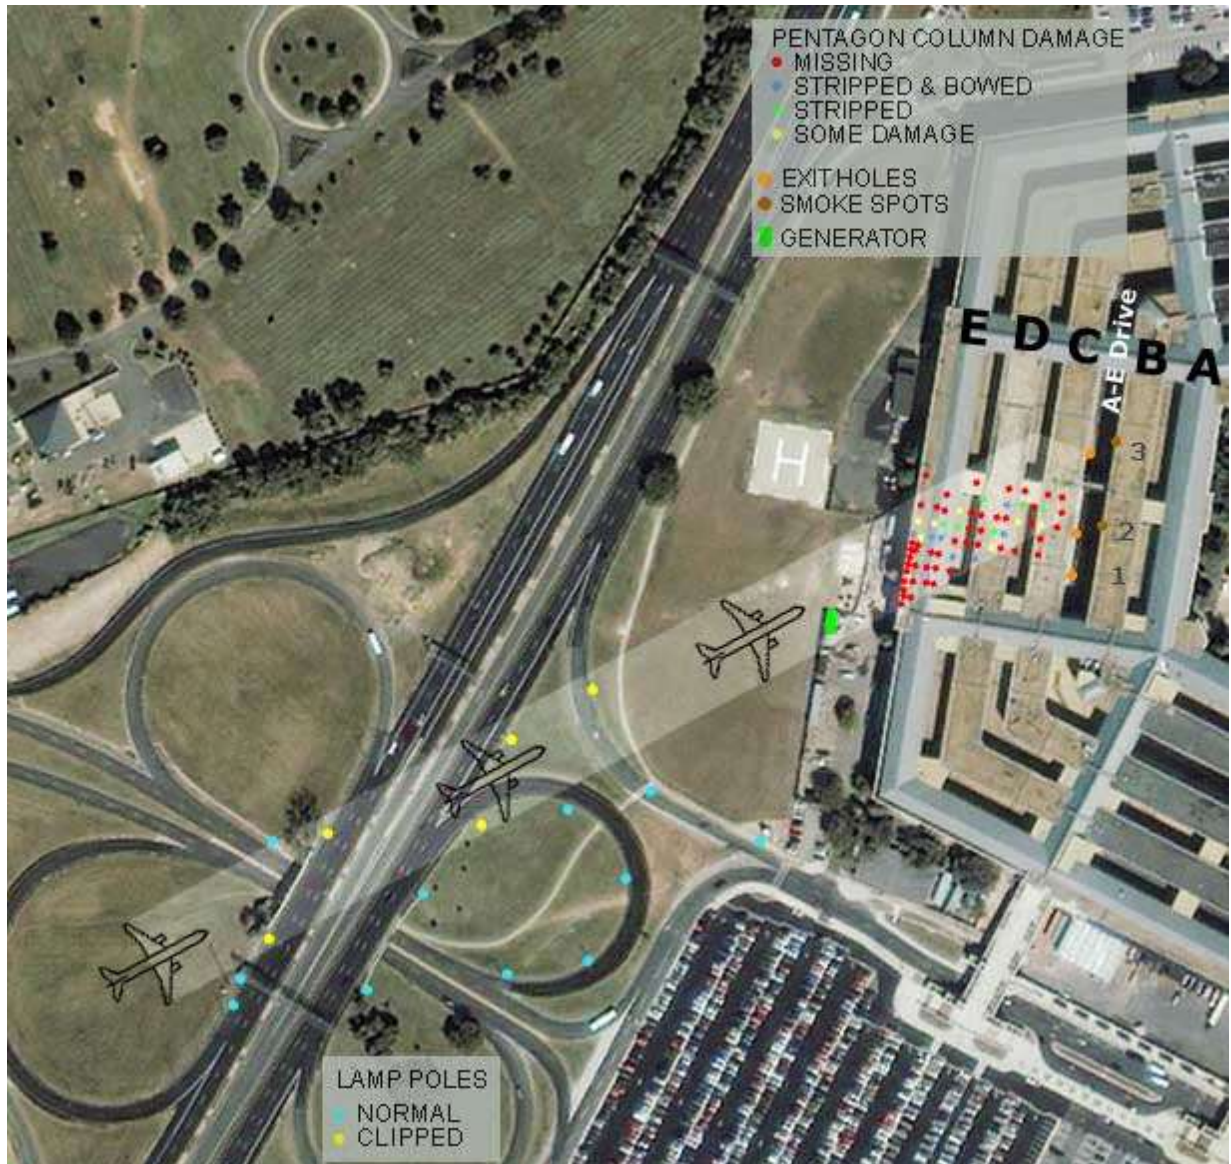
Figure G-5
Aerial photograph with three marked “Exit” holes

Hole 1 is a door, hole 2 is a roll-up door larger in width, and hole 3 is the C Ring hole where debris from the large plane broke through into the A & E driveway. In her text (book) version of her Toronto Hearings' talk, Honegger acknowledges that holes 1 and 2 are doorways, but she does not mention this fact in her Toronto or Seattle live presentations where she compares Figure G-5 with a similar figure showing only one "EXIT HOLE," the C Ring hole (see Figure G-6).

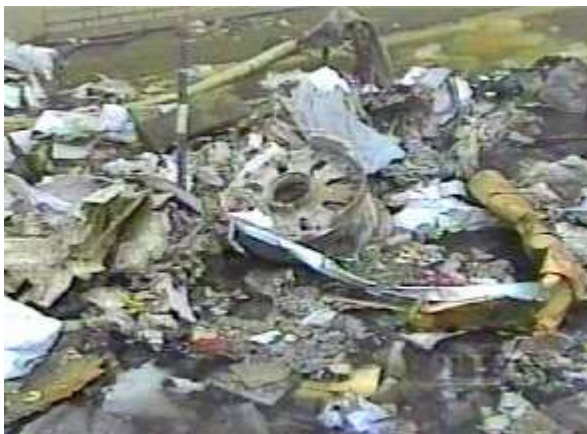
Wheel hub found outside C ring hole

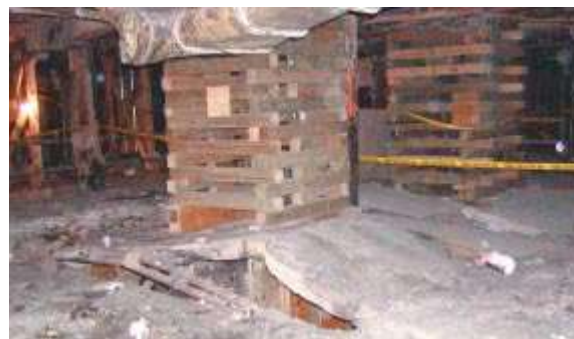
Figure H-2
 Pentagon Building and Performance Report
 Figure 5.27 Breached second-floor slab

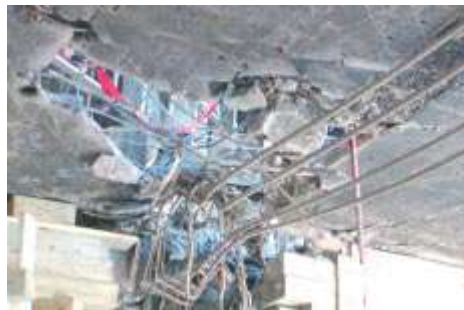
- As noted on page 34 of the PBPR and shown in PBPR figure 5.29 (Figure H-3), “Some floor beams were completely stripped from the underside of the slab above” in the area of the orange rectangle. Since the slab above the floor beams is still largely intact, this stripping was most likely caused by the passage of the plane debris parallel to the slab and not by an explosion that also lifted up parts of the slab.

Figure H-3
Pentagon Building and Performance Report
Figure 5.29 Stripped floor beams under second-floor slab

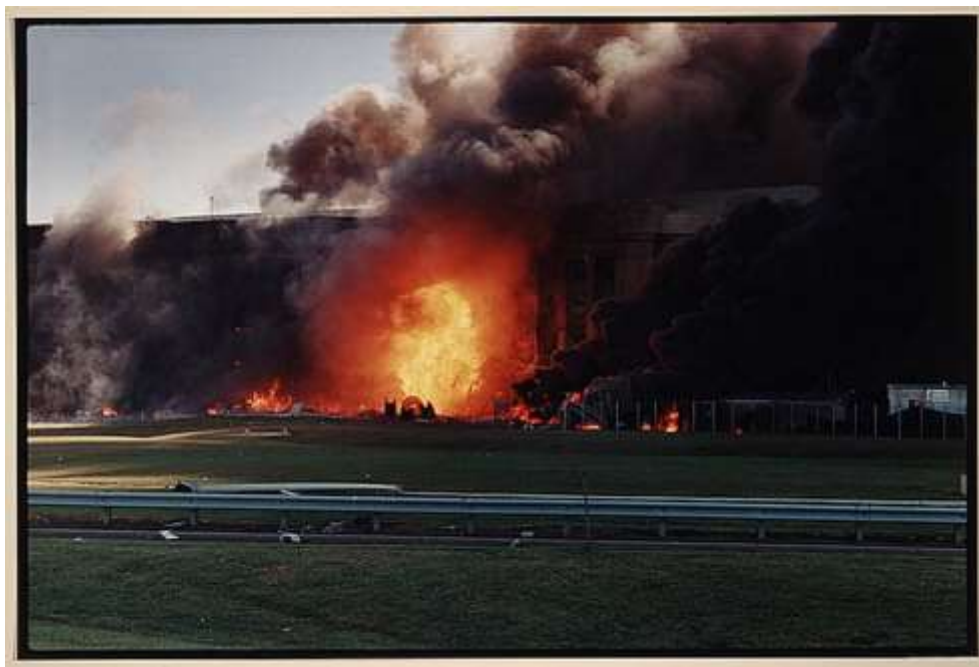
reported only one major “explosion.” The event shown in Donley’s photograph occurred several minutes after he observed the plane fly into the Pentagon when he retrieved his camera from his car and began taking photographs.

Figure H-4
Daryl Donley photograph taken some minutes after plane impact
