## REHABILITATION OF FORMER NUCLEAR TEST SITES AT EMU AND MARALINGA (AUSTRALIA) 2003

REPORT BY THE MARALINGA REHABILITATION TECHNICAL ADVISORY COMMITTEE

DEPARTMENT OF EDUCATION, SCIENCE AND TRAINING

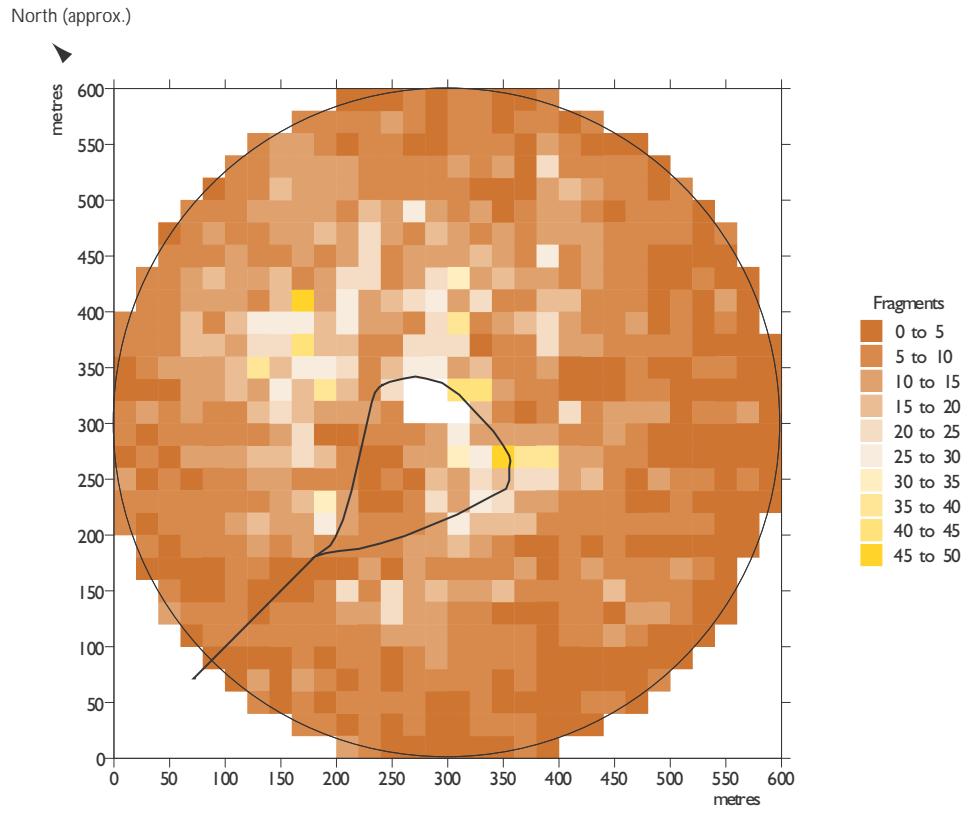
**Figure 4.13** Distribution of uranium fragments retrieved at Kuli. The numbers in the legend refer to the number of fragments within a 40 m x 40 m area.

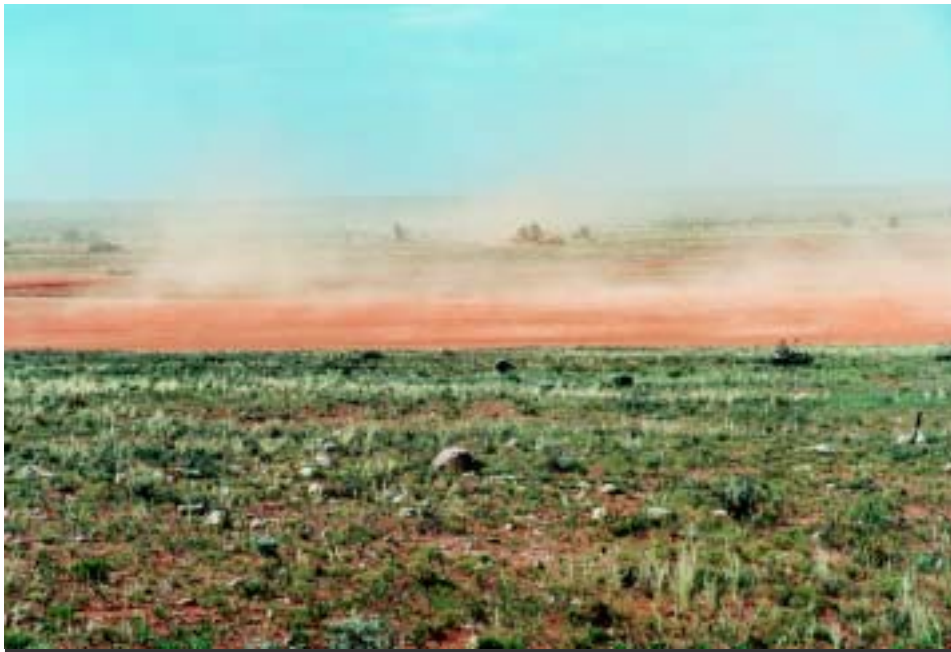
**Figure 5.12** Scene at Taranaki, September 1996. Work suspended during dust storm arising from south-westerly winds in excess of 40 km/hr.
