Phoenix

Issue 2 – August 2009

The Newsletter of the Great Melbourne Telescope Project

REMOVAL OF HOUR ANGLE DRIVE GEAR FROM NORTHERN CONE

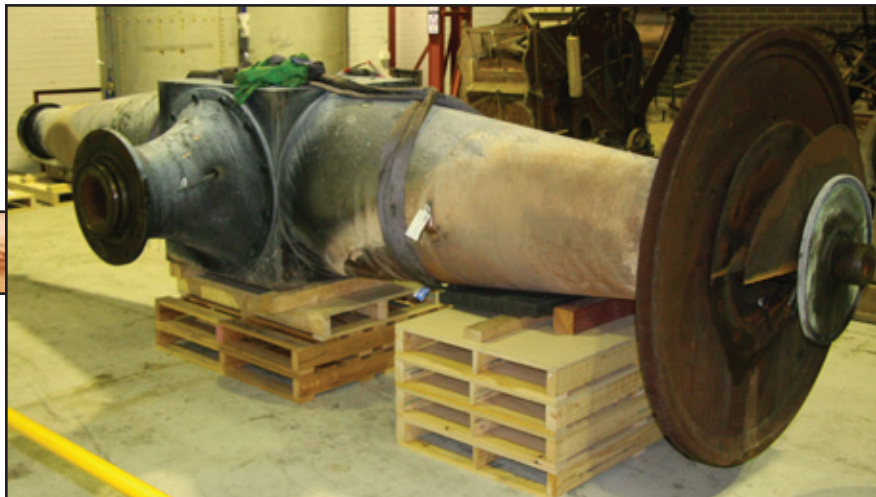
Here's the assembled two-cone polar axis assembly, with the declination axis running through the cube. The right-hand cone is termed the "Northern Cone" because it pointed at the North Celestial Pole (down through the Earth) when the telescope was in its working location. Prominent at its end is a 60-inch (1500 mm) solid iron worm wheel with 480 teeth around its circumference - about 5 teeth every 2 inches. For operation at Mt Stromlo, this disk was driven by a worm gear to turn the entire assembly, with telescope attached, about the polar axis - that is, altering its Hour Angle (so as to keep the telescope pointing at a given Right Ascension). In the original instrument, the moving parts weighed over 8 tons.

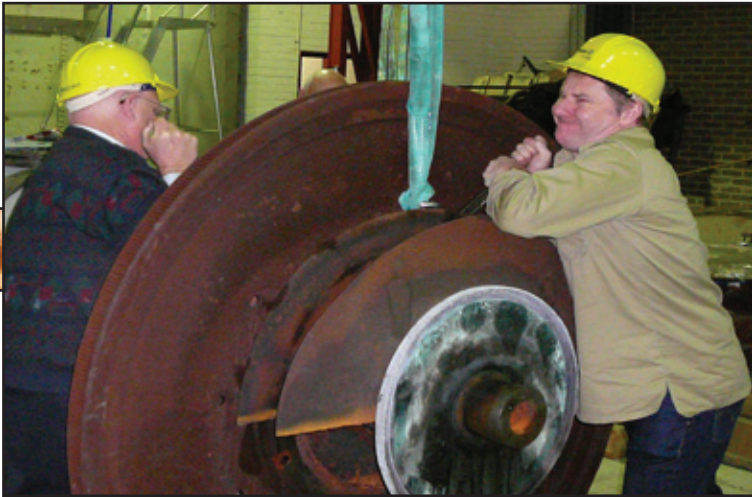
Picture 1 shows more detail of the HA drive gear and a smaller, corroded brass or bronze toothed wheel nearer the end of the shaft. In between them is half of a reel with electrical cables (the other half having been sawn off and discarded at Mt Stromlo). This reel had to be cut further with a sabre saw to allow its removal before anything else could be freed. **Picture 2** shows the cable reel now detached, with some of the badly-burnt copper cables trailing out of it.

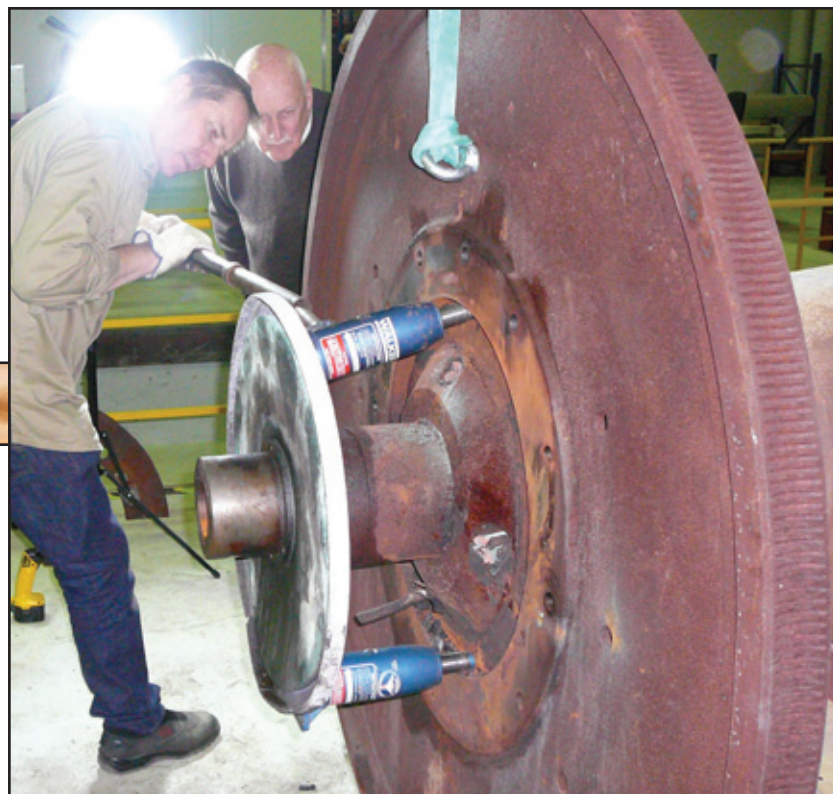
Picture 3

This small toothed wheel was probably added at Mt Stromlo, for sensing the telescope's position in Hour Angle. It appeared to be attached to the shaft by a retaining ring fixed to the hub by six socket-headed screws, one of which was found broken. The remaining screws were removed, with difficulty, but this did not release the toothed wheel or its ribbed protective housing. We then realised that the wheel was an

interference fit onto the hub, and there was no way to get purchase to pull it off, short of building a 20-inch cog puller or hiring the only one known to be available, which was hours away in Mornington.

However, we were able to get a hydraulic (bottle type) car jack between the hub of the 60-inch HA drive gear and the wheel. The jack was nearly horizontal, which led to problems with its internal oil pump needing to be primed. By pressing on the housing with the jack, we were able to distort it to press against the toothed wheel, but the wheel distorted instead of moving. MV then provided three 8-tonne truck jacks, and by pressing at two or three points (**picture 3**) we were soon able to crack a gap. Repetition of the technique at points all around it eventually moved the wheel and its cover off the shaft completely.

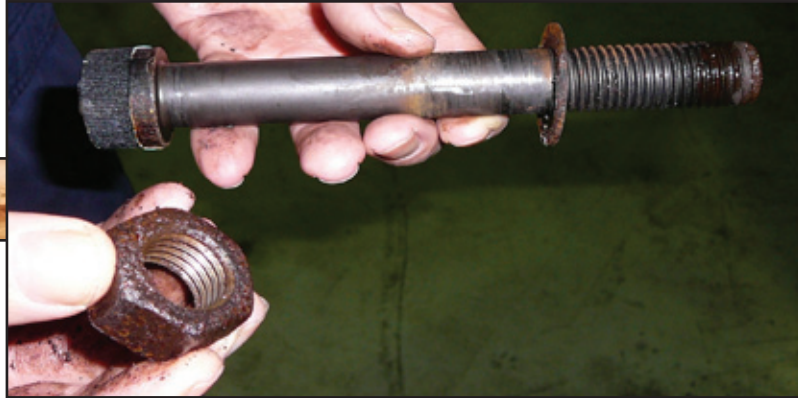
Picture 4

We suspended this 60-inch gear on its own sling under the gantry crane, to take its weight on detachment, and then removed the bolts that held it and the hub to the northern cone. These bolts had previously been loosened - **picture 1** on page 3 showed Neville expending the effort that we now know is typical for loosening any GMT nut or bolt. Here's a picture of one of the bolts (**picture 4**); the exposed threads are wet with WD-40, but it has not penetrated to the threads that were initially inside the nut. Of relevance, therefore, is that most of the threads are generally undamaged and not significantly rusted.

This is a 1950s Stromlo nut and bolt; but we later found that earlier Imperial threads were in similar good condition, which raised our hopes that all the bolts might come out easily, once started, even when the bolts, nuts and surrounding metal were rusty. All bolts had been done up very tightly, and of course that was under *sliding* friction until the rotation stopped; to undo them meant overcoming *static* friction, which is greater. We grew to relish the sound of the “crack” as a nut or bolt suddenly began to rotate under our ministrations. That, and the smell of WD-40 in the morning ...

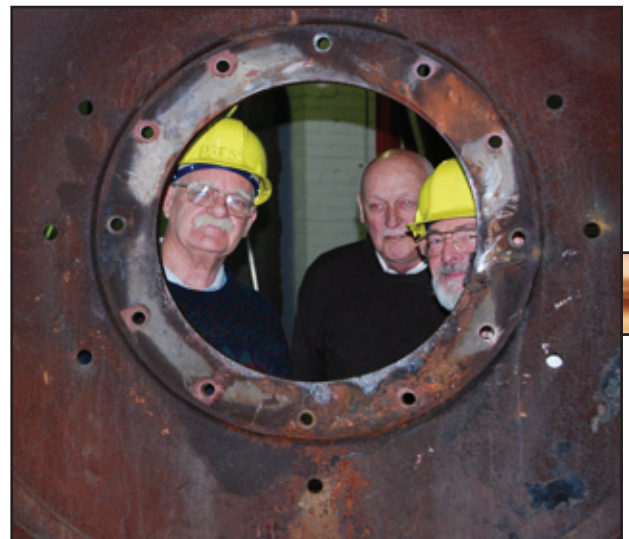
Picture 5

The northern cone is not an original part, but was added by Mt Stromlo engineers in the 1950s to allow the telescope to continue observing an object for longer after its meridian passage. A careful study of their engineering drawings revealed that the cone's function was to fit into a circular recess on the face of the cube and present an identical recess at the cone's other end for the original northern hub of the polar axis to fit into. The recess presents a face about 35 mm deep around a 570 mm circle, in which the hub for the Hour Angle gear fits. We feared that the mating surfaces may have been rusted together, but they turned out to be in good condition, with only a slight colouring of rust; only friction and accurate Stromloidal engineering were holding them together.

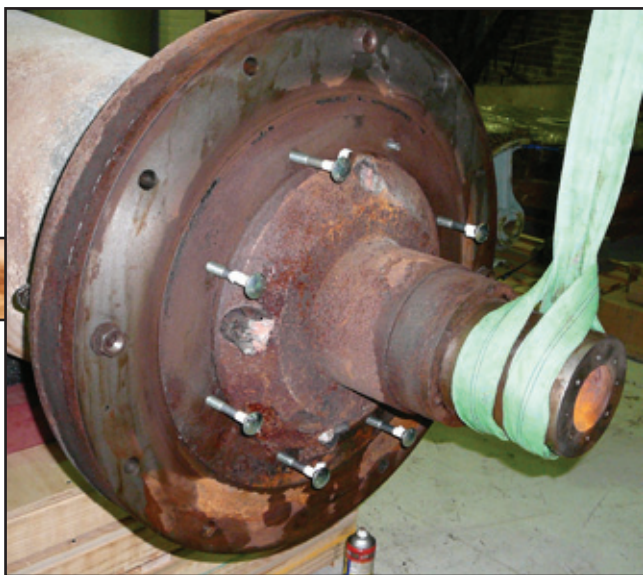
Picture 6

However, the hub would not budge off the end of the cone, despite some judicious tapping and levering. The solution came to one of us while lying half-awake at 4:30 one morning: the hub had a circular array of eight threaded holes about halfway out from its centre. These had not been used for a long time, and would have been part of Grubb's original 1868 configuration. Long enough bolts screwed into these holes should pass right through and press on the inner surface - the end of the cone - thus pushing the hub away from it.

We determined that these holes had been tapped with a 1/2" Whitworth thread, so someone was sent to a nearby hardware store to buy eight long bolts with 1/2" threads. The only stocked bolts long enough were coach bolts, but they would do. Meanwhile, we had carefully cleaned up the threads in the holes, and on screwing in the oiled coach bolts, at the right depth we felt them press against the inner surface. **Picture 6** shows the situation at that stage; note the three capturing bolts in the outer circle, and the taut crane sling, each able to take the weight if a sudden separation occurred. We then continued to turn the coach bolts by half-turns, using about 100 Nm of force on each of them in a staggered order, using a long-handled socket driver. Imagine our elation as a small gap appeared and the hub began to slide out of the end face of the cone. However, we were not able to lever it out - we had to push it all the way using the coach bolts.

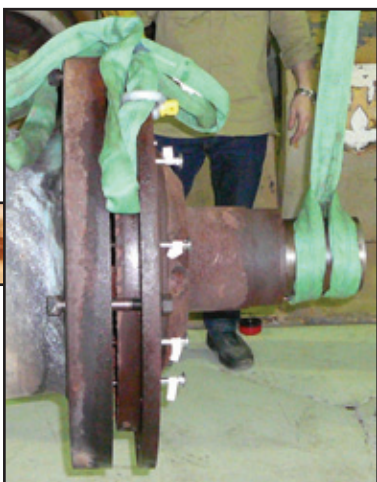
Picture 7

With the hub completely detached but retained by the three outer bolts (**picture 7**) and stable, we attached crane slings to holes in its upper part, removed the three bolts and began to pull it out by sending the gantry crane East (**picture 8**).

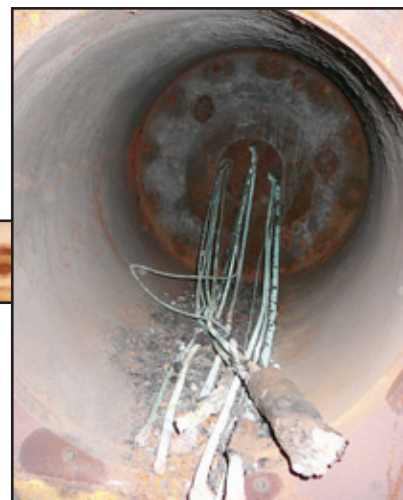
Picture 9

The hub had four steel pipes which served as conduits for electrical cables, running inside the northern cone along its full length; these once fitted, with a rubber lining, into the back of the hub and into the face of the cube, but now they were firmly stuck to the hub by burnt rubber. The pipes therefore pulled out from the cube instead of the hub, but the cables stayed attached to the cube and, with their burnt insulation, they exerted a significant friction as the pipes slid along them. Anyway, with the hub and pipes gone, for the first time we could see clearly into the cone; **picture 9** shows the inside of the "cube end" of the cone, with four bunches of burnt cables coming out of it. Note especially the 12 rusty bolt heads around the edge of this end face. These attach the cone to the cube; and undoing them will be a story for *Phoenix* issue #3.
