# UPDATE REPORT – BLACK SYSTEM EVENT IN SOUTH AUSTRALIA ON 28 SEPTEMBER 2016

AN UPDATE TO THE PRELIMINARY OPERATING INCIDENT  
REPORT FOR THE NATIONAL ELECTRICITY MARKET.  
DATA ANALYSIS AS AT 5.00 PM TUESDAY 11 OCTOBER 2016.

Published: **19 October 2016**

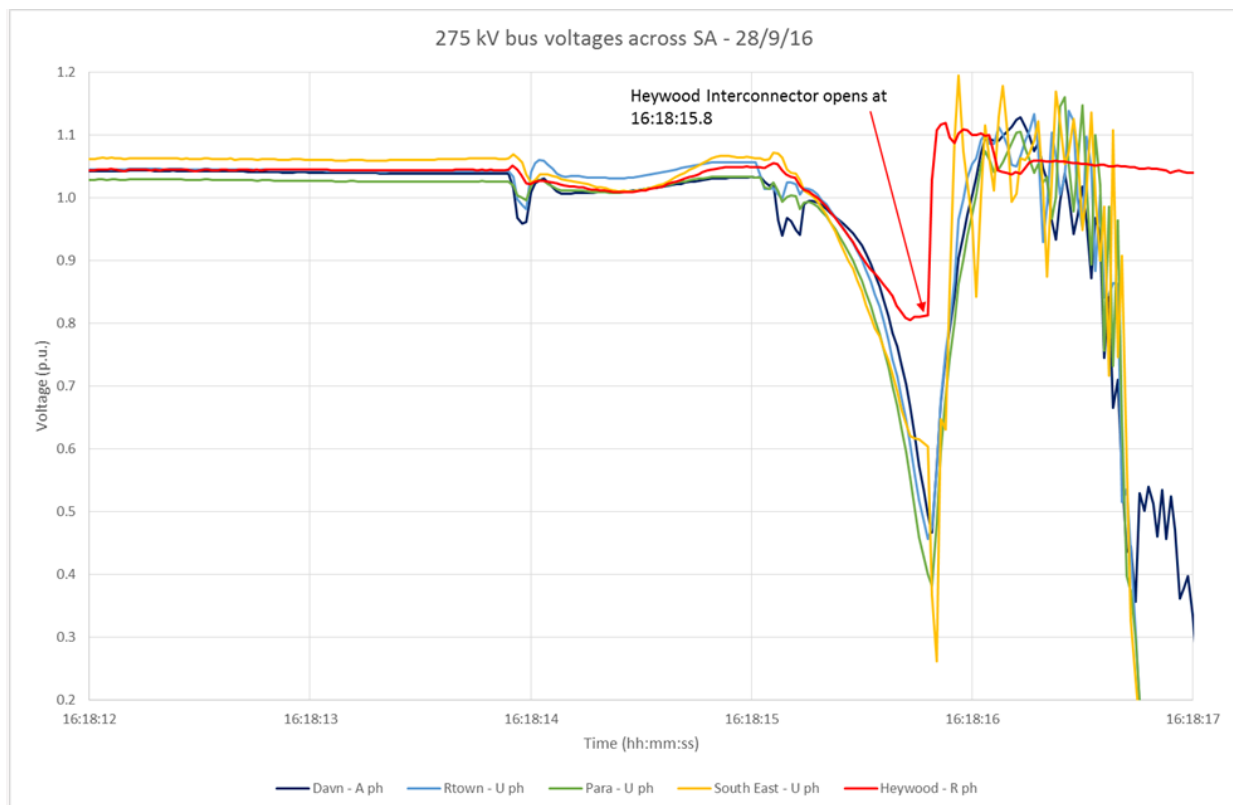
**Figure 1 275 kV voltage decline across South Australia prior to separation**

A rapid decline in voltage across the SA network was observed immediately prior to the opening of the Heywood Interconnector. This rapid voltage decline was consistent across the SA transmission network from the South East to the North. Once separated from the rest of the NEM, network voltage within SA momentarily returned to normal levels before the rapid frequency fall led to the Black System.

This observed reduction in network voltages is consistent with a loss of synchronism between the SA power system and the remainder of the NEM. AEMO will be conducting further analysis to confirm that these changes in network voltages are fully understood and were as expected given the circumstances.

The graph shows a rapid decline in voltage across the SA network following final loss of the Davenport – Mt Lock 275 kV line, and the associated loss of generation just after 16:18:15. The rapid reduction in network voltages is consistent with a loss of synchronism between the SA power system and the remainder of the NEM. Future simulation work will include an assessment of the changes in network voltages during this period.

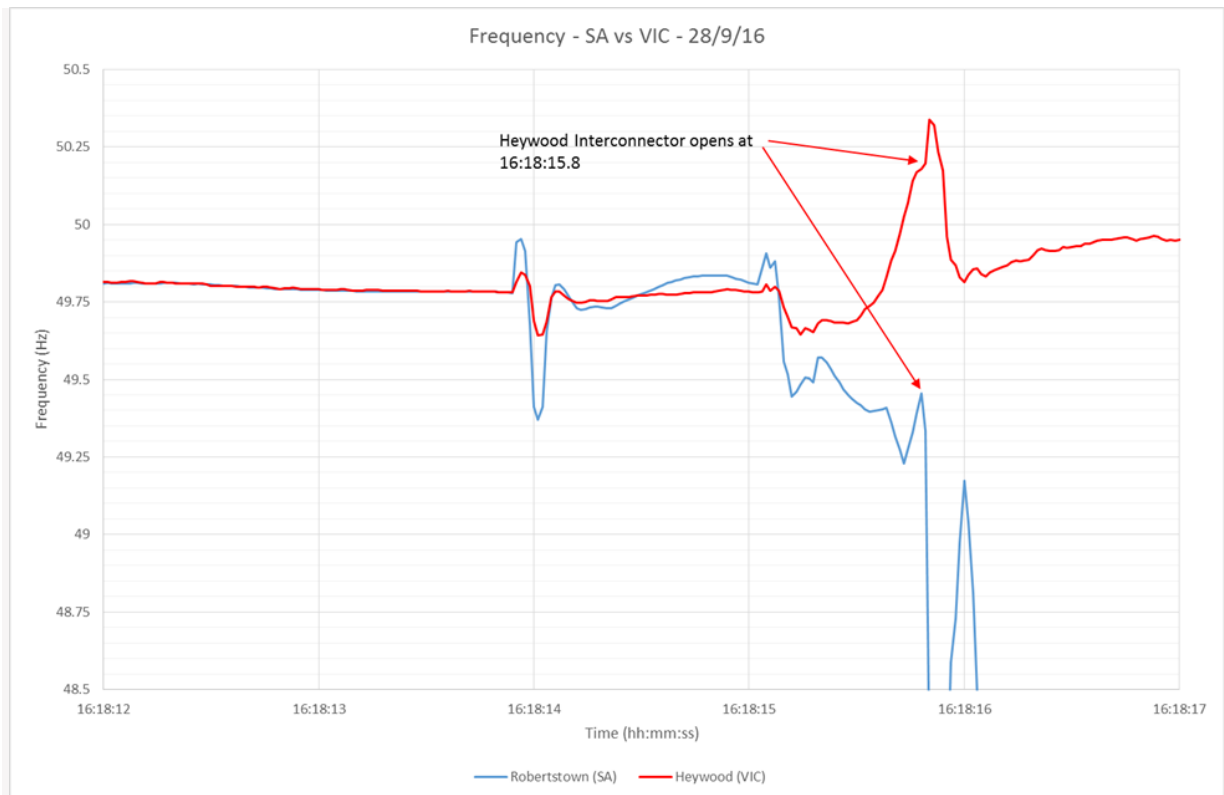
**Figure 2 Frequency SA compared with Victoria during event**

Figure 2 shows frequency measured at Robertstown in SA, and at Heywood in Victoria, in the period immediately before loss of the Heywood interconnection.

It shows a separation in the measured frequency between the two areas in the period immediately prior to loss of the Heywood Interconnector. Again, this is consistent with a loss of synchronism between the SA power system and the remainder of the NEM.

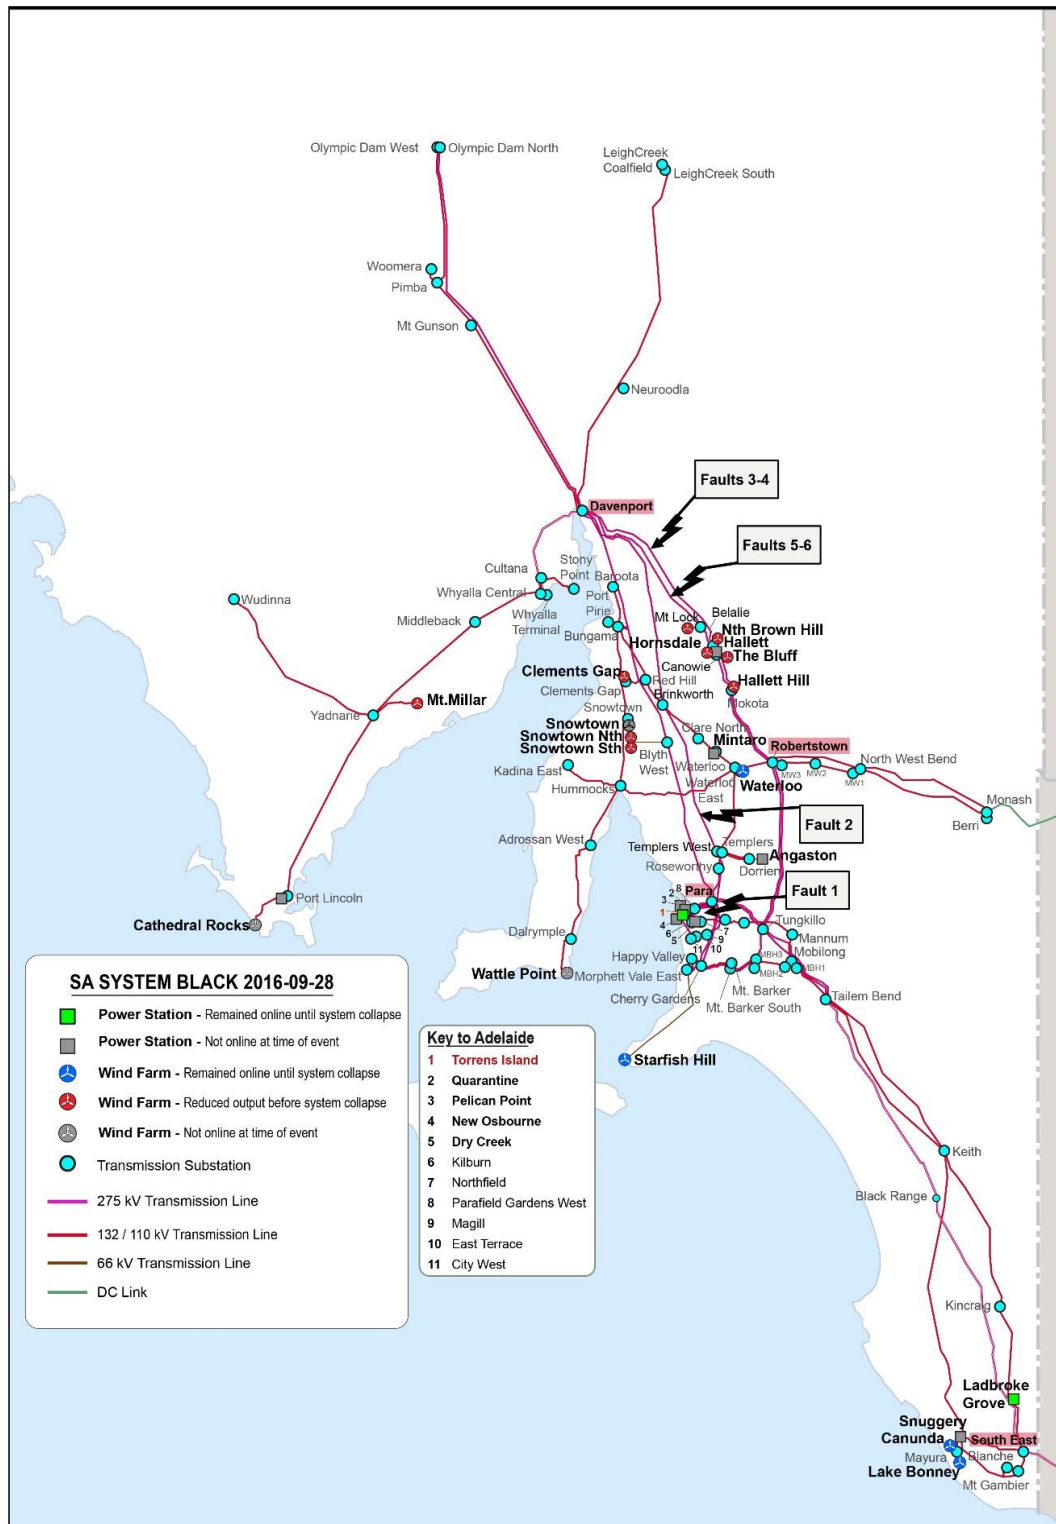
**Figure 3 Map of SA transmission system showing location of faults and major terminal stations**

Figure 3 provides an approximate location of the faults on the SA transmission network in relation to the major substations in the area.

Five transmission line faults, resulting in six voltage disturbances on the network, led to the SA region Black System. Table 3 below provides more detail on each transmission line fault.

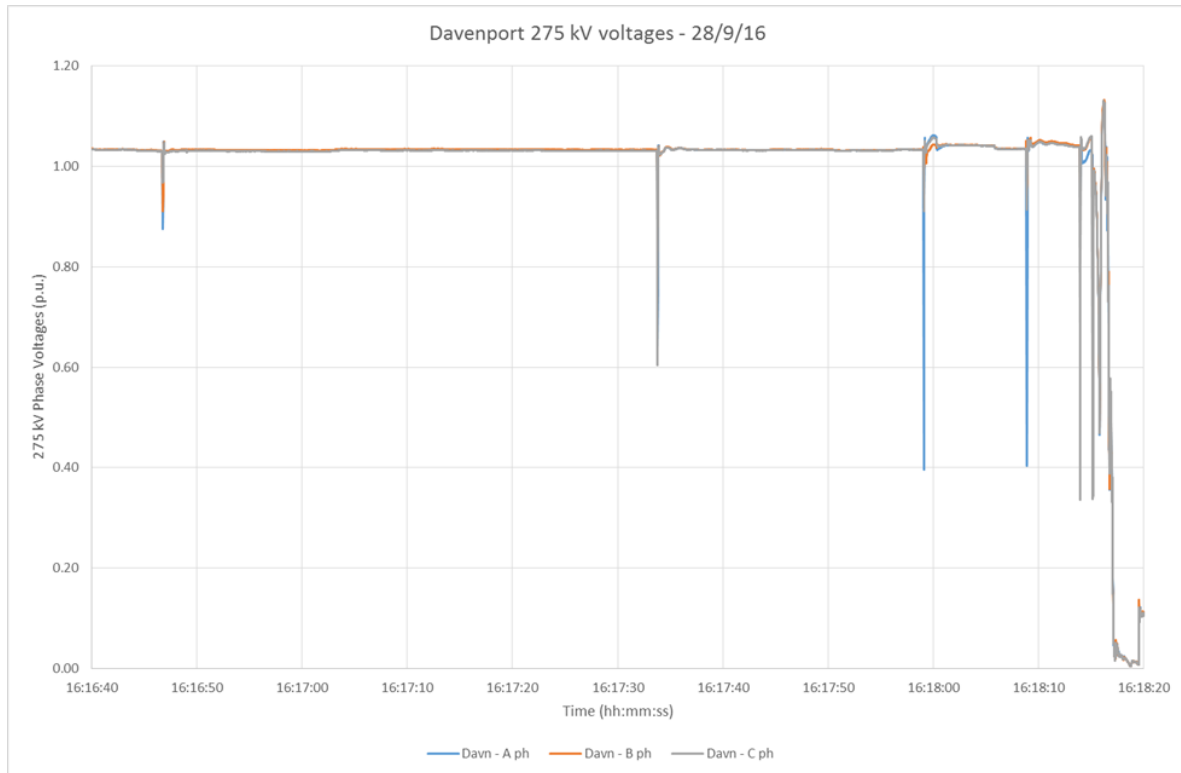
**Figure 4 Voltages measured at Davenport – Olympic Dam 275 kV line**

AEMO has examined the impact of these faults, seen at Davenport, Robertstown, Para, and South East terminal stations, a sample that spans the whole SA transmission network except for the Eyre Peninsula and the line to Olympic Dam. The analysis has confirmed the same six voltage dips were experienced at the above locations between 16:16:46 hrs and 16:18:14 hrs corresponding to the faults on the network. The disturbances observed are smaller in magnitude further from the fault location, with voltages near Mount Gambier remaining within the normal  $\pm 10\%$  range.

The size of the voltage dips for wind farms connected to the South East region of SA, such as Lake Bonney and Canunda wind farms (Figure 7), was not as large as the voltage dips observed at Davenport (see Figure 4). Wind turbines in the South East region initiated fault ride-through mode either once, at around 16:18:15, or not at all.

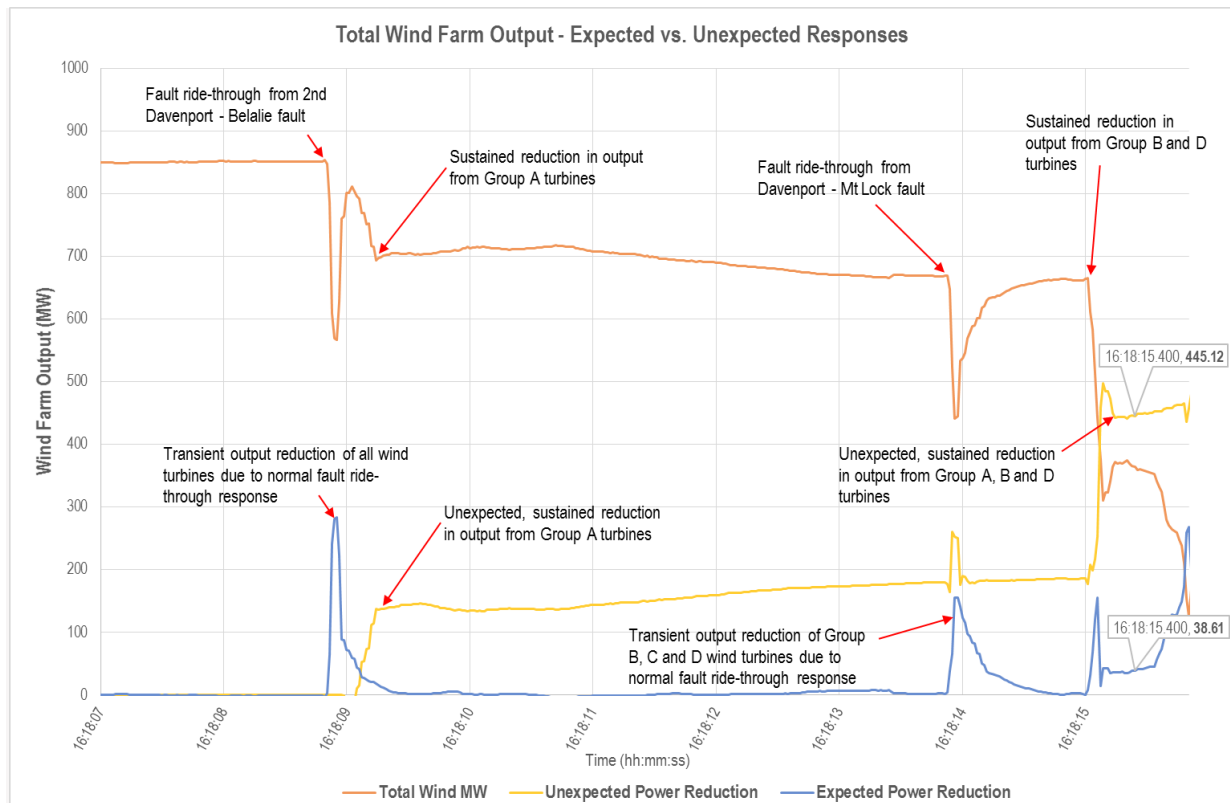
**Figure 8 Total wind farm output – expected vs. unexpected responses, 28 September 2016**

Nine wind farms exhibited unexpected power reduction during the six voltage disturbances on the transmission system. AEMO has been working with each wind farm operator to determine the causes of this reduction, and that engagement is continuing.

- If the pre-set limit was exceeded in the event, each wind turbine either disconnected from the network, stopped operating (remained connected with zero output) or reduced its output.
- The pre-set limit varied from wind farm to wind farm, and some were set low enough for the six voltage disturbances in the event to exceed their limit.
- This control system caused nine wind farms to reduce output when the number of ride-through events caused by voltage disturbances exceeded the pre-set limits.

The power reduction across the wind farms is illustrated in Figure 8 below.

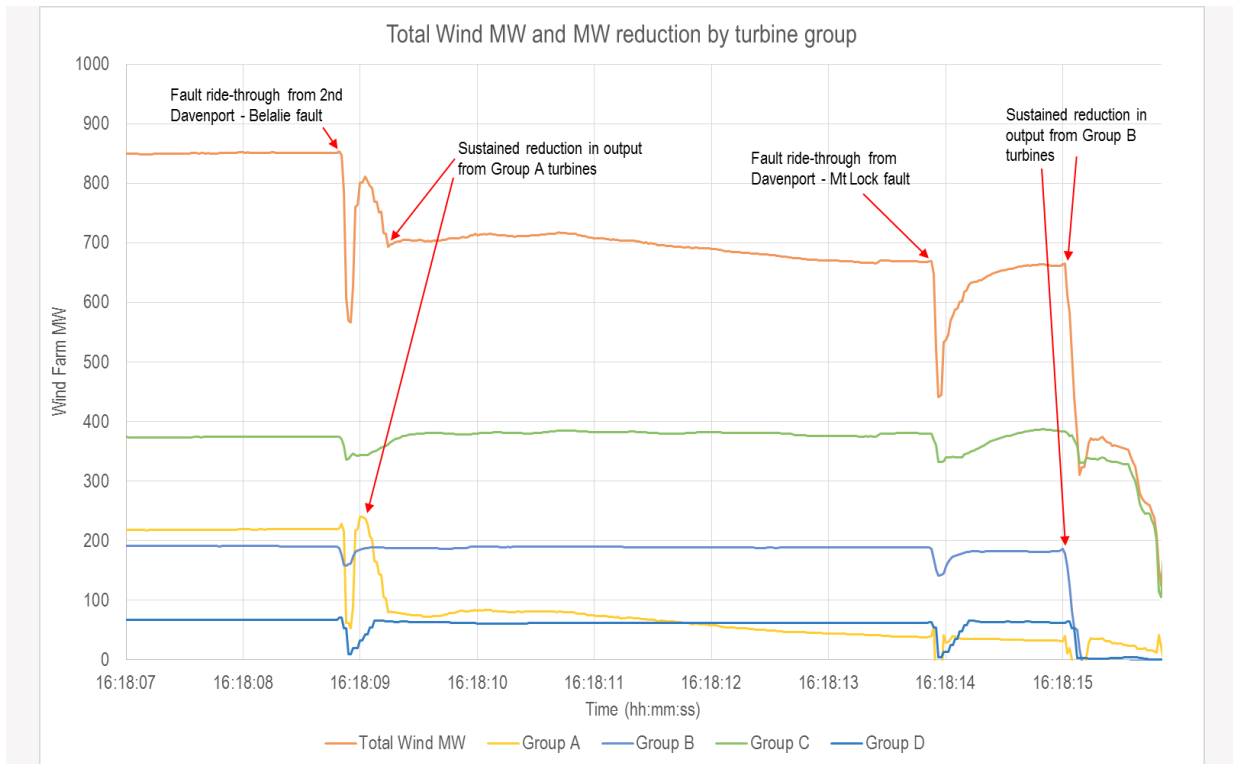
**Figure 9 Wind farm power reduction based on wind turbine grouping**

Figure 9 below illustrates the unexpected power reduction of wind farms, based on the grouping in Table 5.

Figure 9 also highlights the following observations:

- **16:18:08.8:** Fast reduction in power by Group A wind turbines due to the occurrence of a third successive voltage disturbance within two minutes, as seen by most on-line wind turbines. Most wind turbines successfully rode through the third voltage disturbance, then either reduced output or disconnected due to activation of repetitive low voltage ride-through protection.

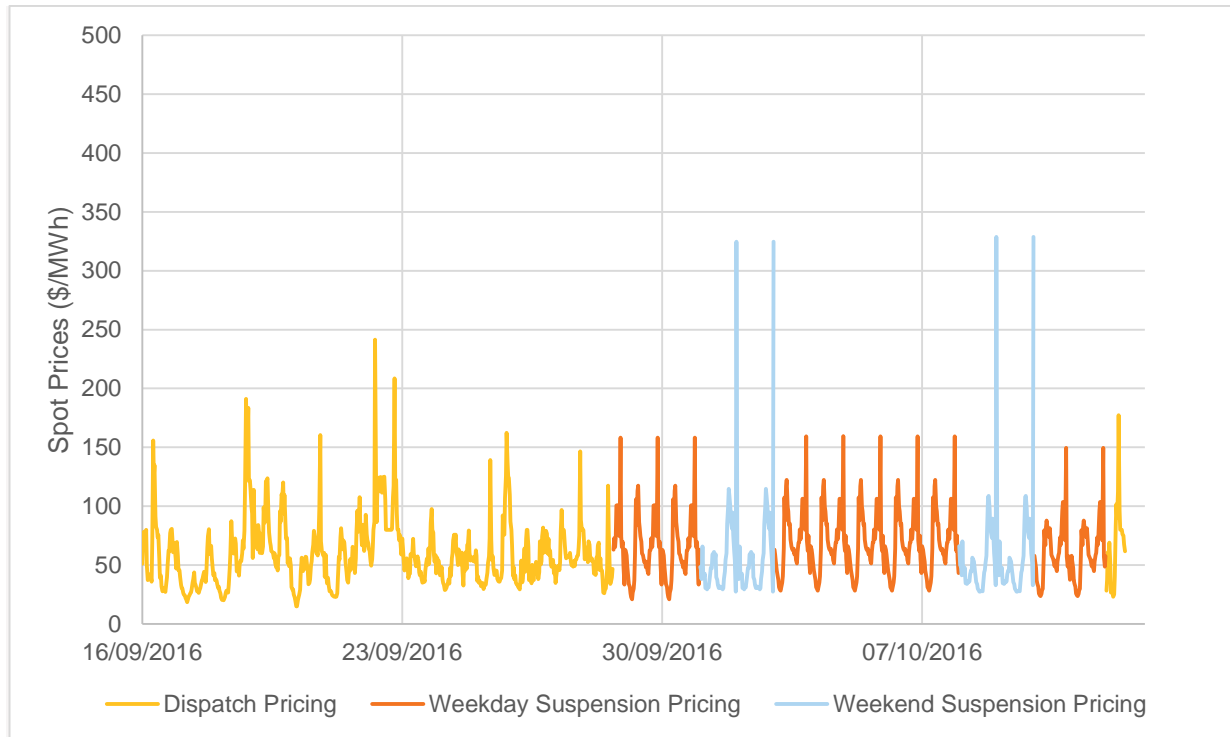
**Figure 10 30-minute spot market price in South Australia since 16 September 2016**

Note: price spikes on weekends reflect price spikes that occurred during the four week price-averaging period prior to market suspension.
