OPERATIONAL TEST  
AND EVALUATIONOFFICE OF THE SECRETARY OF DEFENSE  
1700 DEFENSE PENTAGON  
WASHINGTON, DC 20301-1700

MEMORANDUM FOR UNDER SECRETARY OF DEFENSE FOR ACQUISITION,  
TECHNOLOGY AND LOGISTICSSUBJECT: Observations on the Marine Corps F-35B Demonstration on USS *Wasp*

During the period of May 18 – 29, 2015, the Marine Corps embarked a total of seven F-35B aircraft onboard the aircraft carrier USS *Wasp* (LHD-1) for a shipboard deployment demonstration.<sup>1</sup> The Marines refer to this demonstration event as “Operational Test One,” or “OT-1;” the aircraft were flown by operational pilots, and most of the aircraft maintenance was performed by uniformed military maintenance personnel, albeit heavily supported by contractors. Representatives from the Joint Strike Fighter (JSF) Operational Test Team (JOTT) and analysts from the Institute for Defense Analyses (IDA), the latter representing my office, were permitted to embark for the duration of the event to observe the activities firsthand.

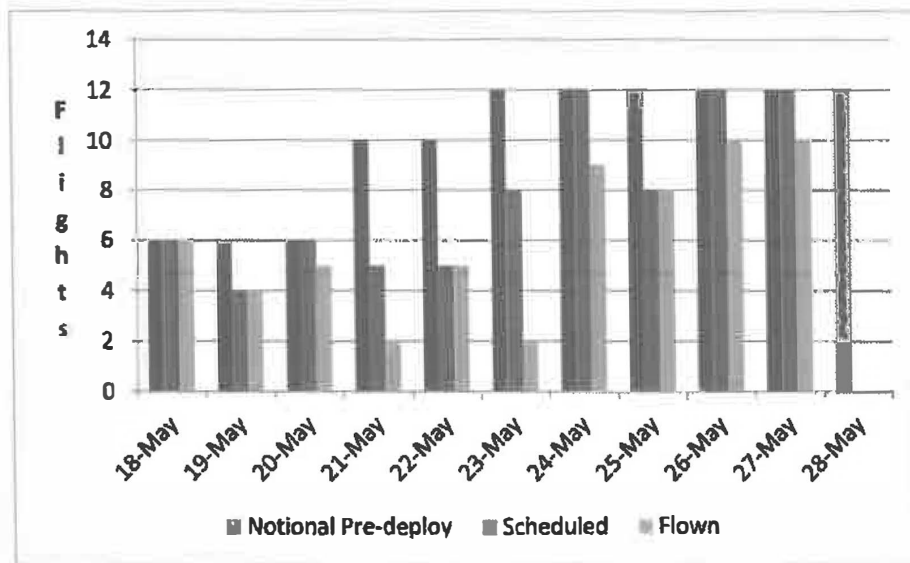
**Figure D-1. Daily Flight Activity**

can be made to a notional air plan that was developed during a pre-deployment planning conference in March 2015. The figure below shows the day-by-day comparison between the notional number of flights envisioned as of the pre-deployment planning conference; the actual number of flights scheduled each day, which was designed around aircraft availability; and the actual number of flights accomplished. Two flights were cancelled due to lightning within the limits of an existing F-35 operating restriction and two nighttime Carrier Qualification (CQ) events were canceled for weather that was anticipated to be outside acceptable limits for CQ operations. The other 13 flights scheduled but not flown appear to have all been omitted for aircraft availability.

- The average utilization rate on a flight basis was less than one flight per aircraft per day, including the ferry flights to the LHD, for the 11 days from May 18 to 28 (including one down day for maintenance to prepare the aircraft for the redeployment). Aircraft utilization was not uniform across aircraft or throughout the time of the deployment. Initial plans were for the number of flights to increase as the deployment progressed; however, flight schedules had to be adjusted daily based on anticipated aircraft availability. The highest utilization rate occurred on May 26 and 27 (days 9 and 10 the deployment underway at sea), at nearly 1.67 flights per aircraft assigned per day.

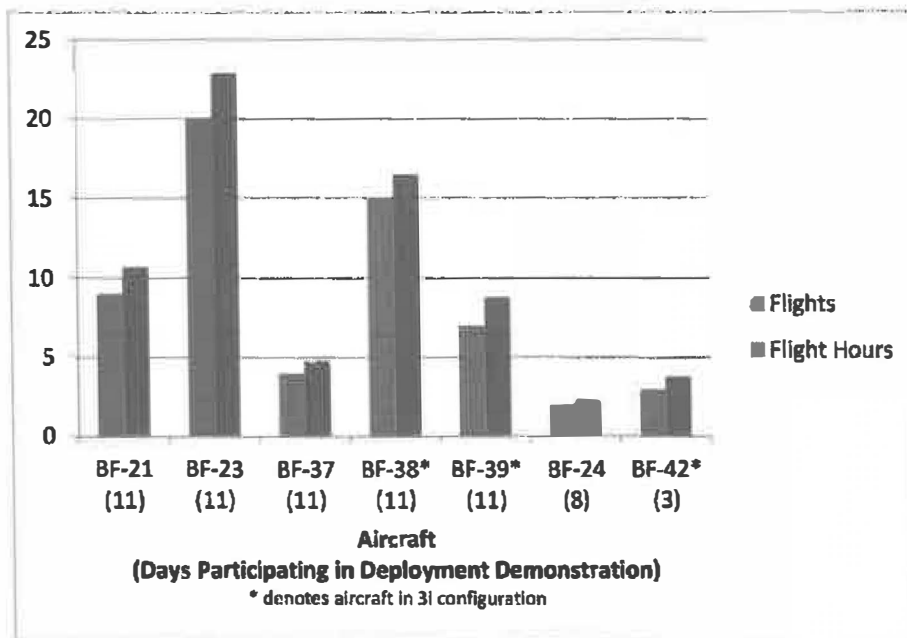
Figure D-2. Aircraft Flights and Flight Hours

- The average utilization rate on a flight hour basis was about one hour per aircraft per day. This was a slight decrease compared to shore utilization for VMFA-121, the operational unit at MCAS Yuma, which achieved about 1.3 flight hours per aircraft per day in April 2015, the month before the deployment. However, it was an increase compared to shore utilization for VMFAT-501, the training unit at MCAS Beaufort, which was around half an hour per aircraft per day in April 2015.

- The number of flight hours flown by each aircraft varied widely, with some aircraft in a down status for up to five days in a row, and other aircraft rarely requiring major maintenance. BF-23 performed best, accumulating roughly 23 flight hours over 20 flights, and was the only aircraft to be scheduled and flown every day while underway. Of the remaining four aircraft that completed the entire deployment, BF-37 flew the least, with approximately five hours and four flights, including the fly-on from MCAS Beaufort and a ferry flight to return from MCAS Cherry Point after diverting there. Due to multiple maintenance issues, BF-37 did not fly from May 19 through May 23, flew on May 24, but emergency diverted to MCAS Cherry Point, and then returned to the ship on May 26. It did not fly on May 27 for a maintenance issue, and only flew again on May 29 to ferry off the ship. The figure below shows the flights flown and flight hours accumulated for each of the aircraft that participated in the deployment.
