MOUNT POLLEY MINE TAILINGS STORAGE FACILITY BREACH

August 4, 2014

Investigation Report
of the Chief Inspector of Mines

November 30, 2015

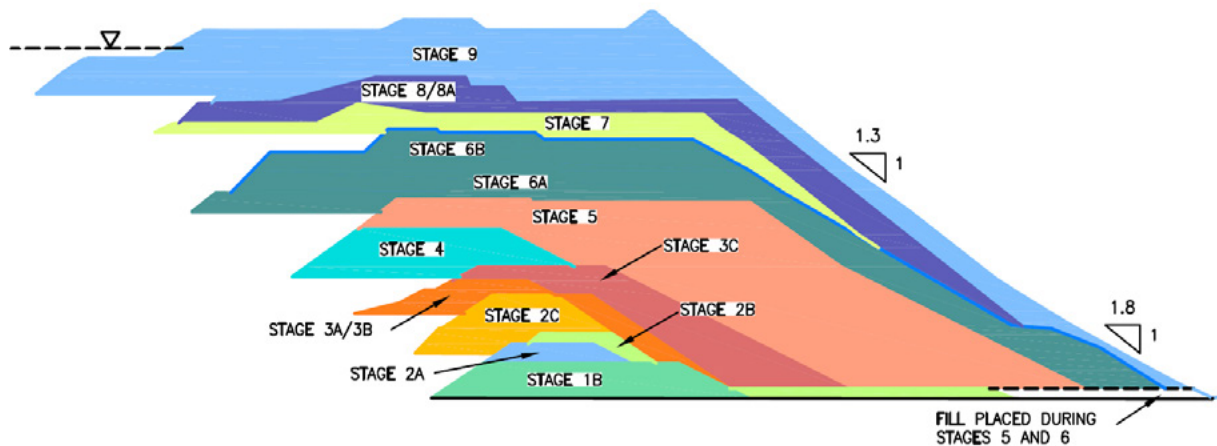
The design profile of the PE at the close of Stage 9 (at the time of the failure) is shown in Figure 1.2. The elevation of the crest is 970 m; the height of the embankment at its highest point (where the breach occurred) is approximately 40 m, and the downstream slope is at 1.3H:1.0V.

Figure 1.2 Embankment Stages Appendix 3, Fig. 2.6

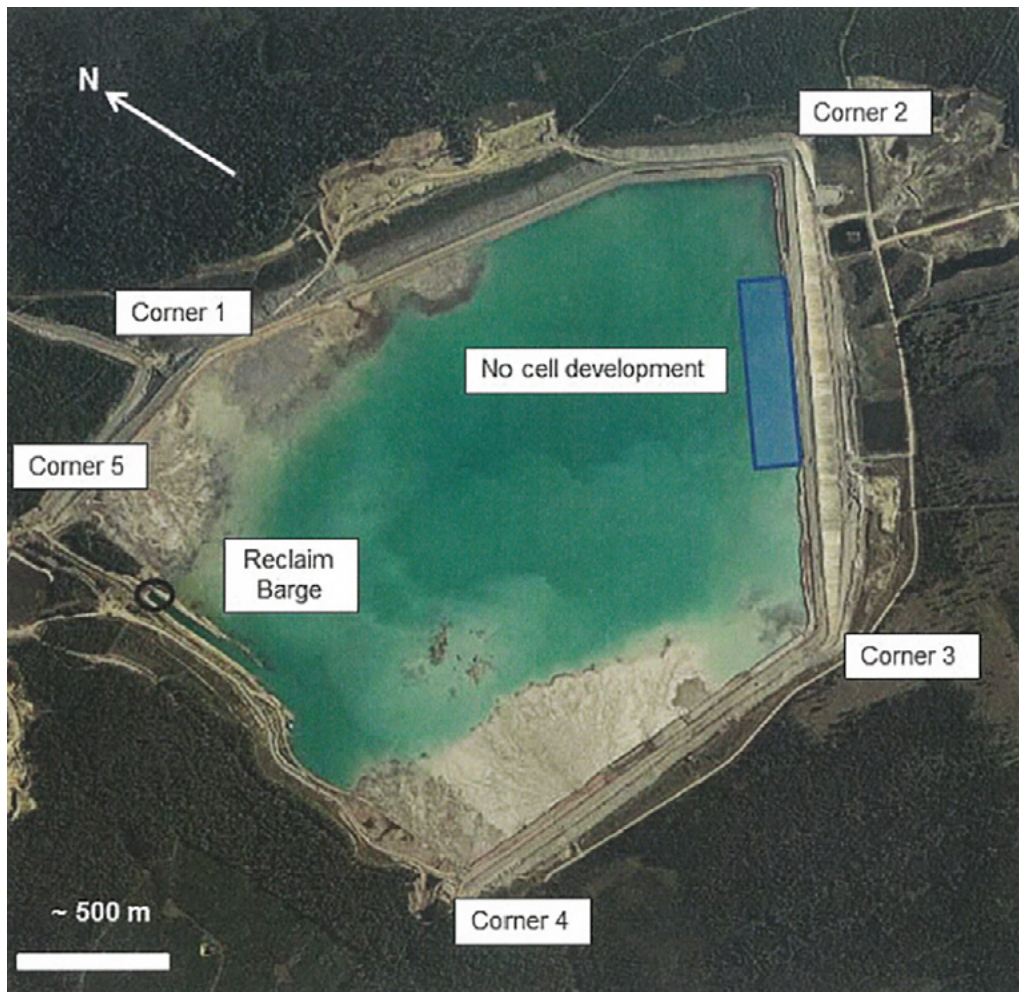
BGC’s assessment noted, “given the orientation of the gravity-fed tailings line, insufficient tailings line pressure prevented cell [Zone U] construction along the central portion of the Main Embankment... The tailings delivery line is currently being redesigned with the expectation that the new alignment will allow for upstream tailings cell construction to take place along the Main Embankment in 2013.”¹¹⁵ The limited cell development (and lack of beaches) can be seen in Figure 6.20.

*Figure 6.20 Sand Cell and Beach Development (commentary by BGC)
BGC Engineering Inc. (2013a) p. 6*

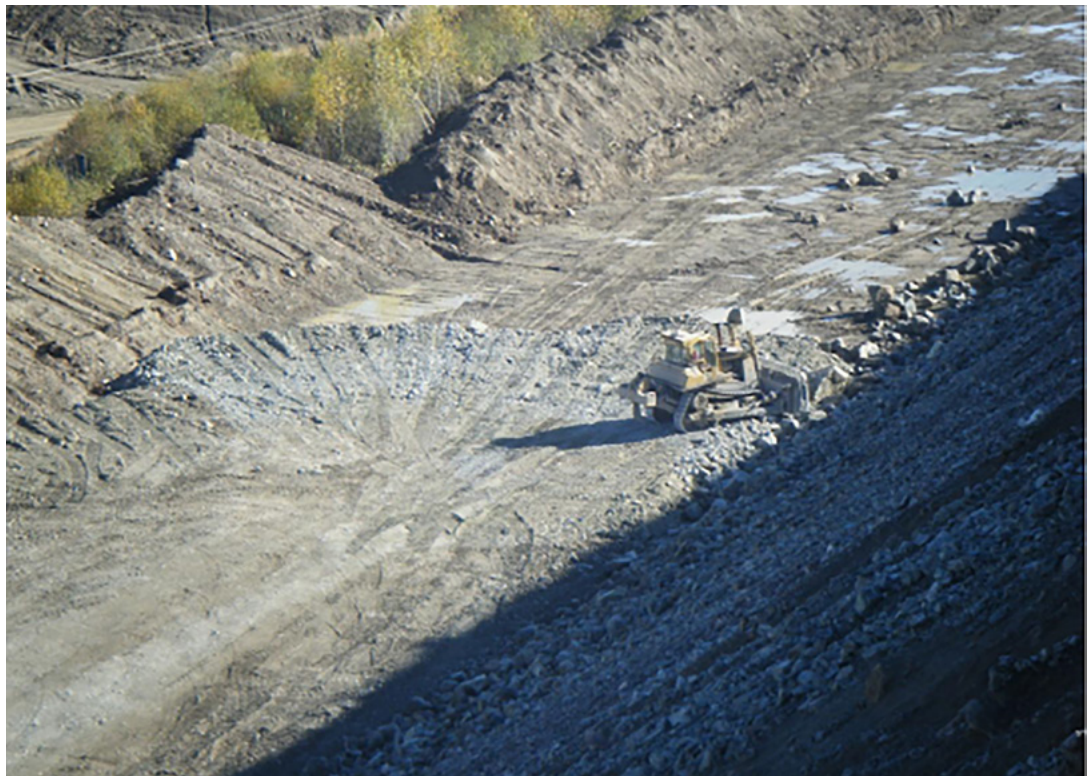
Although they were not referenced to specific locations along the embankment, daily construction reports referred to buttress subexcavation along the PE. Construction photos likewise depicted multiple instances (again not referenced by location) on the PE where a foundation was prepared in panels of unspecified length, filled with Zone C rock, and compacted by equipment traverses (see, for example, Figure 6.23). The excavations would require site engineer inspection prior to refilling.

Figure 6.23 C Zone Material Placed in PE Subexcavation, October 19, 2013
AMEC Environment and Infrastructure (2013b)

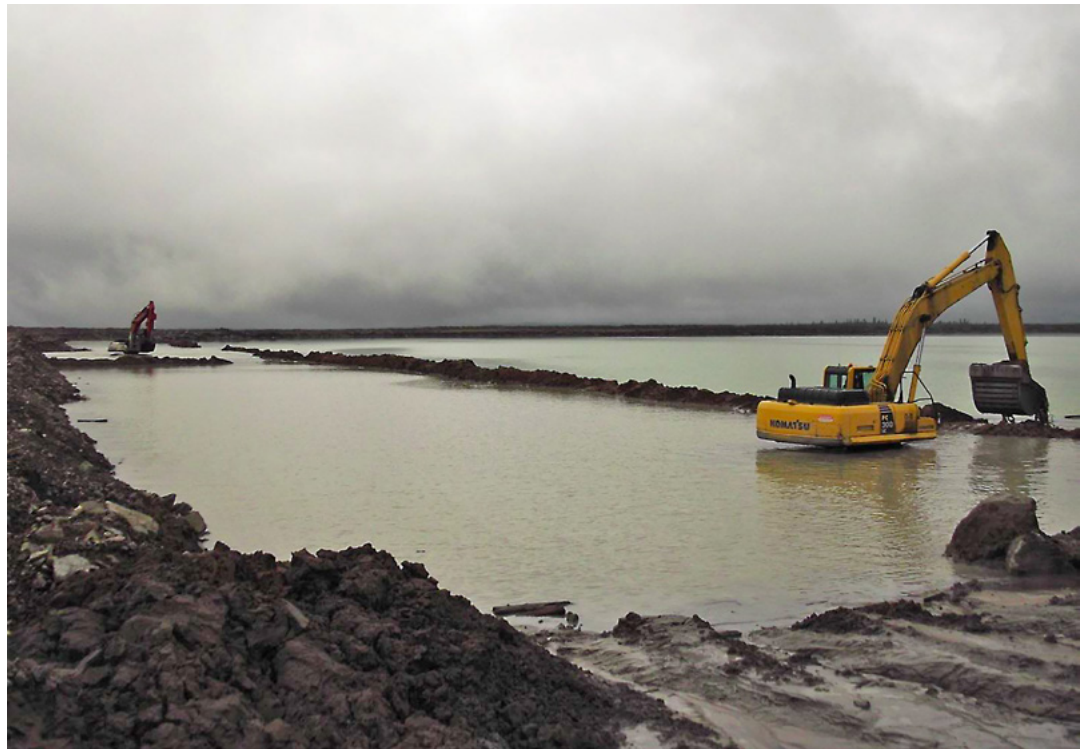
Figure 6.24 Creation of sand cells 3+150 to 3+050, on May 18, 2014, indicating high water level 6 days before the overtopping event AMEC Environment and Infrastructure (2014c)

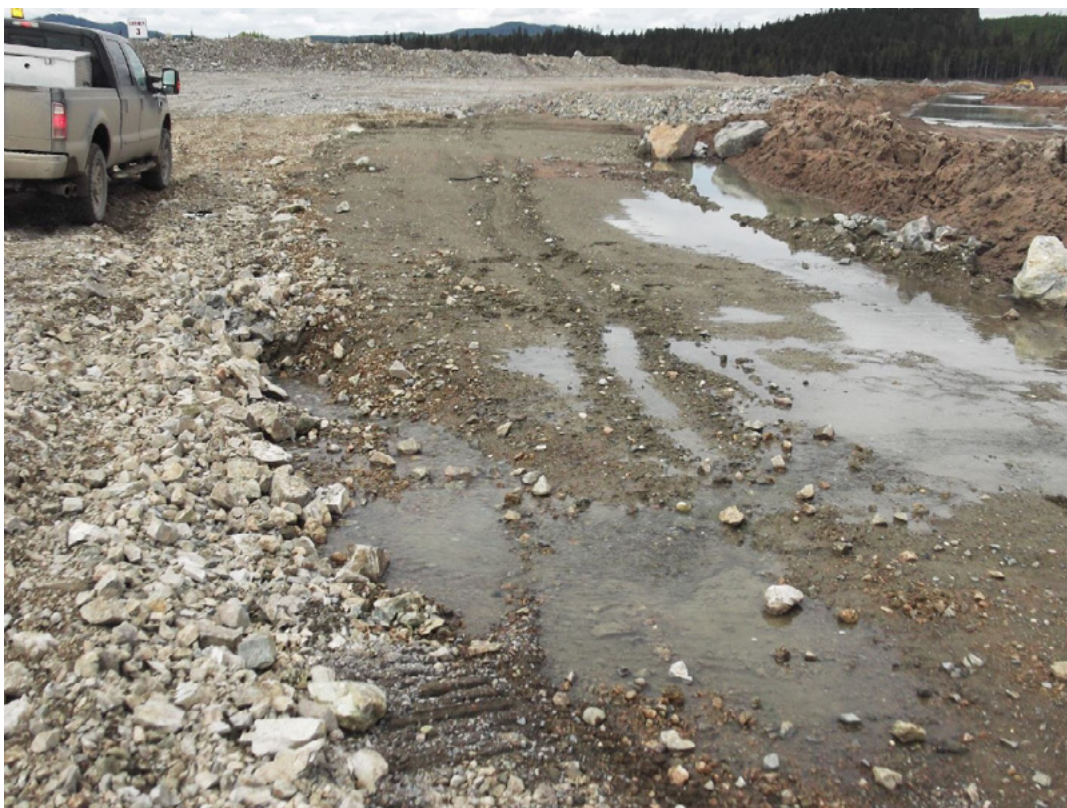
Figure 6.25 Water Overtopping Embankment Core and Entering Filter Zone, Station 1+530 on SE, May 24, 2014 AMEC (2014d) p. 5

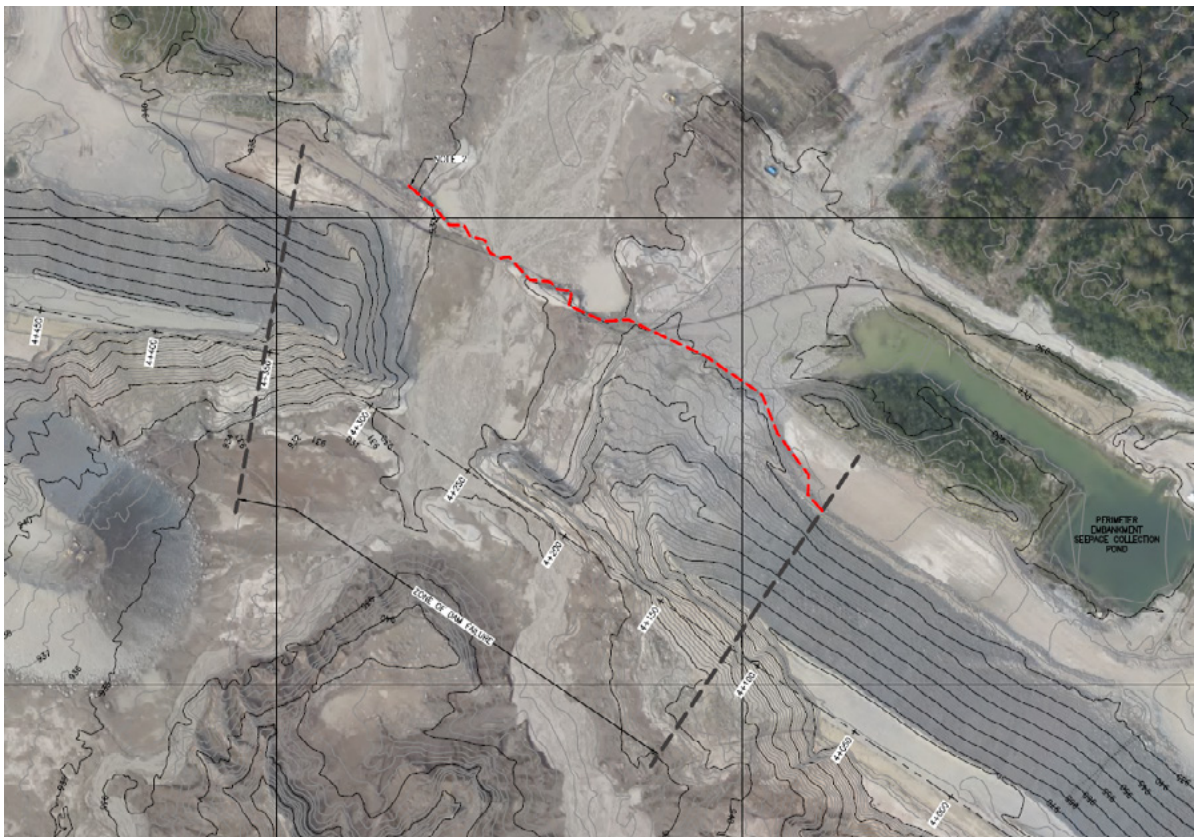
Figure 8.1 Aerial View of Dam Breach

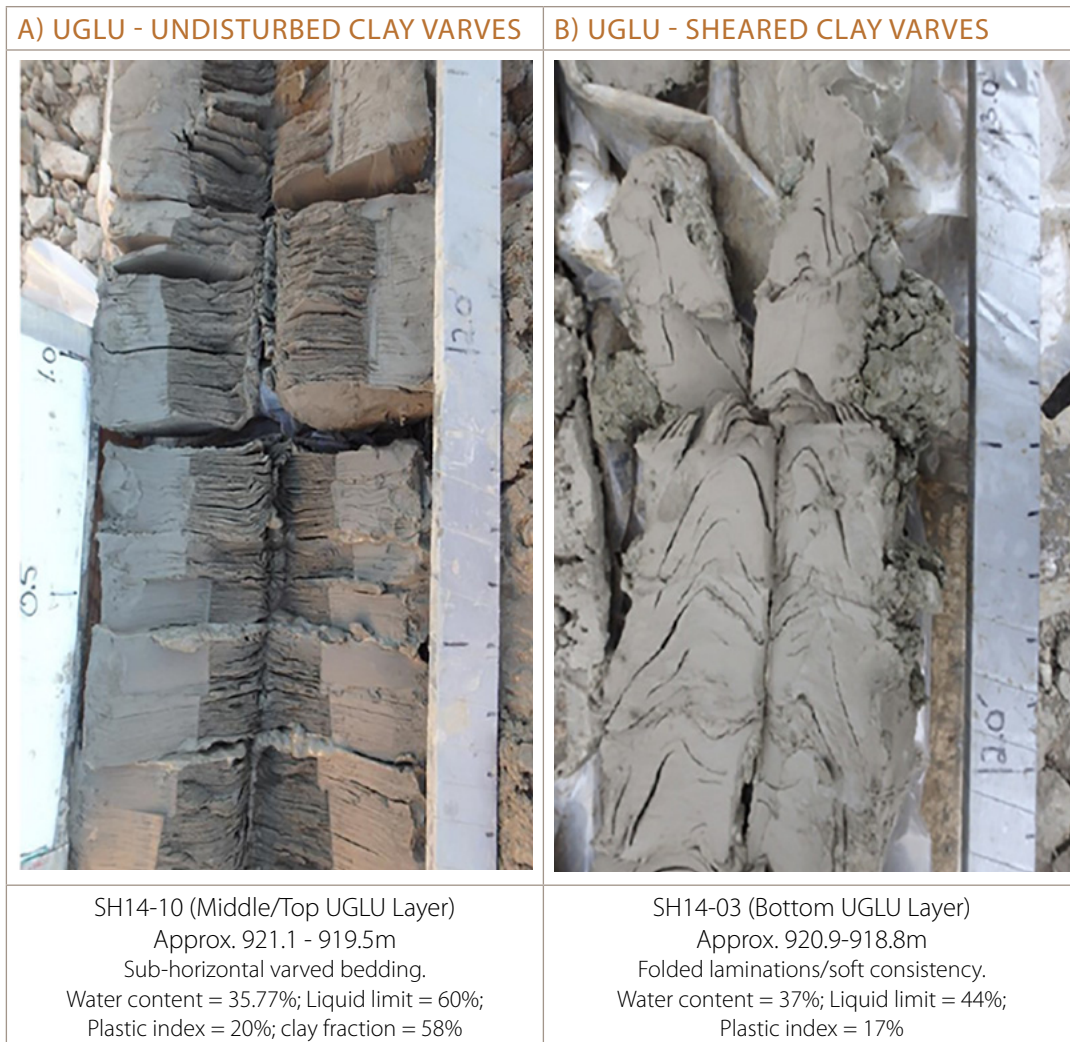
Figure. 9.1 Buckling of Varved Clay Laminations in UGLU
Appendix 3, Fig. 5-10

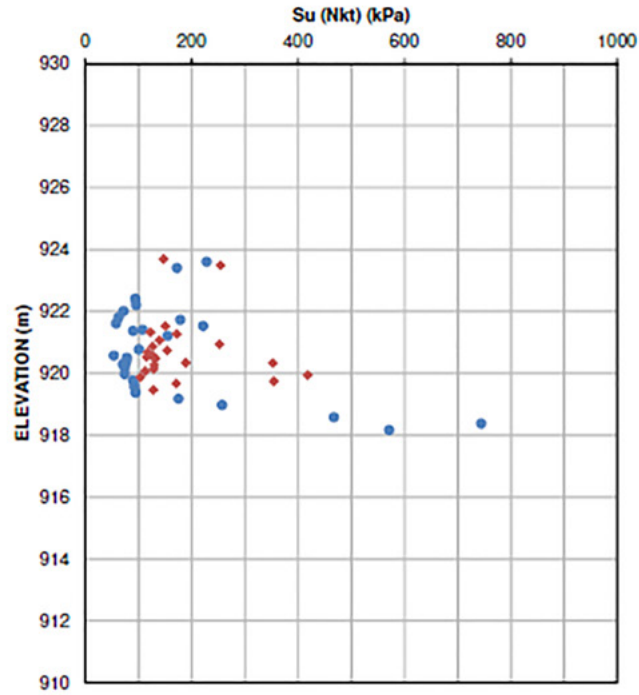
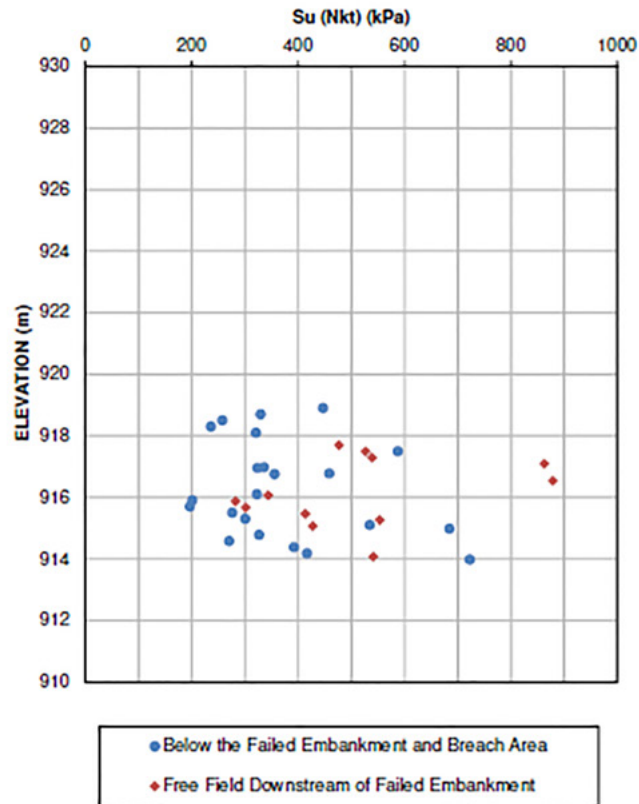
a) UGLU - INTERPRETED UNDRAINED STRENGTH FROM CPT TESTING

b) LGLU - INTERPRETED UNDRAINED STRENGTH FROM CPT TESTING

Figure 9.2 Undrained Shear Strength in GLUs
Appendix 3, Fig. 5-16, 5-17

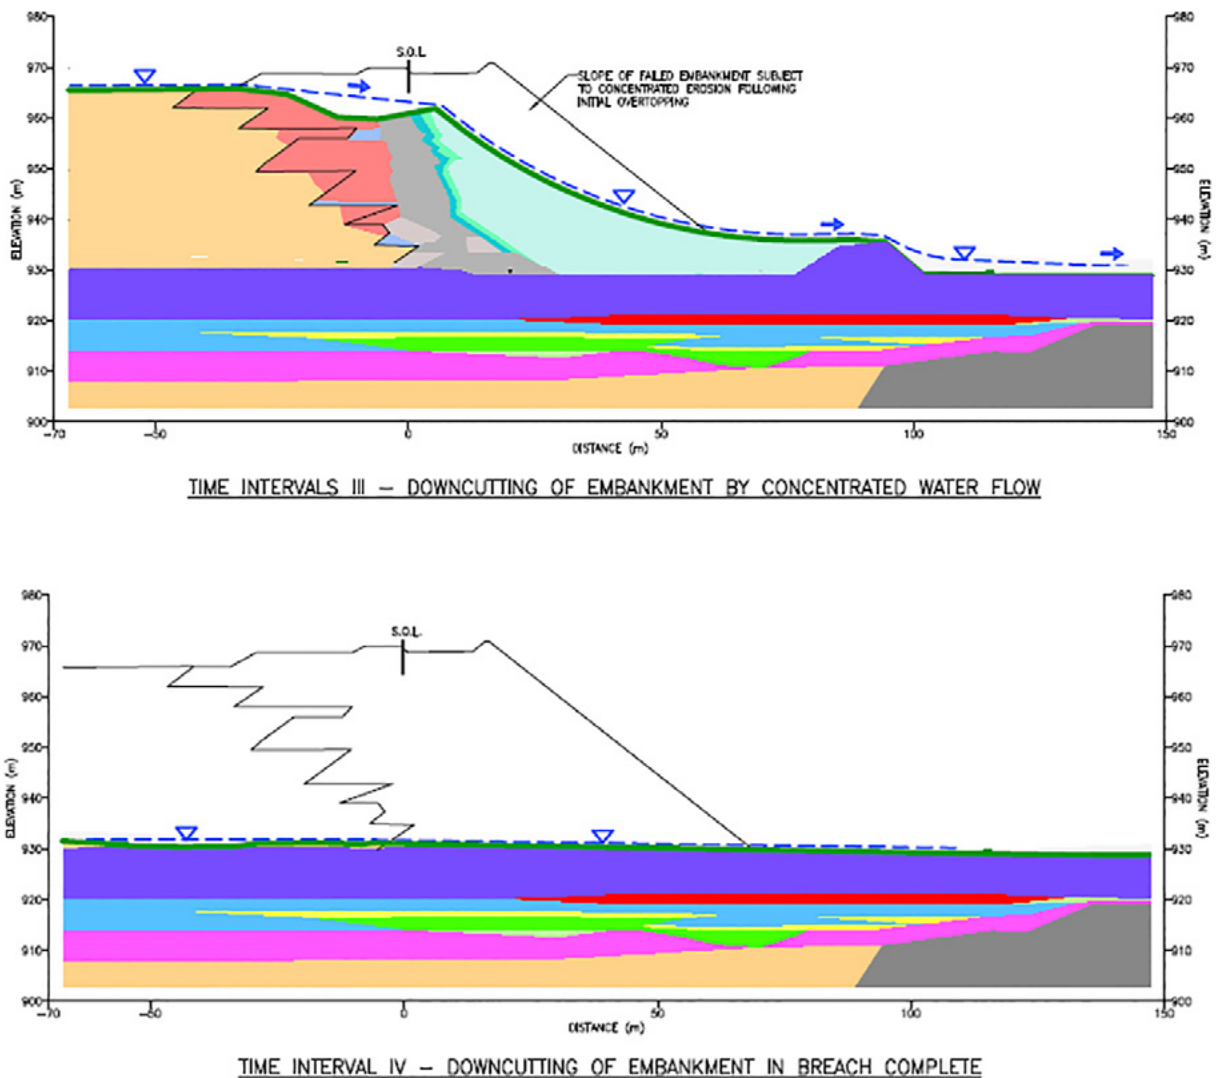
*Figure 9.4 Hypothesized Embankment Breach Sequence
Appendix 2, Fig. 3-12*

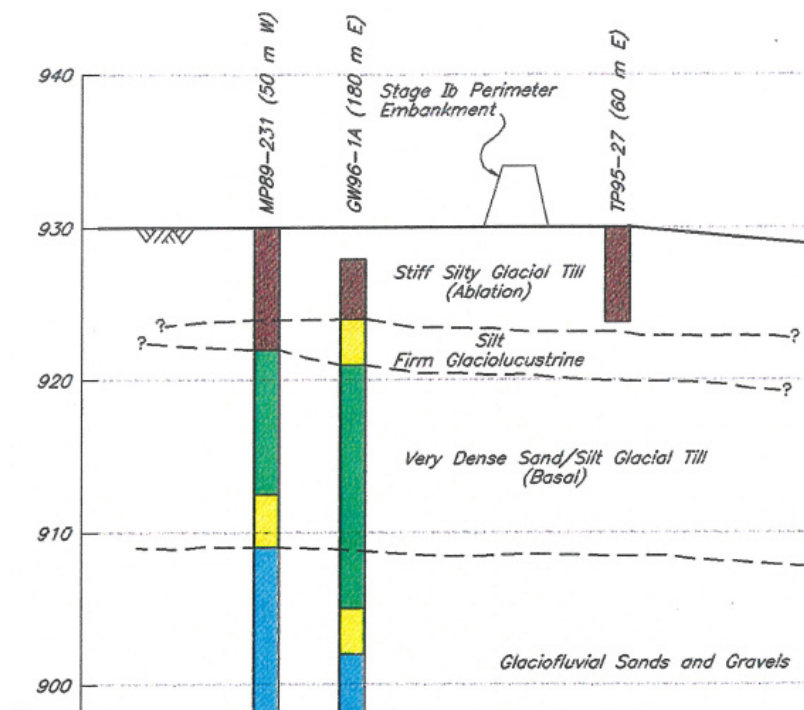
Figure 10.2 Detail of UGLU
Knight Piésold (1997c) Dwg 1627.011

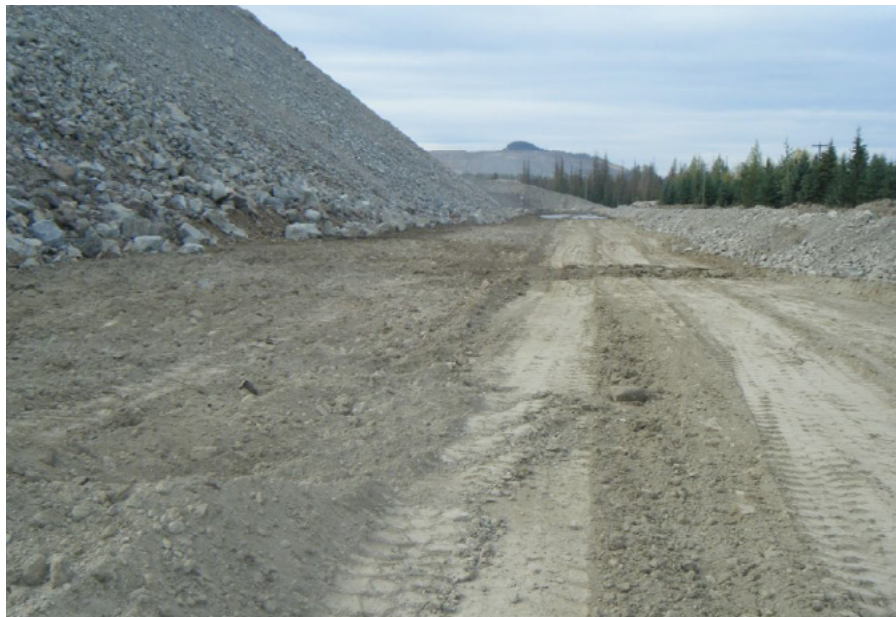
Figure 10.3 Typical Buttress Subexcavation
AMEC Environment and Infrastructure (2014a) Appendix A)
