ATSB TRANSPORT SAFETY REPORT
Aviation Occurrence Investigation
AO-2008-070
Final

In-flight upset
154 km west of Learmonth, WA
7 October 2008
VH-QPA
Airbus A330-303

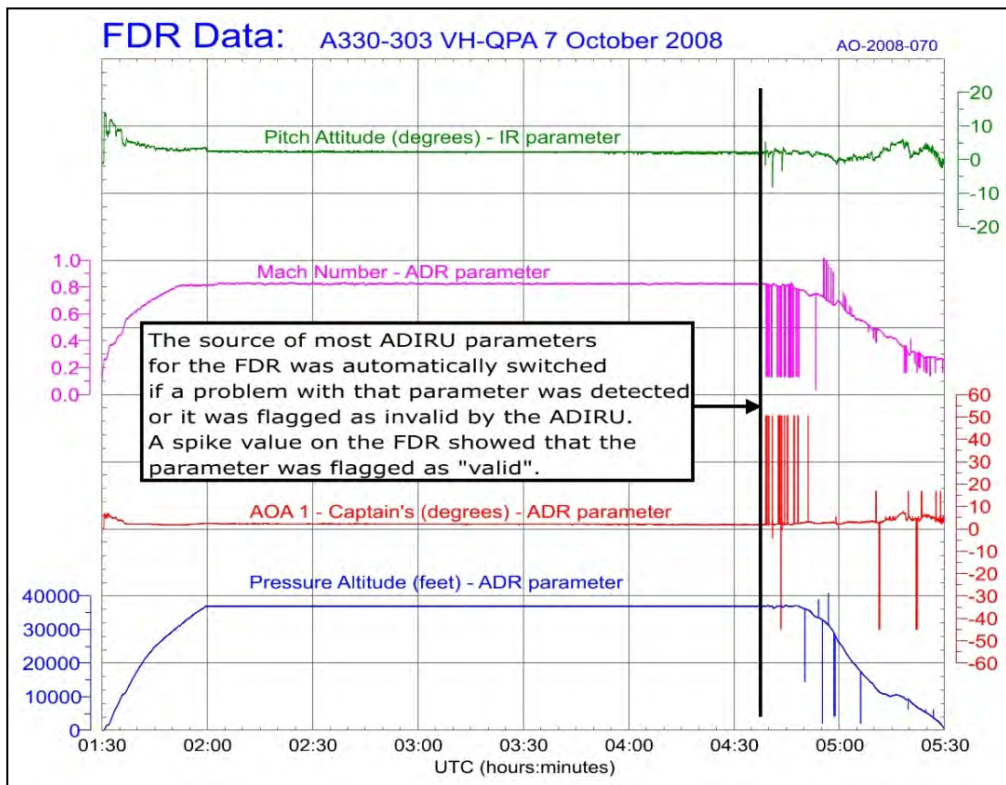
Figure 19: FDR plot showing key ADIRU parameters

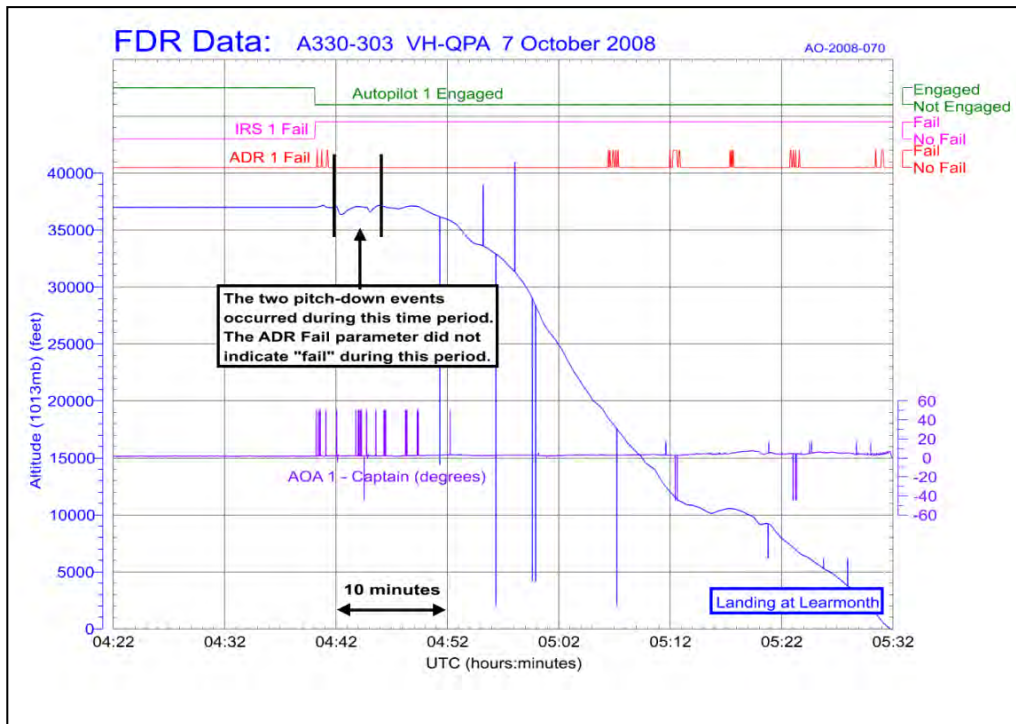
Figure 20: ADR 1 and IR 1 Fail parameters (from the FDR)

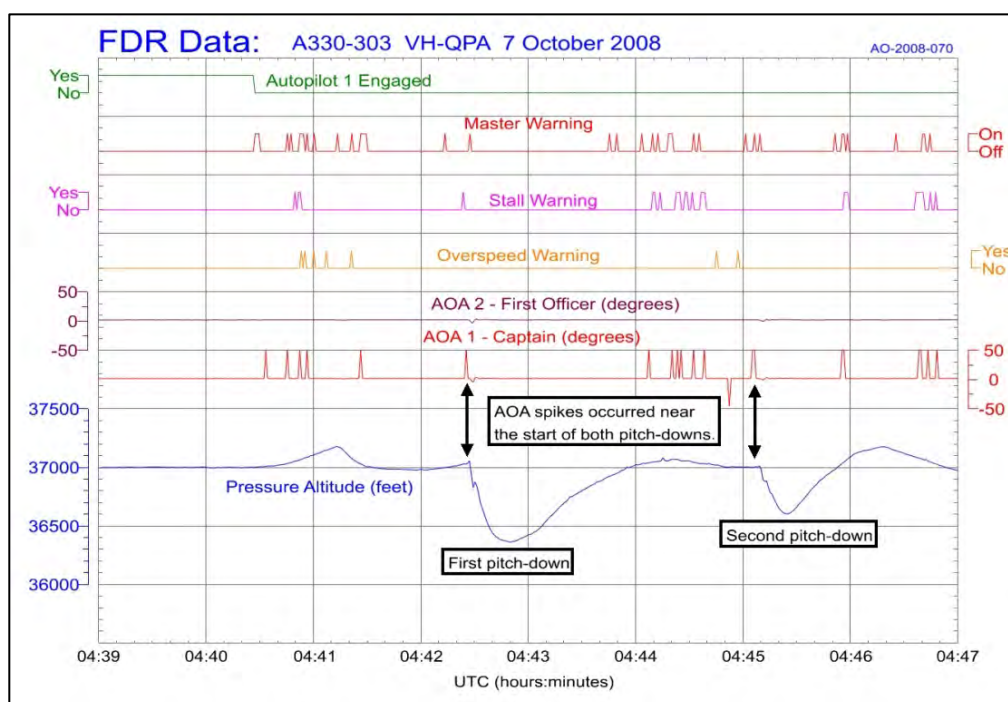
Figure 23: FDR plot showing recorded AOA spikes for both pitch-downs

⁵² There were also several instances of invalid AOA 1 data being provided by the ADIRU. When this occurred, it was indicated on the FDR with a value of -45° (Appendix B).

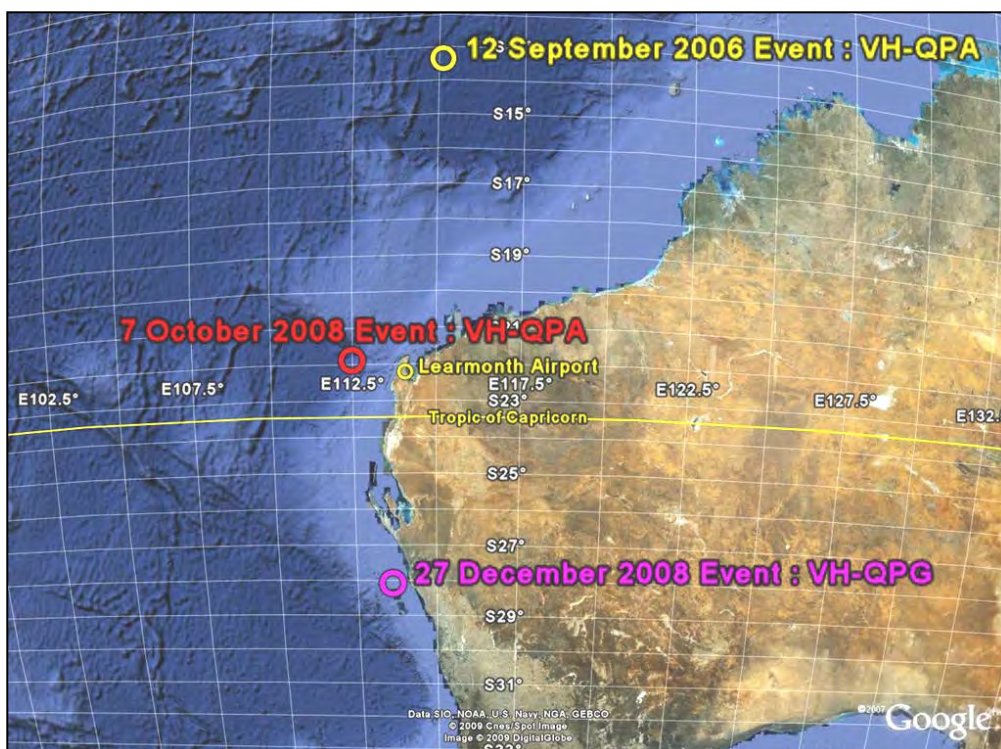
Figure 26: Locations of the three ADIRU data-spike occurrences⁷²

⁷² The point shown for each event is where the anomalous ADIRU behaviour commenced.

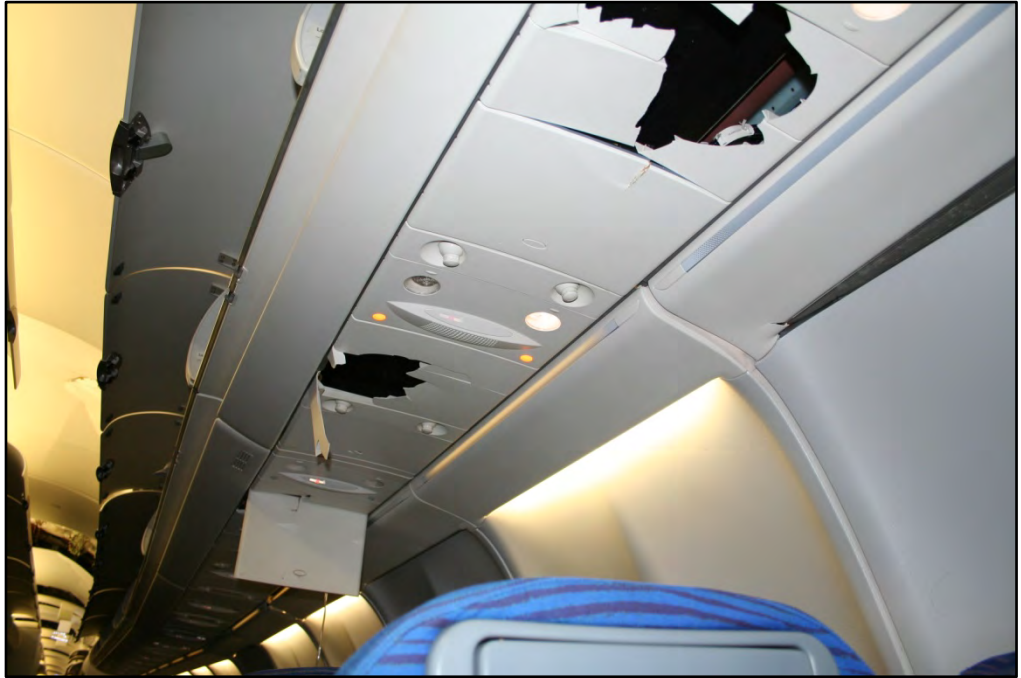
Figure 48: Example of damage to the fittings above passenger seats (centre section)

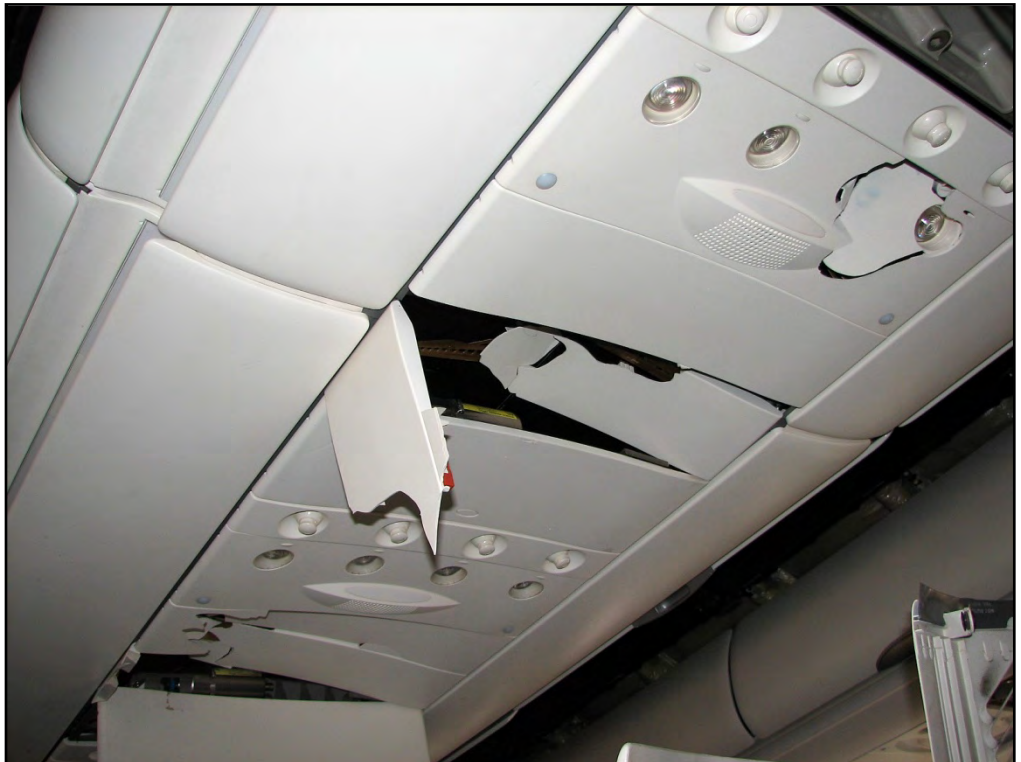
Figure 49: Example of damage to the fittings above passenger seats (rear section)

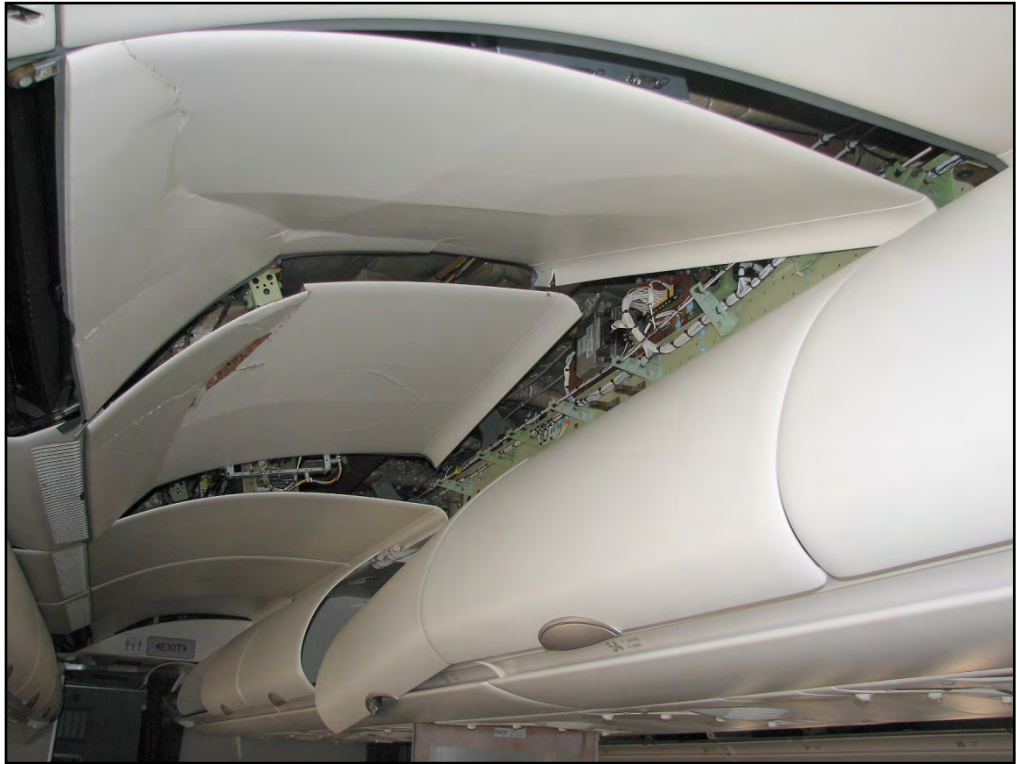
Figure 50: Example of damage to the ceiling panels in the aisle (rear section)

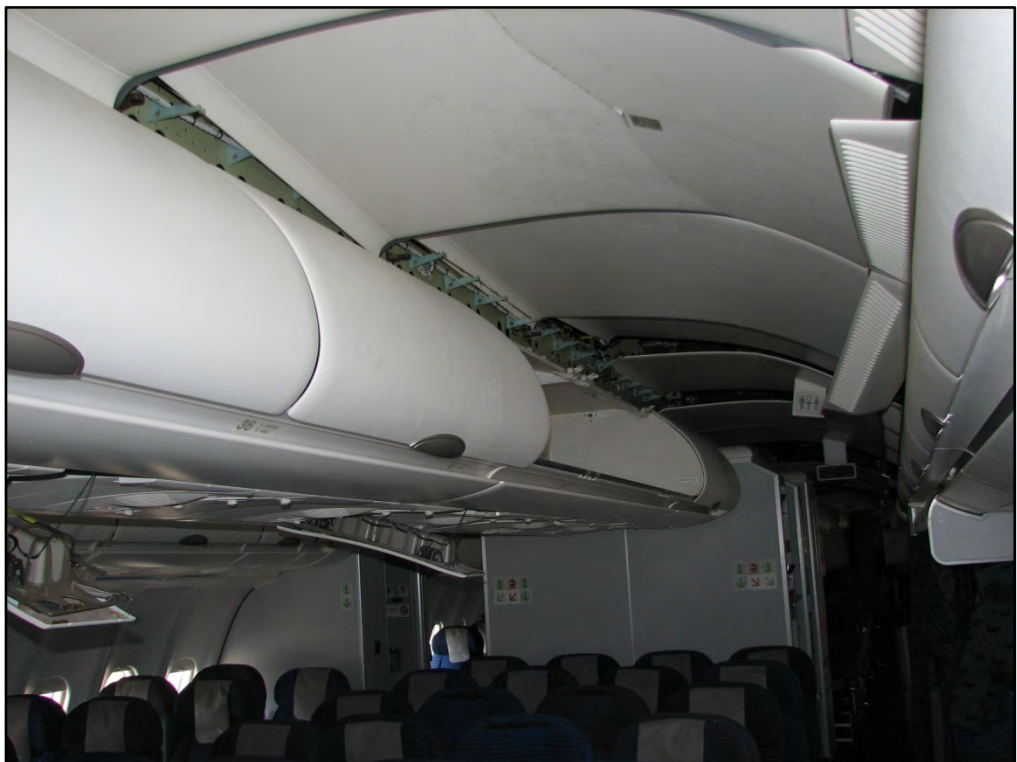
Figure 51: Example of damage to the ceiling panels in the aisle (centre section)

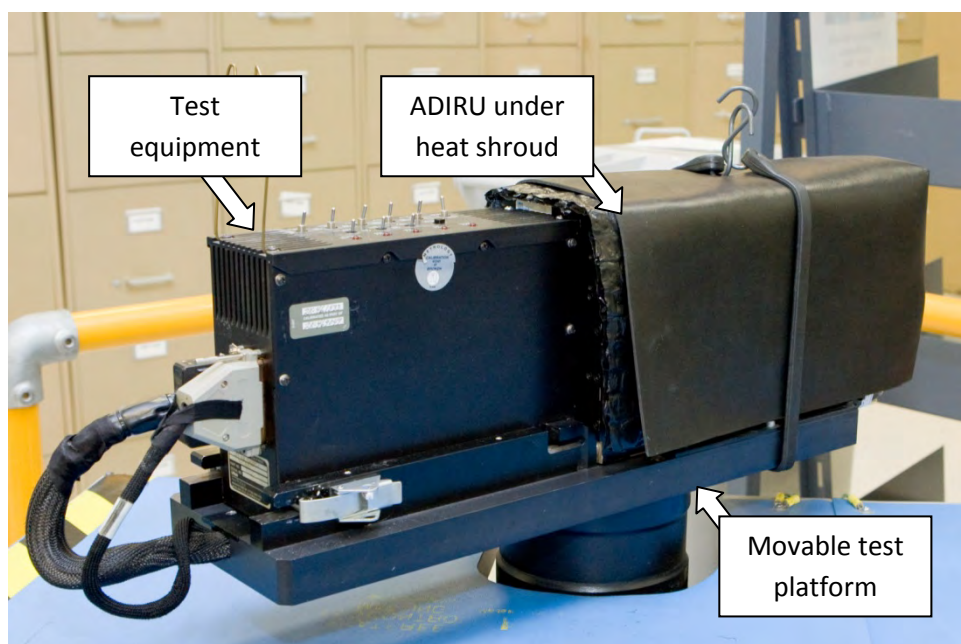
Figure E2: ADIRU undergoing test under heat shroud

Unit 4167 passed 2,223 of 2,272 tests, with the remainder failing due to navigation drift that was considered normal in a high-temperature environment. This issue was not considered relevant to the occurrences under investigation. No other problems were identified.
