NATICK LABS Field Investigation Report

SUBJECT: Joint Land Attack Cruise Missile Defense Elevated Netted Sensor System (JLENS)
Failure Review Board (FRB) Report

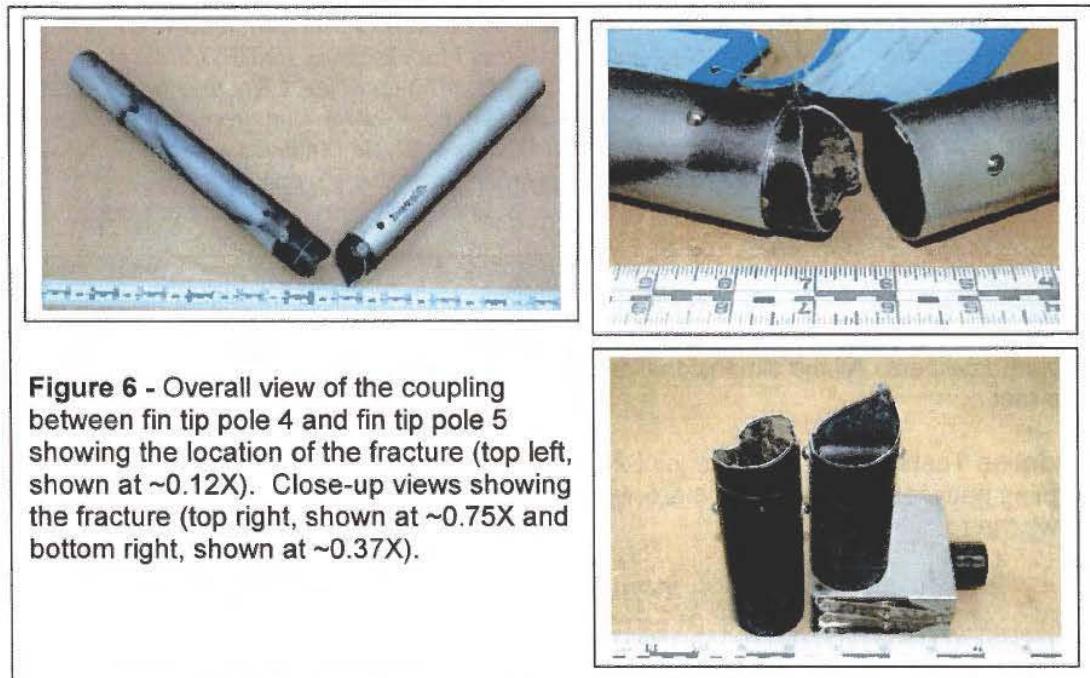
4. A fracture occurred at the coupling (4D00253G01) between fin tip pole 4 (4D00368H06) and fin tip pole 5 (4D00368H07). The fracture surface exhibited shear lips around the entire circumference of the tube. The fracture travelled around the weld bead that holds the spring plunger. Dirt deposits were present on the inner diameter of the coupling. There were no signs of corrosion around the area of fracture (Figure 6).

Figure 6 - Overall view of the coupling between fin tip pole 4 and fin tip pole 5 showing the location of the fracture (top left, shown at $\sim 0.12X$). Close-up views showing the fracture (top right, shown at $\sim 0.75X$ and bottom right, shown at $\sim 0.37X$).

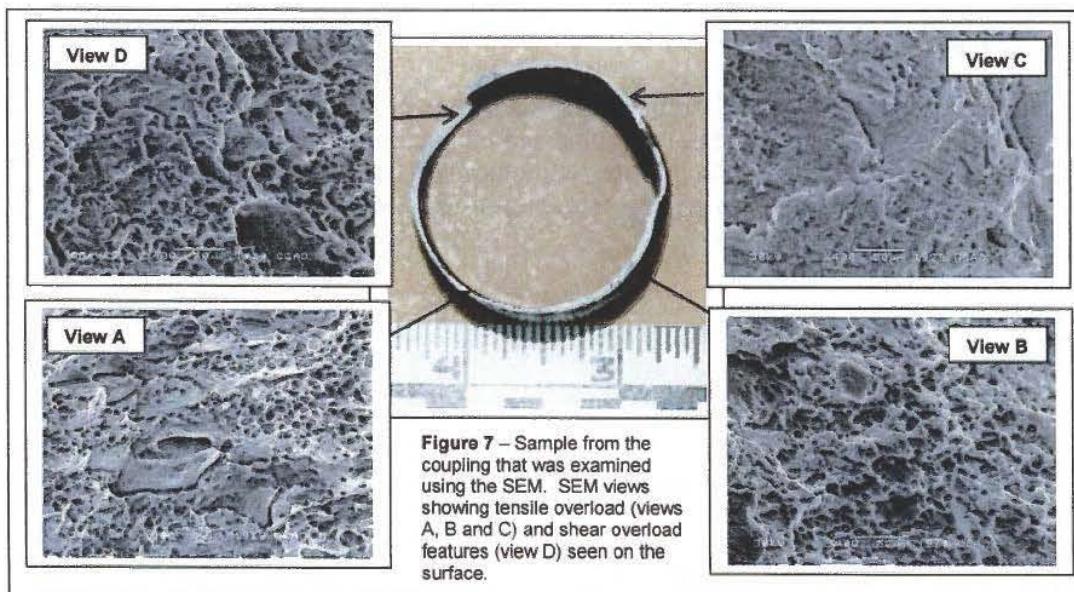
One of the fracture surfaces from the coupling was sectioned and prepared for examination using the Scanning Electron Microscope (SEM). The fracture appeared to have originated in the area adjacent to the spring plunger. The fracture progressed around and through the coupling. SEM examination revealed areas of cup cone topography around the majority of the fracture surface. Where the coupling finally broke, areas of shear overload were present (Figure 7). No other anomalies were noted on the fracture surface which might have contributed to the fracture.

Figure 7 – Sample from the coupling that was examined using the SEM. SEM views showing tensile overload (views A, B and C) and shear overload features (view D) seen on the surface.

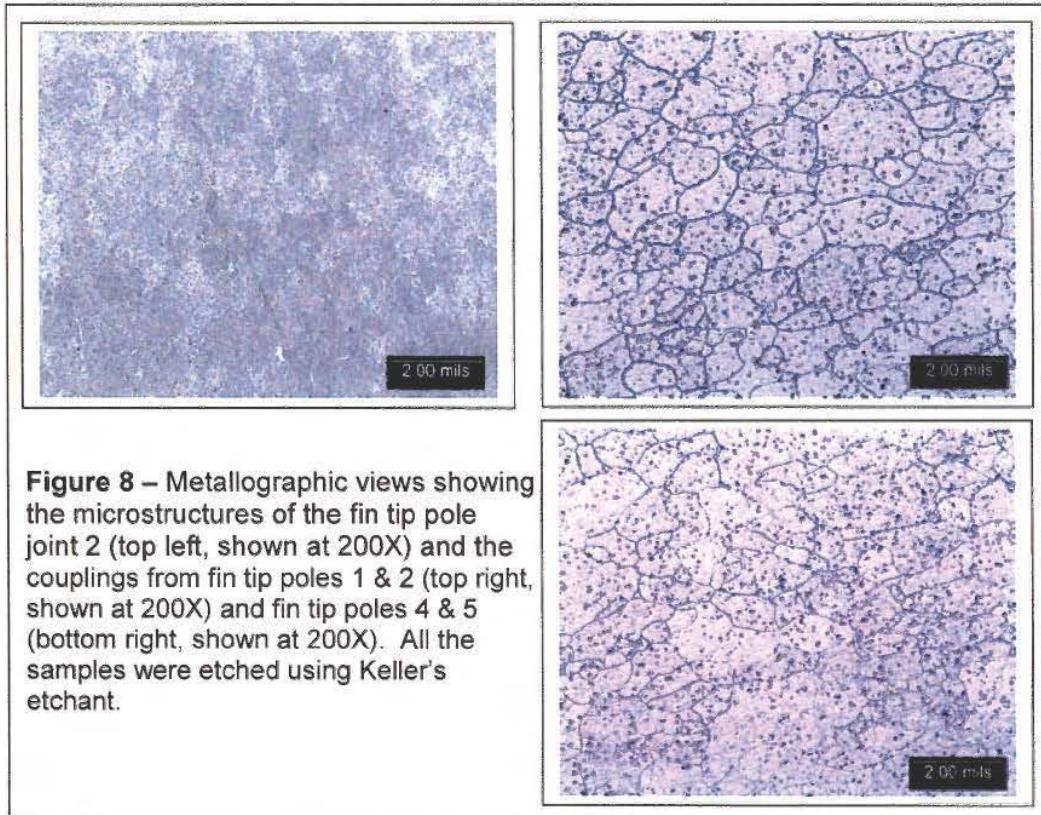
Metallographic Examination- Mounted cross sections of the fin tip pole joint 2 and both couplings were used for metallographic examination. Examination up to 800X did not find any discontinuities within the microstructure that could have contributed to the failure. The microstructures were judged to be normal for 6061 in the T6 condition (Figure 8).

Figure 8 – Metallographic views showing the microstructures of the fin tip pole joint 2 (top left, shown at 200X) and the couplings from fin tip poles 1 & 2 (top right, shown at 200X) and fin tip poles 4 & 5 (bottom right, shown at 200X). All the samples were etched using Keller's etchant.
