45 Park Place New York, NY B4176.00

45 Park Place – Peer Review B4176.00

December 12, 2014

This report is provided as a peer review of 45 Park Place located in lower Manhattan, New York. The project consists of a 44-story residential building, and was prepared by WSP Cantor Seinuk. The approximate height of the building is 690 feet. The structural system for the building is flat plate concrete construction. The lateral system of the building consists of a core of concrete shear walls and link beams as well as concrete outrigger wall beams at the 12th and 41st floors. Two levels of slosh damper tanks are to be placed above the 42nd floor to control building motions. The main tower will be founded on high capacity caissons which will be socketed into competent rock.

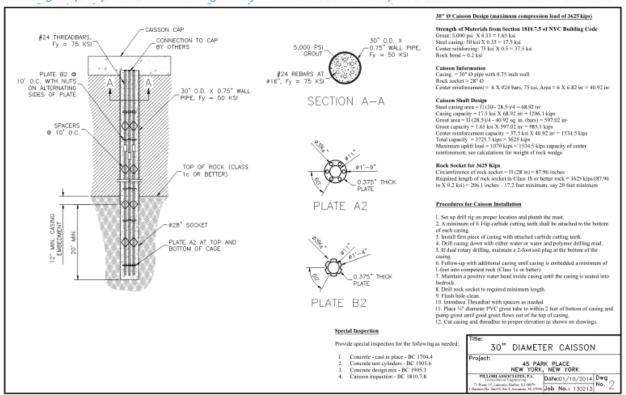
The foundations were reviewed in conjunction with the aforementioned geotechnical report. The design intent follows the general recommendations of the report. However, the report references high capacity caissons but does not specify a design or capacity of the caissons that are being specified in the structural drawings.

High capacity caissons were designed my Pillori Associates in a separate document. Cut sheet shown below:

This is adequate pending 100% CD referencing or showing this document.

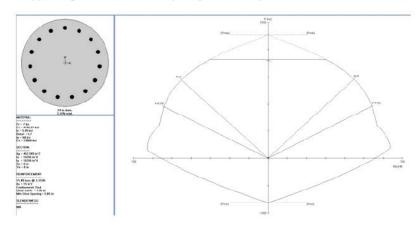
- Column 3 on the 1st floor and 11th floor Column 3
 - 1. Supporting floor 2 is 38" round with a capacity of 6780kips, demand shown in column schedule was 6778 kips. Adequate design.

2. Supporting floor 12 is 22x48 with 16-#11. Demand is 6050 kips and capacity is 6250 kips. Adequate design.

This is adequate.

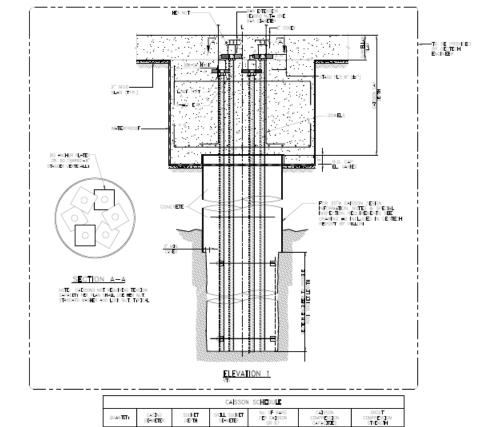
TYPICAL SECTION THRU CAISSON CAP

- Tie-down rock at pressure slab detail is provided on FO-203. Anchor size is not shown.
- m) Plans do not indicate locations of tie-down anchors.

A detail has been added in an RFI response below:

Please provide tension capacity of the caisson and geotechnical engineer confirmation of caisson capacity.
