Road Hunt:

A Survey of Road Closure Effectiveness In the Flathead National Forest's Swan Valley Geographic Area

by
Keith Hammer

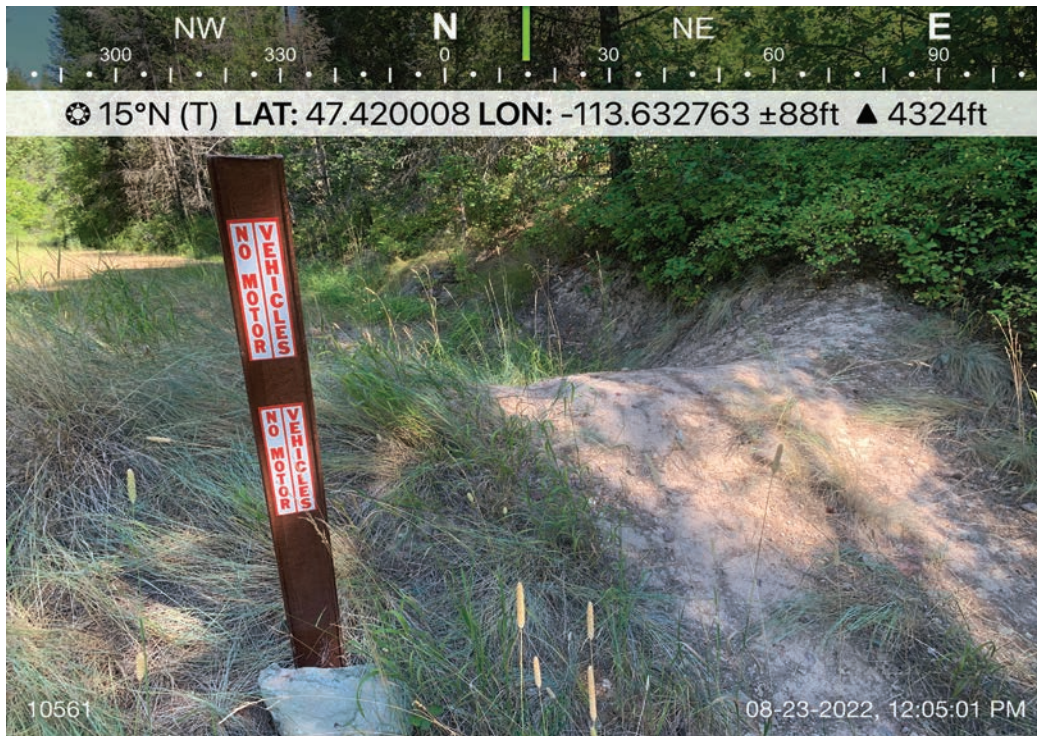
Fig. 1: Despite a sign, an earth berm, road closure maps, and promises, motorized use of closed road 10561 persists.

For example, the FS found earth berm closure 10561 (Figure 1) ineffective in 2020 and in need of rocks to make it effective. That closure was not inspected in the FS’s 2021 and 2022 surveys, however, so it was not counted as ineffective. [40] As mentioned earlier, we found the device ineffective in 2022 and still in need of repair.

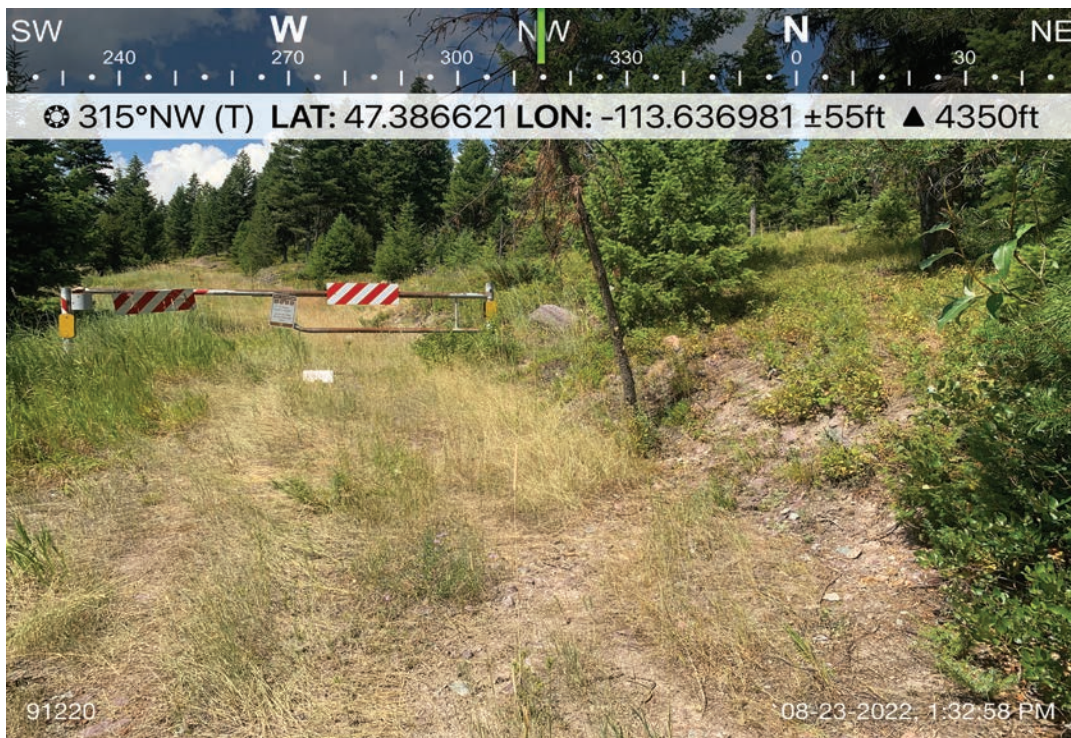
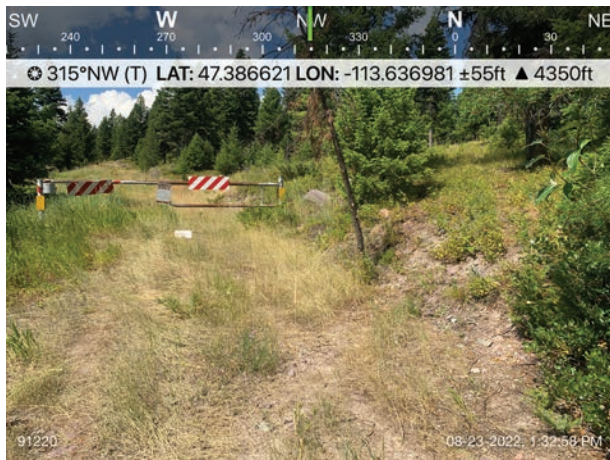
Fig. 2: A road closure gate on Flathead National Forest road 91220 shows tracks of large motorized vehicles detouring around the gate via the gentle hillside and open space between the trees.

passable” to motor vehicles. Figures 2 and 20 (presented again below) show lengthy motor vehicle detours around gates, which could just as easily have been established around 50’ of “impassable” treatments.

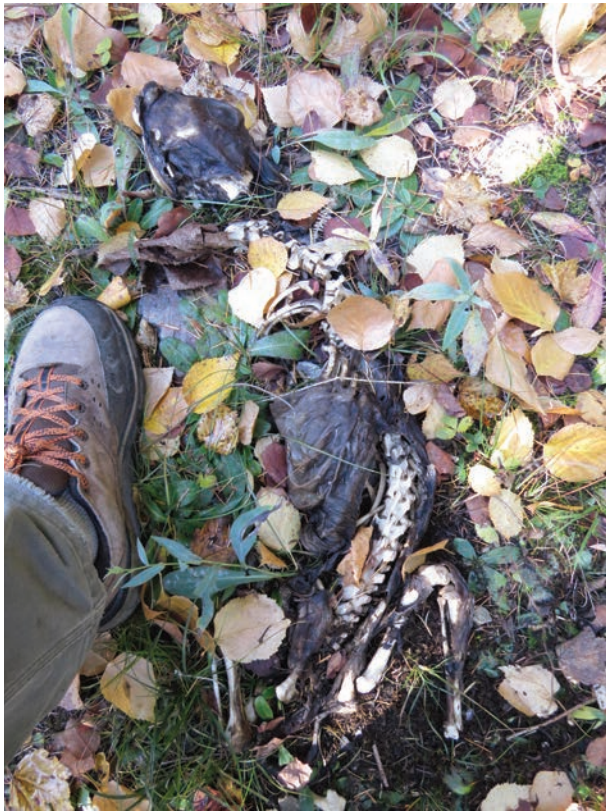
Figure 7 shows a decomposing wolverine carcass we discovered in the middle of closed road 5392Y, about a mile behind its ineffective closure device on 10/21/21. Research shows that wolverine tend to avoid roads and other human intrusions. [18, 19] We have been unable to find research showing that wolverine tend to leave forest cover and lie down in the middle of a road to die of natural causes. Wolverine

Fig. 7: 10/21/21 photo of dead wolverine on road 5392Y.

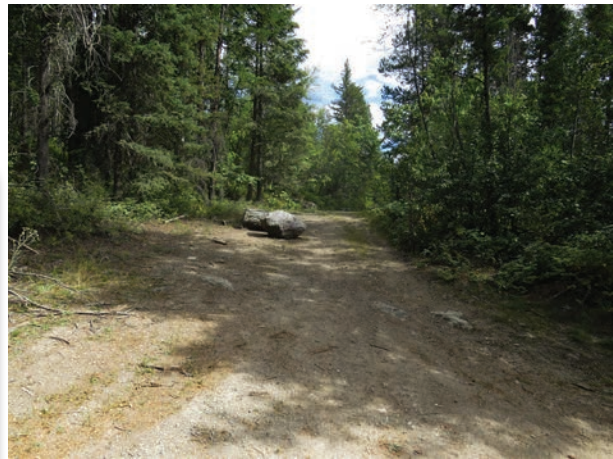
To add insult to the death of this particular wolverine, the ineffectiveness of the 5392Y road closure has been readily evident for years to Forest Service staff traveling Jewel Basin Road 5392 to reach a Forest Service cabin and trail heads servicing the most popular Hiking Area on the Flathead NF. Figure 8 shows the earliest (8/25/16) photo we have of boulders moved aside to allow passage of full size passenger vehicles to road 5392Y.

Fig. 8: 8/25/16 view of closed road 5392Y from road 5392.

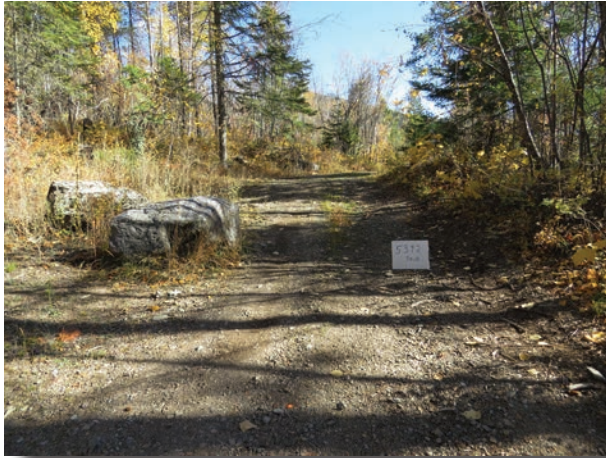
Figure 9 shows this road closure device still not repaired on 10/21/21, more than five years later. We inspected road 5392Y on foot on 10/21/21. Figure 10 shows an example of the cutting of deadfall that kept the road passable and exhibiting use by ATVs for about a mile to Birch Creek, where motorized use then appears to cease due to a rotten, caved in log bridge.

Fig. 9: 10/21/21 photo of road closure 5392Y.

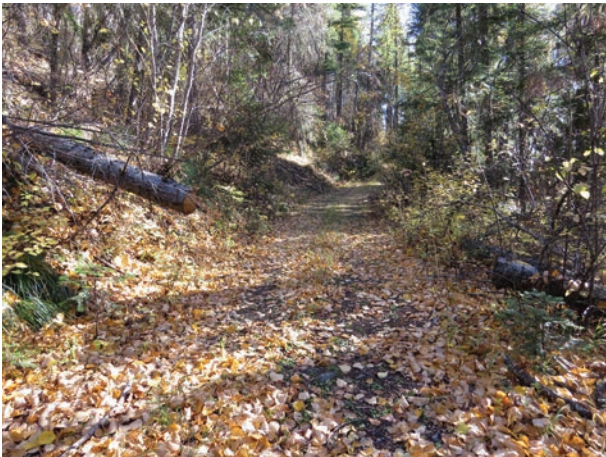
Fig. 10: Clearing of road 5392Y behind its closure device.

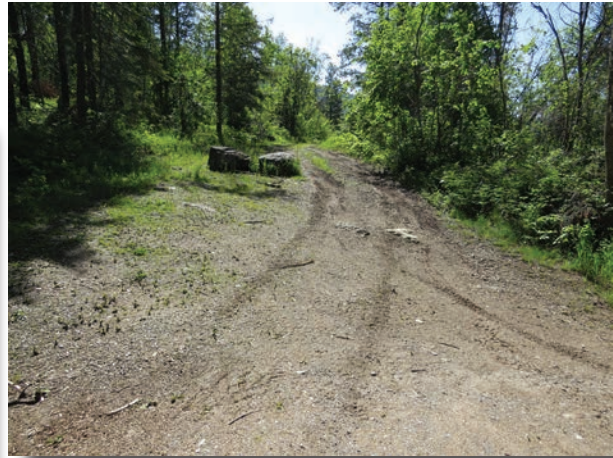
Figure 11 shows that the road closure had not been repaired by 6/17/22 and was continuing to be trespassed by motor vehicles. Nor had it been repaired by 7/27/22, when it was inspected as a part of this road closure survey, as shown in Figure 12.

Fig. 11: 6/17/22 photo of road closure 5392Y.

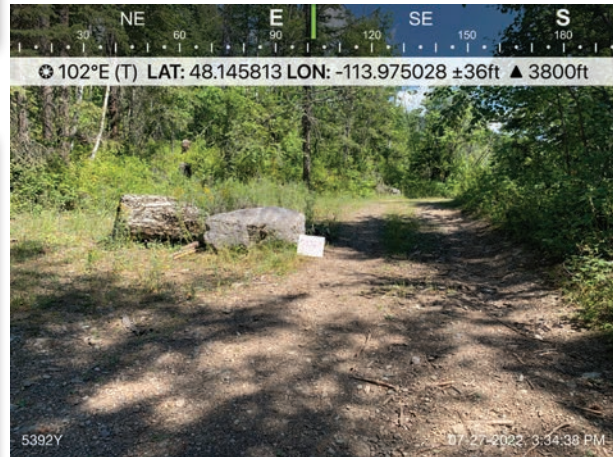
Fig. 12: 7/27/22 photo of road closure 5392Y.

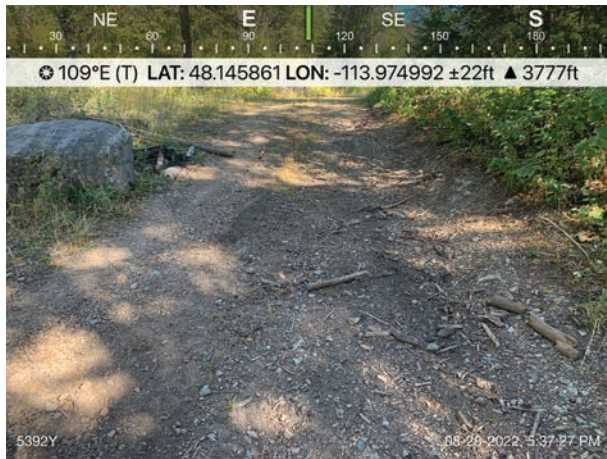
We inspected the closure again on 8/28/22 and 10/28/22, and it still had not been repaired, as shown in Figures 13 and 14, respectively. This although the FS inspected this closure on 9/1/22, reporting “Lots of motorized traffic going past the rocks.” [24] This serves as just one example of the many years the Flathead NF allows ineffective closures to persist without repair, with potentially fatal consequences to wildlife.

Fig. 13: 8/28/22 photo of road closure 5392Y.

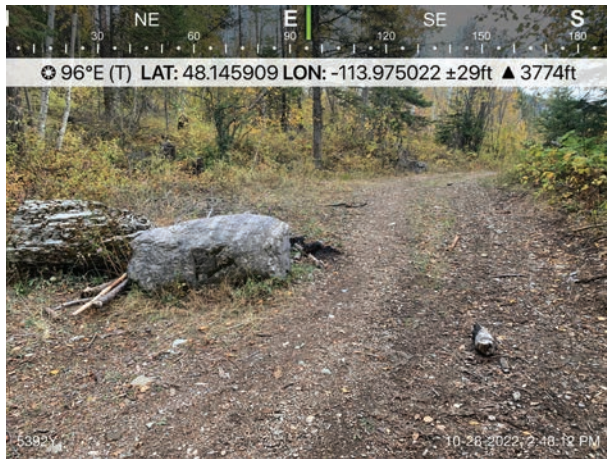
Fig. 14: 10/28/22 photo of road closure 5392Y.

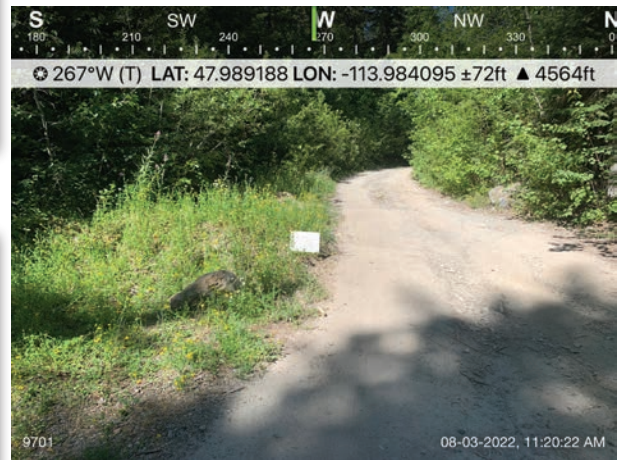
Boulder closures, however, are not the only type of closure devices allowed to languish as ineffective on the Flathead NF. Figure 15 shows an earth berm closure of road 9701 that has been driven over for so long that the berm is barely discernible. This closure was inspected by the FS in 2020 and 2021 and noted as “ineffective” and “no longer functions,” respectively. [25] Both inspectors noted the need for repairs, but repairs had not been made prior to our inspection in 2022, as shown in Figure 15. It is not known how long this closure had been ineffective prior to being reported in need of repair in 2020, but the total lack of vegetation on the roadbed suggests it has been trespassed for many years.

Fig. 15: Flattened earth berm on “closed” road 9701.

Similarly, the FS found earth berm closure 9701 (Figure 15) “flattened allowing cars to pass through” and needing repairs in 2020 and 2021, but did not inspect or report that closure in 2022 even though it remained un-repaired and ineffective, as we found it in 2022. [41]

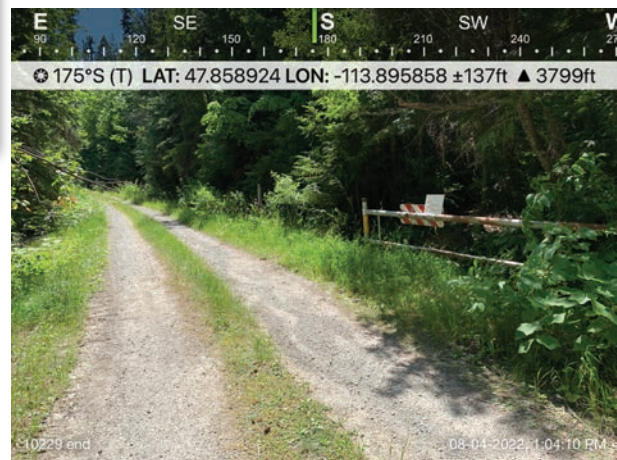
We encountered a similar situation with a gate found wide open on road 10229, as pictured in Figure 16. This road has been reported as closed year-round since at least 2006, as shown on the oldest District map readily available. Lack of vegetation in the tire lanes is an indication of significant use by full size motor vehicles.

Fig. 16: Year-round gate closure left open on road 10229.

The FS on 8/13/20 reported this gate locked and “effective” but did not inspect it in 2021. [26] We reported it open to the District Ranger on 8/4/22 and wonder if the gate was left open in 2021 as well. The above examples show that, when FWS says the FS repairs closures “as soon as they are able,” this may take years. [27]

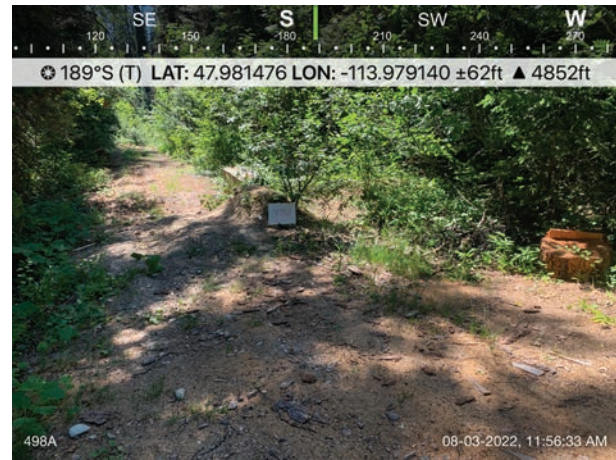
Secondly, the FS tends to either overlook motor vehicle trespass or fails to preempt it where it appears imminent. For example, the FS in 2020 found the closed road 498A berm “effective” but “could be improved.” In 2021, rather than improve the berm, the

Fig. 17: Berm driven over by pickups on road 498A.

FS determined the road “difficult to locate and fully blocked by vegetation,” calling its closure berm “functional.” The FS did not inspect or report this closure in 2022. [42] We found the berm on 8/3/22 driven over extensively by pickup trucks and the road behind it driven for cutting firewood, as shown in Figure 17.

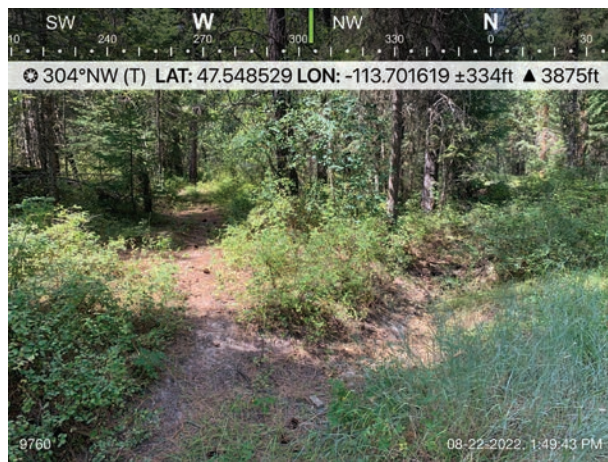
Figure 18 shows how we found road closure 9760 on 8/22/22, noting a wide detour with ATV tracks circumventing the berm closure. We deemed the closure ineffective at preventing motorized use beyond the berm. The FS inspected the closure on 9/20/22 and found the "Berm is functional but path cut to the left of berm where motorized trespassing is occurring." [47]

Fig. 18: ATV detour around road closure berm 9760..

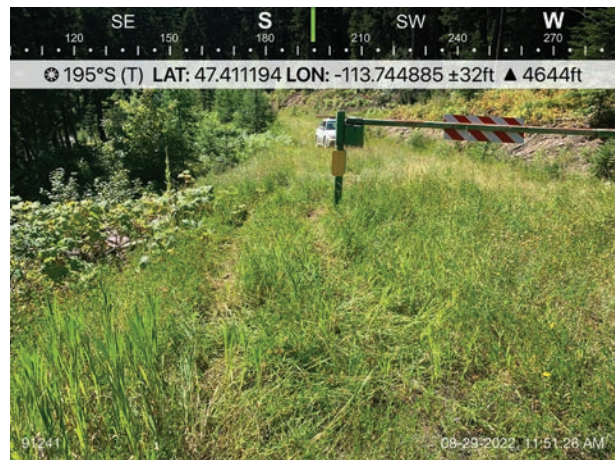
Figure 19 shows how we found gate closure 91241 on 8/29/22, noting clear ATV tracks bypassing the locked gate on

its right side when viewed from the open portion of the road. We deemed it ineffective. The FS inspected this gate on 9/13/22, acknowledged the motorized breach and noted the "Gate is functional. Need a rock installed on right side to keep out atv/dirt bikes." [48]

Fig. 19: Gate driven around by ATV on road 91241.

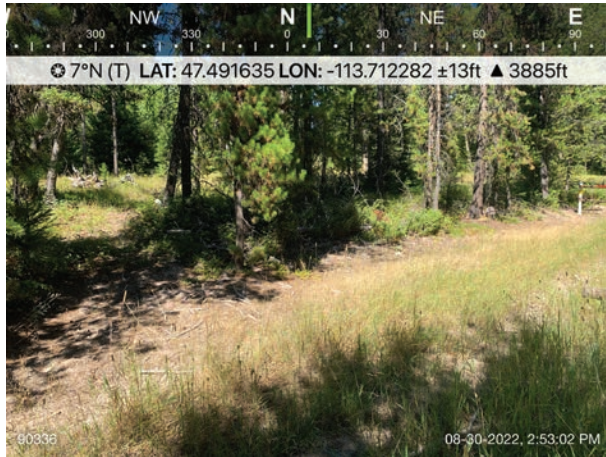
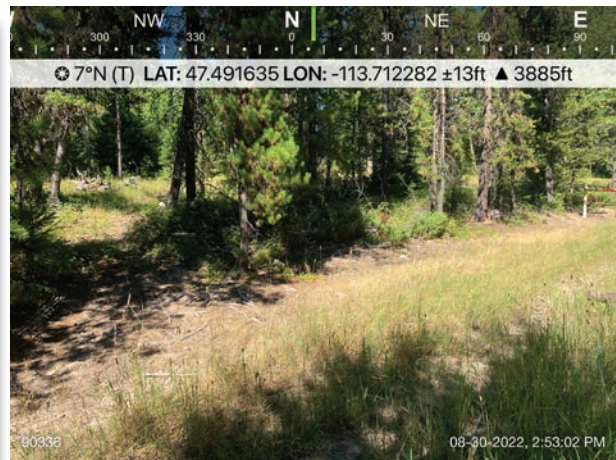
Figure 20 shows how we found gate closure 90336 on 8/30/22, noting tracks of both motorcycles and ATVs detouring around the gate on its left side. We deemed it ineffective. The FS inspected this gate on 9/20/22 and, while acknowledging it had been breached by motor vehicles, simply deemed the gate "functional" without acknowledging the long, well established motorized detour around it. [49]

Fig. 20: Motorcycle and ATV detour around gate 90336.

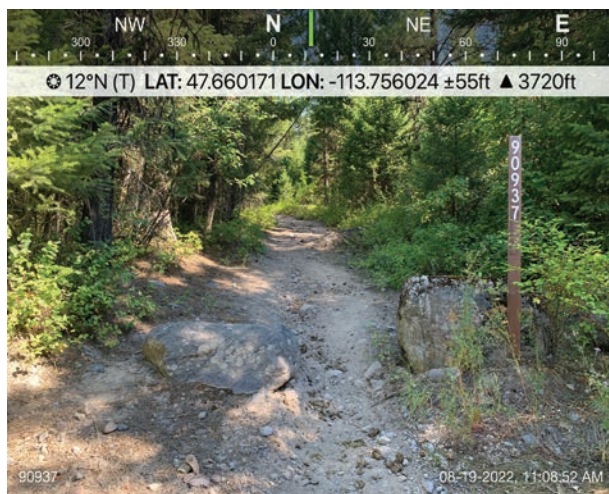
We note here that a number of closure devices showed so much human use behind them that it was difficult to determine whether there were motorized vehicle tracks among the horse or mountain bike tracks. Road closure 90937, for example (Figure 21), exhibited so much horse use that, if it was being violated by electric e-bikes or motorcycles, those tracks were obliterated by horse hooves. We deemed this closure “effective” according to our motorized use inspection protocol, but such closures beg the question of whether or not they are actually achieving the objective of securing wildlife habitat due to intense non-motorized human uses also known to displace wildlife. [59]

Fig. 21: Heavy horse use of road 90937.

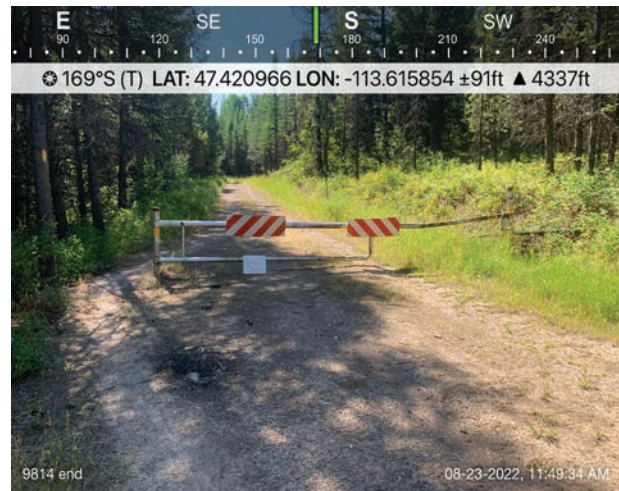
Our survey also inspected each closure for the presence of mountain bike tracks. We found significant mountain bike tracks circumventing the gate closure on road 9814 above Holland Lake near the Flathead/Lolo National Forests boundary (Figure 22). [60] We deemed this closure

Fig. 22: High-use mountain bike and motorcycle detour.

“ineffective” not because of the mountain bike tracks, but because there were car/truck tracks through the gate and motorcycle tracks going around the left side. It is of course impossible to tell which of the mountain bike tracks may have been electric e-bikes (currently considered motorized vehicles by the FS and prohibited from closed roads and trails). [61]
