## National Safety Committee

### Dynamic Testing of Yacht Stanchions

Conducted during August 2013

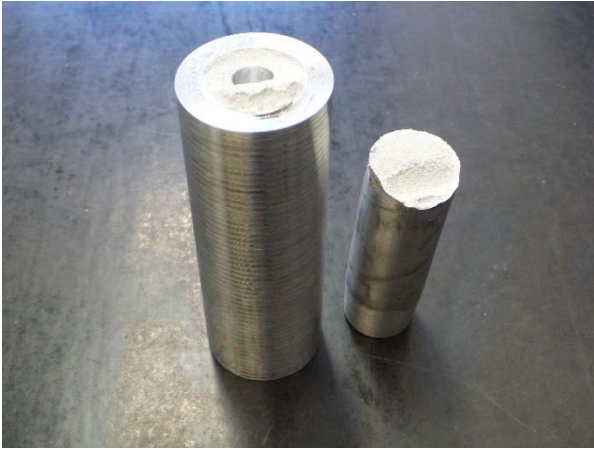
TEST#1 The aluminium spigot sheared, leaving the stainless steel stanchion intact:

Fig. 11: Fractured aluminium spigot taken from stainless steel stanchion (TEST#1).

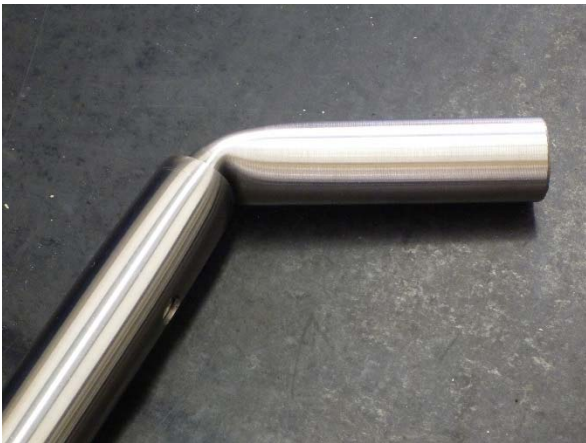
TEST#2 The stainless steel tube spigot buckled, leaving the stainless stanchion intact. It is expected the same behaviour would have occurred even if the stainless steel stanchion was inserted directly into the deck socket or a conventional deck-mount bracket:

Fig. 12: Spigot in Test#2

The stainless steel and aluminium stanchions fail in a predictable ductile manner. The stainless steel stanchion buckled and remained in one piece (Fig. 12), as did the aluminium stanchion although it exposed a sharp fractured edge (Figs. 13 and 14).

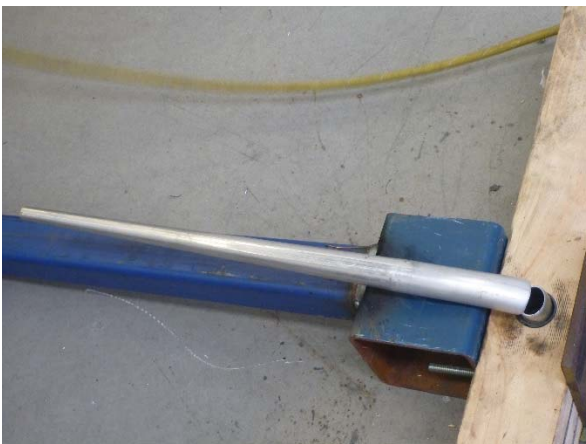
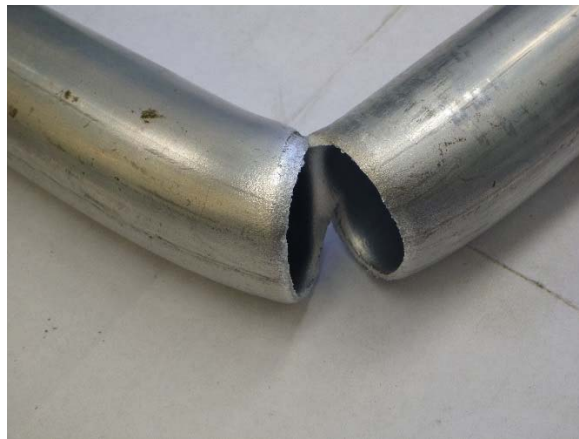
TEST#3 The hollow tubular aluminium stanchion buckled and tore, exposing a sharp edge while just remaining in one piece – see Figs. 13 and 14 below:

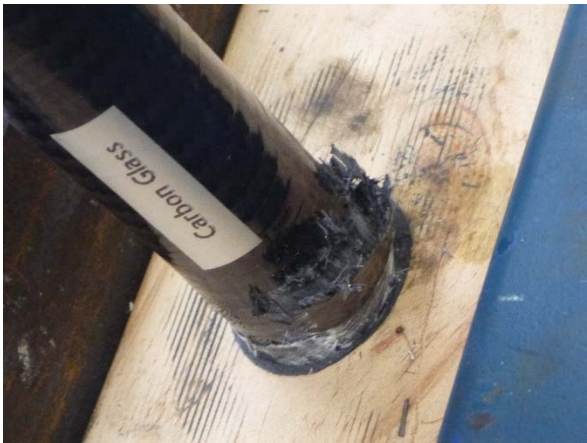
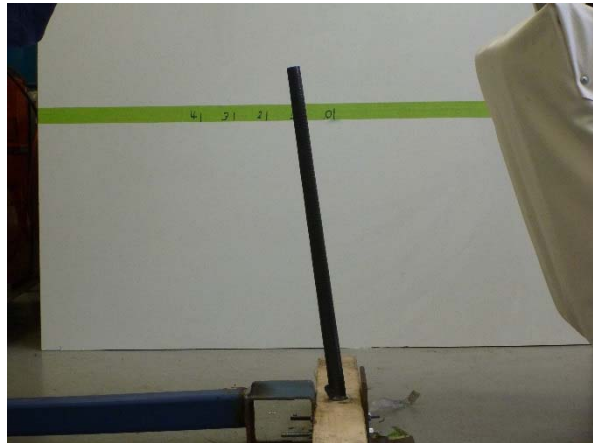
TEST#4 The carbon/E-glass stanchion fractured but remained intact and showed a momentary elastic bend of 700mm and permanent yield of 100mm at the tip – see Figs. 15 and 16 below:

The carbon fibre/E-glass stanchion displayed elastic yield upon impact of 700mm while permanent tip yield was 100mm and remained intact (Fig.16). It exposed a fractured edge that was rough but not sharp or able to cause any injury (Fig. 15).

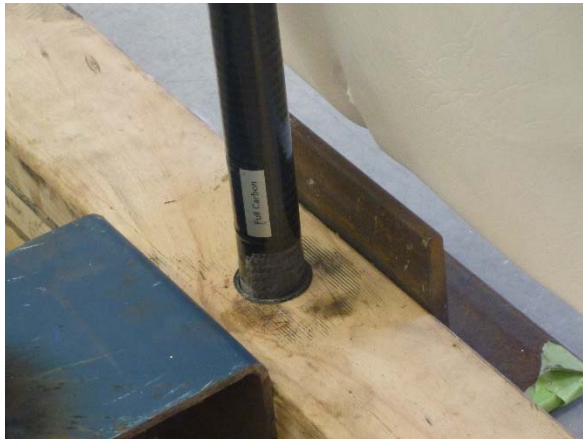
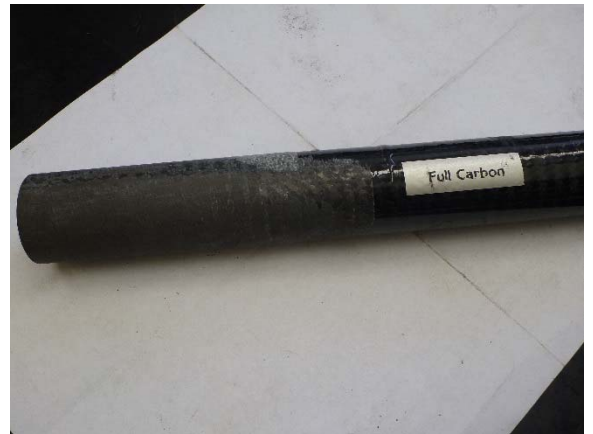
TEST#5 The carbon stanchion displayed little damage but elastically deflected up to 300mm during impact and retained a permanent yield of 50mm (see Figs. 17 and 18 below):

Upon first impact, the carbon fibre stanchion displayed 300mm of elastic impact yield and remained intact with no exposed fracture surface (Figs. 17 and 18). Upon second impact, it was sufficiently strong to break the test rig (Fig. 19). This was mostly due to the disposition and inertia of the lead weights about the centrally mounted vertical aluminium swing arm (Fig. 9). Although rather spectacular, the appearance of the failure belied a behaviour that may not be prevalent in the case of human contact with the stanchion.

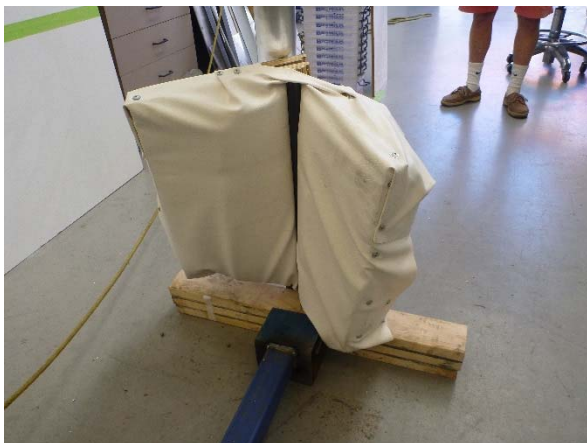
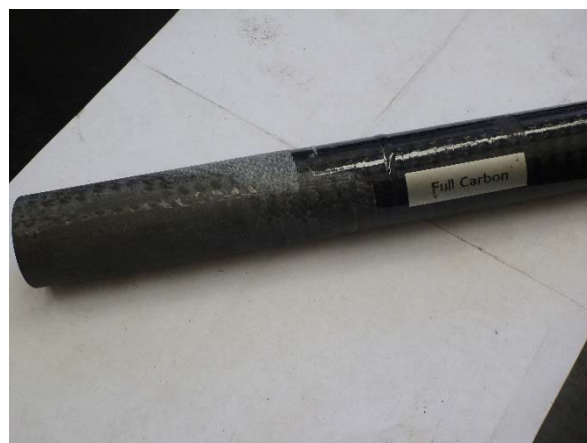
TEST#6 The same carbon stanchion was subjected to a second impact, which broke the test rig and caused some additional damage to the stanchion (see Figs. 19 and 20 below):
