FLYER TO THE LEISURE BOATING SECTOR

ECC Topaz: Fire and subsequent foundering 11nm off Lowestoft, 14 January 2014

Marine Accident Investigation Branch

February 2015

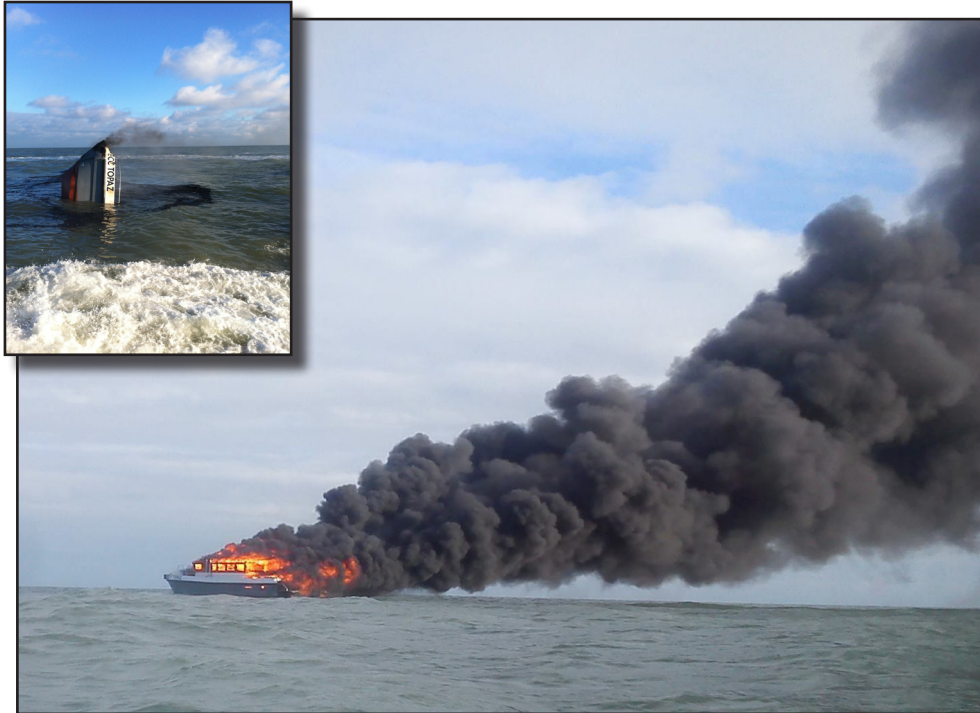
Figure 1: *ECC Topaz* on fire (inset: subsequent foundering)

On 14 January 2014, at approximately 1230, the 14m wind farm support catamaran, *ECC Topaz*, caught fire off the coast of Lowestoft. The fire is thought to have originated in a compartment in the starboard hull directly under the wheelhouse. The skipper became aware of the fire when he saw smoke coming out of the heating air outlet vents. Within seconds, the fire had broken through into the wheelhouse and spread rapidly throughout the vessel's GRP structure.

Although the vessel could carry a maximum of 14 people, there were only three crew members on board on the day of the accident. Due to its rapid spread through the vessel, the crew were not able to extinguish the fire and were forced to abandon the vessel to a liferaft, from which they were airlifted to safety. The burnt out wreck of the vessel sank at 1420.

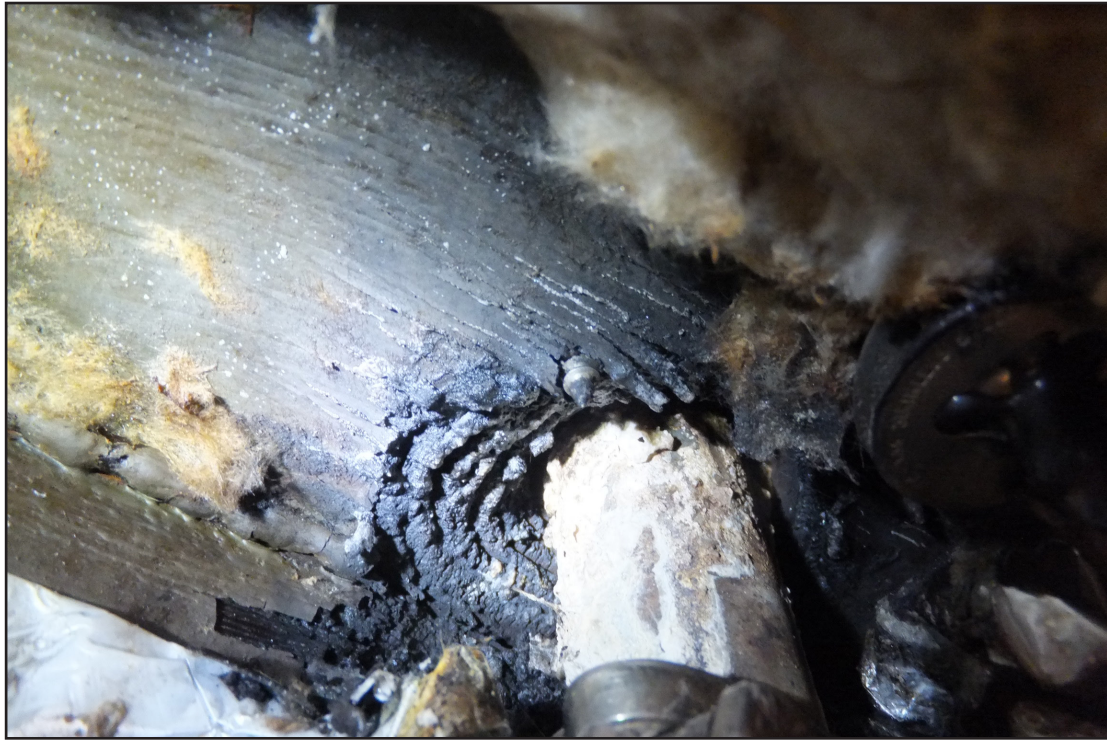
A few days after the accident, the MAIB received information from the owners of similar workboats stating that charring to the underside of the wooden deck through which an uninsulated section of a diesel fired air heater exhaust pipe was routed had been noted (**Figure 2**). Further investigation identified that it also was possible that *ECC Topaz's* exhaust pipe might have deteriorated, allowing hot exhaust gases to impinge directly onto the wooden deck above or flammable substances stored in the heater compartment. These included drums of diesel and lubricating oils, sacks of rags and paper rolls.

Figure 2: Scorching of the plywood underdeck on a similar vessel

Uninsulated exhausts from air heaters can reach temperatures well above the auto ignition temperature of many flammable materials including plywood, wood, paper and cotton. Therefore, any contact between either exhaust gases or uninsulated exhaust pipes and these materials has the potential to start a fire.

- Check that all the exhaust systems on your vessel are adequately lagged.
- Inspect the exhaust pipes frequently for signs of deterioration and replace them if required.
- Follow the inspection and maintenance schedule for your vessel's air heaters as required by the manufacturer.
- Do not store flammable material in the heater compartment.
