Imperial College London

Building Bridges 2015

An engineering expedition to Malawi, central Africa

Uledi Bridge – Inspection and Maintenance Summary

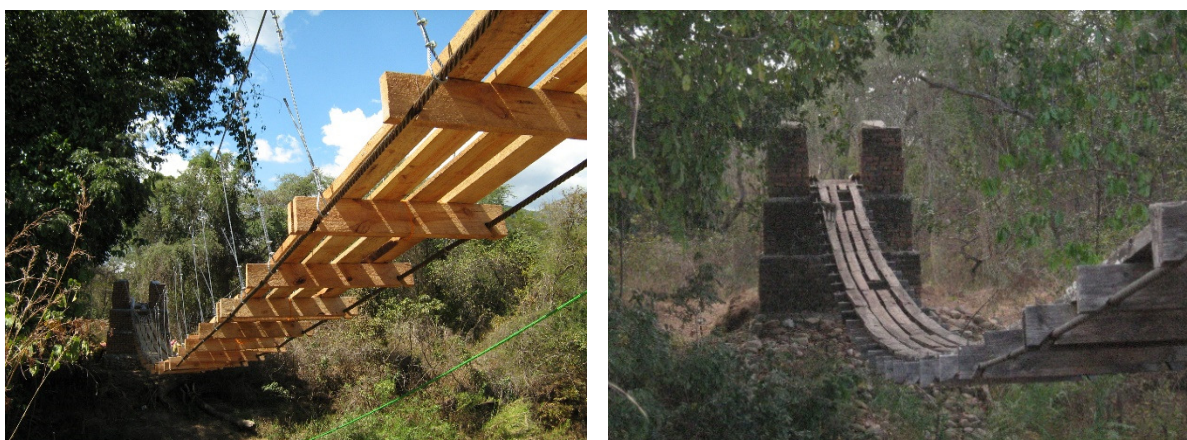
Figure 10: The bridge as we left it in 2007, and as we found it in 2015

Our first task was a detailed inspection of the bridge. This took a full day and included all elements above ground. We did consider excavating the backs of the anchor blocks to inspect the cables – however, this is potentially dangerous and would be very labour intensive and time consuming, and the risk of any damage to the cables in this location was small, so we decided against it. We did however carry out some probing to confirm the extents of the anchor blocks below the embankments. The inspection showed that the handrail cables had been cut through just above embankment level and removed, along with the hanger cables. The decking was completely rotten, and this in combination with the lack of handrails meant that the bridge was very flexible and was quite terrifying to attempt to stand on! Other than this, the bridge appeared to be in good condition. In particular the walkway cables showed no signs of damage or corrosion.

When we left the site, we had constructed anchor blocks for the new handrails, built the embankments, replaced the decking and re-pointed the towers. However, we were not able to replace the handrails themselves. The national park had provided some rope which we had attempted to install, but it was too stretchy to provide the stability required. We removed it from the bridge as we did not want to create an illusion of safety, and recommended that chain should be installed instead as this will be axially much stiffer.

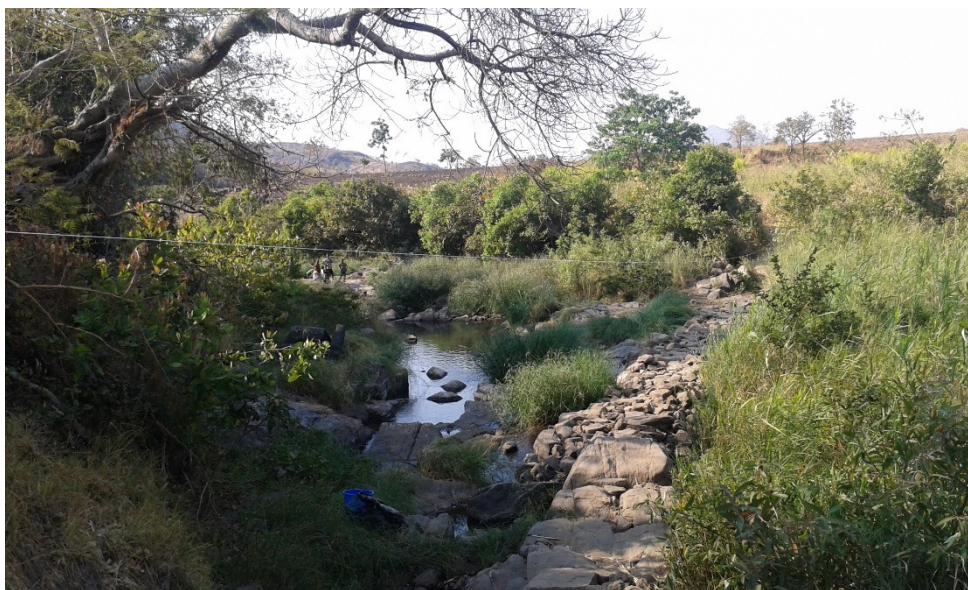
Figure 22: The traditional crossing point, which is impassable during the rainy season

only potential site we found (which is also the traditional crossing point) has limited space available on the left bank, meaning it would not be possible to construct the tower and anchor block. Other more traditional options such as concrete, masonry or steel truss construction would require intermediate piers within the river for a span of this size. Intermediate piers are likely to be difficult to construct because the river is never dry.

For now, we have advised the communities that while a bridge would clearly bring significant improvements to their quality of life, design and construction will be technically difficult and is likely to require significant financial outlay. We will be pursuing potential avenues with Bridges to Prosperity and Imperial College London to consider whether there is a feasible and affordable solution. We have also recommended that Susan supports the community in gathering additional information which will support their need for a bridge.

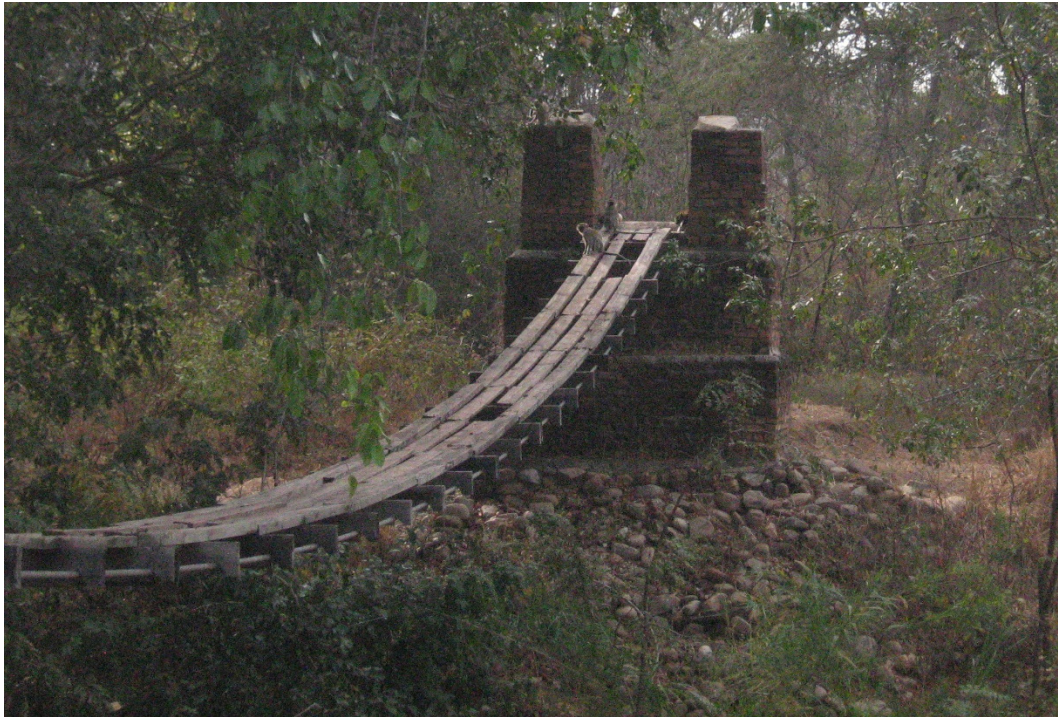
View of bridge from left bank – showing missing handrail cables and rotten decking

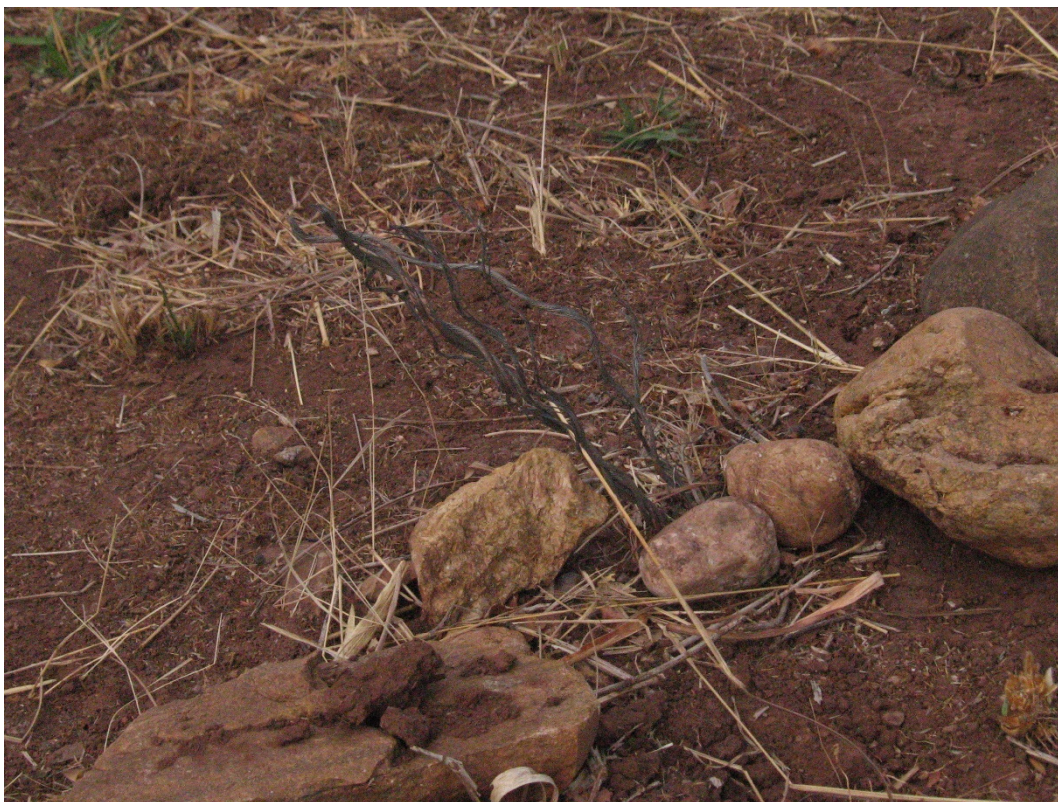
Handrail cable cut through just above embankment level

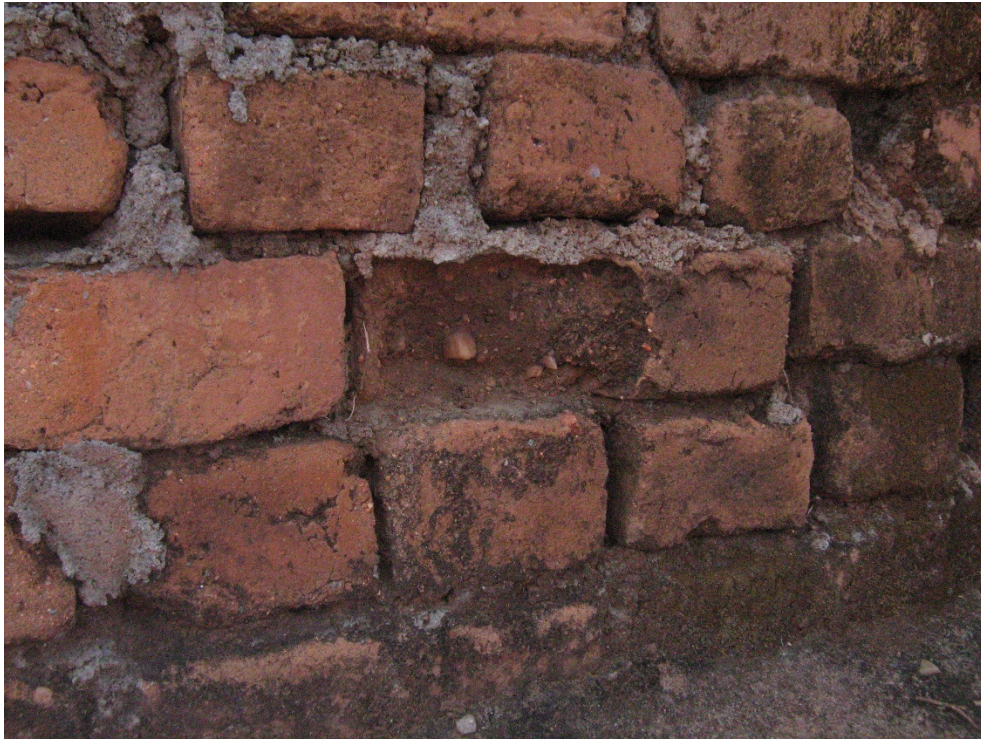
Brickwork on left tower, in need of repointing

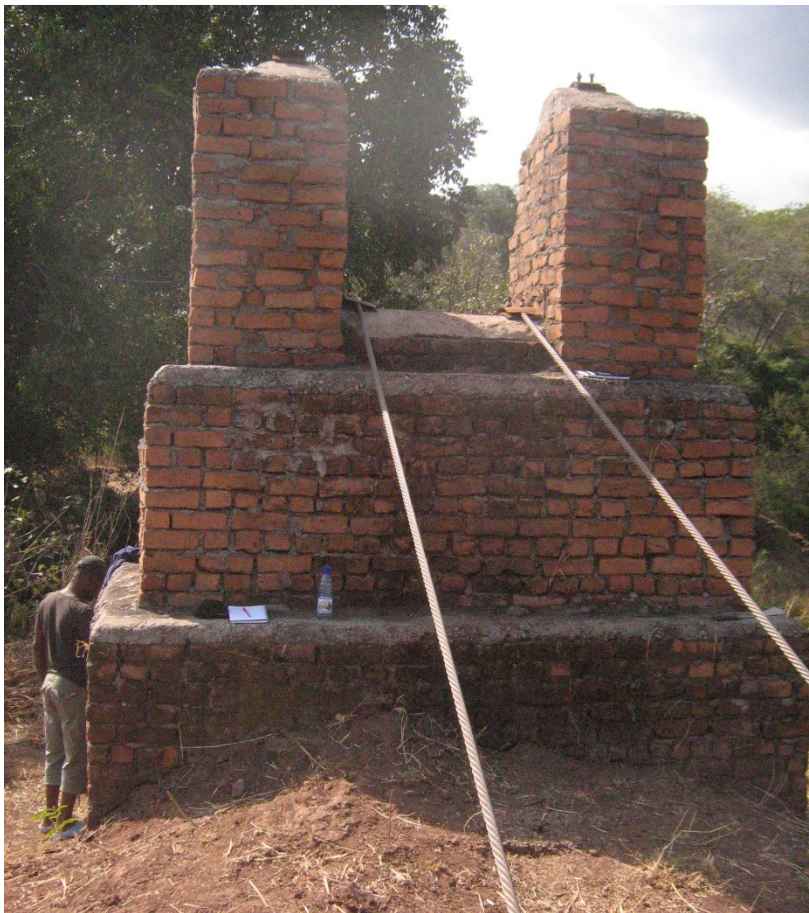
Tower generally in good condition

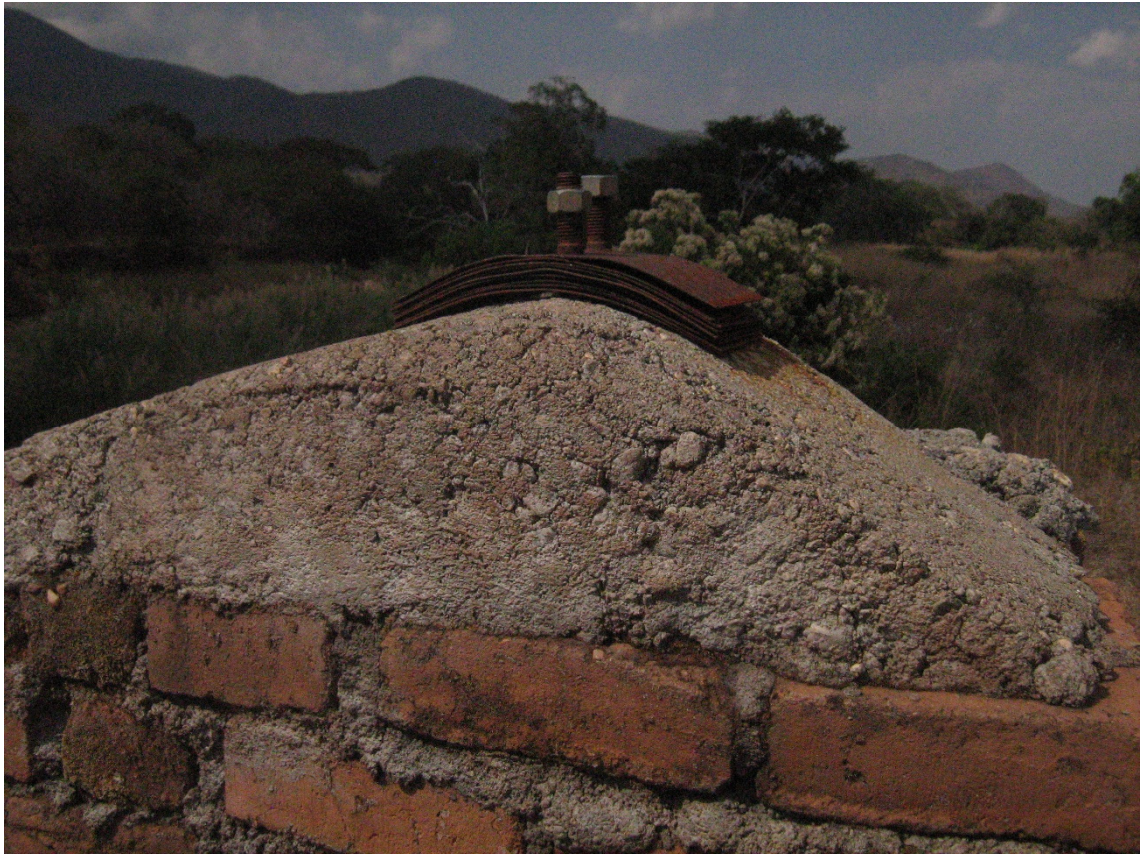
Saddles in good condition

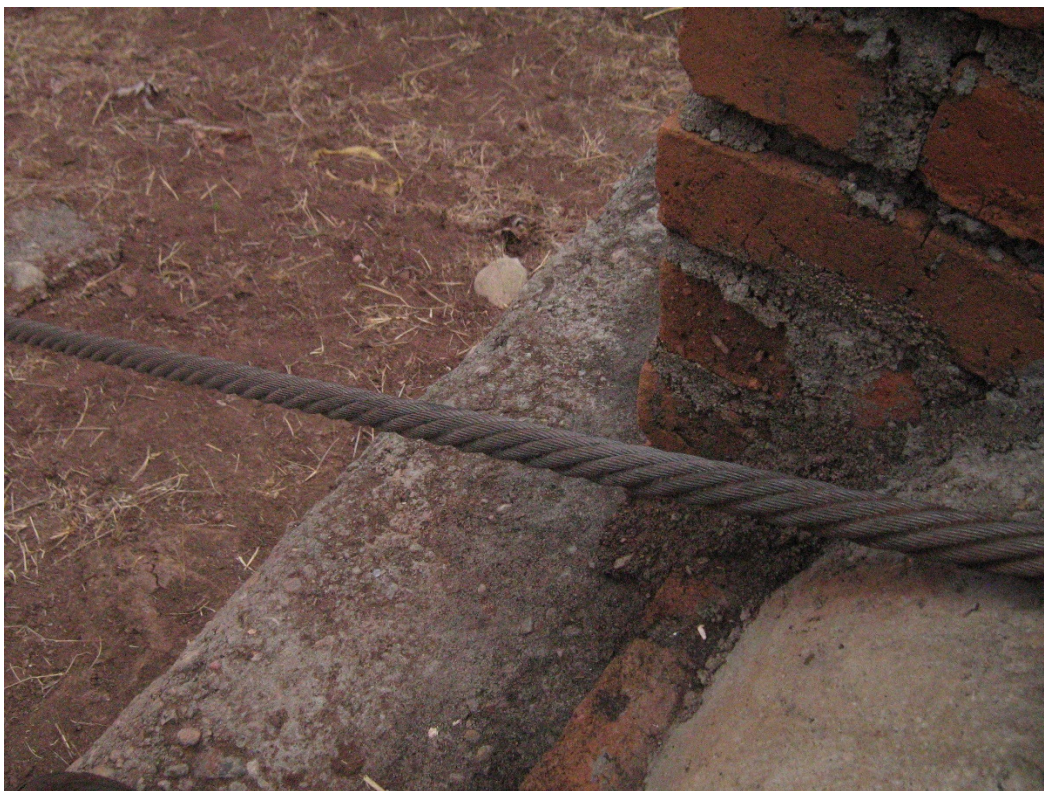
Main walkway cable in good condition

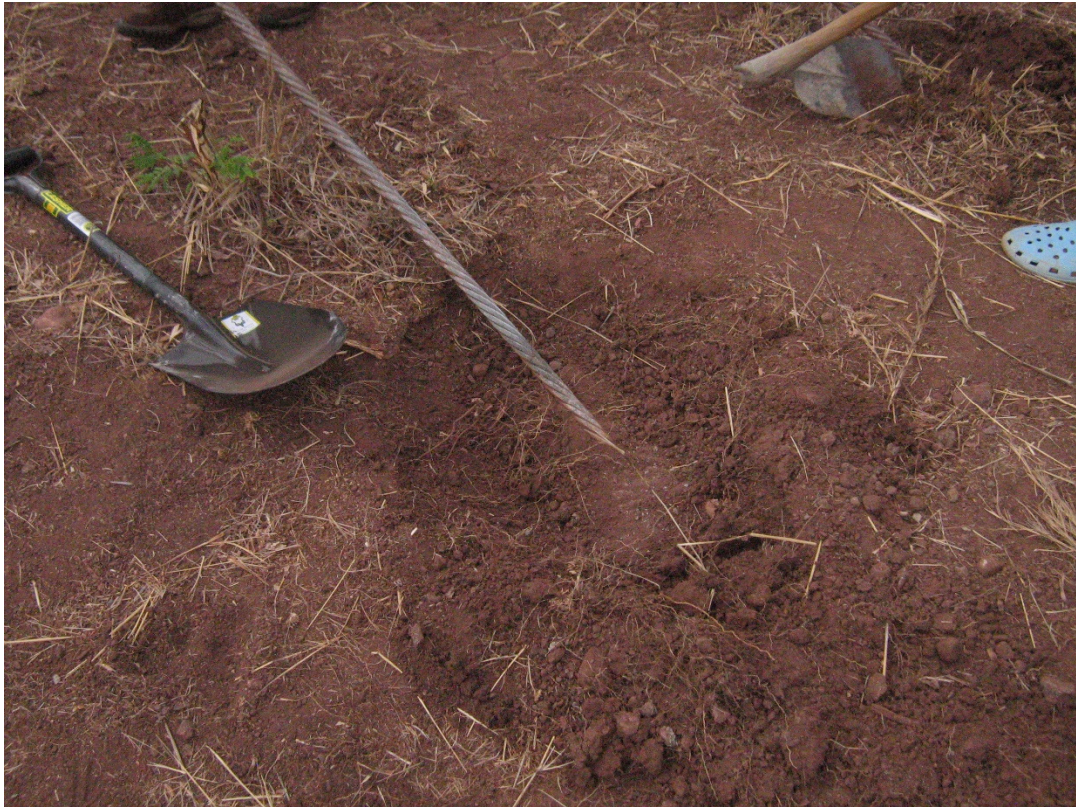
Main walkway cable in good condition

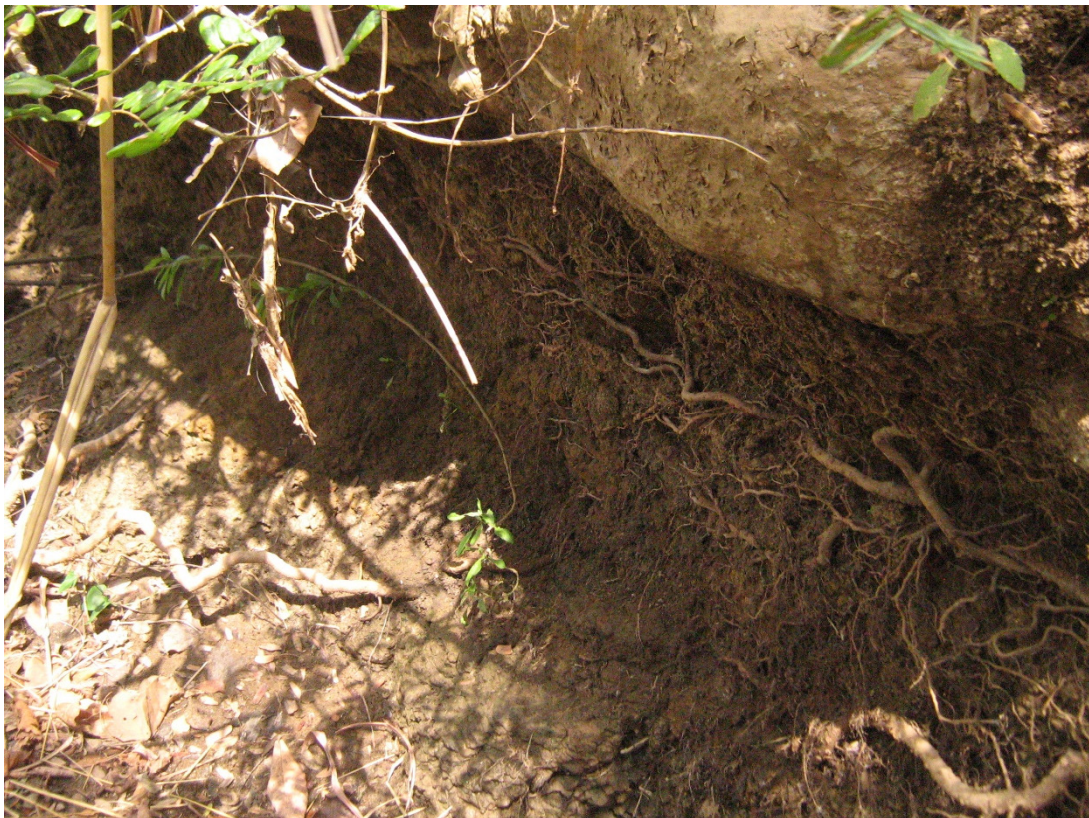
Erosion below left tower

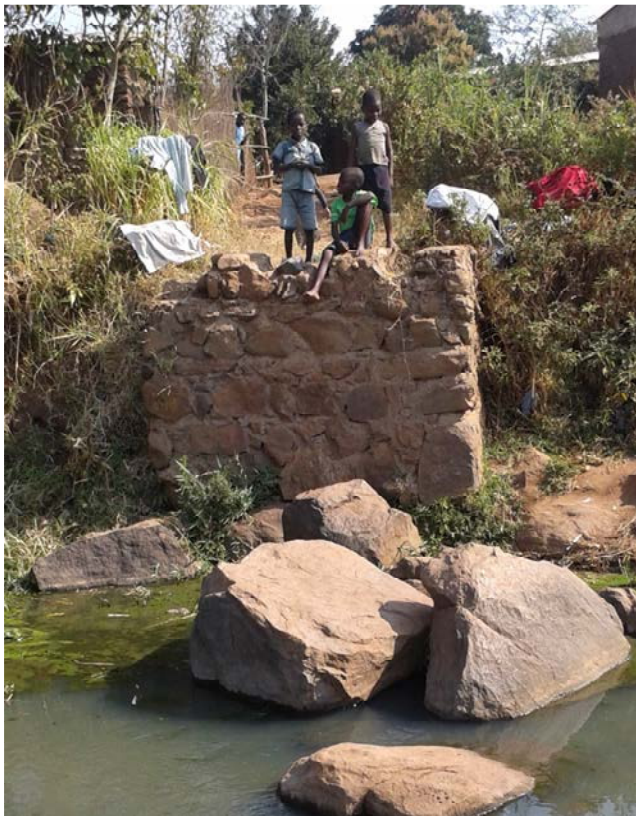
Figure 2: Existing crossing point from left bank, showing stepping stones and right abutment

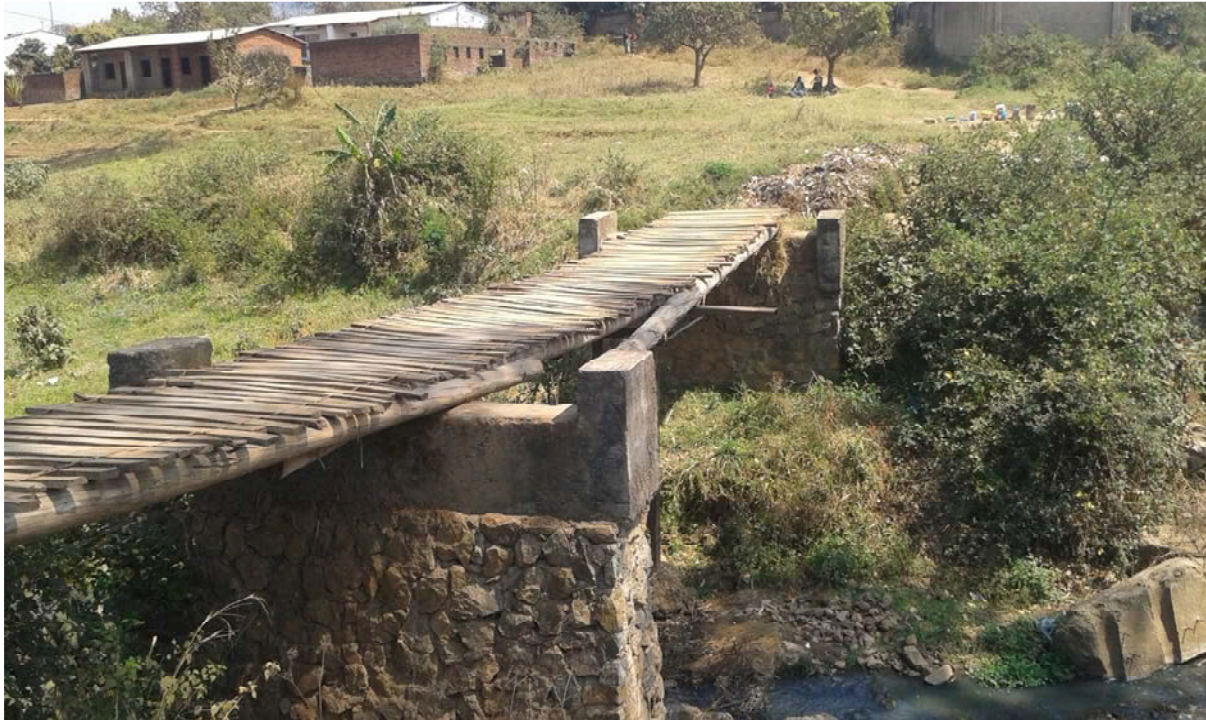
Figure 3: Chiwembe Bridge, viewed from the left bank

Significant bank erosion was noted on both sides of the river, and in particular on the left bank the bridge will soon need to be extended because of erosion behind the abutment.

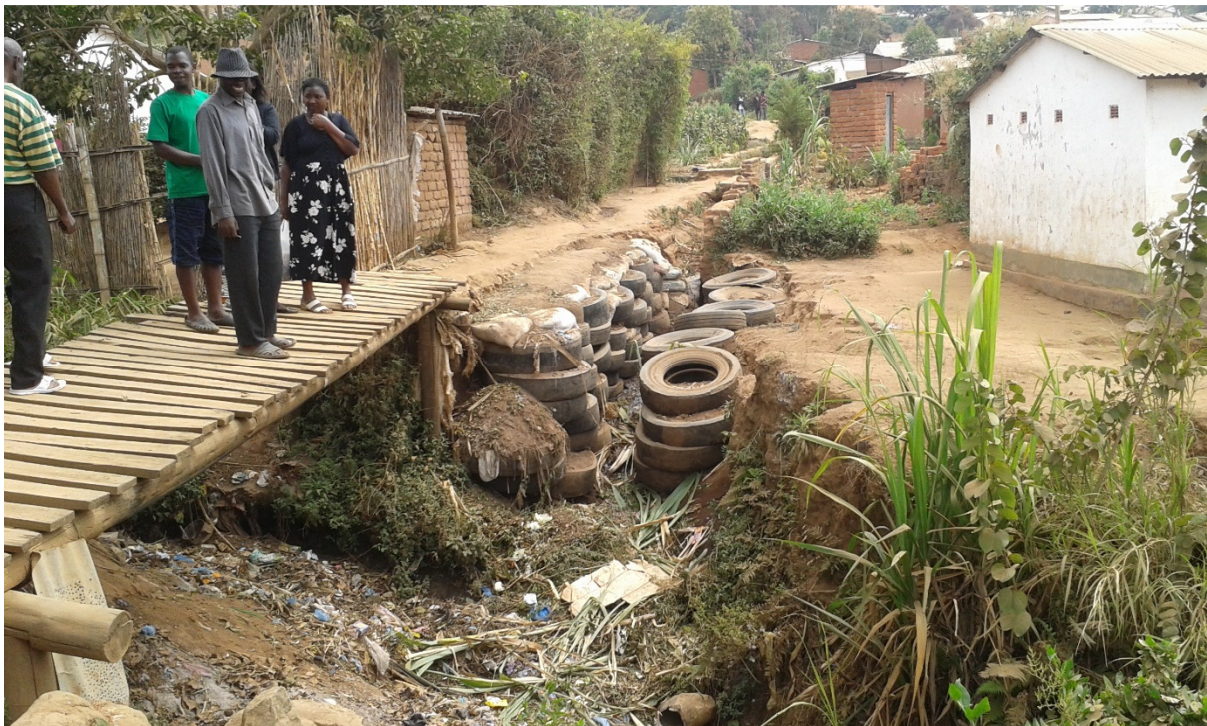
There is an alternative and safer crossing point only 3 minutes' walk away, where there is another wooden bridge of approximately 5m span. This bridge is already used by those living close by or when the first bridge has problems. This site is less affected by erosion and the banks do not flood during the rains. The channel is used as a rubbish dump.

Figure 6: Existing bridge and adjacent gully, showing erosion protection

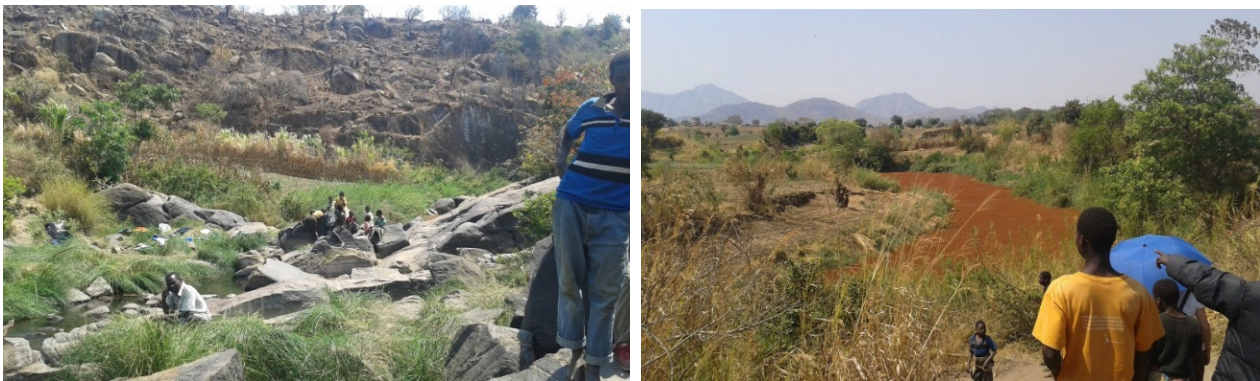
Further downstream the west bank of the river has very steep, almost vertical rocky banks. The slope above this rock face looks unstable and prone to slip. The height difference between the banks close to the river is more than 5m. The combination of unstable slopes and large height difference means this would not be a sensible bridge site.

Figure 5 Photos of downstream (left) and upstream (right) locations showing rocky terrain and stagnation upstream of ford
