# SILVERSTEIN PROPERTIES RELEASES ENGINEERING REPORTS EXPLAINING HOW THE TWIN TOWERS WITHSTOOD THE IMPACTS OF TWO JETLINERS — AND WHY THEY EVENTUALLY FELL

# COMPUTER MODELS SHOW HOW THE BUILDINGS REACTED TO THE STRIKES

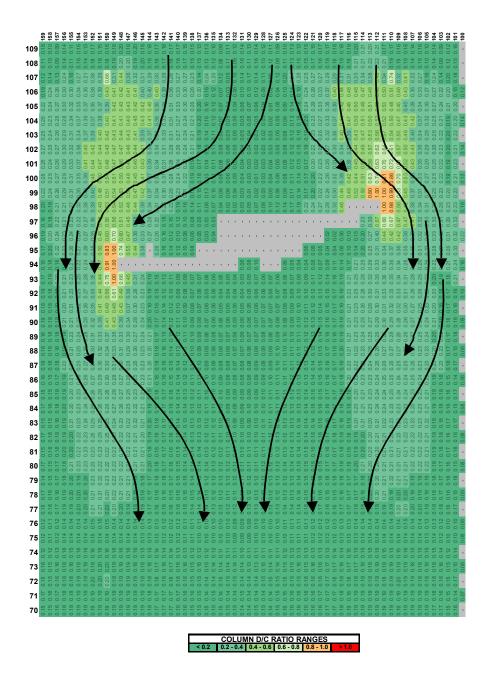
Because the Towers were designed with a redundant system of perimeter and core columns, connected at the top with a steel framework known as a "hat truss," the weight or "loads" meant to be carried by the impact-damaged columns were redistributed to the remaining columns. This load redistribution allowed the Towers to remain standing for as long as they did. In fact, the team concluded that, absent further fire damage, the Towers would not have collapsed. Matthys Levy of Weidlinger stated: "The fact that Tower 1 stood for 103 minutes after losing approximately 53 column lines and that Tower 2 stood for 56 minutes after losing approximately 34 column lines is a testament to the strength of the buildings and the skill of Leslie Robertson and the other engineers who designed them. I believe that few, if any, other buildings could suffer that amount of damage and not collapse immediately."

Diagram illustrating the way Tower 1 redistributed loads to other columns on its North face and staved off immediate collapse, as modeled by Weidlinger Associates.

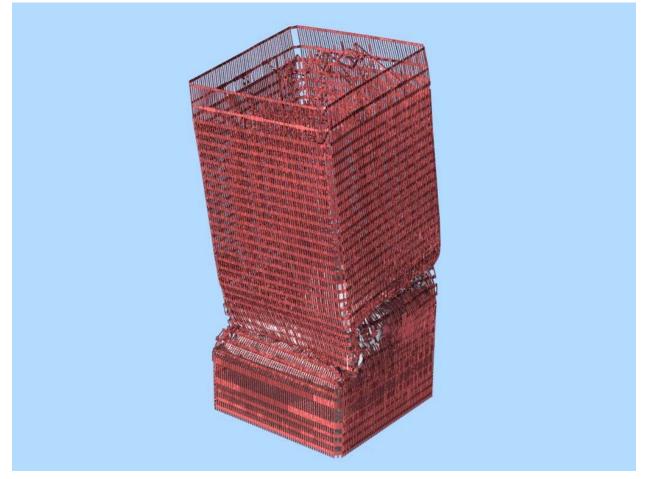
One frame from the computer model of the initiation of the collapse of Tower 2 performed by Weidlinger Associates.

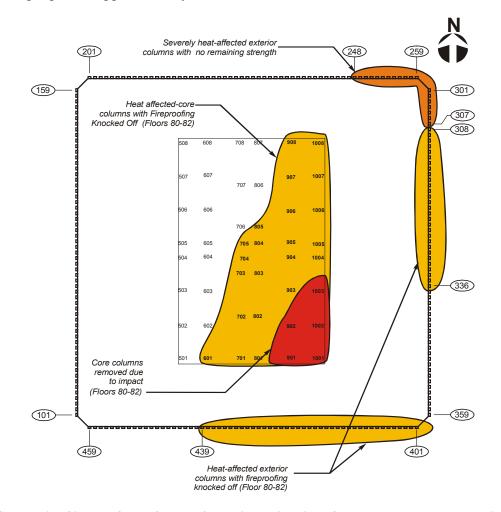
The studies conducted on behalf of Silverstein also answer the question of why Tower 2, struck 16 minutes after Tower 1, fell first. Photogrammetric studies of videos showed that American Airlines Flight 11 hit the middle of Tower 1 almost dead on at a speed of approximately 500 MPH. In contrast, United Airlines Flight 175 struck Tower 2 off center and on a diagonal flight path at approximately 550 MPH. The team concluded that because Tower 2

Schematic of impact floor of Tower 2 showing estimation of core columns damaged by impact (in red) and columns stripped of fireproofing by impact (in yellow).

was hit off center, Tower 2 was left without one of its corner columns in the core of the building and, like a table losing one of its legs, had less ability to redistribute the weight meant to be carried by the weakened or lost columns; this effect was further accentuated by the fact that Tower 2 was struck at approximately 12 floors lower than was Tower 1. In contrast, the core of Tower 1 after impact retained its corner columns and, like a table with all four of its legs, was better able to redistribute the weight meant to be carried by lost columns.

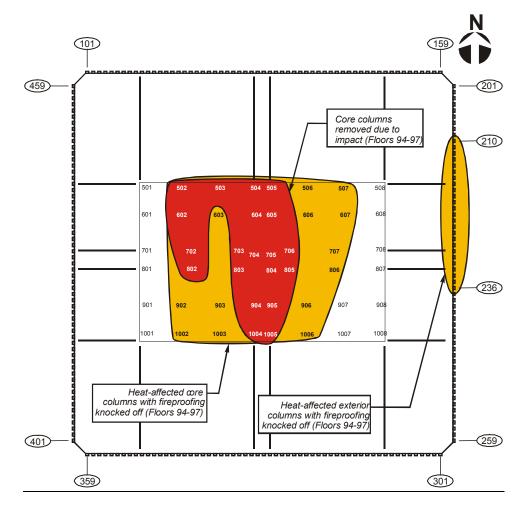
Schematic of impact floor of Tower 1 showing estimation of core columns damaged by impact (in red) and columns stripped of fireproofing by impact (in yellow).

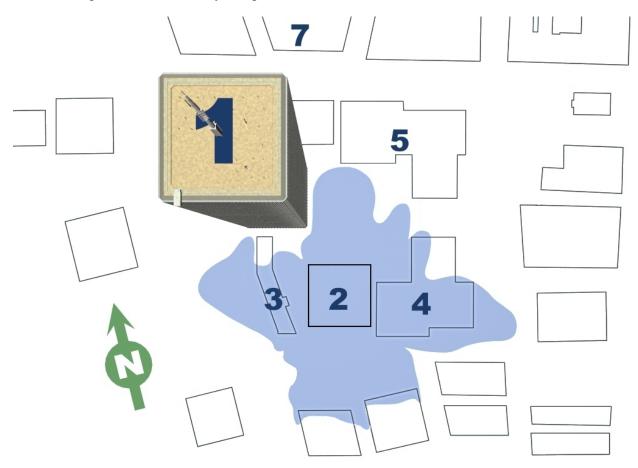
The engineering analysis led by researchers from LZA Technology/Thornton-Tomasetti examined the way in which each Tower collapsed. Once collapse initiated in each tower, essentially all of the interior structure of the Tower fell straight down with floors pancaking on top of one another. The network of perimeter steel columns and spandrels acted like a chute to funnel the interior contents into the Tower footprint. Some debris, primarily the perimeter columns, was thrown outward from the face of the Tower, creating a lobe pattern of debris. Based on an extensive review of the collapses and debris captured in photos and videos, as well as observations of engineers involved in the Ground Zero rescue, recovery and cleanup efforts, the team was able to identify the actual pattern of debris from each building collapse. This analysis establishes that the collapse of Tower 2 did not cause any significant structural damage to Tower 1. Because the Towers were offset, Tower 1 stood out of the way of the falling Tower 2 walls and pieces of debris only scraped the surface of Tower 1.

Pattern of heavy debris after the collapse of WTC 2 as mapped by LZA Technology.
