Protection of watercourse upstream of *Galaxias aequipinnis* and recent logging disturbance

Flow of water in east & west branches of the northern stream adjacent to coupe 830-507-0023

Logging disturbance in eastern branch of the northern stream adjacent to coupe 830-507-0023

Photographs of watercourse on northern border of coupe 830-507-0023

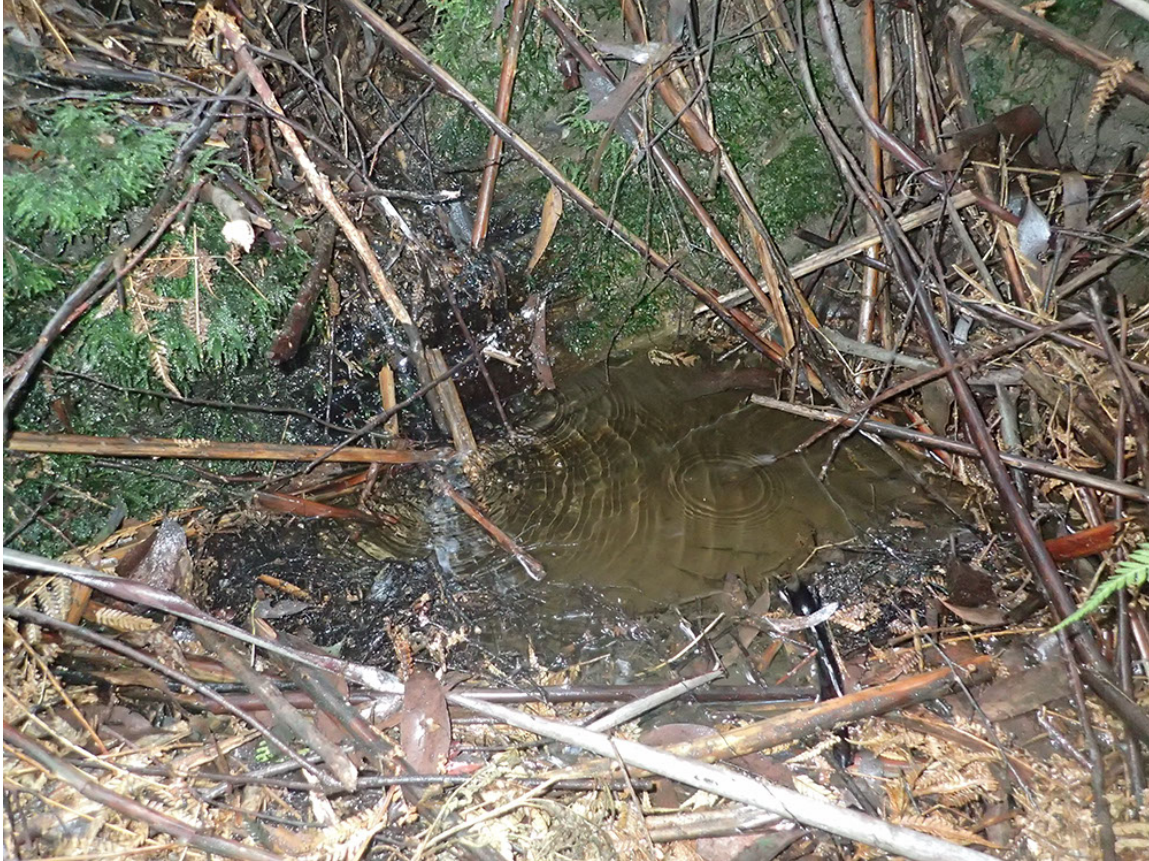
Recent investigations within coupe 830-507-0023 have shown that in fact there is little or no water flowing above ground in the western branch of the relevant stream and that it is the eastern branch of the relevant stream that has observable flowing water more voluminous than its western counterpart.

Figure 1(a). Eastern branch of watercourse (Little Arte River, Arte River) 55 H 657372 5845993 (GDA94 UTM)

As such, if the Department wishes to maintain the implementation of its woefully inadequate strategy of only protecting one part of the relevant watercourse, or one portion of what is properly and plainly understood to be “upstream”, then the eastern branch of the stream adjacent to coupe 830-507-0023 on its northern border must be protected with at least a minimum vegetative buffer of 100m.

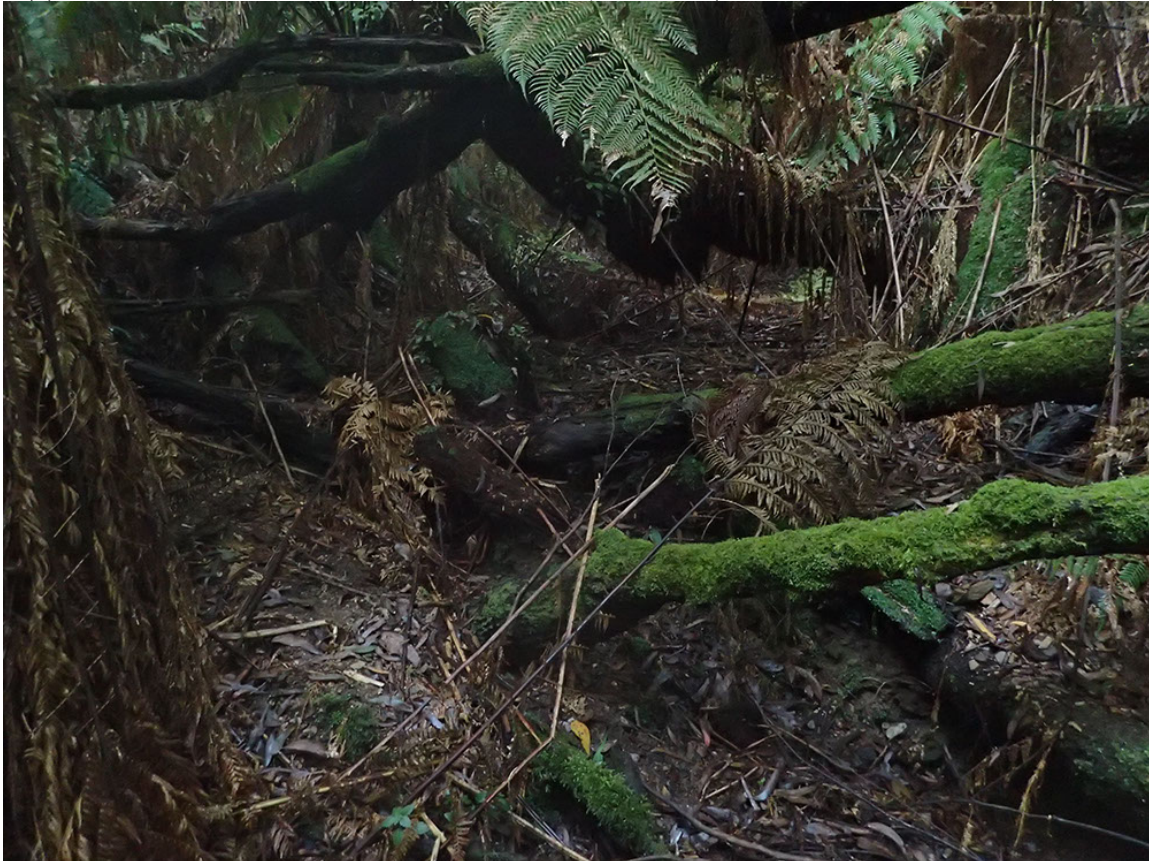
Figure 1(b). Western branch of watercourse (Little Arte River, Arte River) 55 H 657355 5846002 (GDA94 UTM)

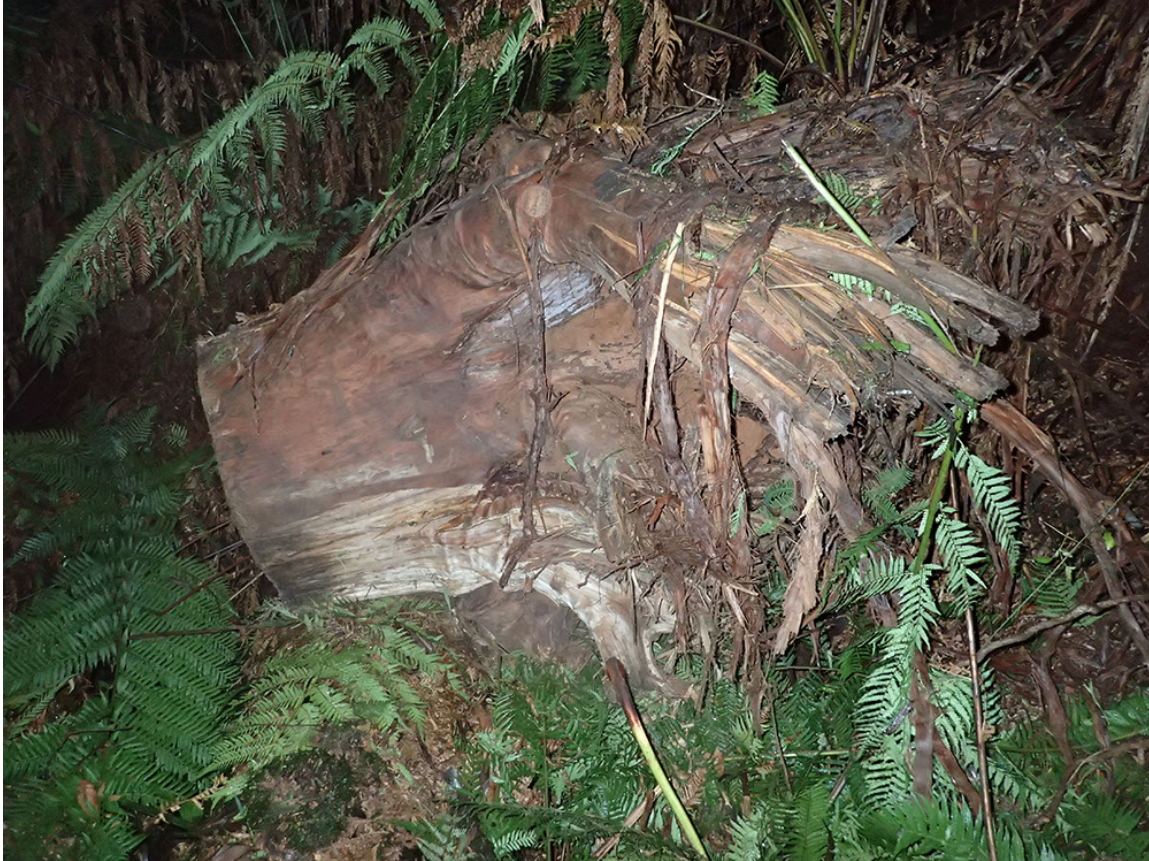
Included in this investigation was the discovery that a tree stump and root ball has been cut within the current logging operation of coupe 830-507-0023 and thrown down slope in to the eastern branch of the watercourse flowing on the coupes northern border.

The photographs attached to the end of this letter show the cut stump root ball thrown into the relevant stream and still present at 55 H 657493 5845916 (GDA94 UTM). This location is also shown on the map included within this letter.

This action by the logging contractors operating within coupe 830-507-0023 constitutes a clear breach of what should be the 100m minimum buffer for the Critically Endangered *Galaxias aequipinnis* and a clear breach of the regulatory framework governing logging operations in Victoria's State Forests including Sections 3.3.1.1 and 3.3.1.2 of the "Management Standards and Procedures for timber harvesting operations in Victoria's State forests" (Department of Environment and Primary Industries, The State of Victoria, October 2014).

Figure 2(a). Cut stump root ball thrown into the Little Arte River, Arte River on northern border of coupe 830-507-0023

I call on the Department to enforce the protection of the minimum 100m buffer on the eastern branch of the relevant stream described above (and all upstream areas of *Galaxias aequipinnis* populations) by restraining all logging operations within this area as a matter of urgency given the ongoing logging operations in coupe 830-507-0023.

Further, the Department must prosecute the logging contractors operating within coupe 830-507-0023 for flagrantly degrading the stream detailed above by throwing a cut stump root ball into the upstream habitat of the Critically Endangered *Galaxias aequipinnis* and breaching Sections 3.3.1.1 and 3.3.1.2 of the "Management Standards and Procedures for timber harvesting operations in Victoria's State forests" (Department of Environment and Primary Industries, The State of Victoria, October 2014).

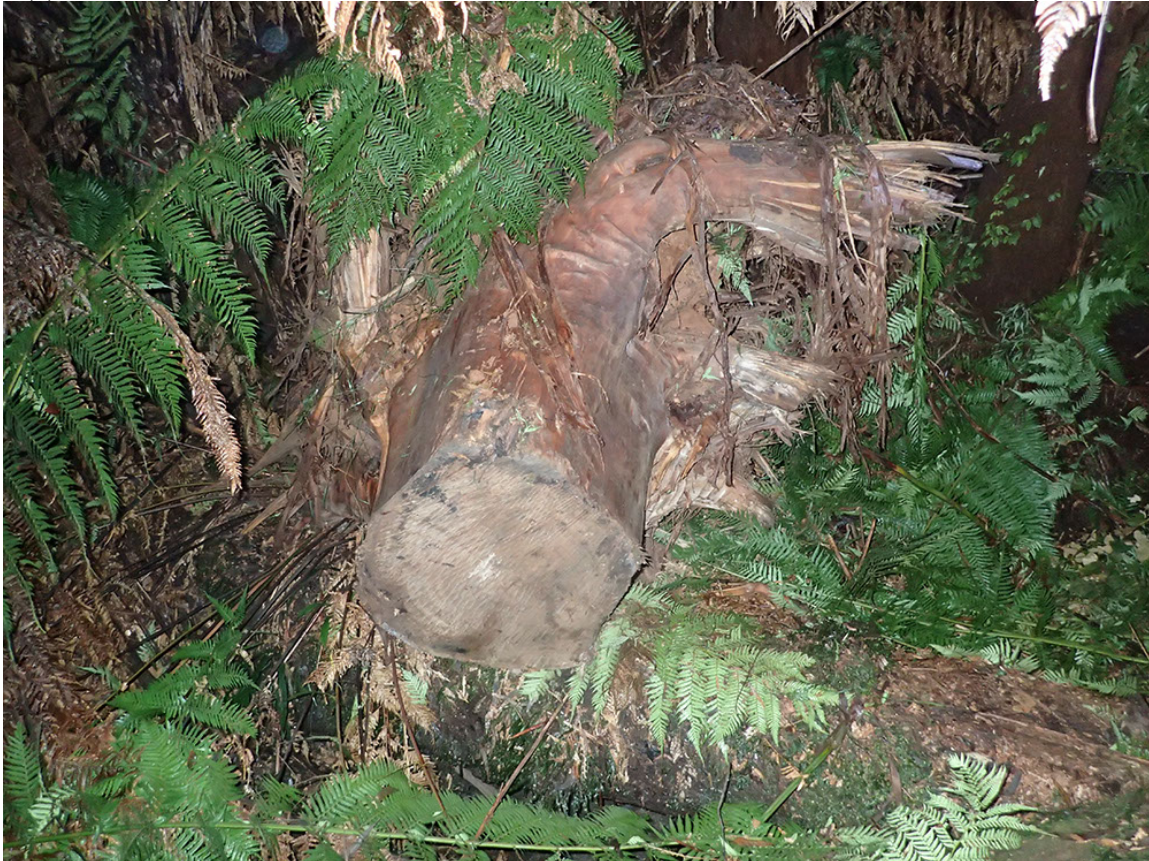
Figure 2(b). Cut stump root ball thrown into the Little Arte River, Arte River on northern border of coupe 830-507-0023
