ANATOMY OF COLLAPSE

Surfside tower was flawed from day one. Designs violated the code, likely worsened collapse

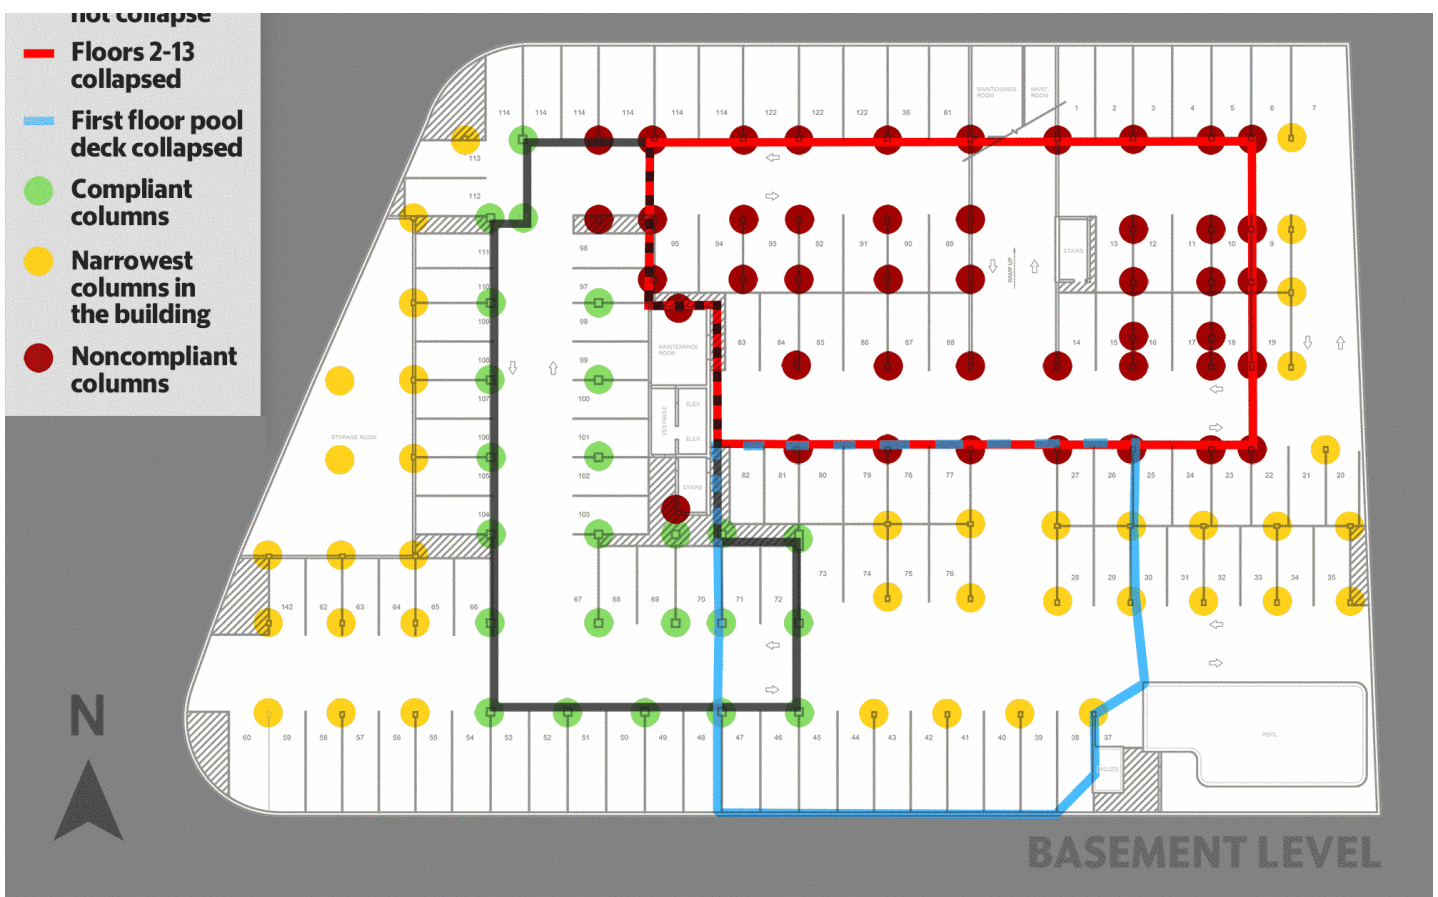
Collapsed portion of building wasn't designed to code

The Champlain Towers South design violated building codes at the time of original construction. On the northern side, under the portion of the tower that collapsed, the columns were too narrow to accommodate all of the vertical and horizontal rebar called for in the plans while maintaining clearance required by the code. The pool deck had narrow columns and inadequate load bearing capacity, engineers consulted by the Herald found. Only columns beneath the surviving structure were fully compliant with the code at the time.

Narrow columns that were not up to the building code standards of the time were clustered below the part of the structure that experienced progressive collapse. In contrast, larger, code-compliant columns featuring twice the amount of concrete as the others were located under the western structure and withstood the buckling stresses of the initial pool deck collapse — bolstered by a reinforced elevator shaft and second-floor beams located only in that half of the building.

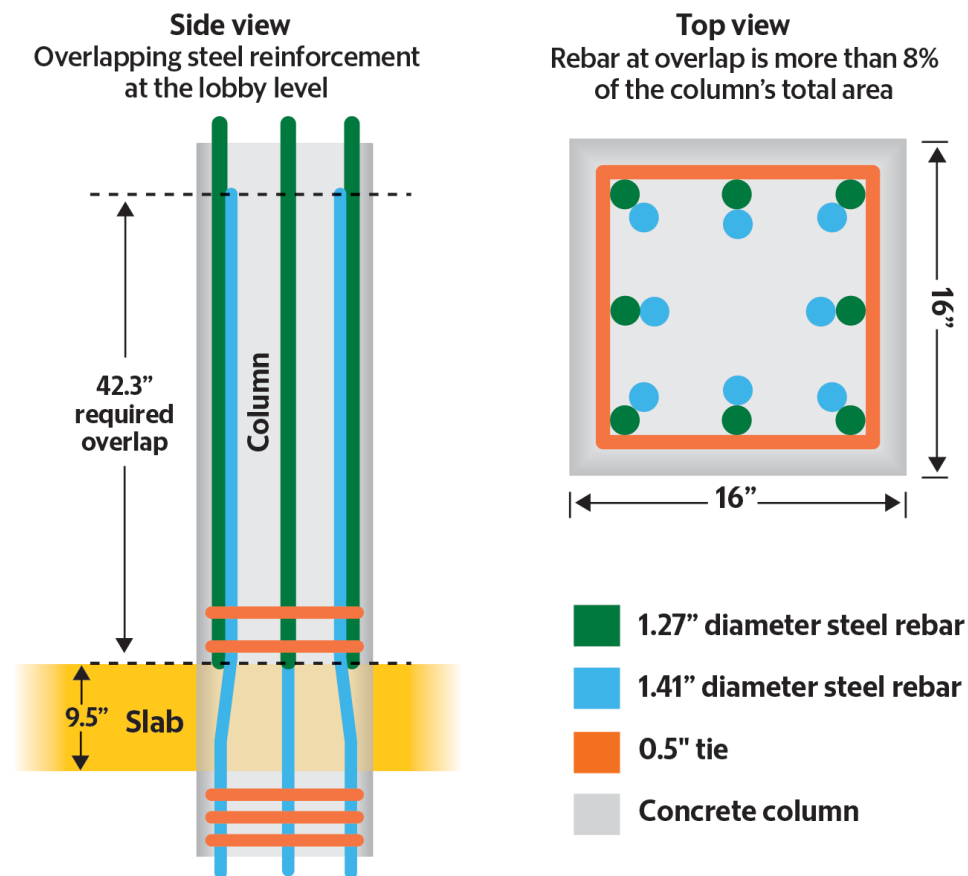
Common Champlain column design

Overcrowded, noncompliant column design

The American Concrete Institute’s 1977 code required a rebar-to-concrete ratio of no more than 8% to prevent overcrowding, which can make the column difficult to properly construct and reduce its overall strength. All but two column types in the Champlain Towers South plans were noncompliant where rebar overlaps in the basement and lobby levels. The overcrowded columns were clustered under the north portion of the condo that collapsed on June 24, 2021.

“If you have too much reinforcing in the column, it will crack as it dries. Concrete shrinks and the rebar doesn’t,” Santiago said. “What this means is all of the columns were cracking from day one.”

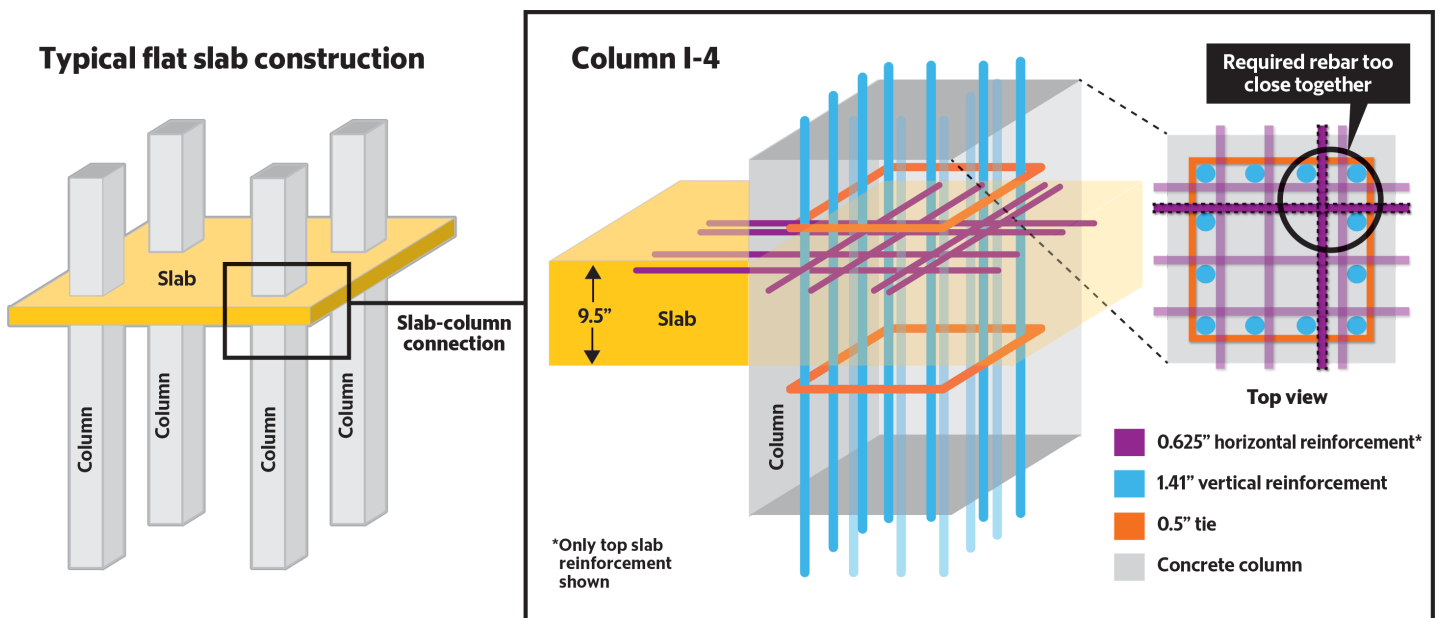
Design violated minimum spacing requirements for connecting steel

Again, the Champlain Towers design violated the code at many of the column connections, especially in the northeast part of the structure, between the basement and lobby levels, calculations by engineers showed.

Some structural elements in the collapsed portion of Champlain Towers South did not meet minimum spacing requirements for reinforcing steel set by the American Concrete Institute at the time the condo was designed. For example, at Column I-4 between the basement and first floor, building plans required four pieces of horizontal rebar through the column in both directions to connect it to the slab. If built to plan, the column was too narrow to fit all of the rebar with the required spacing.

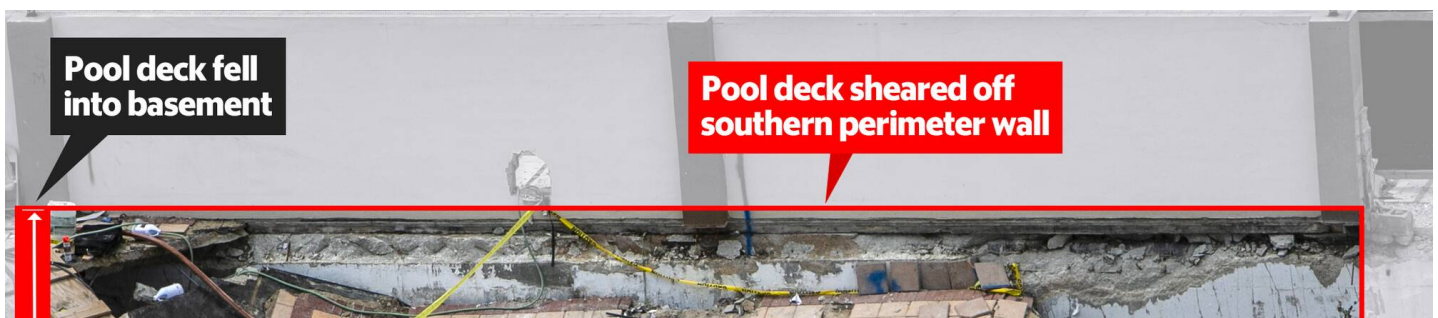
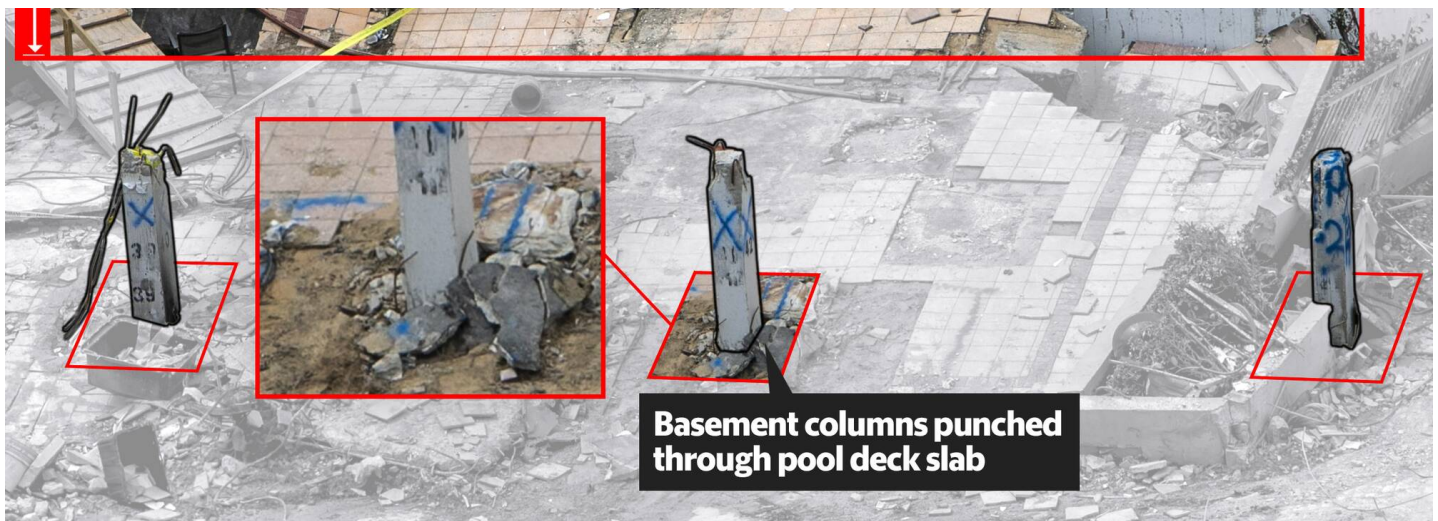
Pool deck falls into the garage in “punching shear” failure

Between 5 and 10 minutes before the north side of the condo pancaked down, eyewitnesses and [a cellphone video](#) suggest the pool deck began to sag. The spindly columns supporting it poked through the slab — a failure called "punching shear."

Punching is the most common failure mechanism for flat-slab construction featured at Champlain Towers and should have been anticipated at the time of construction, the engineers said. Load calculations based on the 1977 standards published by the American Concrete Institute show the pool deck design was inadequate and did not have the required capacity at the time of construction to mitigate the risk of punching failure.

Eyewitnesses saw the pool deck collapse, shearing off completely from the southern perimeter wall of Champlain Towers South minutes before the tower came crashing down. Photos from the collapse site show that narrow columns from the parking garage below poked through the pool deck as the slab sagged — a dangerous type of failure called “punching shear” which experts say is known to cause sudden collapse.

"My calculations show that the capacity was lower than the load that was imposed at these pool deck columns," said Aghayere, the engineer from Drexel University. "So I would have added drop panels to increase the shear strength."

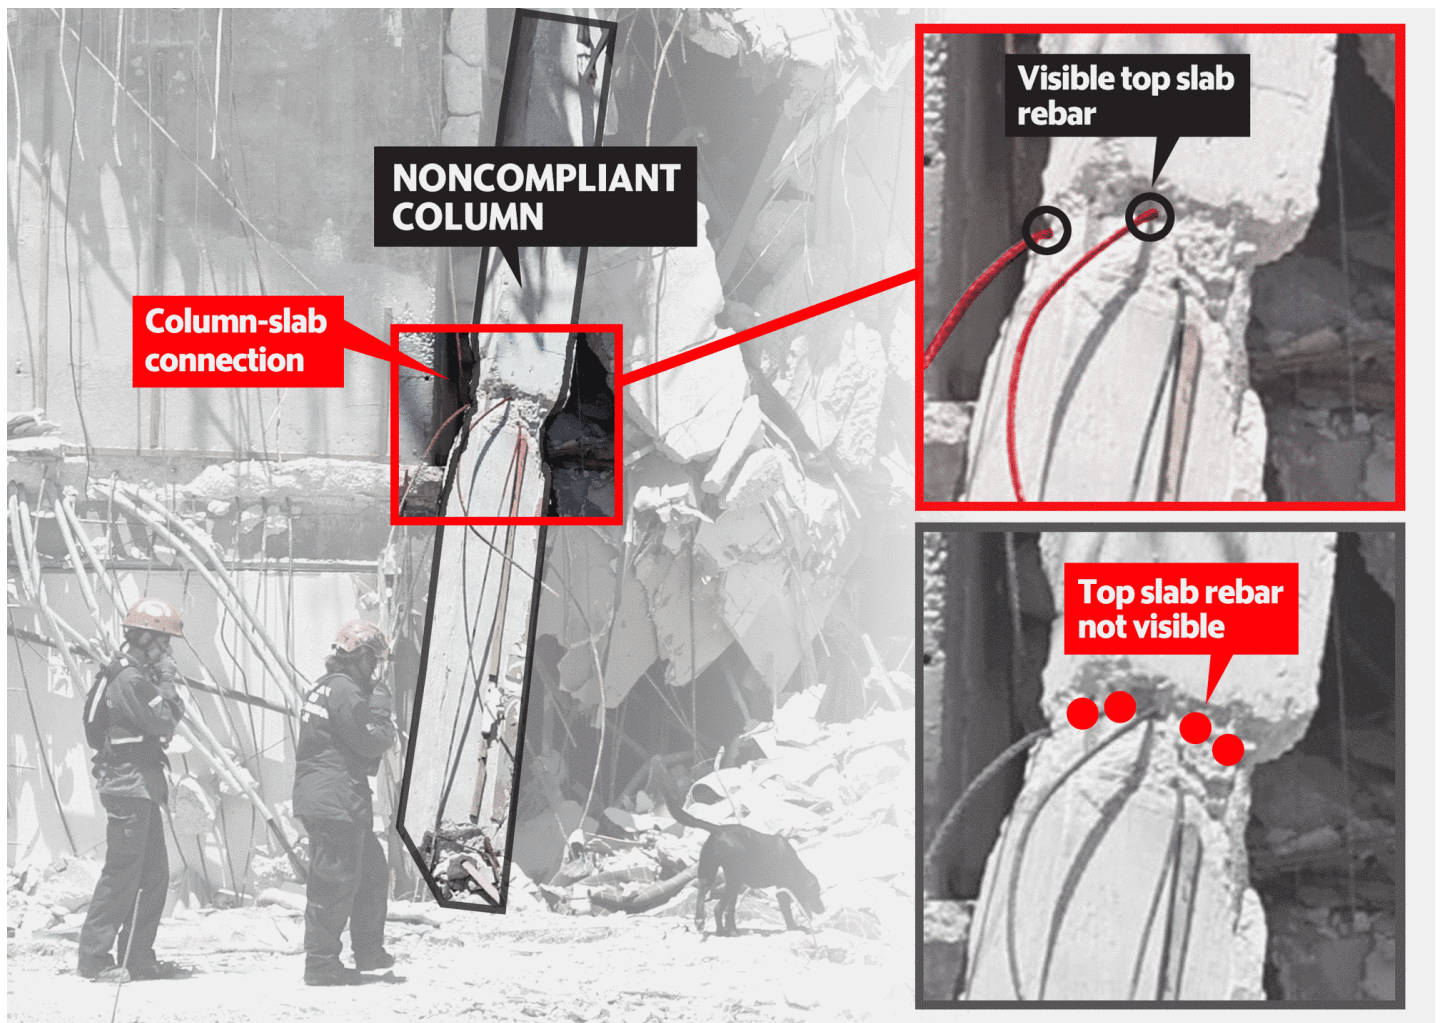
Expected rebar appears missing from column-slab connections

Engineers who compared the Champlain Towers South plans to photos of the post-collapse debris saw examples in various parts of the structure where rebar designed to connect the column to the slab appeared to have been left out during construction. For example, in this column from the north side of the tower, plans called for at least three pieces of horizontal rebar in both directions to connect the column and the slab at the joint pictured below — six pieces of horizontal rebar total. Only two of the expected six are visible in the debris.

Exposed connections in damaged columns in the pool deck, as well as in both sides of the high-rise structure, appeared to have fewer pieces of horizontal rebar than called for in the plans, said the engineers, who reviewed hundreds of photos of the debris and compared the visible columns to building plans.

“It’s pretty clear to me that the required slab reinforcement did not go through that [pool deck] column given the way it should be spaced,” she said.
