**FROM:** California Fatality Assessment and Control Evaluation (CA/FACE) Program

**SUBJECT:** Warehouse Worker Dies When He Falls Through a Skylight

**SUMMARY**  
**California FACE Report #09CA007**

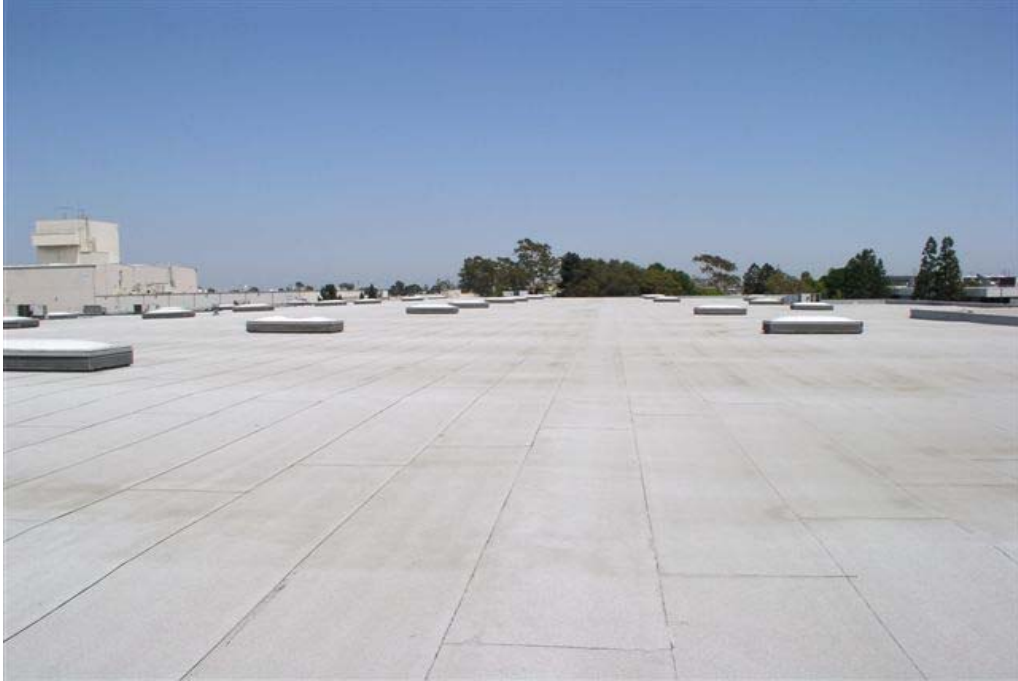
**Exhibit 1. The roof of the warehouse.**

The incident scene was the flat roof of a large warehouse occupied by four separate businesses. The roof housed numerous air conditioning units and 35 skylights (Exhibit 1). Access to the roof was obtained by ascending a 10-foot straight ladder from the warehouse floor to the top of an interior office module (Exhibit 9), and then another 20-foot straight ladder to the roof (Exhibit 10). According to the property management company for the warehouse, the roof and its roof-mounted equipment are inspected annually and defective skylights replaced at that time.

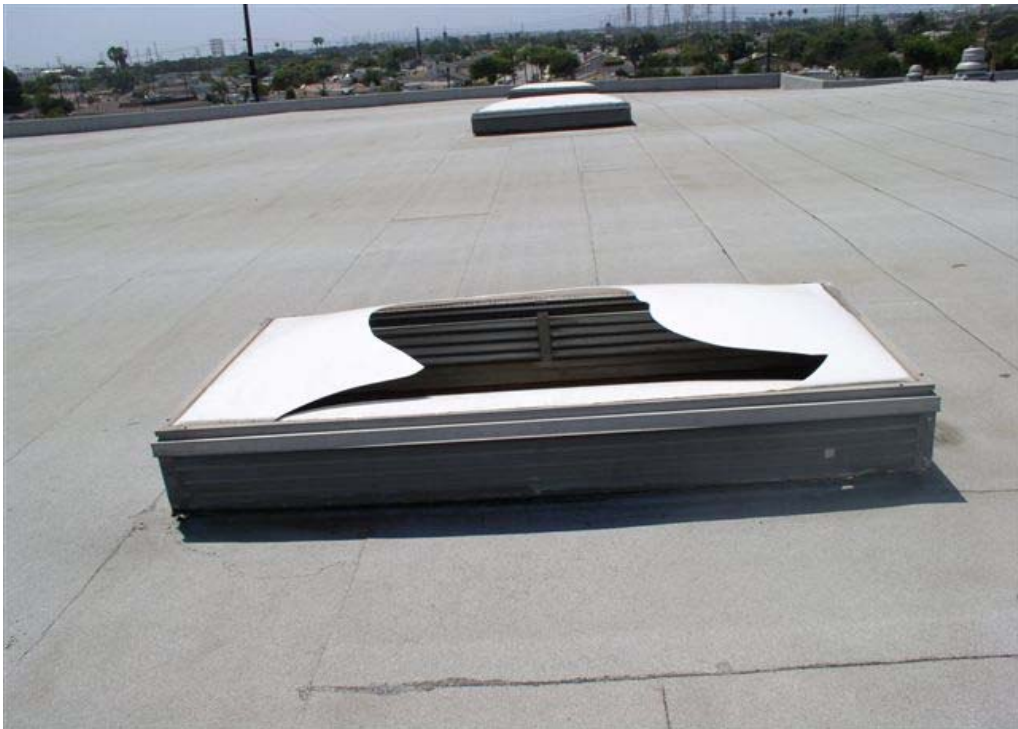
**Exhibit 2. The skylight the victim fell through.**

conditioning units was not part of his normal assigned duties. The employer did not have any policies or procedures to ensure that workers did not perform hazardous jobs outside of their usual tasks. When the victim requested that he service the air conditioner and go onto the roof, his supervisor allowed him to proceed. Although the incident was not witnessed, the victim likely fell through the skylight after he slipped on the roof or climbed onto, sat, or lay down on the skylight. Servicing of equipment on warehouse roofs should be performed only by qualified technicians who have been trained on appropriate safety procedures. Warehouse employees without this training should not be permitted by their employer to access the roof and thereby place themselves at risk of falls. If the employer had policies and procedures that would have prevented the victim from servicing the air conditioner, this incident would have been prevented.

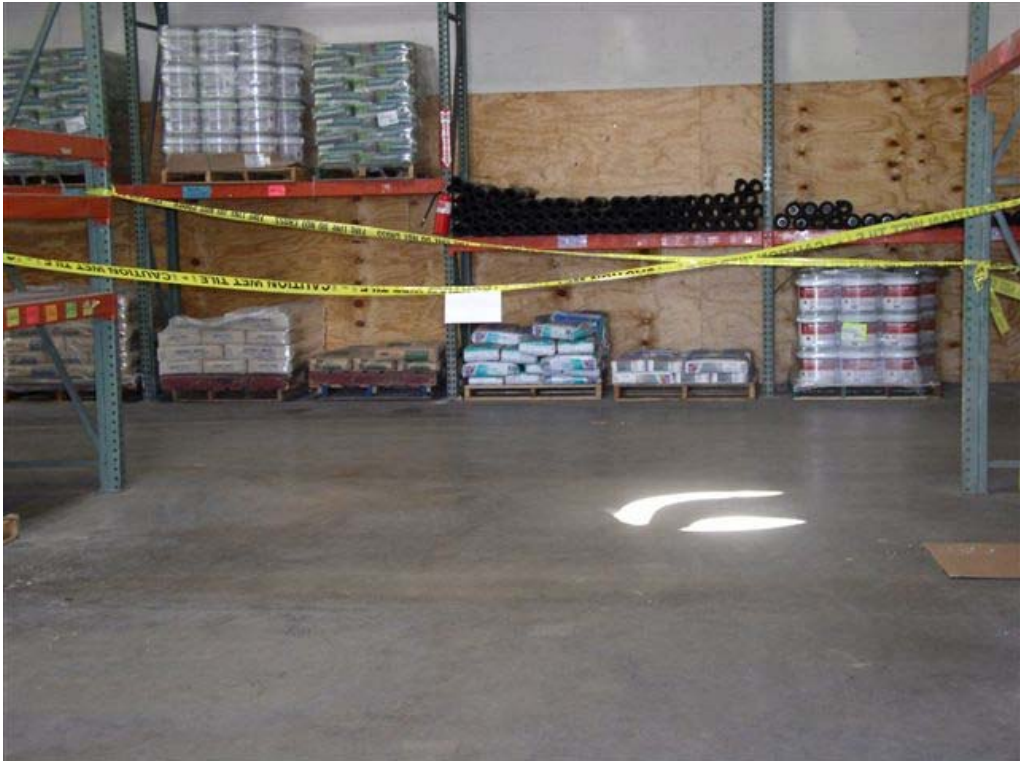
**Exhibit 4. The warehouse floor where the victim landed.**

The employees in one of the adjoining businesses in the warehouse heard a loud noise. The manager of this business sent one of their warehouse workers to investigate the source of the sound. A few minutes later, this warehouse worker radioed back to his office for the manager to call 911 as he had found the victim lying injured on the warehouse floor (Exhibit 4). The paramedics and fire department responded within minutes of the call and performed CPR on the victim but were unable to revive him. He was pronounced dead at the scene.

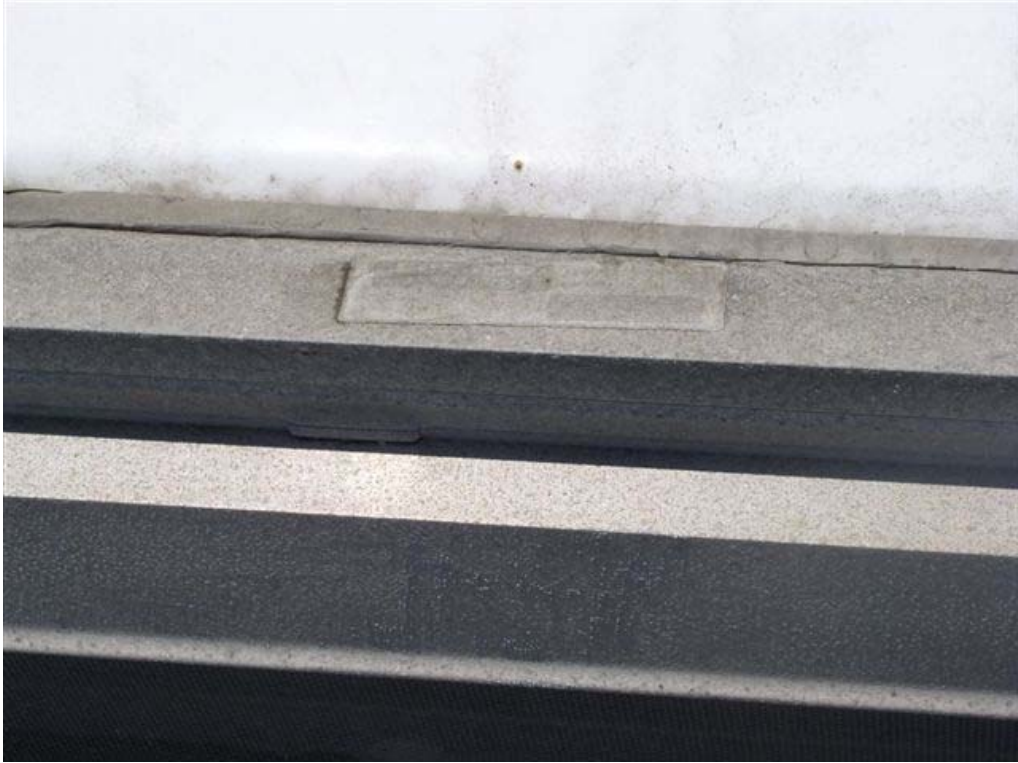
**Exhibit 5. The identification label on the skylight. Exposure to the environmental elements over time has made the label unreadable.**

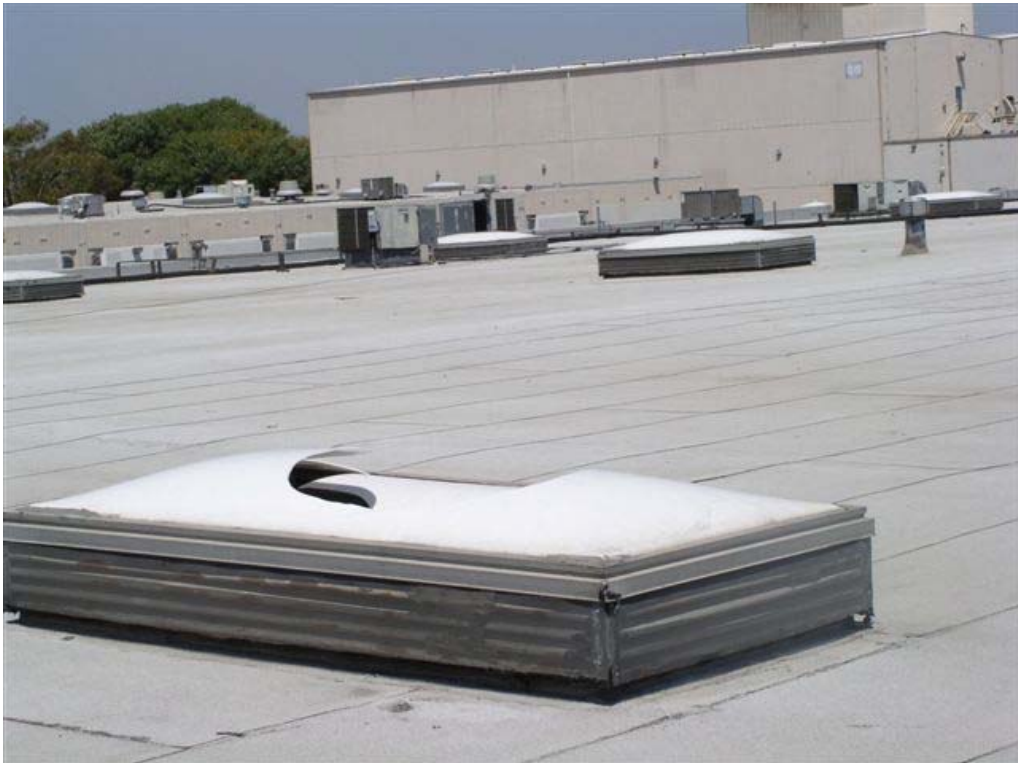
**Exhibit 6. The distance between the air condition unit and the skylight.**

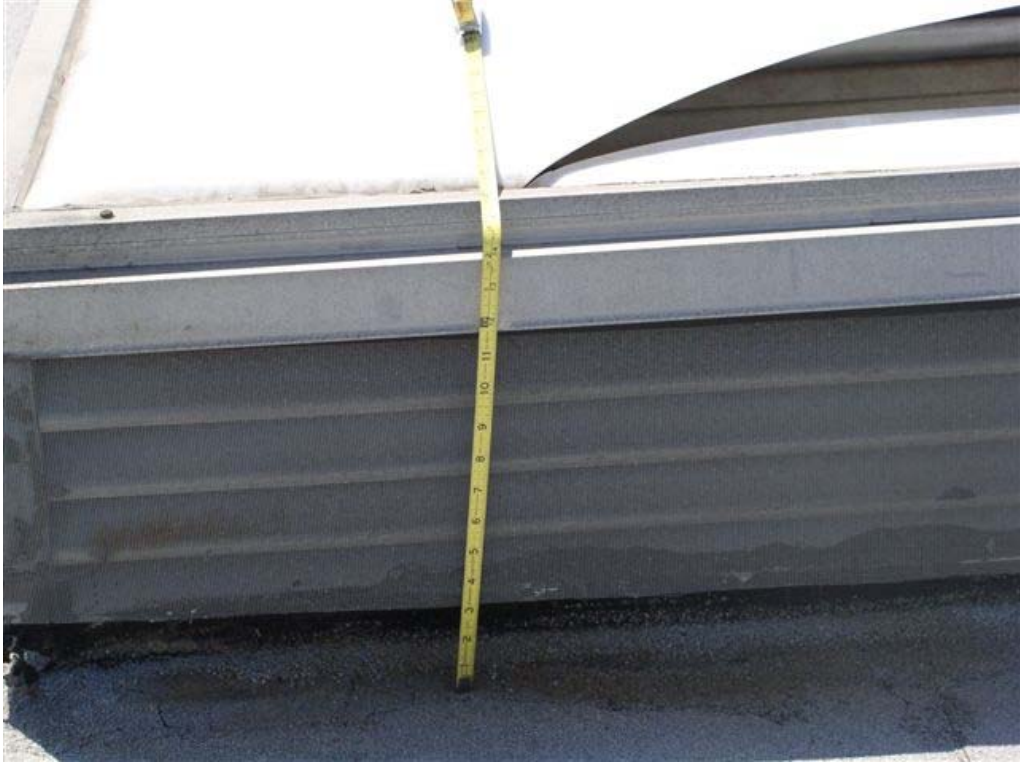
**Exhibit 7. The skylight base was approximately 15 inches tall.**

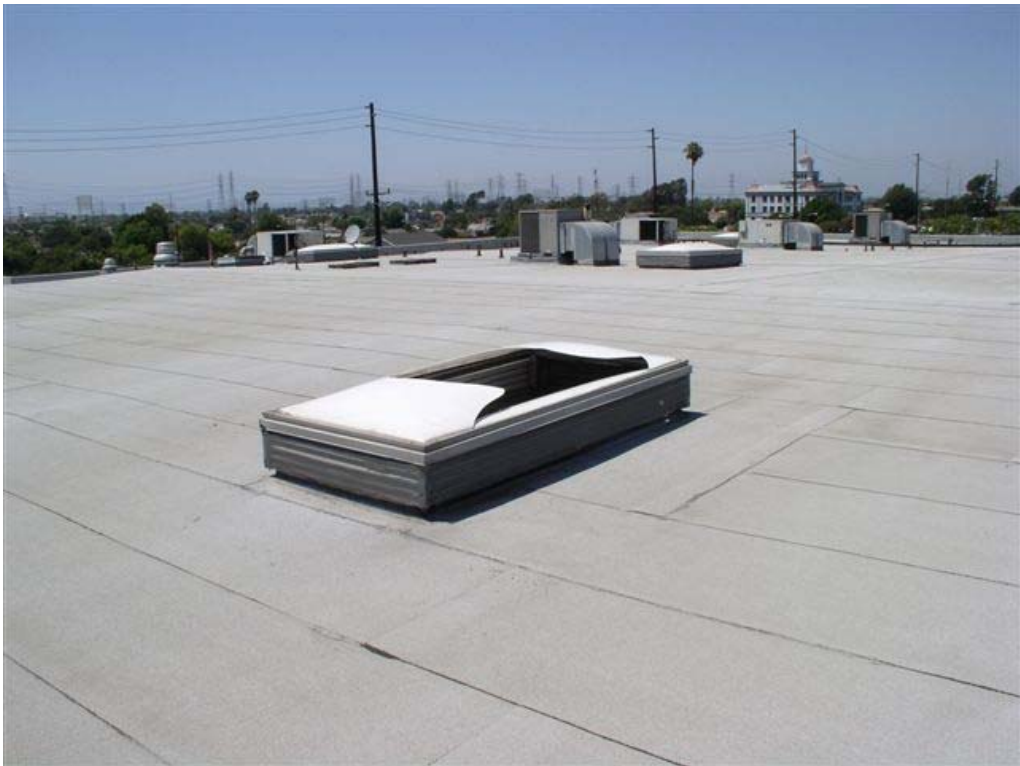
**Exhibit 8. The area around the base of the skylight.**

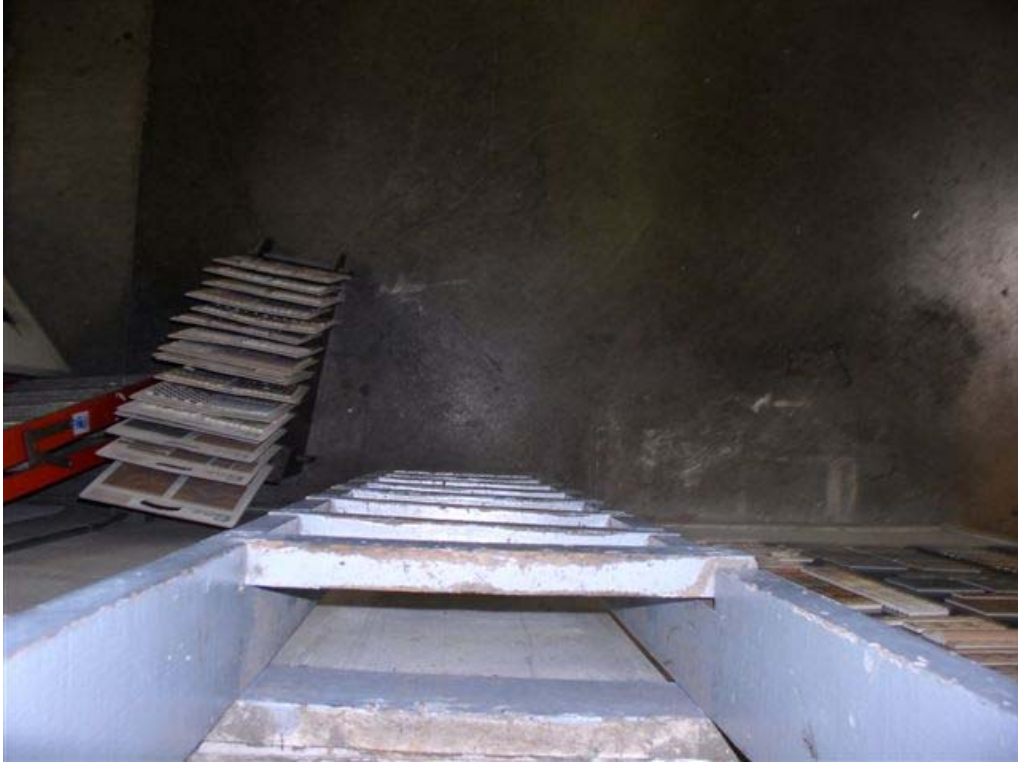
**Exhibit 9.** A picture from the top of the first ladder used to gain access to the roof.

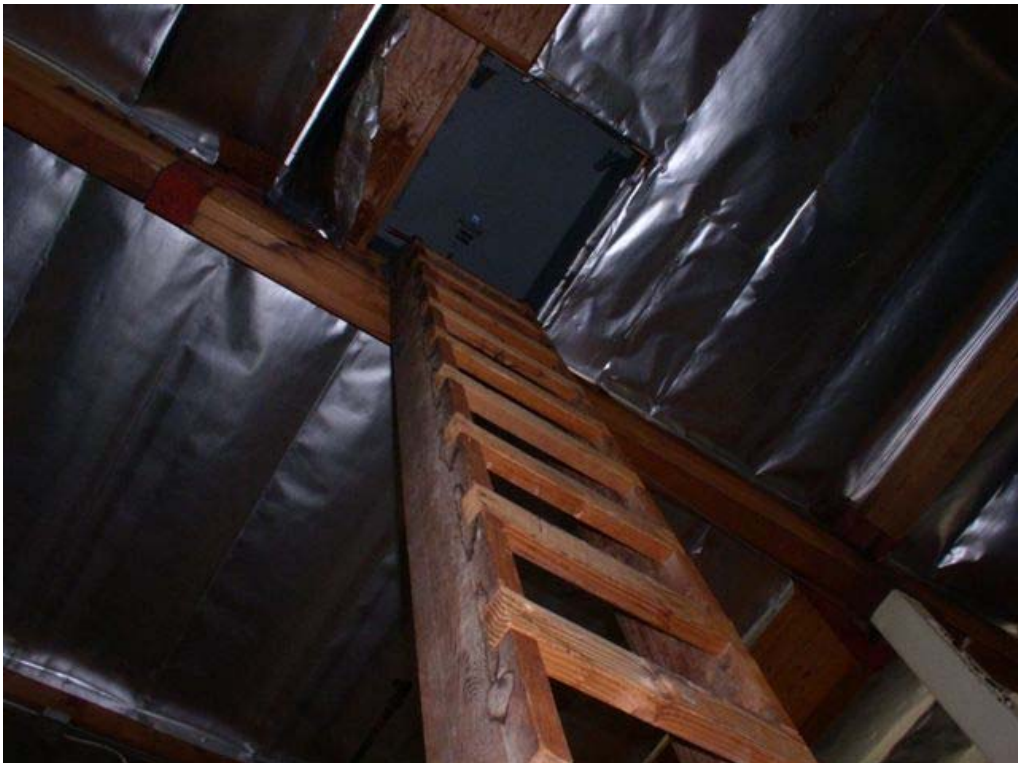
**Exhibit 10.** A picture looking up at the second ladder used to gain access to the roof.
