**SUBJECT:** Janitor Dies When He Falls into a Baling Machine that Bales Cardboard for Recycling

**SUMMARY**  
**California FACE Report #09CA009**

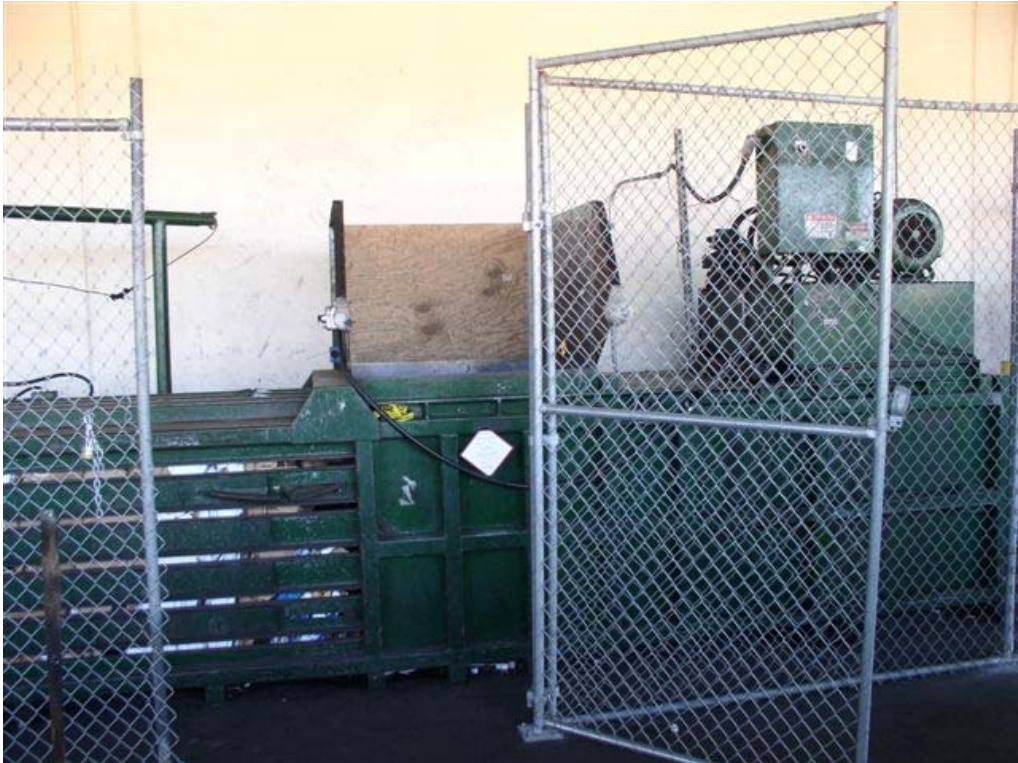
**Exhibit 1. The front view of the cardboard baling machine involved in the incident.**

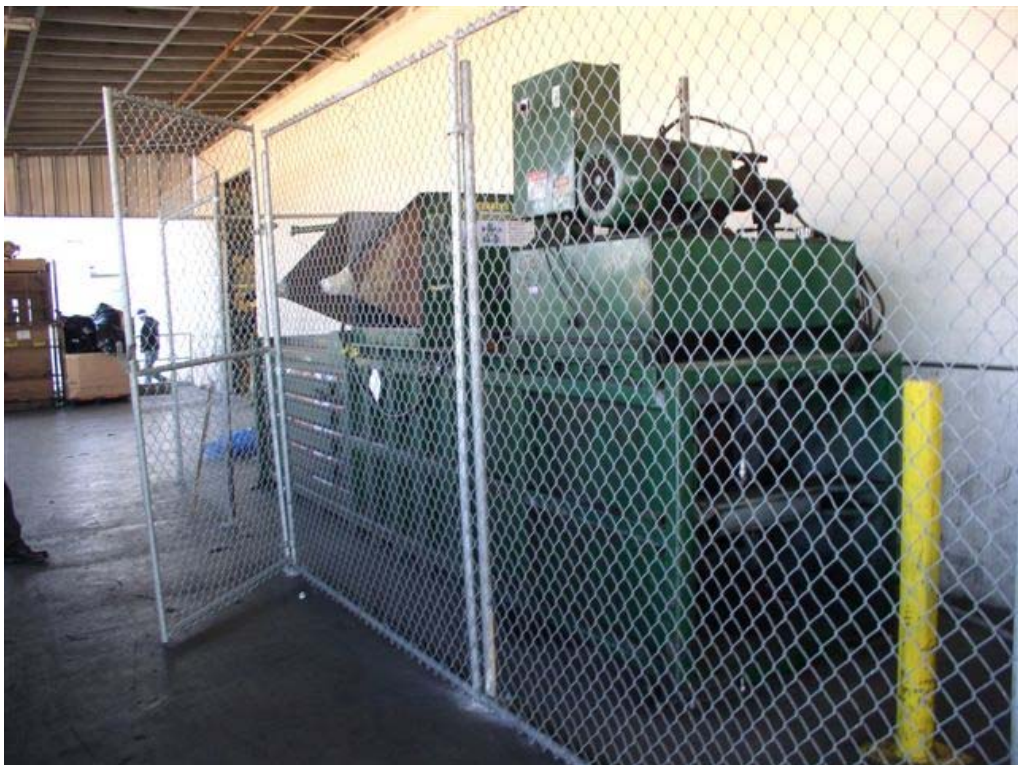
**Exhibit 2. Side view of the cardboard baling machine.**

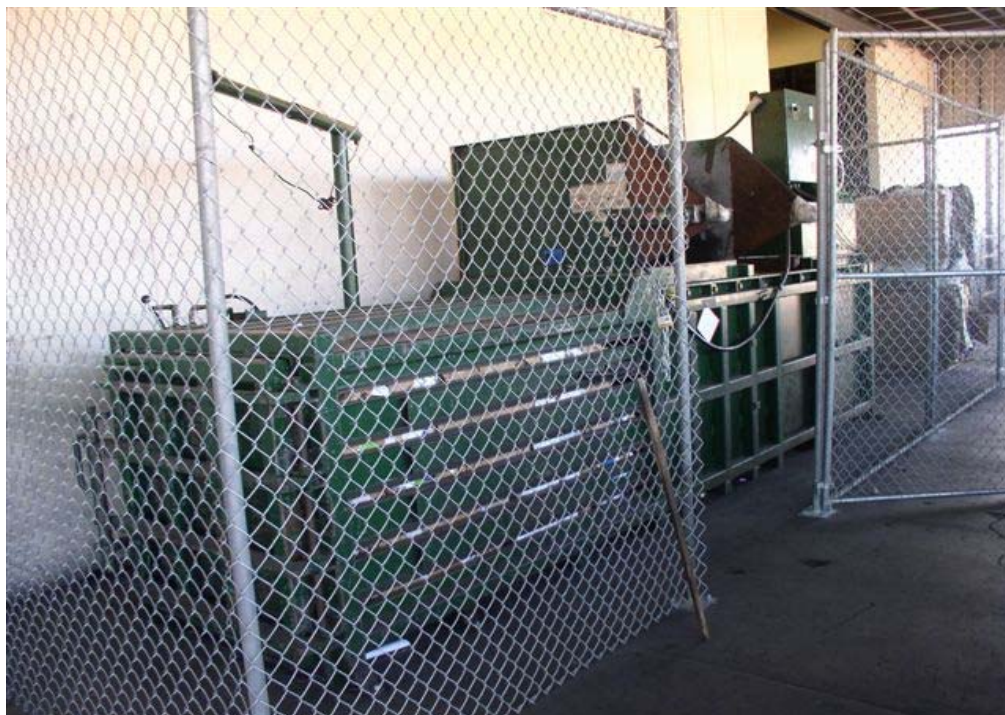
**Exhibit 3. Alternate side view showing the baling chamber.**

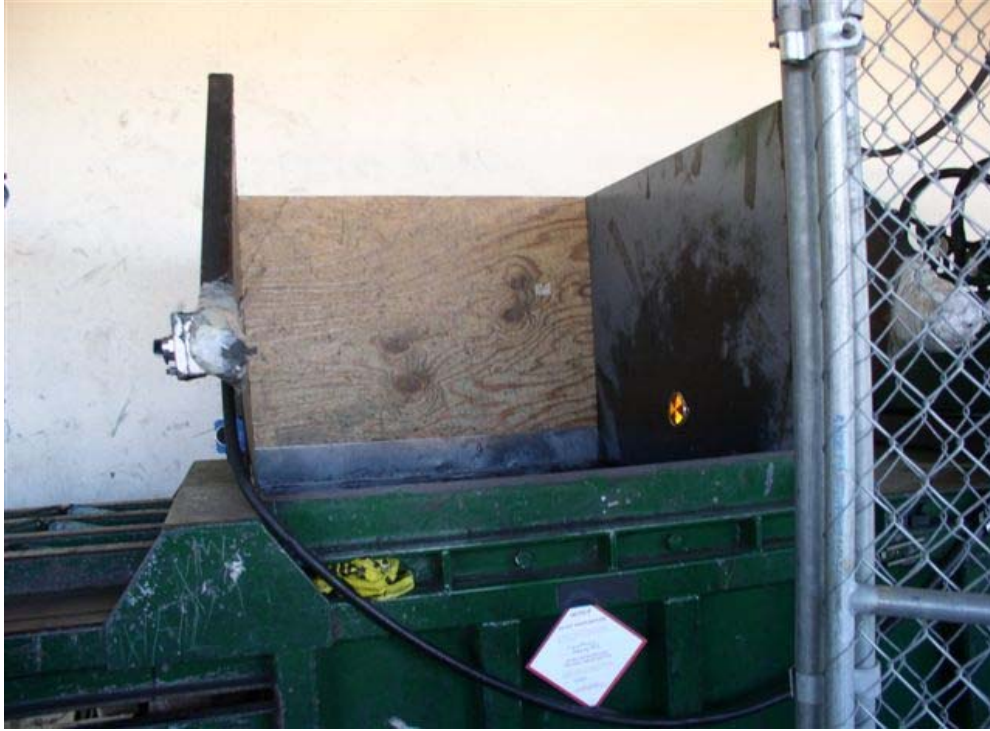
**Exhibit 5. Closer view of the feed hopper.**

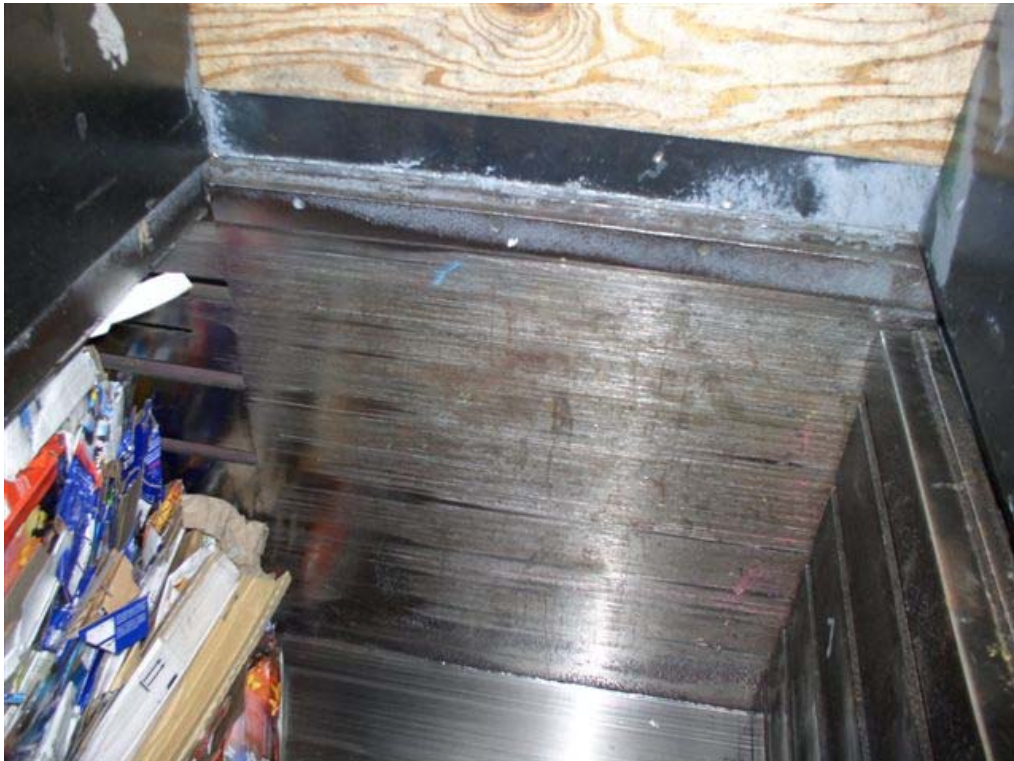
**Exhibit 6. Inside view of the compaction chamber.**

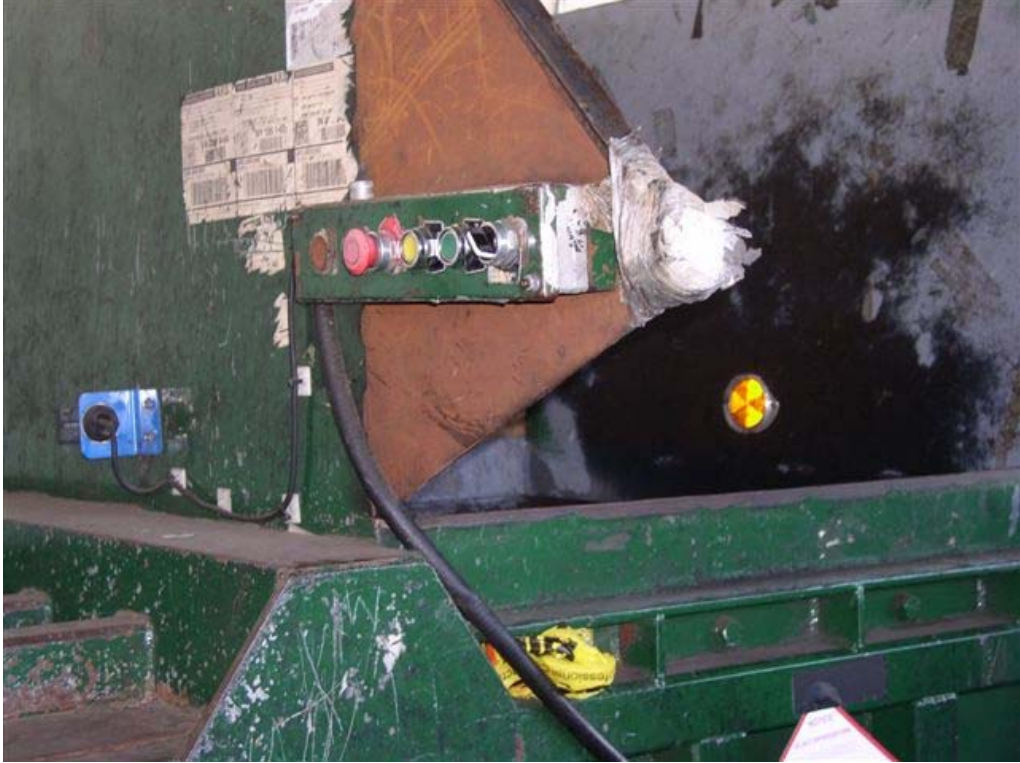
**Exhibit 7. The controls and electronic sensor.**

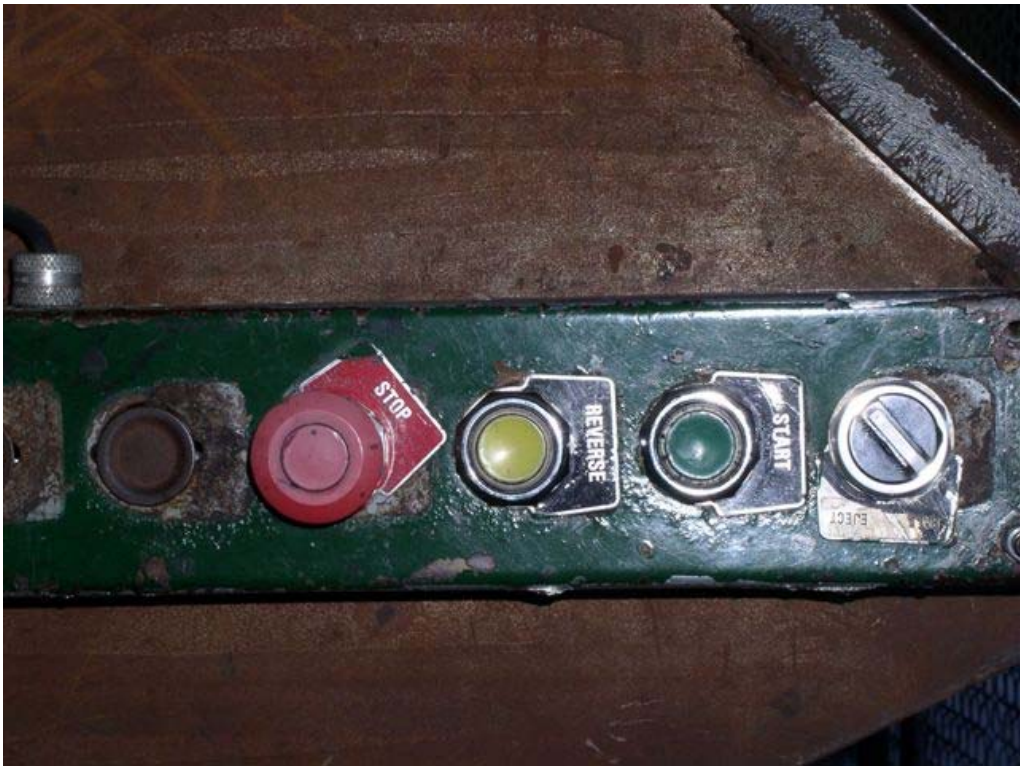
**Exhibit 8. Close-up of the controls.**
