Trackside Inspection of Roller Bearings

Produced as a service to the railroad
industry by The Timken Company

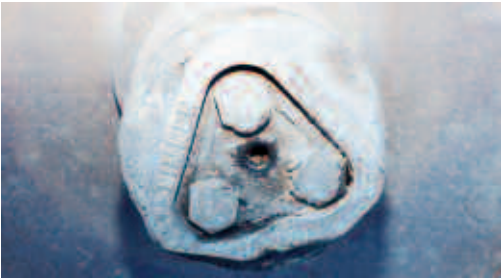
Figure 1

- 1) Check the axle end cap for missing lubricant fittings or plugs.

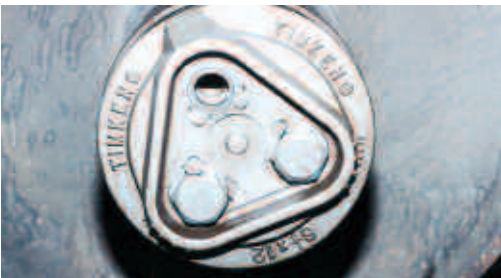
Figure 2

- 2) Check for loose and/or missing cap screws.

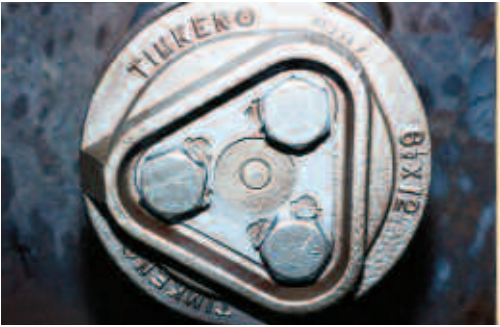
Figure 3

- 3) Be sure that all tabs of the locking plate are properly bent up against the flats of the cap screw heads.

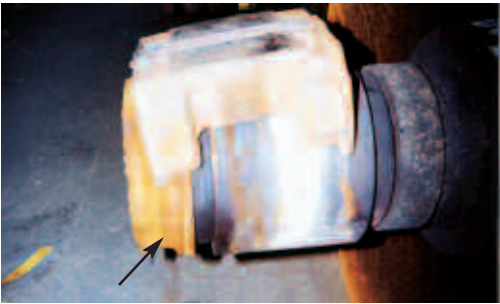
Figure 4

- 4) Inspect for damage or wear to the end cap from a displaced (cocked) adapter.

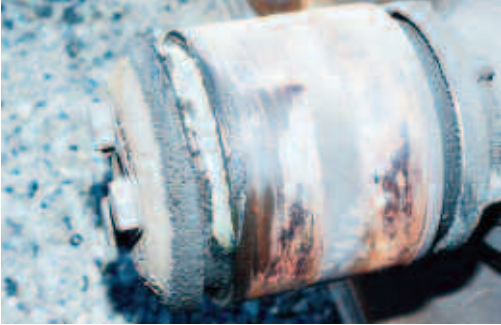
Figure 5

- 5) Inspect for loose or damaged seals.
Excessive accumulation of fresh grease around a seal *may* indicate a loose, damaged or defective seal.

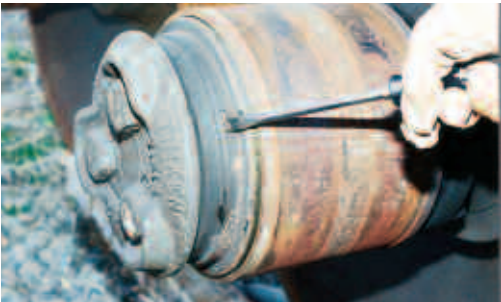
Figure 5A

- 5A) A seal that can be moved laterally (back and forth) or rotated by hand using a suitable probe, such as a screwdriver.

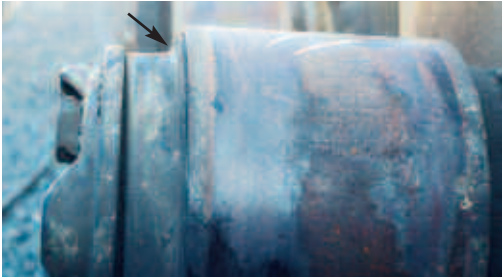
Figure 5B

5B) A seal that is cocked out of position in the bearing outer ring.

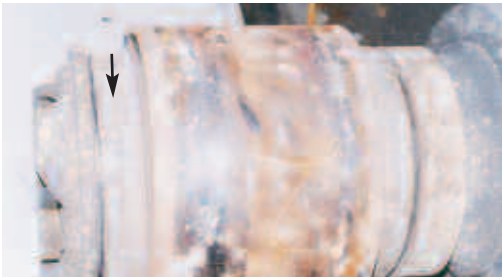
Figure 5C

5C) A seal case that is damaged (bent) from an external source

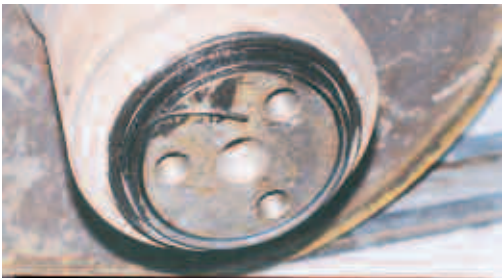
Figure 5D

5D) Seal lips that are damaged.

(Bearing shown without end cap for illustration.)

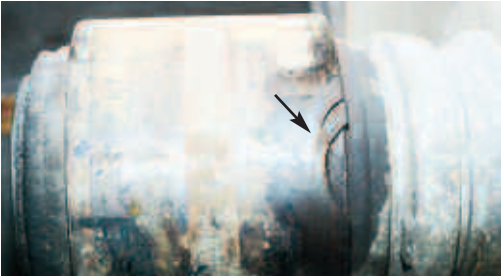
Figure 6

6) Check for cracked or broken outer rings (also called bearing cups).

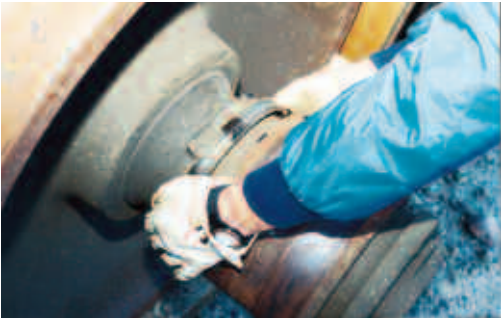
Figure 7

7) Inspect for a loose backing ring. If a backing ring can be moved or rotated by hand, remove the bearing from service.

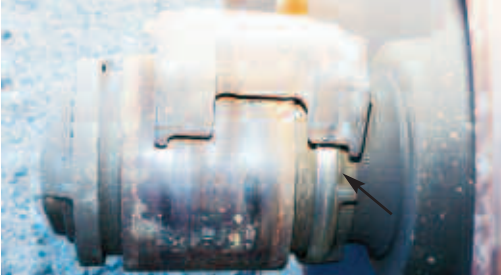
Figure 8

- 8) Check the backing ring for damage or wear from a displaced (cocked) adapter.

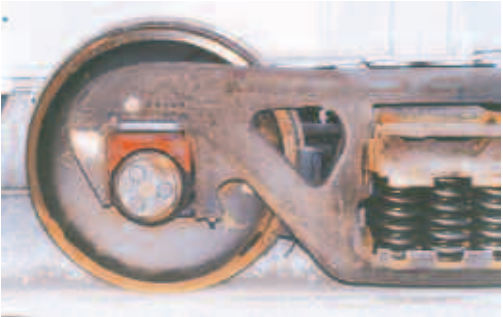
Figure 9

- 9) Note that the bearing assembly size matches the frame and adapter size (for example, a 100-ton bearing in a 100-ton truck).

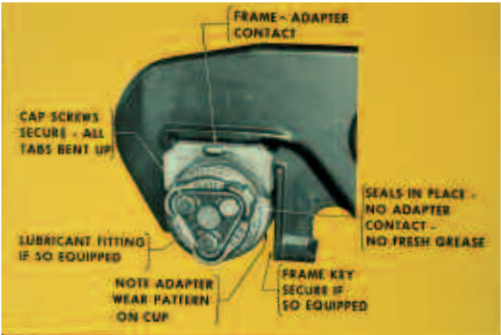
Figure 10
Key Inspection Points
on a Timken® AP™ Bearing
in a Narrow Pedestal Frame

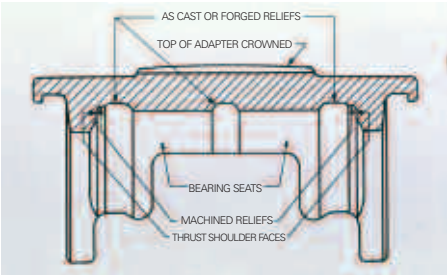
The standard freight car narrow adapter is shown in Figures 11 and 12. This is the most common style in service today. There

Figure 11
Narrow Adapter Half Section

As indicated in Figure 11 on page 9, the frame adapter has a thrust shoulder at each end. During operation, the thrust shoulder can be worn or embedded into by either end of the outer ring. If either face of the thrust shoulder is embedded or worn by the outer ring .025" or more, the adapter must be scrapped.

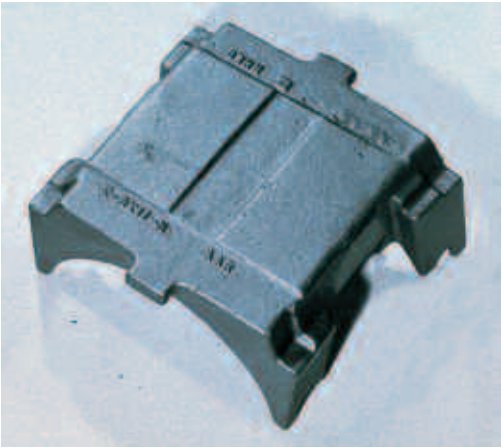
Figure 12
Narrow Adapter

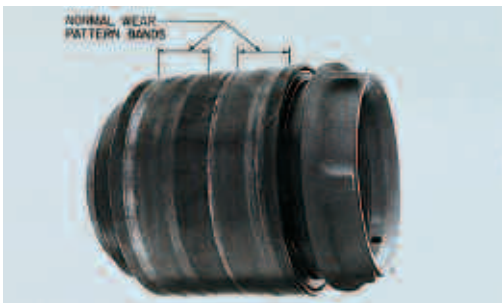
Figure 13 shows a bearing that has been operating in an adapter that was in satisfactory condition. Two definite wear bands are visible on the bearing outer ring. Most freight car bearings will “creep” in service, causing the wear bands to appear. This is a normal condition that also causes wear to the adapter’s seat pads.

Figure 13
Normal Wear Bands on Outer Ring
(Bearing Cup)

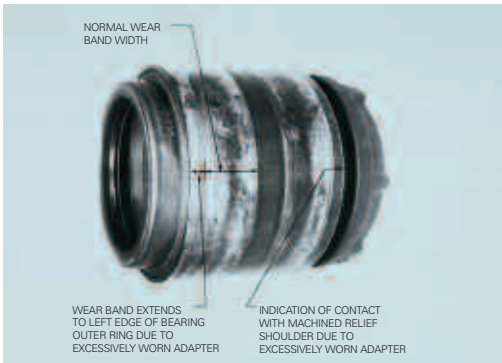
The bearing in Figure 14 indicates an adapter wear pattern that extends to the *left edge* of the outer ring. This is wider than the normal wear pattern and indicates the adapter seat pads are worn. If continued in service, these adapters will cause premature bearing damage.

Figure 14
Wear Patterns on Outer Ring (Bearing Cup)
Caused by Excessively Worn Adapter

Another indication of a worn adapter is shown in Figure 14 on the *right side* of the outer ring. Note the narrow wear band (shiny edge) on the extreme end of the outer ring. Adapters worn to this extent must be removed from service.

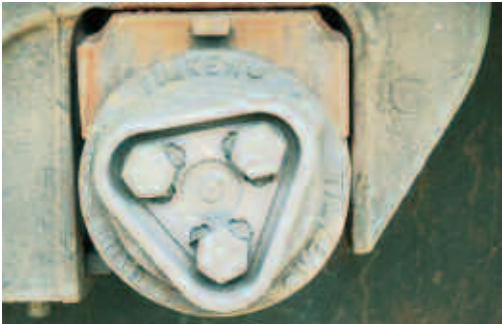
Check the adapter top for excessive crown wear by observing the frame contact with the adapter, as shown in Figure 15.

If the frame is contacting the reliefs at either end of the adapter or light is not visible through the center relief, the adapter should be removed from service.

Figure 15
Adapter in Truck Frame Pedestal

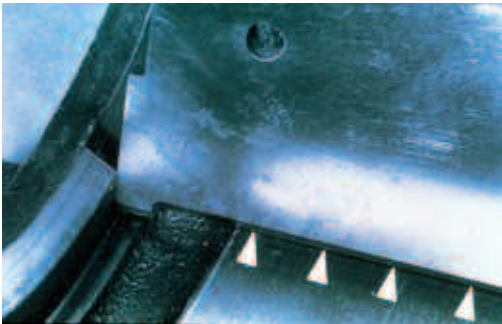
Adapters must be scrapped if they do not have 1/32" or greater depth from the bearing seats to the machined reliefs. The edge of the gage indicated by the arrows in Figure 16 must seat on the bearing seat pads. If the bearing seat pads of the adapter are worn to the extent that the toe (A) of the gage prevents the edge (B) from seating, as shown in Figure 17, at any point in the adapter, the adapter must not be returned to service.

Figure 16.
Gaging Adapter Bearing Seat Pad Wear.
Edge of Gage Contacting Bearing Seat Pad
- OK

Any time wheelsets are removed from trucks, the adapters should be inspected for damage and checked using the AAR adapter checking gage as shown in Figures 16, 17 and 19 (unless it is obvious the adapter is excessively worn or damaged).

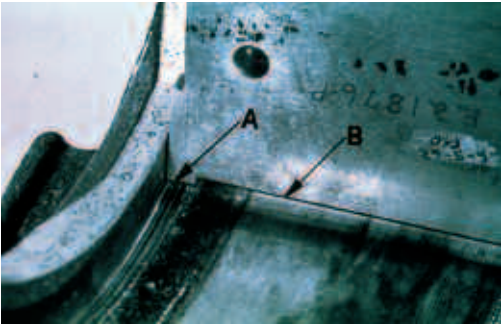
Figure 17.
Gaging Adapter Bearing Seat Pad Wear.
Edge of Gage "B" Not in Contact with
Bearing Seat Pad – Scrap

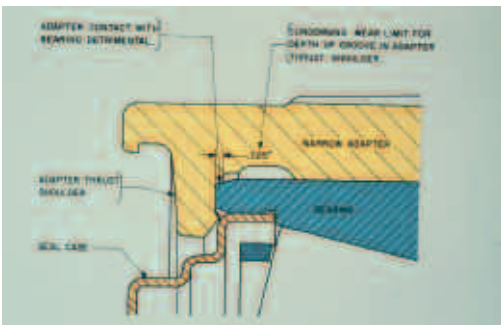
Figure 18.
How Thrust Shoulder Wear Occurs

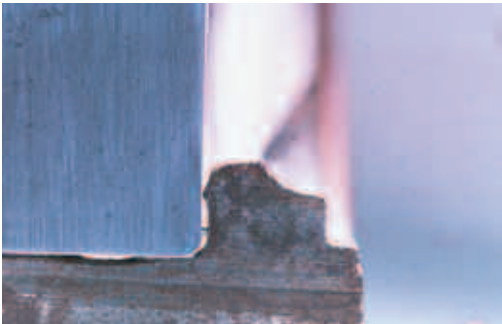
The nib of the AAR adapter gage is used to determine if the bearing outer ring has embedded into the thrust shoulder of the adapter to the condemning limit, as shown in Figure 19.

The nib of the gage should contact the thrust shoulder keeping the flat portion of the gage away from the thrust shoulder face.

Figure 19
Gaging Adapter Thrust Shoulder Wear

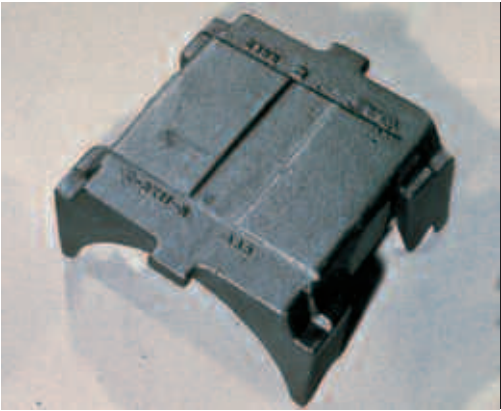
Figure 20

If the pads on the top of the adapter are worn so that the remaining depth of relief at the center of the adapter is less than 1/16", the adapter should be scrapped. The adapter reliefs are shown in Figure 20. Look for uneven wear on the top of the adapter. Uneven wear is usually the result of worn, bent or distorted side frame truck parts. Adapters with excessive uneven wear must be scrapped.

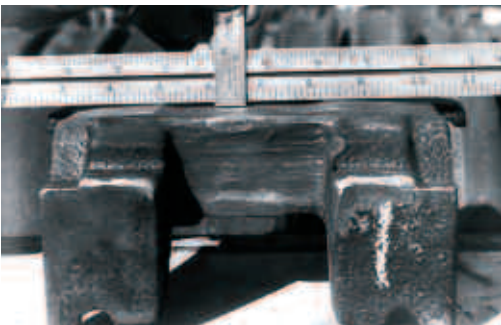
When adapters are used in truck frames that have had roof liners applied, hollow wear can occur, as shown in Figure 21. Measure the remaining depth of relief. The adapter should be scrapped if it is less than 1/16".

Figure 21
Adapter with Hollow Wear
Caused by Frame Roof Liner

Adapters that are gaged and found satisfactory for further service and have been used in frames with roof liners must always be used in frames with roof liners.
