The Development and Testing of a Full-Scale Piloted Ornithopter

J.D. DeLaurier *

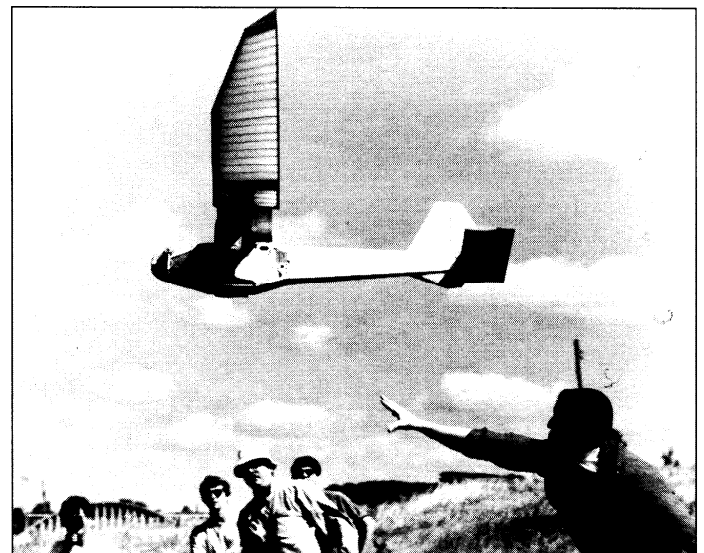
Figure 1.
Proof-of-concept model ornithopter being launched.

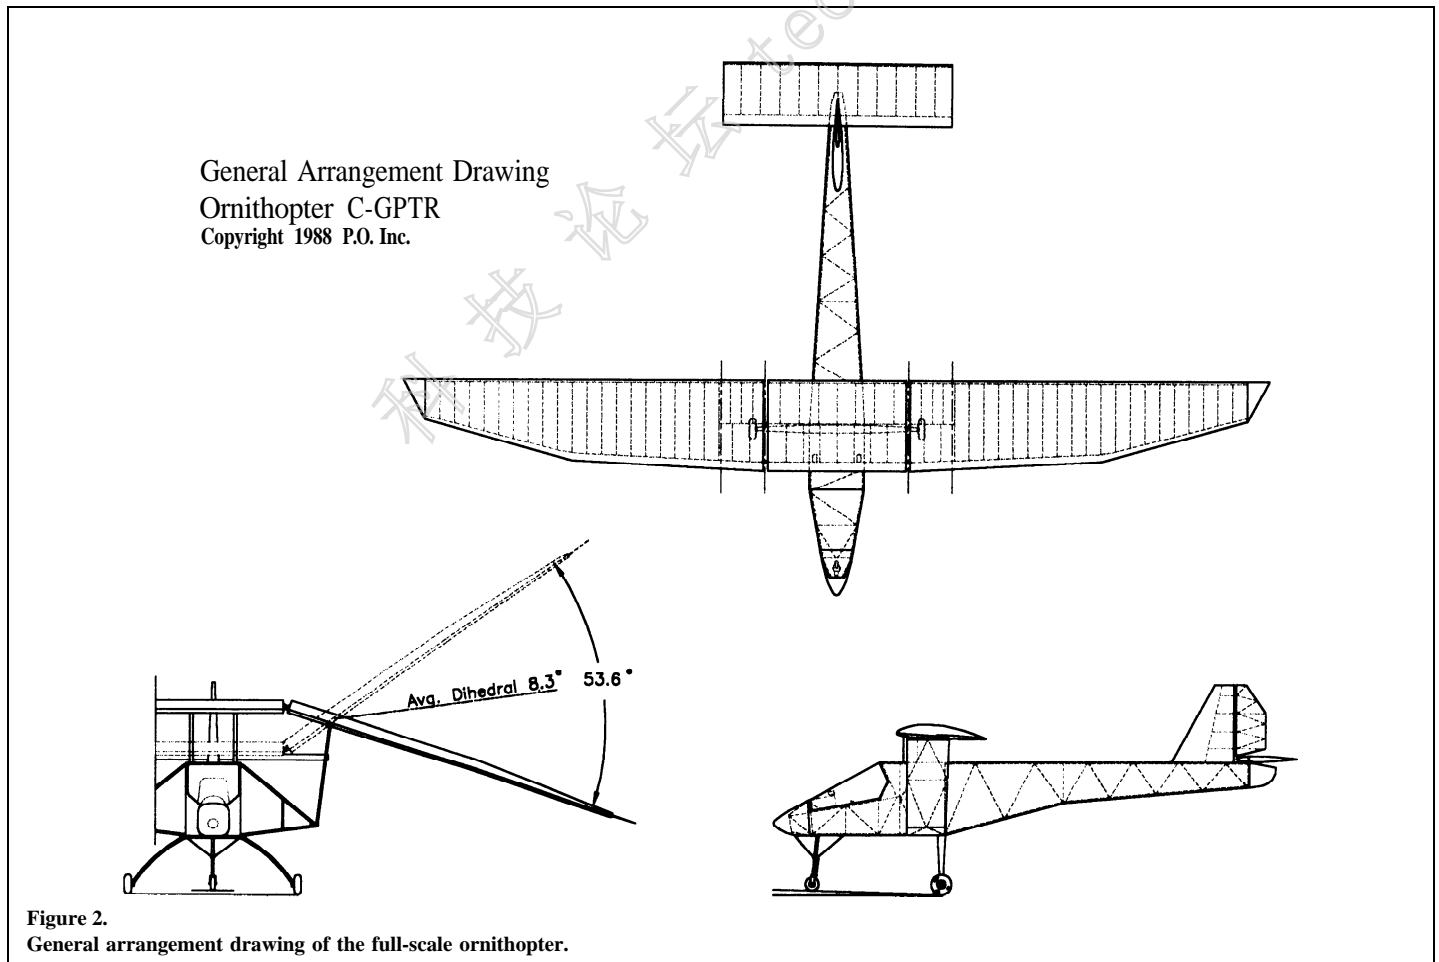
Figure 2. General arrangement drawing of the full-scale ornithopter.

A general arrangement drawing of the ornithopter is shown in **Figure 2** and photographs of the uncovered and covered craft are shown in **Figures 3** and **4**. The design process began with the goal of building a single-seater aircraft powered by a 24-hp König engine, popularly used for ultralight aircraft. It was felt that by choosing such an engine an “ultralight philosophy” would prevail, resulting in an aircraft of sufficient simplicity and compactness to be achievable with a small team and a limited budget. At the same time, it was desired that the structure should meet Chapter 549 load criteria which requires the ability to experience 3.8 g before failure occurs. The consideration was that if the ornithopter had commercialization potential, it should have the operational robustness of a general-aviation airplane. As will be described, these goals were successfully achieved with an aircraft that is approximately four times bigger (in linear dimension) and 76 times heavier than the proof-of-concept model. In particular, its overall as-built characteristics are:

As seen in **Figure 2**, the wing has an average positive dihedral angle because its maximum upstroke angle is larger than its downstroke angle. In fact, this effective dihedral is more than the arithmetic mean if one does a time averaging of the dihedral angles through the flapping cycle. From the excellent turning performance of the proof-of-concept model, it was clear that yaw-roll coupling works well as a means for directional control.

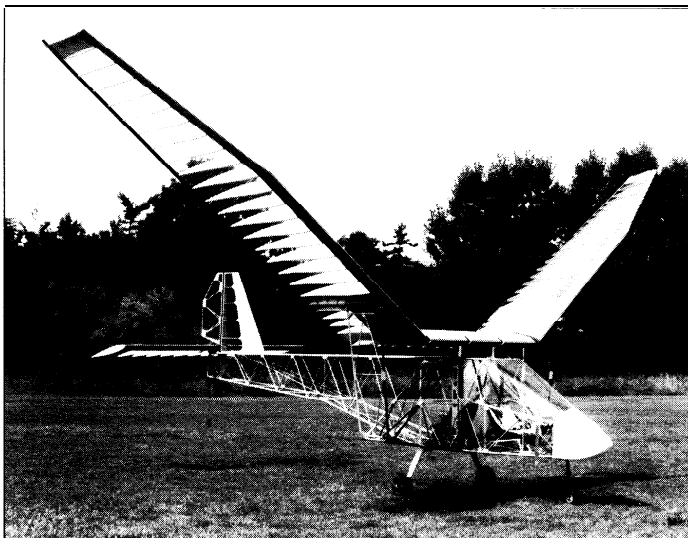
Figure 3.
Full-scale ornithopter before covering.

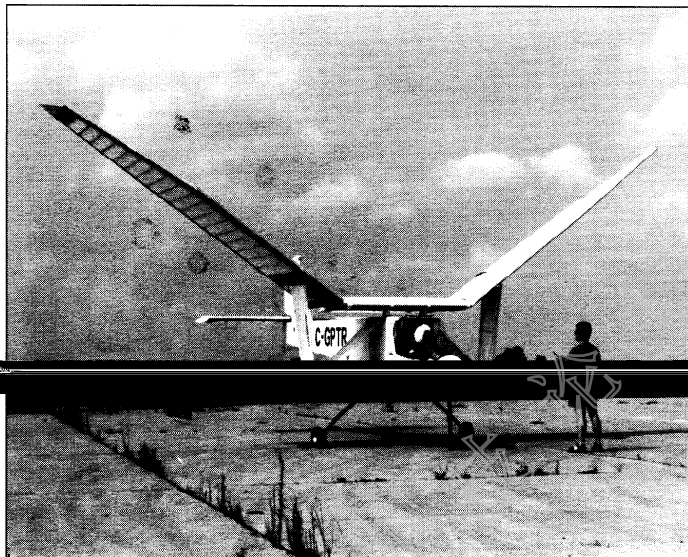
Figure 4.
Completed full-scale ornithopter, 1997.

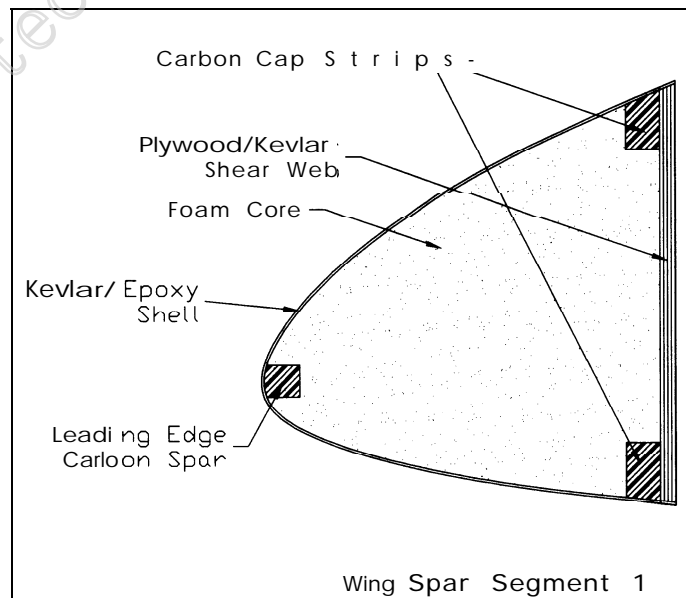
The spar construction is shown in Figure 5, consisting of a “wet lay-up” of Kevlar cloth and epoxy over a leading-edge shaped structural-foam core backed with a carbon-fibre reinforced shear web. The ribs are cut from 1/2-inch wide sheets of structural foam and capped with basswood strips. These are glued to the shear web; and the trailing edges are unidirectional carbon-fibre strips. The finished wing, before covering, is shown in Figure 6.

Figure 5.
Cross-sectional construction of the wing spar.

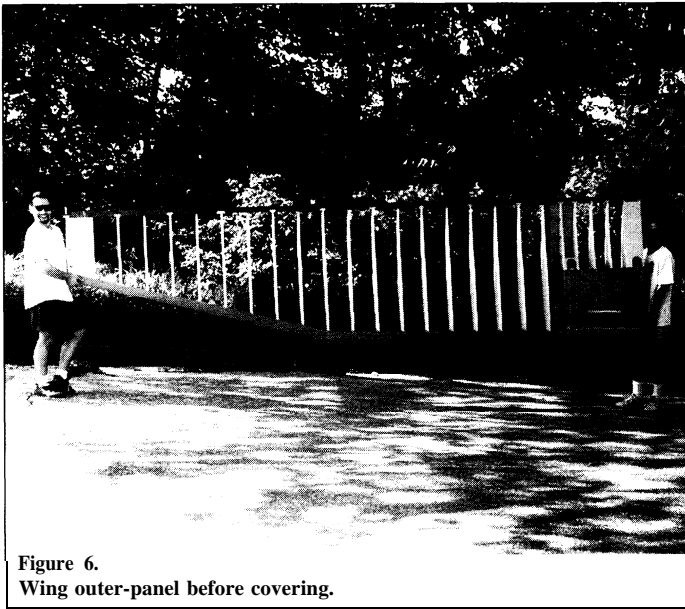
Figure 6.
Wing outer-panel before covering.

As seen in **Figure 6**, the structure of the wing outer panels is open between the ribs until the very last portion near the tip, which was covered (top and bottom) by 1/32" plywood full-chord sheets. These provided a spanwise-rigid surface upon which the tensioned fabric is anchored and also served the purpose of allowing the shearflexing action to carry through. That is, the trailing edges of the sheets are not constrained, relative to one another, in the spanwise direction.

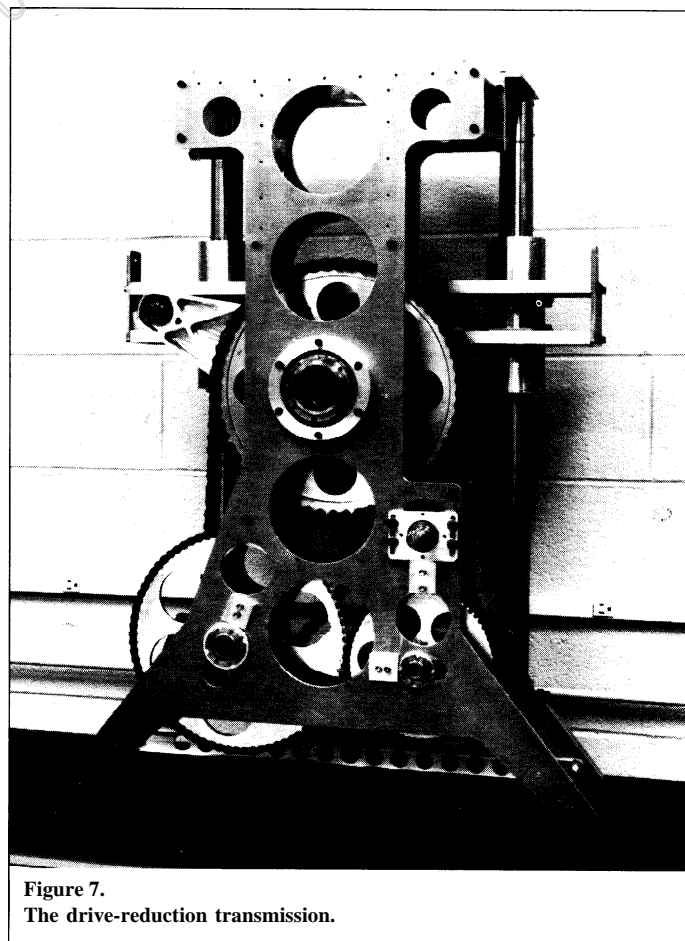
As mentioned before, the ornithopter is powered with a König 3-cylinder, 2-cycle, radial engine that produces 24 hp at 4000 rpm. The drive-reduction unit, shown in **Figure 7**, was designed to efficiently transmit this power to the wings in order to flap at a maximum frequency of 1.2 Hz. Its drive ratio of 60 to 1 is achieved with a three-stage reduction using chains and sprockets, terminating in a Scotch-yoke mechanism to convert the rotary motion to oscillatory motion driving the vertical pylons upon which the centre panel is mounted (**Figure 2**).

Figure 7.
The drive-reduction transmission.

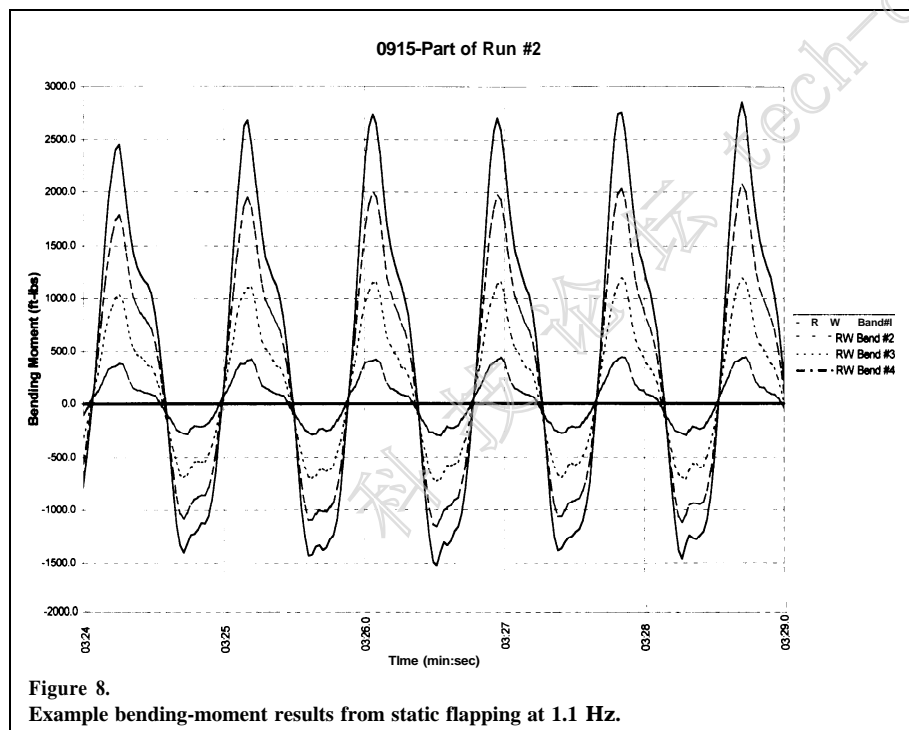
The methodologies for acquiring bending and twisting-moment data are discussed, in detail, in Reference 8; and an example plot (from a 1997 test) is shown in **Figure 8**. The acquisition of this data was important for every test throughout the program, both static and taxiing. The reduction of the most recent readings is now the subject of a forthcoming M.A.Sc. thesis, from which it will be possible to compare the experimental loads with those predicted from analysis.

Figure 8.
Example bending-moment results from static flapping at 1.1 Hz.

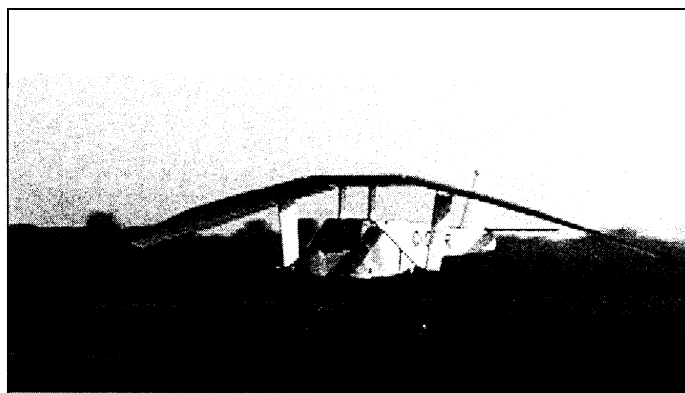
After some additional minor repairs, as well as increasing the nose-gear tire pressure, the aircraft returned to the runway on 15 Sept. The intention of these tests was to explore the effect of applying a certain amount of negative stabilator angle (trailing-edge up) so as to lighten the load on the nose wheel. On this occasion, the aircraft accelerated to a speed of approximately 40-mph and the applied stabilator caused a series of controlled bounces of increasing amplitude until the pilot throttled back. This was not sustained flight because the aircraft only rose during the downstroke of the wing and would touch down during the upstroke (**Figure 9**).

Figure 9.
15 September 1997 taxi trial.
