672-- Man at steam pump in a N.Y. power-house
An Industrial design
By Lewis W. Hine- 1920

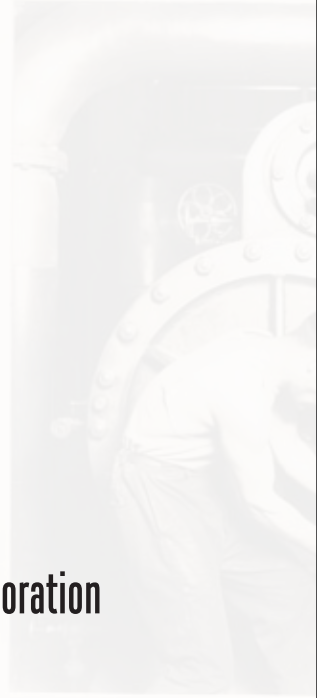
672-- Man at steam pump in a
An Industrial design
By Lewis W.

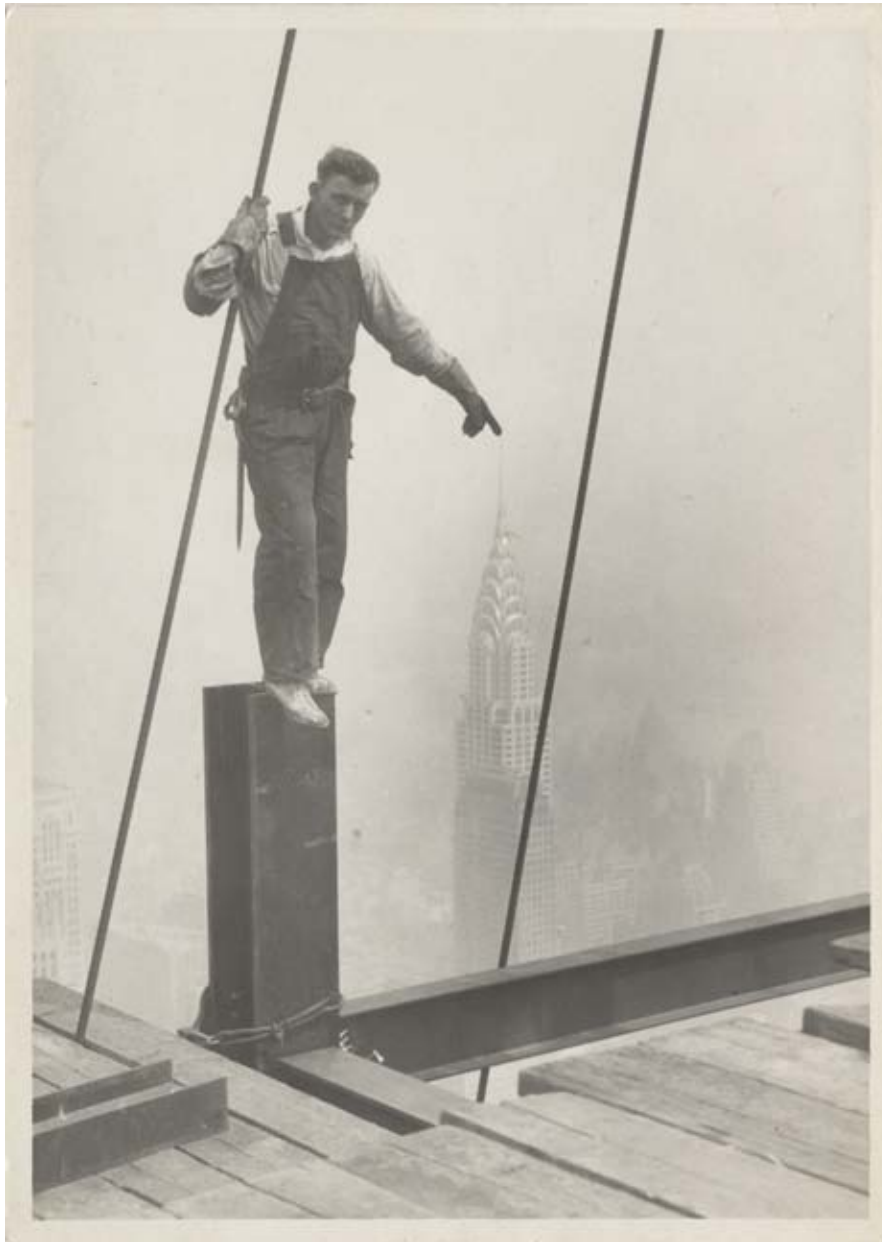
INFO@GAWAINWEAVER.COM

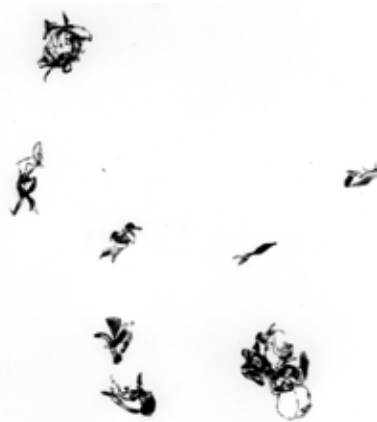
The color of silver also changes when it reacts with chemicals in its environment to form new compounds such as silver sulfide. This can occur intentionally during toning, or over time, as the silver image reacts with chemicals in the air, such as hydrogen sulfide. When this process occurs over time, the silver grains tend to disperse into smaller particles causing image fading. In contrast, toning causes an immediate reaction that better maintains the image particle size. The particles are made more robust by partially converting them to silver sulfide or by partially replacing the silver with a less reactive metal such as gold.

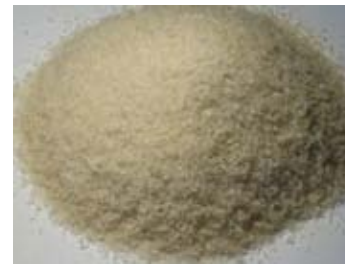
However, yellowing can become visible as the gelatin ages. Chromophores—portions of a molecule that are responsible for color—can develop in gelatin as it interacts with its environment. A primary cause of such yellowing is contact with poor quality paper materials. These contain lignins and other components that have been shown to produce yellowing when in proximity to a photograph. This is one of the reasons why high-quality enclosures are recommended for the storage of photographs, particularly those that have passed the Photographic Activity Test.

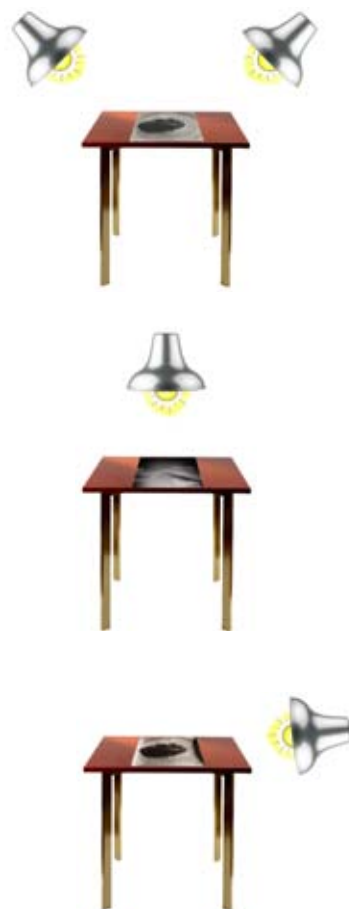
Before we discuss the types of deterioration, we must first consider the act of examination, and some of the basic vocabulary that we use in describing the parts of an image. The importance of looking cannot be overemphasized in the understanding of print deterioration. Proper lighting will reveal aspects of a print that cannot otherwise be seen.

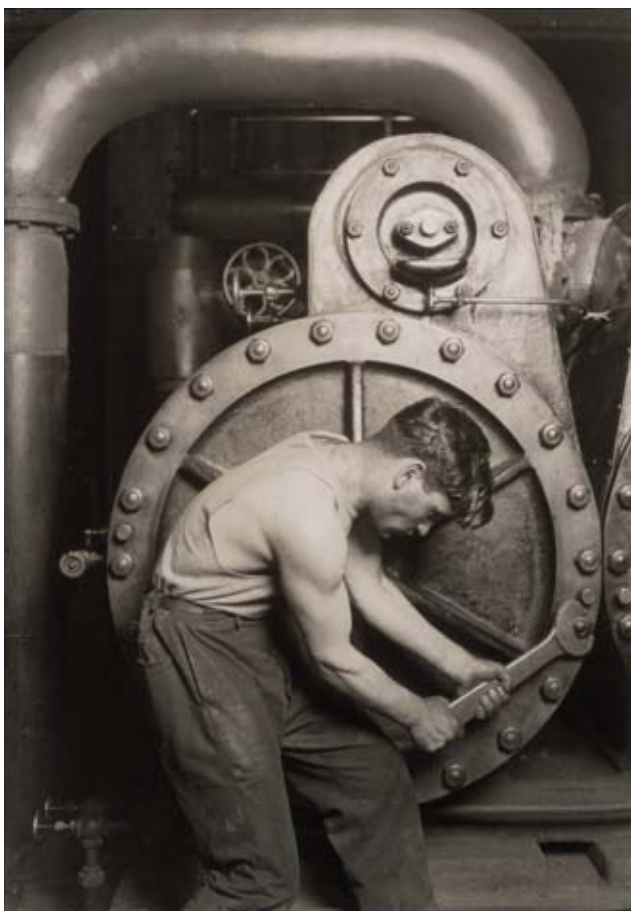
THE BASICS OF DETERIORATION

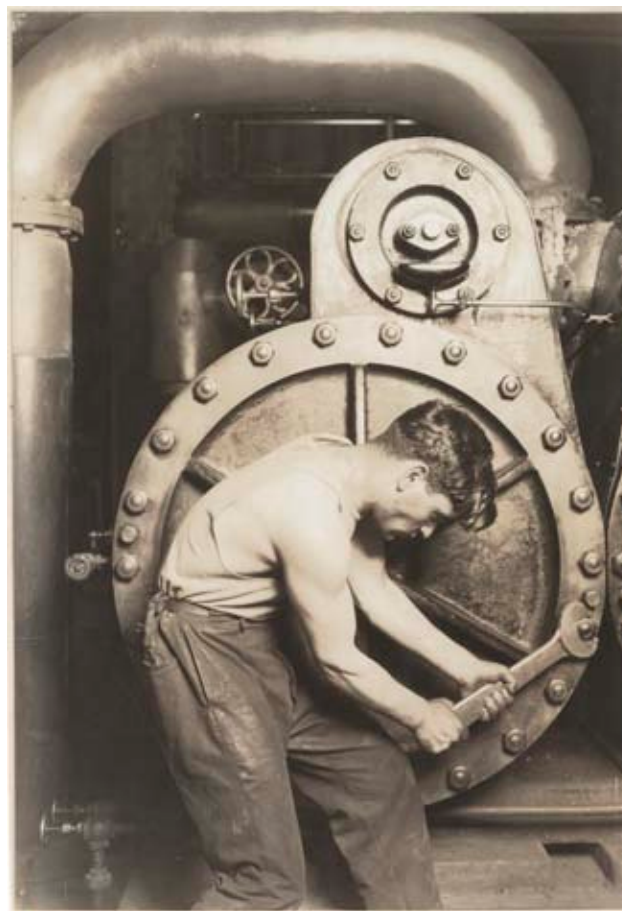
ance, and their descriptions can be found at the end of the guide (pages 22–39). Sometimes deterioration can have more than one possible cause. You can use the deterioration charts (see pages 16–17) to locate the Pathway that you are curious about, or just use the references in the text to find the right one. Each Pathway (labelled P1–P16) is identified here in parentheses, e.g. (P3).

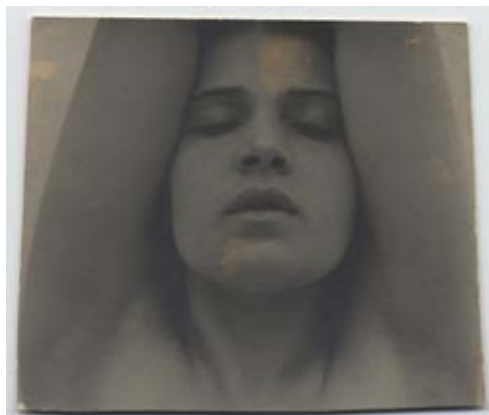
contact with poor-quality storage materials (P7 and Sidebar 2). Also closely related to faulty processing are chemical stains and other localized image deterioration caused by contamination from chemicals or fingerprints (P8 and Figure 19).

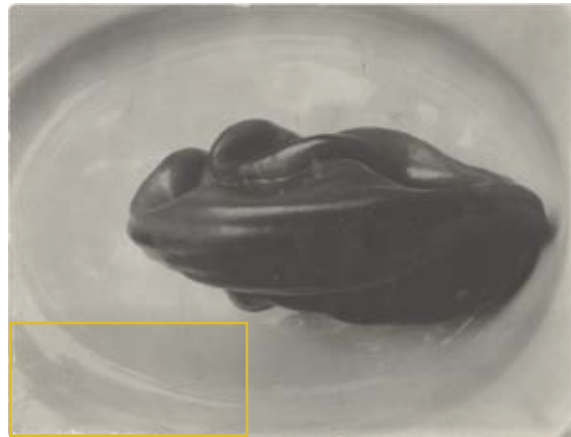
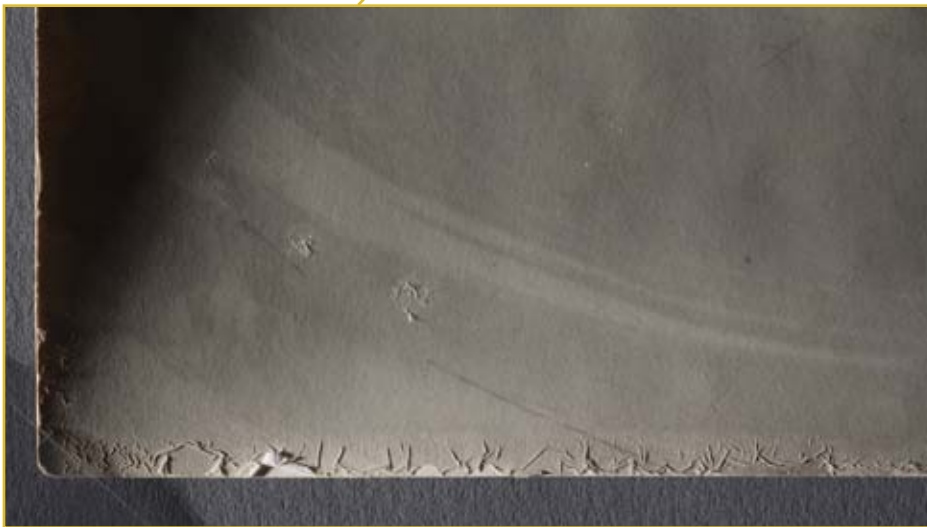
danger of the gelatin detaching from the baryta layer, particularly at the edges (Figure 21). This is known as frilling at the edges, or blistering on the surface of the print. Frilling and blistering may occur during processing of the print as well, particularly during extended times in processing solutions or when processing baths are at higher than normal temperatures (P9). Exposure to water may also cause tide lines and other water-related stains both in the gelatin and in the paper, which may be very difficult to remove (Figure 22 and P10). A change in the surface gloss is very likely when a print is wetted, particularly if the print dries against another surface, such as a piece of glass. When this happens, the gelatin print conforms to the glass and assumes its high gloss surface. This is known as ferrotyping (P11).

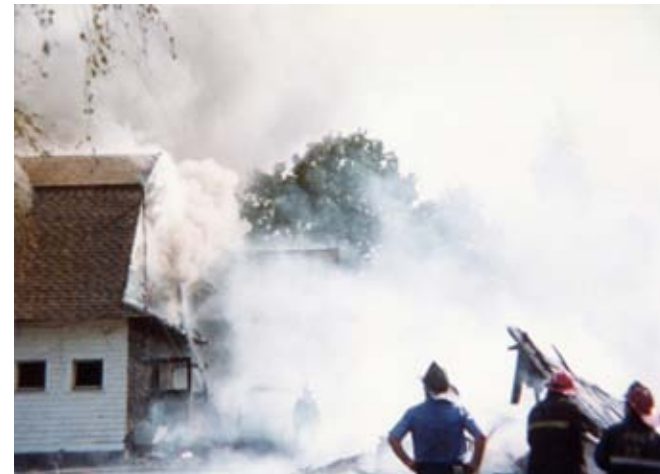
Figure 24: Fires often lead to water damage to photographic prints, such as in this fire on the grounds of George Eastman House, May 29, 1978. (Courtesy George Eastman House)

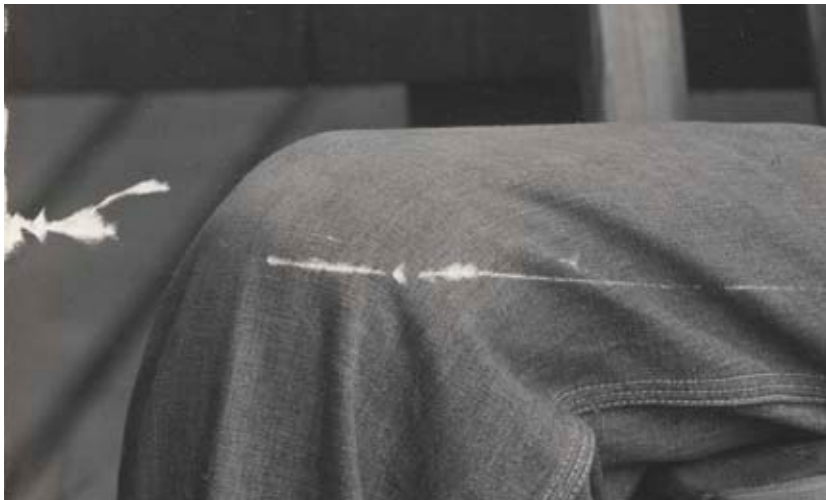
The surface of the photograph is also quite vulnerable. For example, loss of binder by scraping may occur if a photograph is stored unprotected in a drawer that is too full (Figure 25 and detail). Other damage, such as minor surface abrasions, tears, and creases all fall into this category, and they can make a significant impact on the viewing of a print.

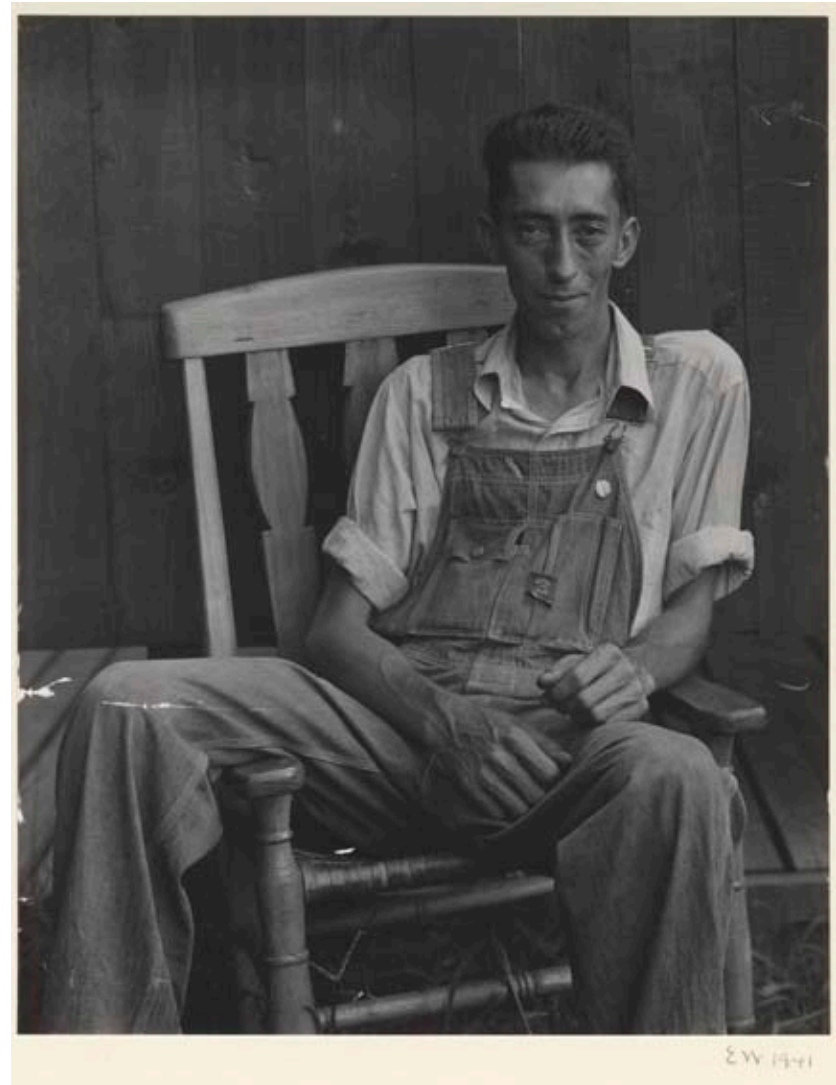
Figure 25 (and detail): Edward Weston, *Dillard King, Monteagle, Tennessee*, 1941. The detail highlights mechanical damage to the print, with complete loss of image and exposure of paper fibers in the damaged area. (Courtesy George Eastman House, Acc. No. 1966.0070.0055; ©1981 Center for Creative Photography, Arizona Board of Regents)

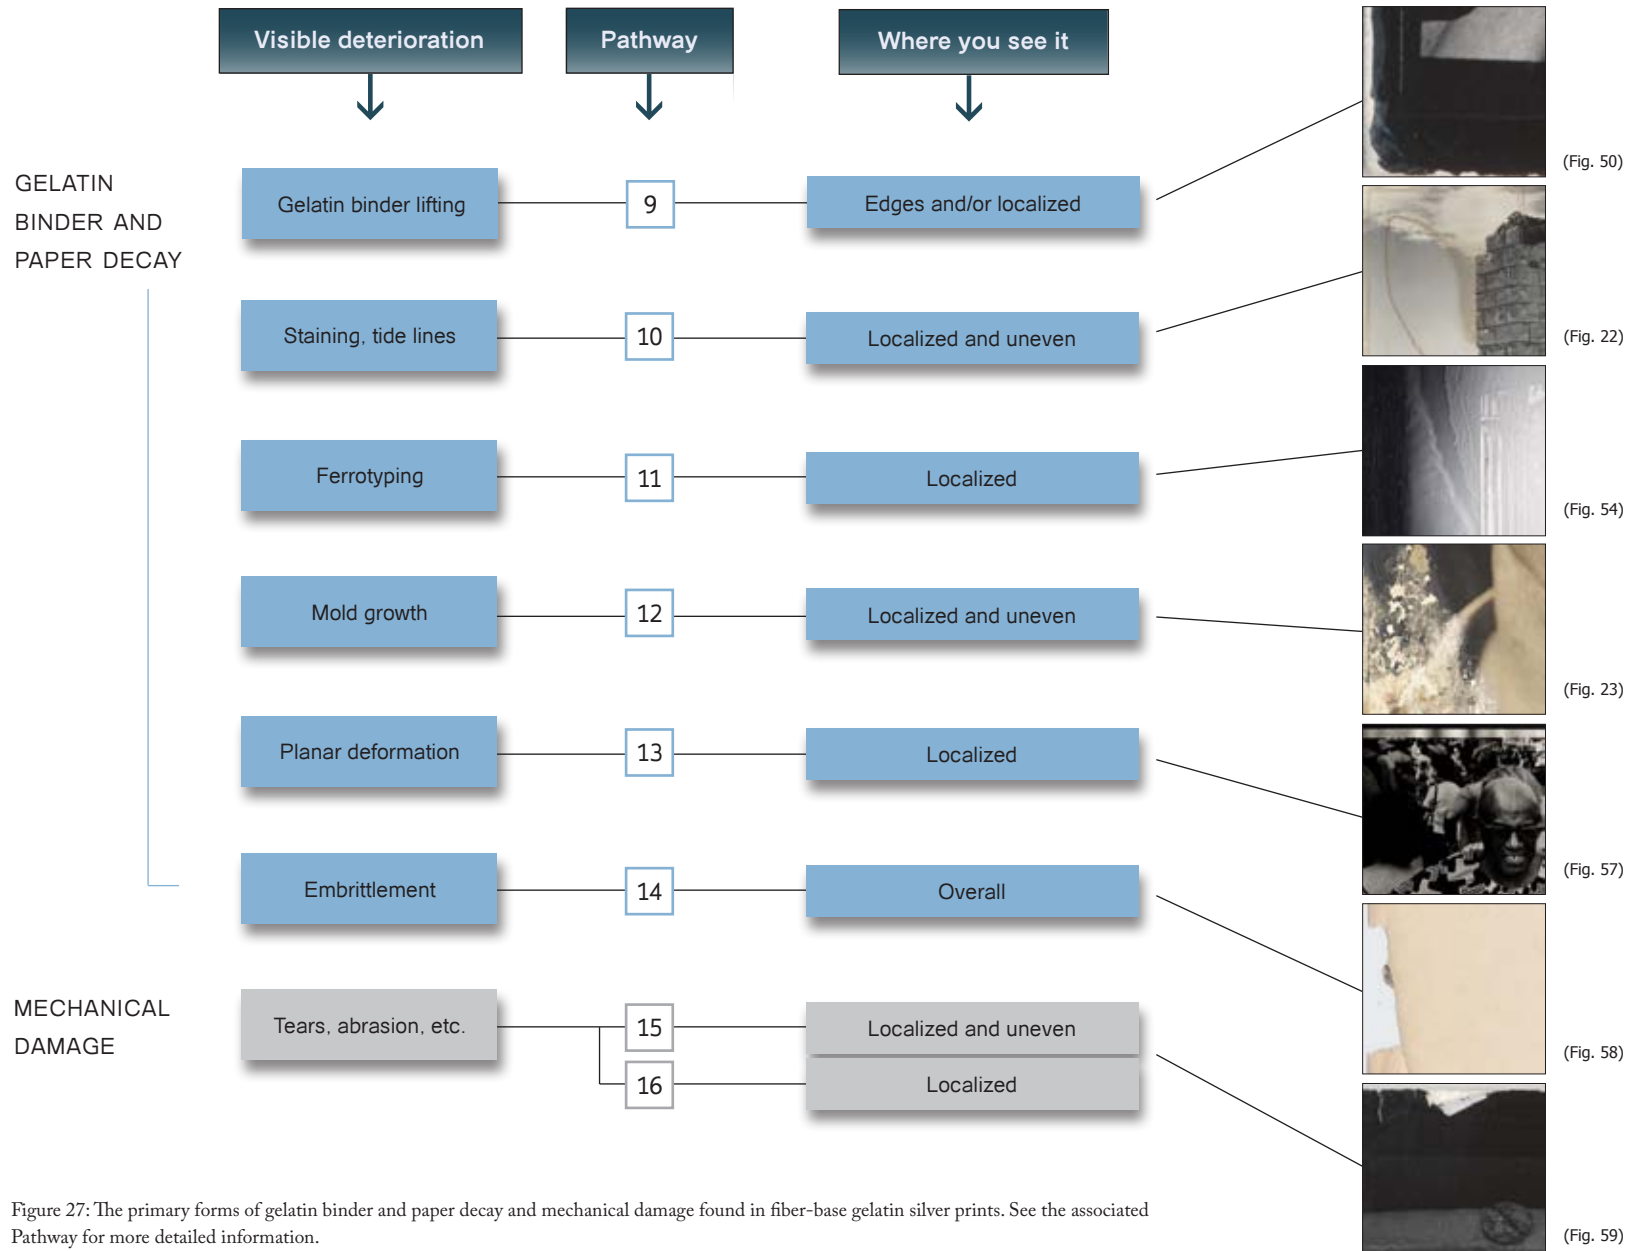
Figure 27: The primary forms of gelatin binder and paper decay and mechanical damage found in fiber-base gelatin silver prints. See the associated Pathway for more detailed information.

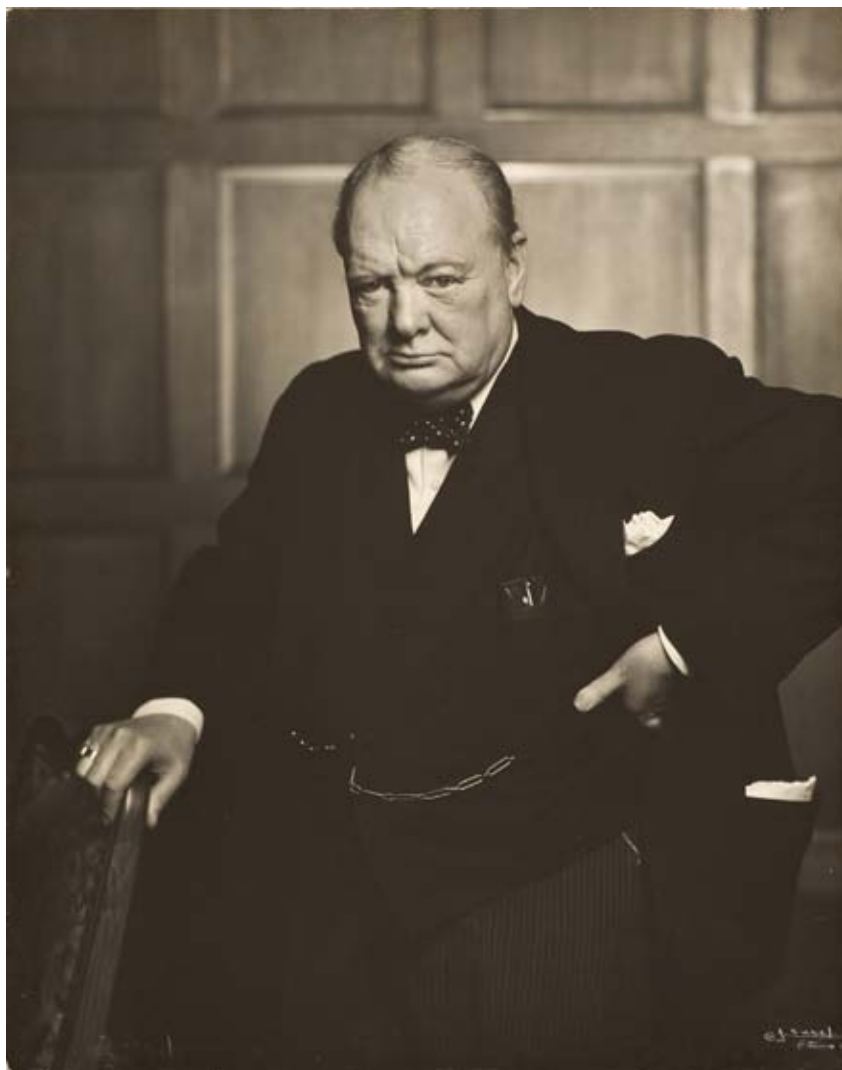
Figure 28: Yousuf Karsh, *Winston Churchill*, 1941 (© Yousuf Karsh)

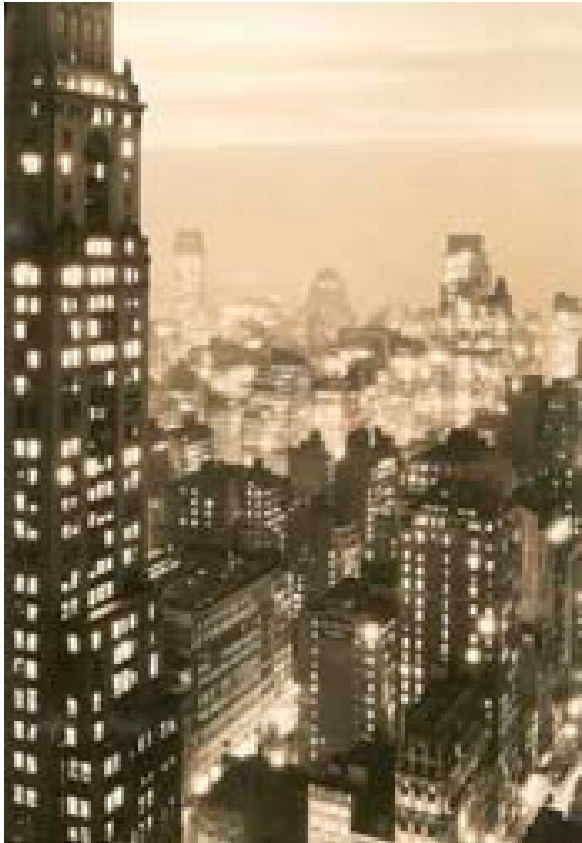
it was printed in the 1930s is irrelevant. Of course, the print is highly valued in the fine art market.

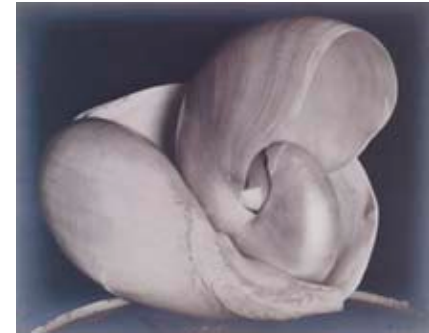
On April 7, 1998, an early Edward Weston print depicting two shells was sold at auction at Sotheby's New York (Figure 30). A full page reproduction and extensive description in the auction catalog highlighted its importance. A unique feature of this print was the halo of mirroring that emanated from the edges, surrounding the shells, and seeming to assure the print's authenticity. It sold for \$101,500 (with premium)—a very strong price at the time.

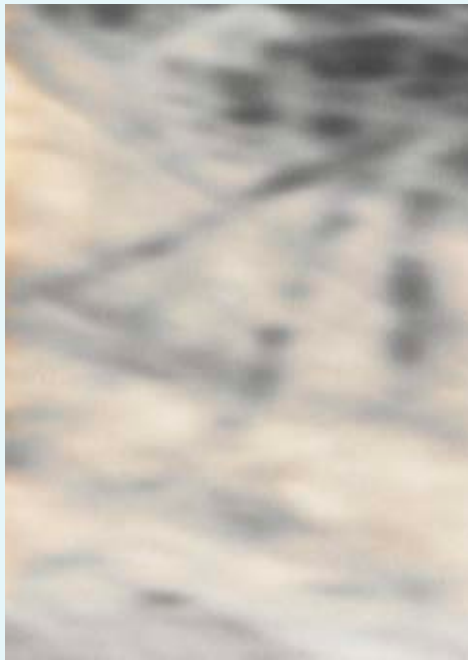
that results from exposure to peroxides causes the silver to appear yellow/orange in color.

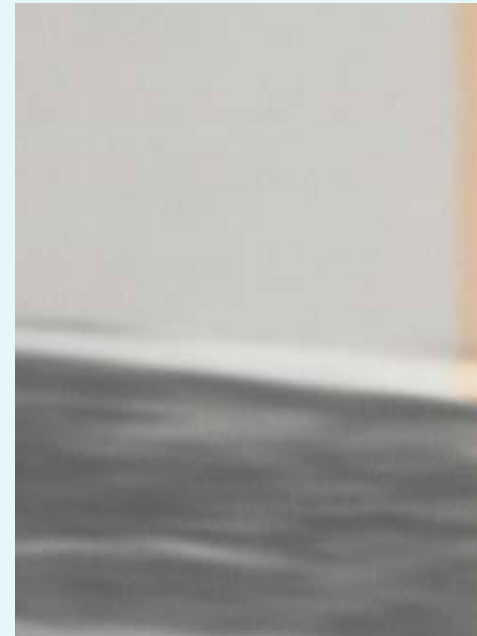
P2: SILVER-MIRRORING, EDGES

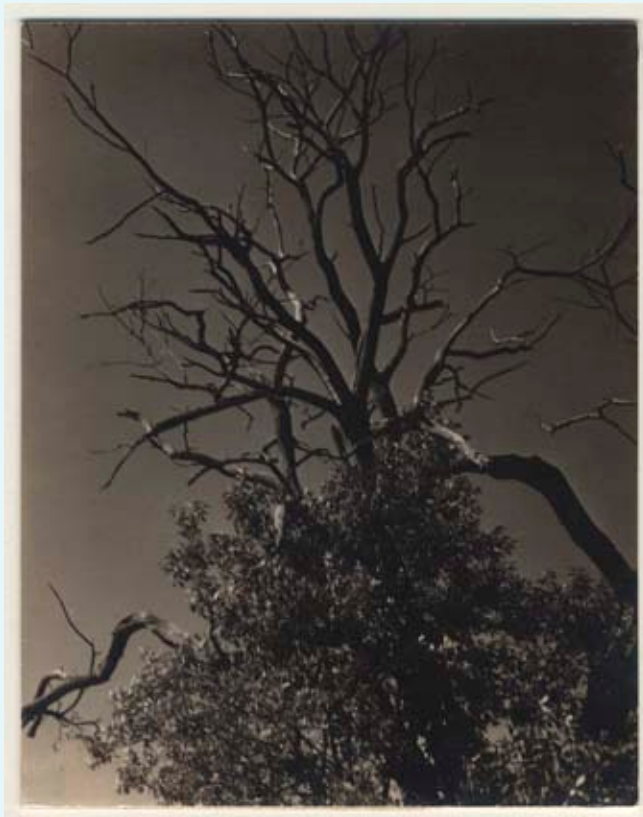
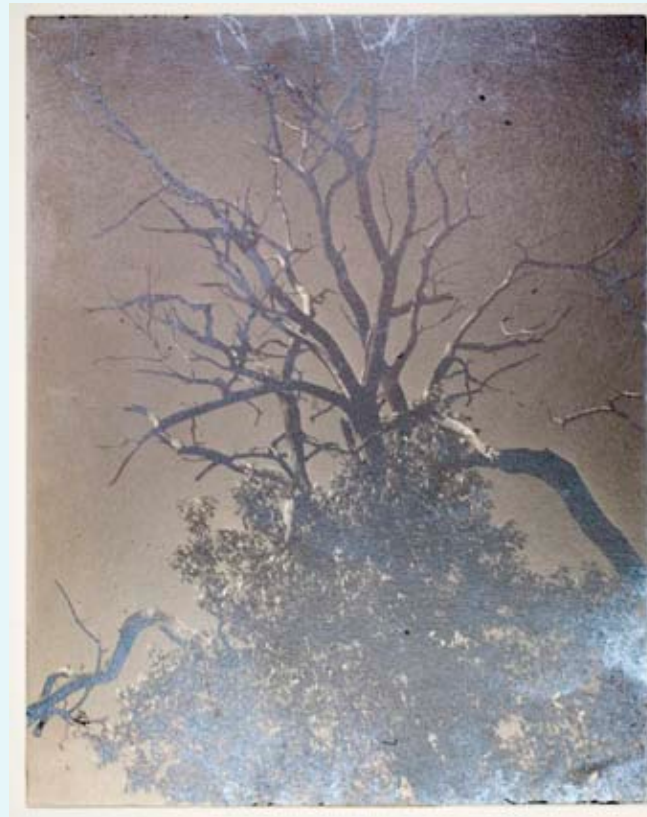
Left
Figure 35: Alfred Stieglitz, *Lake George*, ca. 1930

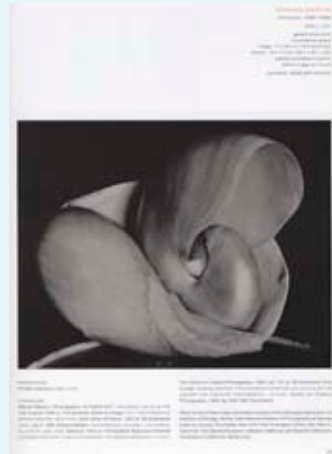
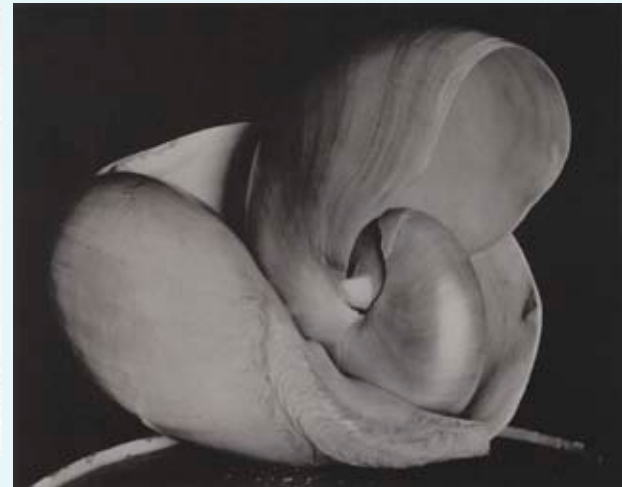
Below
Figure 38: Edward Weston, *Shells*, 1927. Shown here as reproduced in the Phillips auction catalog, April 23/24 2004, the print no longer exhibited any silver-mirroring. (Reproduced by permission of Phillips de Pury & Company)

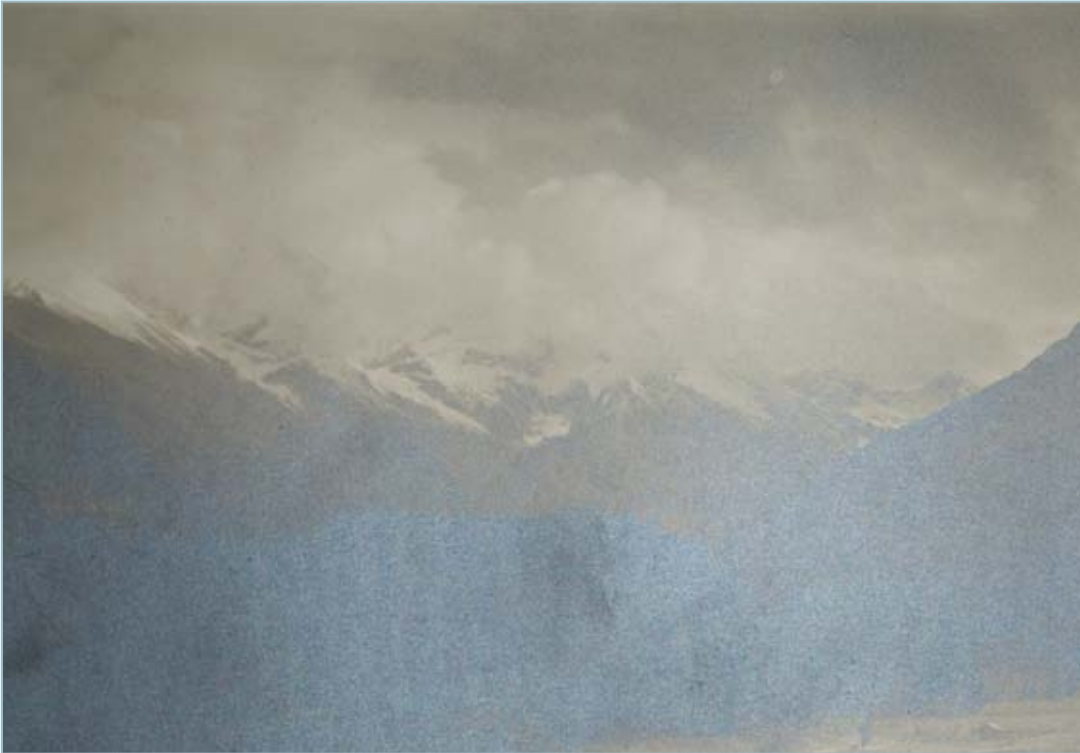
Figure 39: A gelatin silver print from Albert Mebes' 1913 *Der Bromsilber- und Gaslichtpapier-Druck*. Overall silver-mirroring has resulted from contact with the book's paper that contains unpurified wood pulp.

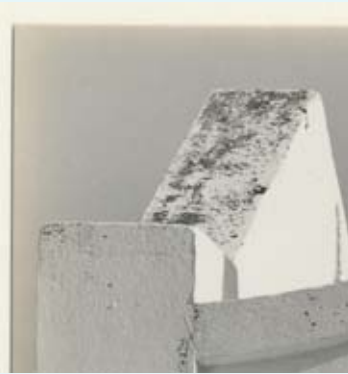
Yellow/brown discoloration and fading occurs along the edges of a print for two reasons: air pollutants or storage materials. Air pollutants will cause edge discoloration due to concentration gradients in the air surrounding the print, while a window mat may expose only the edge of the print to the deteriorating effects of a poor-quality matboard. This discoloration and fading is often limited to the highlights and midtones, while the shadows remain unaffected, or exhibit some silver-mirroring. Yellow/brown discoloration and fading can be clearly seen on the edges of Edward Weston's print, *St. Roche Cemetery* (Figure 40).

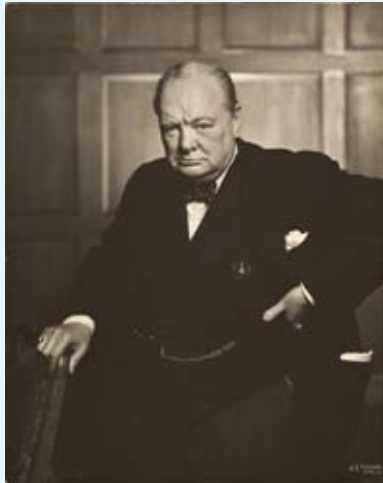
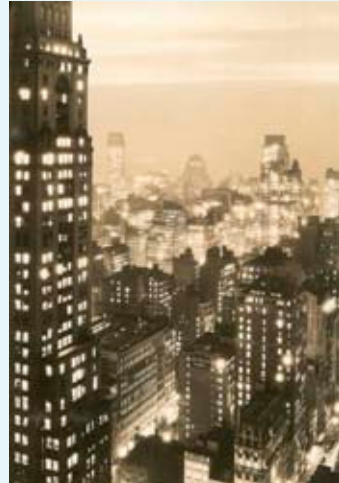
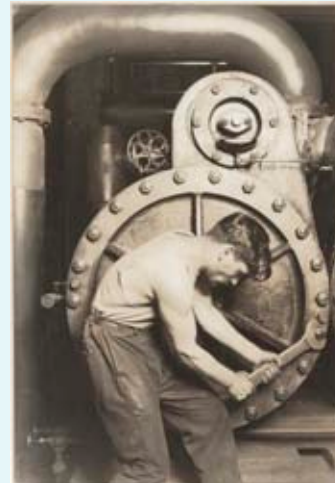
Yellow/brown discoloration and fading, as described in Pathway 4, may also occur over the entire image after prolonged exposure to air pollutants in the presence of water (i.e. high RH will accelerate deterioration). It can also be caused by contact with poor-quality storage materials or by faulty processing. However, these two causes may also create yellowing in the non-image areas (P7).

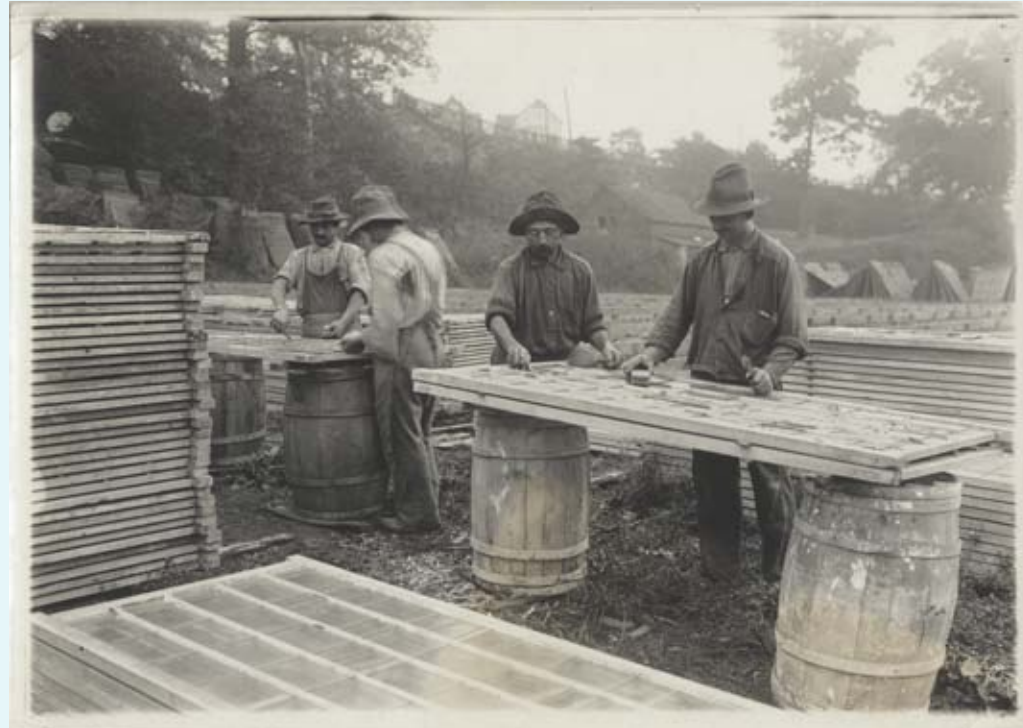
Figure 44: Lewis Hine, *Preparing hot-house frames, truck garden, NY state, ca. 1920*. This print is an excellent example of poor processing that leads to image discoloration. It appears that another print was in partial contact with this print during fixing or washing, as evidenced by the right-angle shape of the discolored area. (Courtesy George Eastman House, Acc. No. 1978.1000.0004)

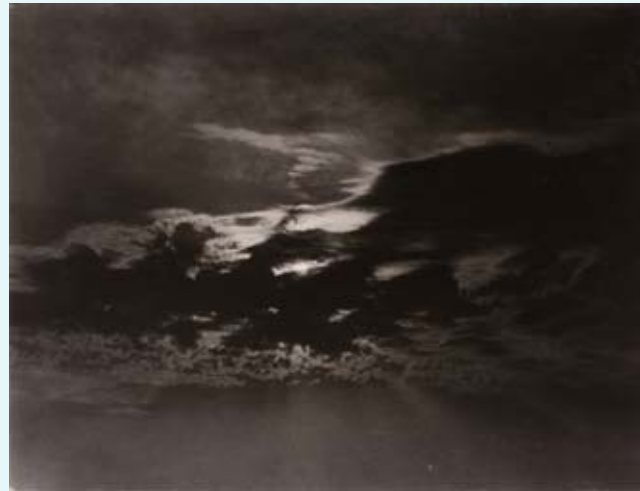
Yellowing of non-image areas can occur for two reasons: faulty processing and contact with poor-quality storage materials. Although the visible result can be similar, the two forms of yellowing are very different in nature.

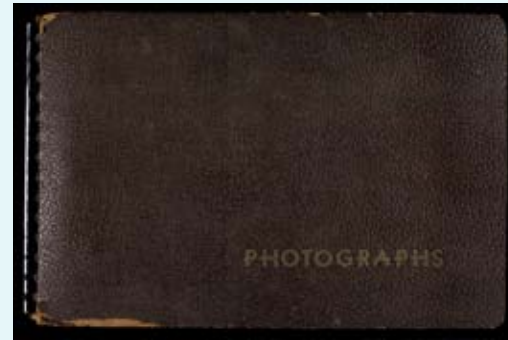
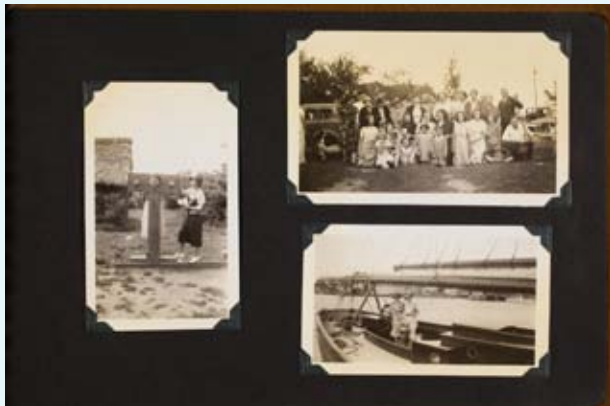
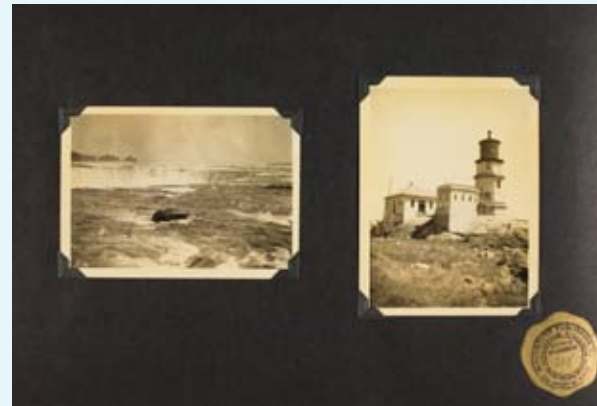
Figure 47: The gelatin silver prints on the first and last pages of this photograph album exhibit strong yellow staining of the gelatin as a result of their close proximity to the covers, which were made with lignins-containing board. Pictured here are the front cover (top), a page near the middle of the album that was not strongly affected by the covers (left), and the last page that was in contact with the back cover (right). (Courtesy Katharine Whitman)

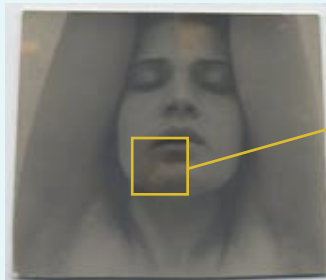
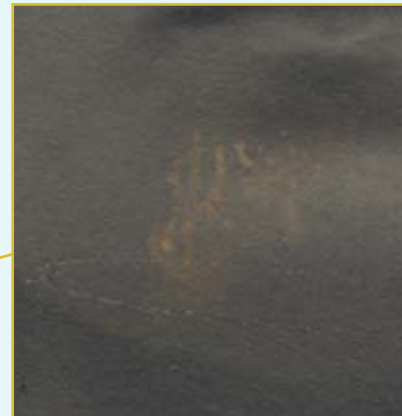
Figure 48: Edward Weston, [Tina Modotti], ca. 1925. This detail shows a silver sulfide stain caused by touching the print surface with fingers contaminated with processing chemicals such as fixer. (Courtesy George Eastman House, Acc. No. 1974.0061.0141; ©1981 Center for Creative Photography, Arizona Board of Regents)

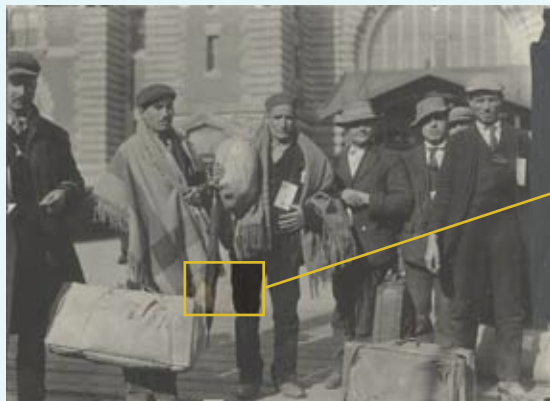
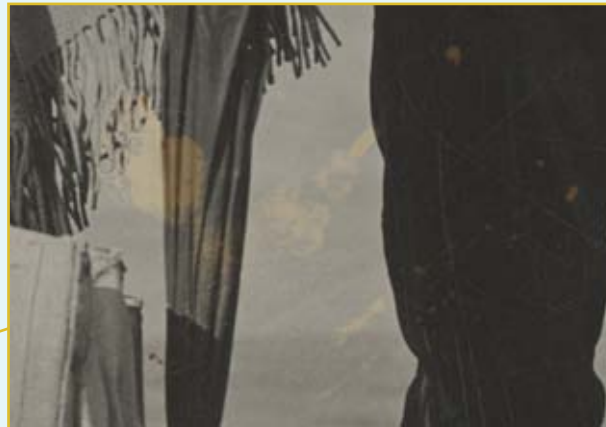
Figure 49: Lewis Hine, *From Sicily*, ca. 1905. Silver sulfide stains caused by what appears to be contamination by processing chemicals. (Courtesy George Eastman House, Acc. No. 1977.0177.0007)

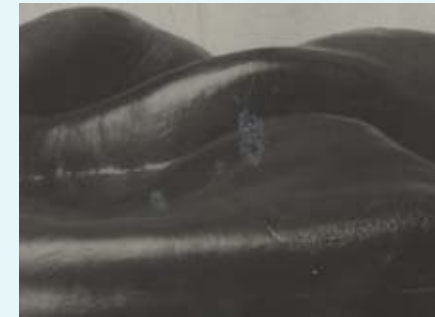
Figure 51: Edward Weston, *Pepper*, 1930. This print appears to have been damaged in a disaster. Details show frilling along the edges and blistering near the center of the print (see also Figure 21). (Courtesy George Eastman House, Acc. No. 1970.0162.0004; ©1981 Center for Creative Photography, Arizona Board of Regents)

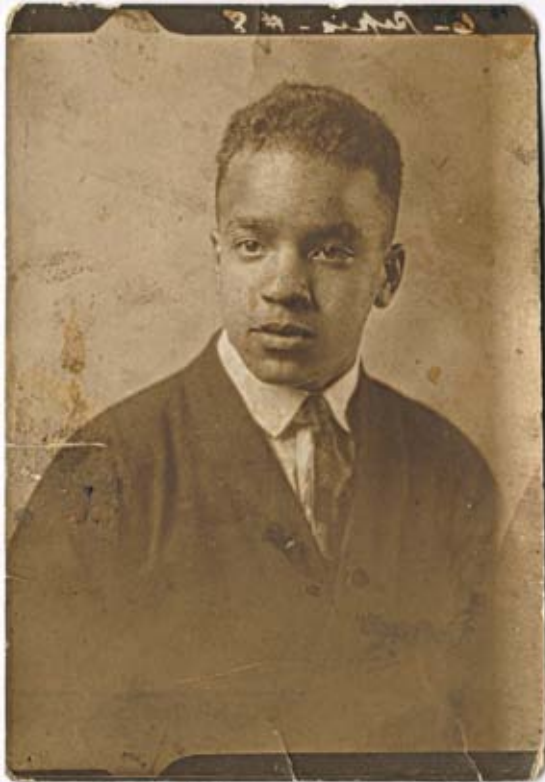
When a gelatin silver print is immersed in water, stains may be caused by the transfer of colored substances from nearby materials. This could be brown organic matter from paper materials made from unpurified wood pulp, or the bleeding of ink stamps or writing from the back of the print. This most often occurs as a result of water damage from floods or the extinguishing of fires (see Figure 22 and Sidebar 5).

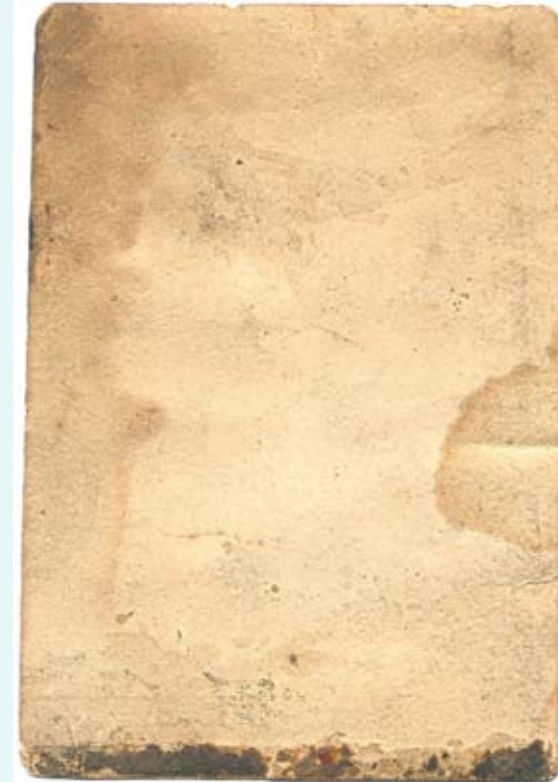
P11: FERROTYPING AND OTHER SURFACE CHANGES

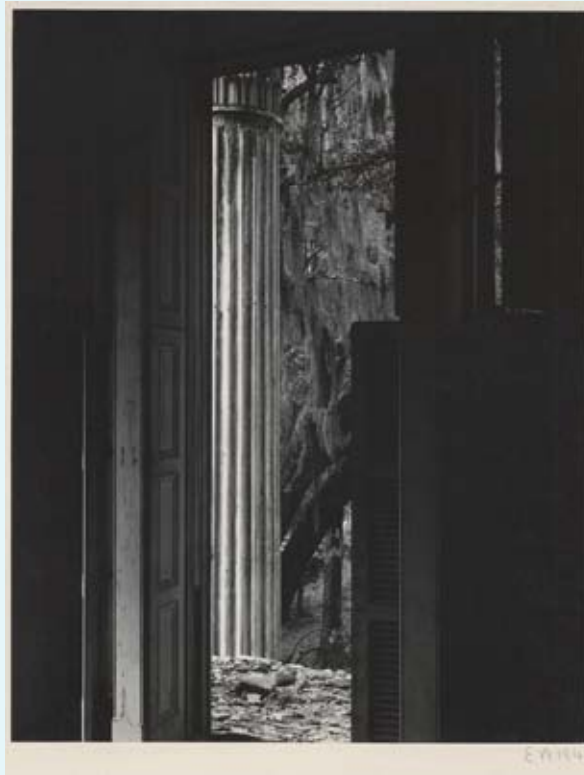
Ferrotyping is not only a technique used to produce a high gloss on fiber-base prints. It also refers to a form of print damage, when a print is exposed to water or a high relative humidity while in contact with a smooth surface. The gelatin swells and reforms in the shape of the surface it is contacting. A common example is when framed photographs are pressed against their protective glass and either accidentally exposed to water or exposed even briefly to a warm and humid environment. These types of surface changes are most easily observed in specular light, as can be seen in the images of an Edward Weston print in normal (Figure 53) and specular lighting (Figure 54).

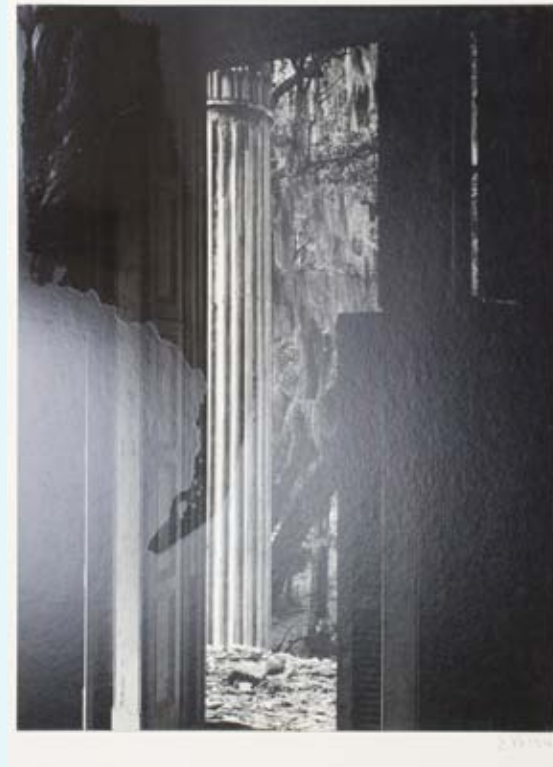
Figure 53: Edward Weston, *Belle Grove Plantation House, Louisiana* [open window], 1941.

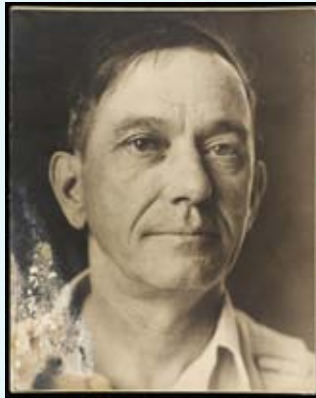
The properties of gelatin as it interacts with water make it an ideal photographic binder, but as we have seen, it also makes it susceptible to damage by water. As a hygroscopic protein, gelatin is also an excellent medium for biological growth.

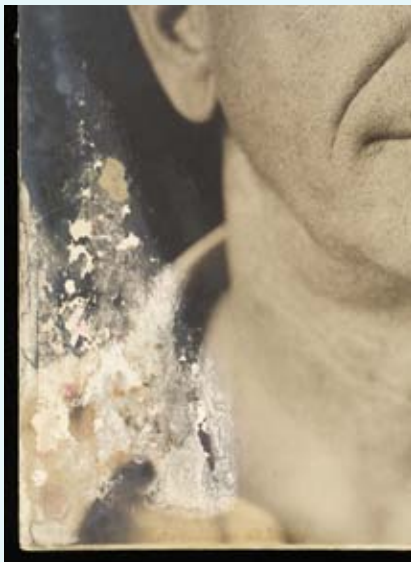
Left
Figure 55: Lewis Hine, [Portrait of worker, Empire State Building], ca. 1931. Water-damaged photographs often exhibit severe mold damage and consequent staining and loss of emulsion.

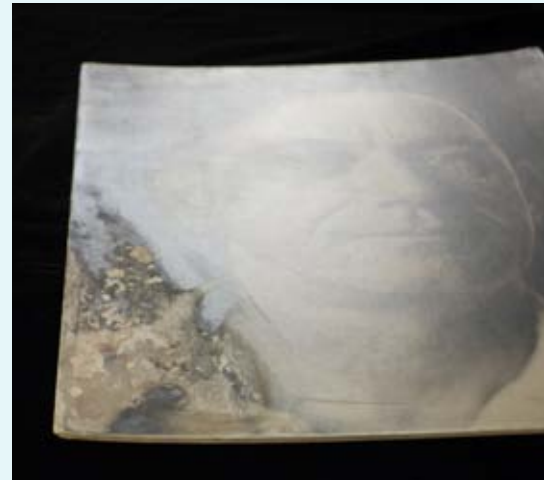
The growth of mold weakens the gelatin, but it will also likely create stains that will be very difficult to remove, since treatment in water becomes difficult once the gelatin has been weakened. The colors of mold vary, and black and red stains are commonly found on mold damaged photographs (Figure 55). Mold damage to the gelatin binder will always result in a loss of gloss in the print surface, most noticeable in specular lighting (Figure 56).

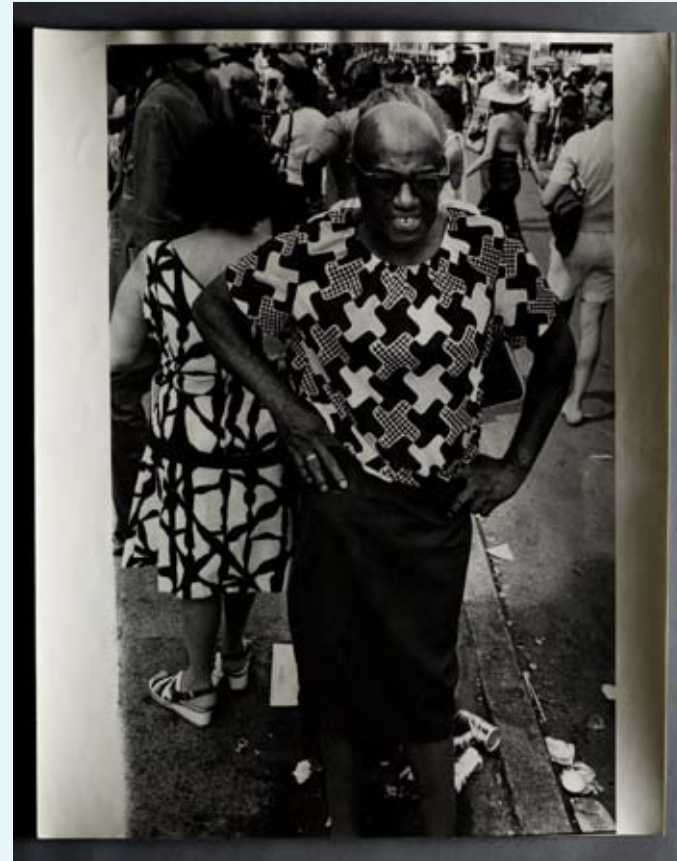
P14: *EMBRITTELEMENT OF THE PAPER SUPPORT*

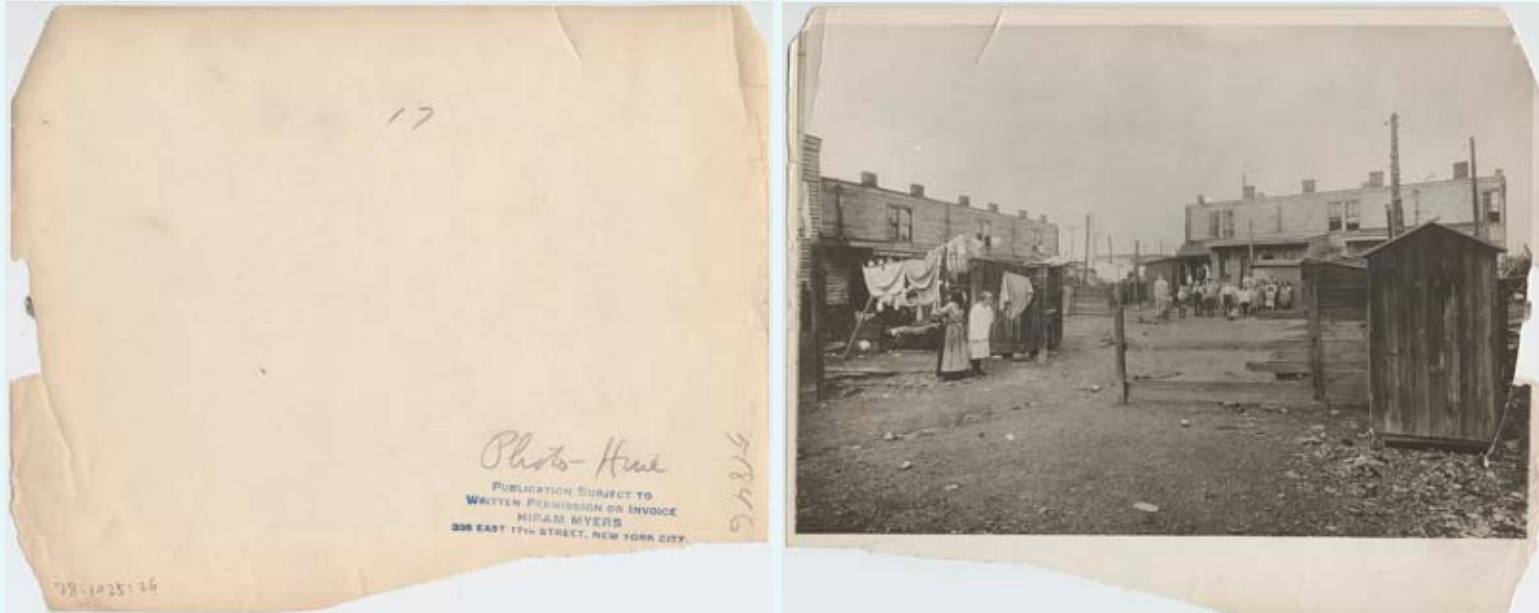
The flexibility of a photographic print is an important quality in its long-term physical stability. This flexibility enables it to withstand the rigors of handling with a minimum of damage. Flexibility can be lost over time as the paper is exposed to moisture, heat, and the degrading effects of poor-quality storage materials. These can lead to a shortening of the cellulose chains and a consequent embrittlement of the paper support. This loss of flexibility, combined with improper handling, may lead in turn to cracking of the photograph. Generally speaking, photograph supports are of very high quality, and it requires a very poor environment to cause this level of decay. However, older photographs, particularly those made before the 1930s, have more variability in their quality, and may be more prone to brittleness.

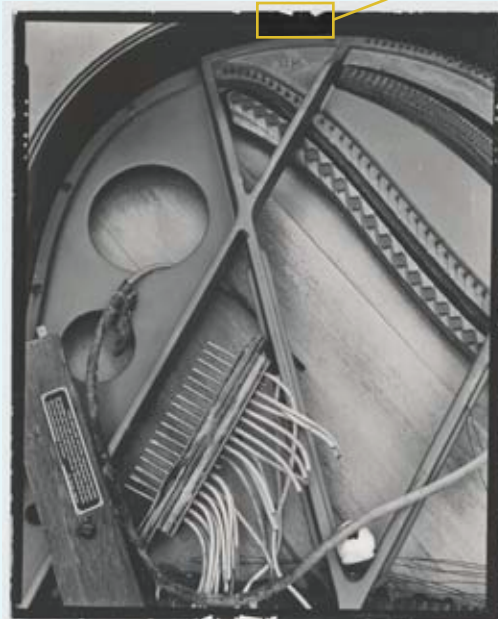
Damage to a print as a result of handling and poorly designed storage is one of the most common forms of deterioration. Such damage generally occurs very quickly and proper handling and storage will prevent any further damage.
