672-- Man at steam pump in a N.Y. power-house
An Industrial design
By Lewis W. Hine- 1920

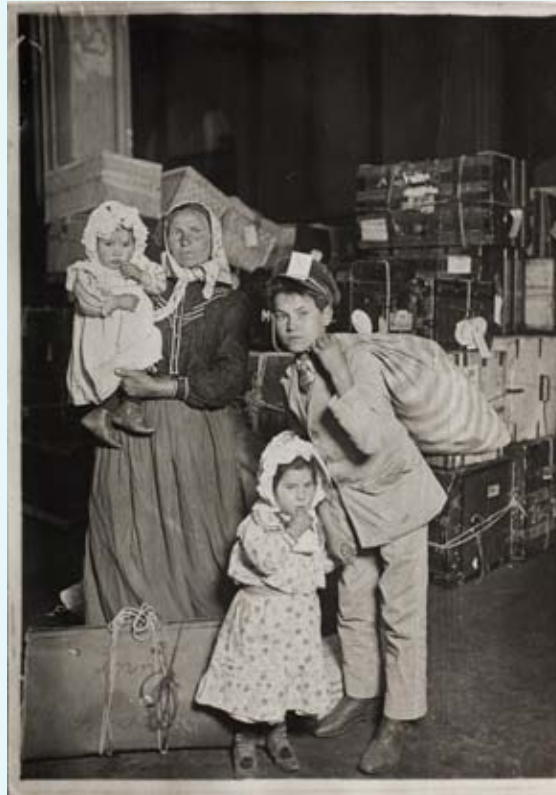
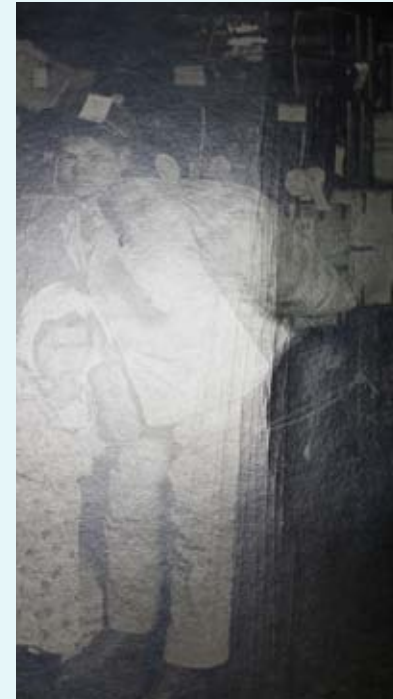
(Courtesy George Eastman House, Acc. No. 1977.0177.0134)
