# **Dismantlement of Unit 1 Reactor Building Cover for Fuel Removal at Fukushima Daiichi Nuclear Power Station**

May 9, 2013

Tokyo Electric Power Company

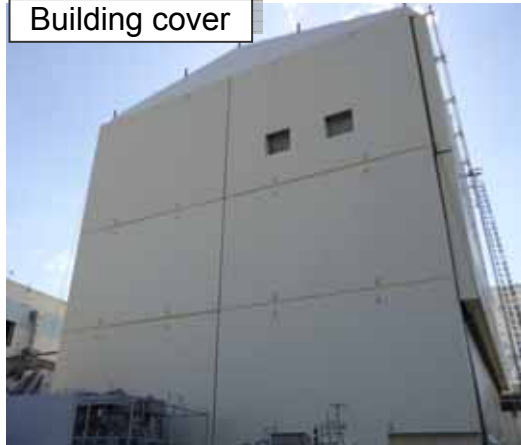
Building cover

- Even now, debris is still scattered on the operation floor inside the building cover.

Photo taken in October 2011

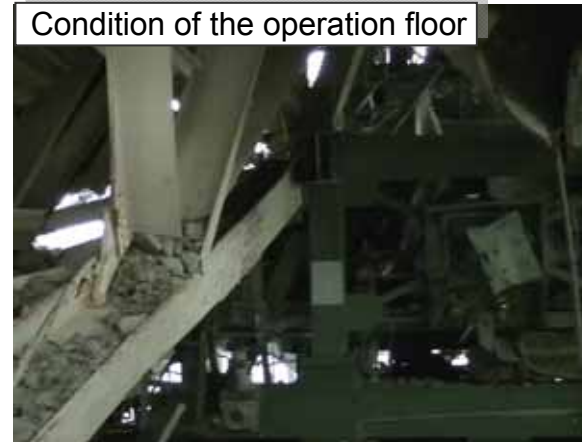
Condition of the operation floor

Photo taken in October 2012 (during the investigation of the operation floor utilizing a balloon)

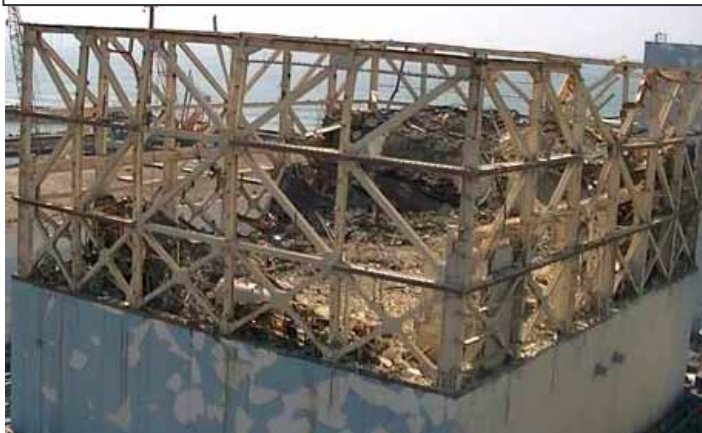
Full-view of the operation floor (northwest side)

Photo taken around June 2011

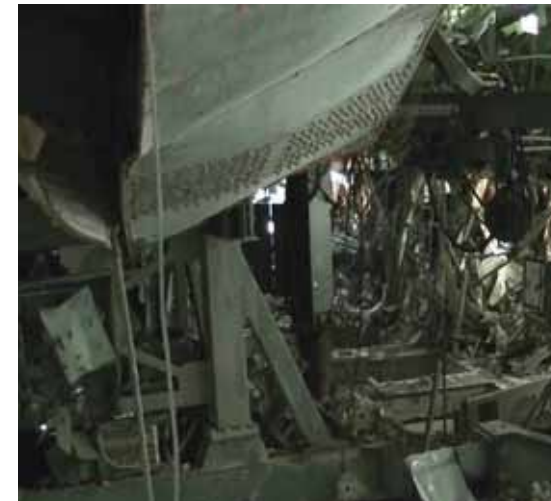
Photo taken in October 2012 (during the investigation of the operation floor utilizing a balloon)
