Precautionary Measures of Accumulated Water inside the Dike against Typhoon No.27 (Francisco) at Fukushima Daiichi NPS

<Reference>
October 25, 2013
Tokyo Electric Power Company

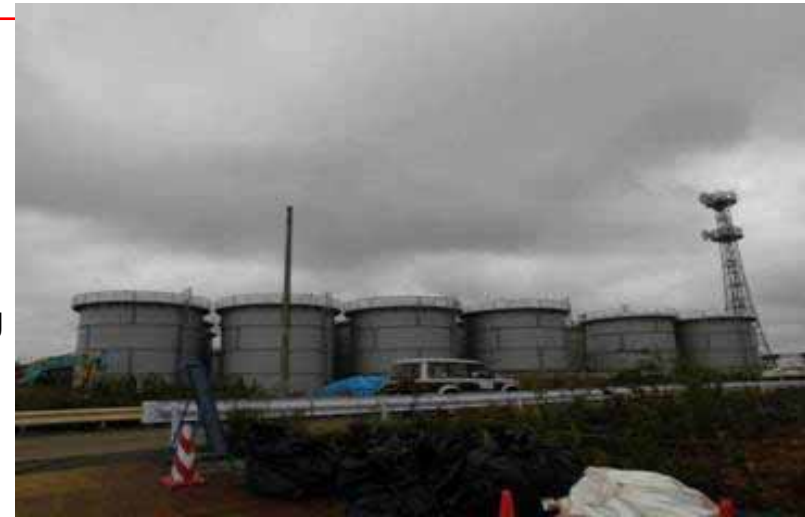
Full view of the east side of the H4 area

3. Implementation of Water Discharge of Corridor at H4 Tank Area

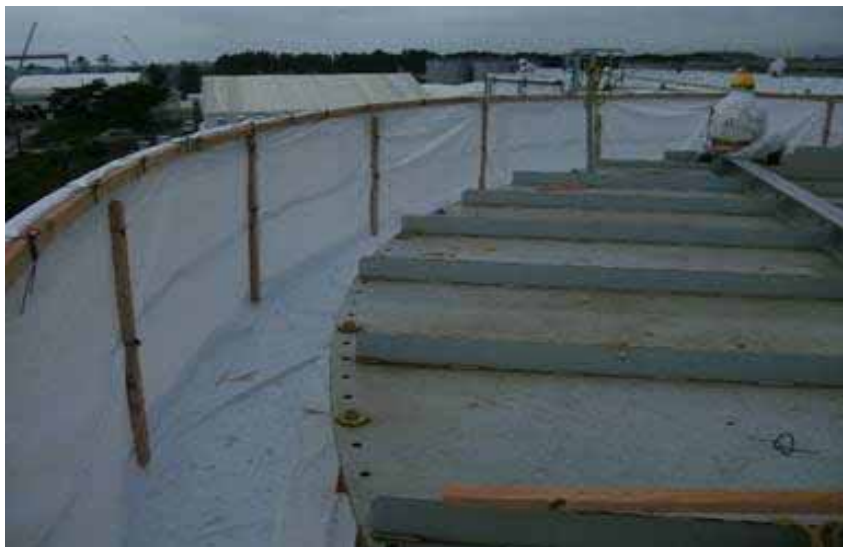
Foothold of the tank No.3

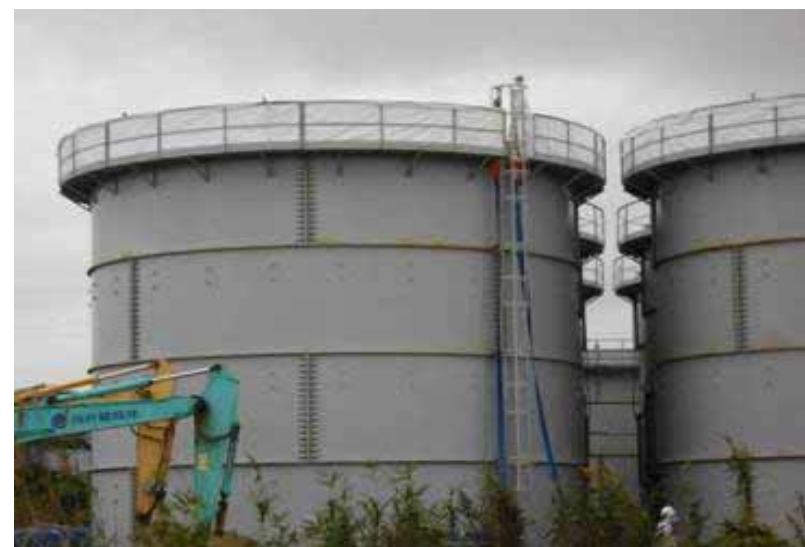
Full view of the tank No.12

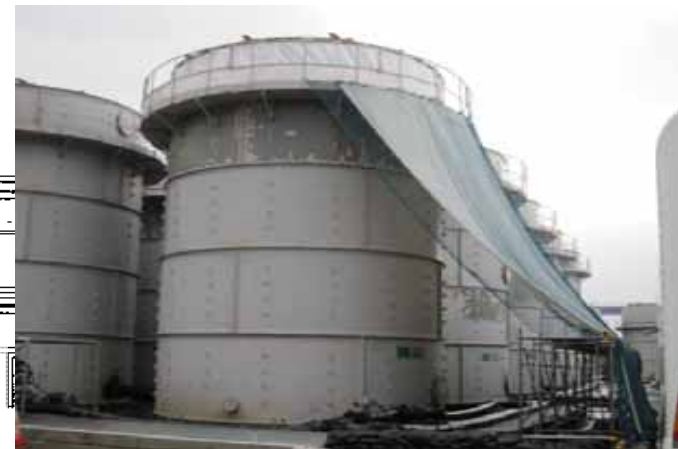
Completion of installation of protection tent for countermeasure testing

* Reference: Protection Tent Installed at B Tank Area for Countermeasure Testing
