Beachwatch

State of the beaches 2015-16

Sydney region

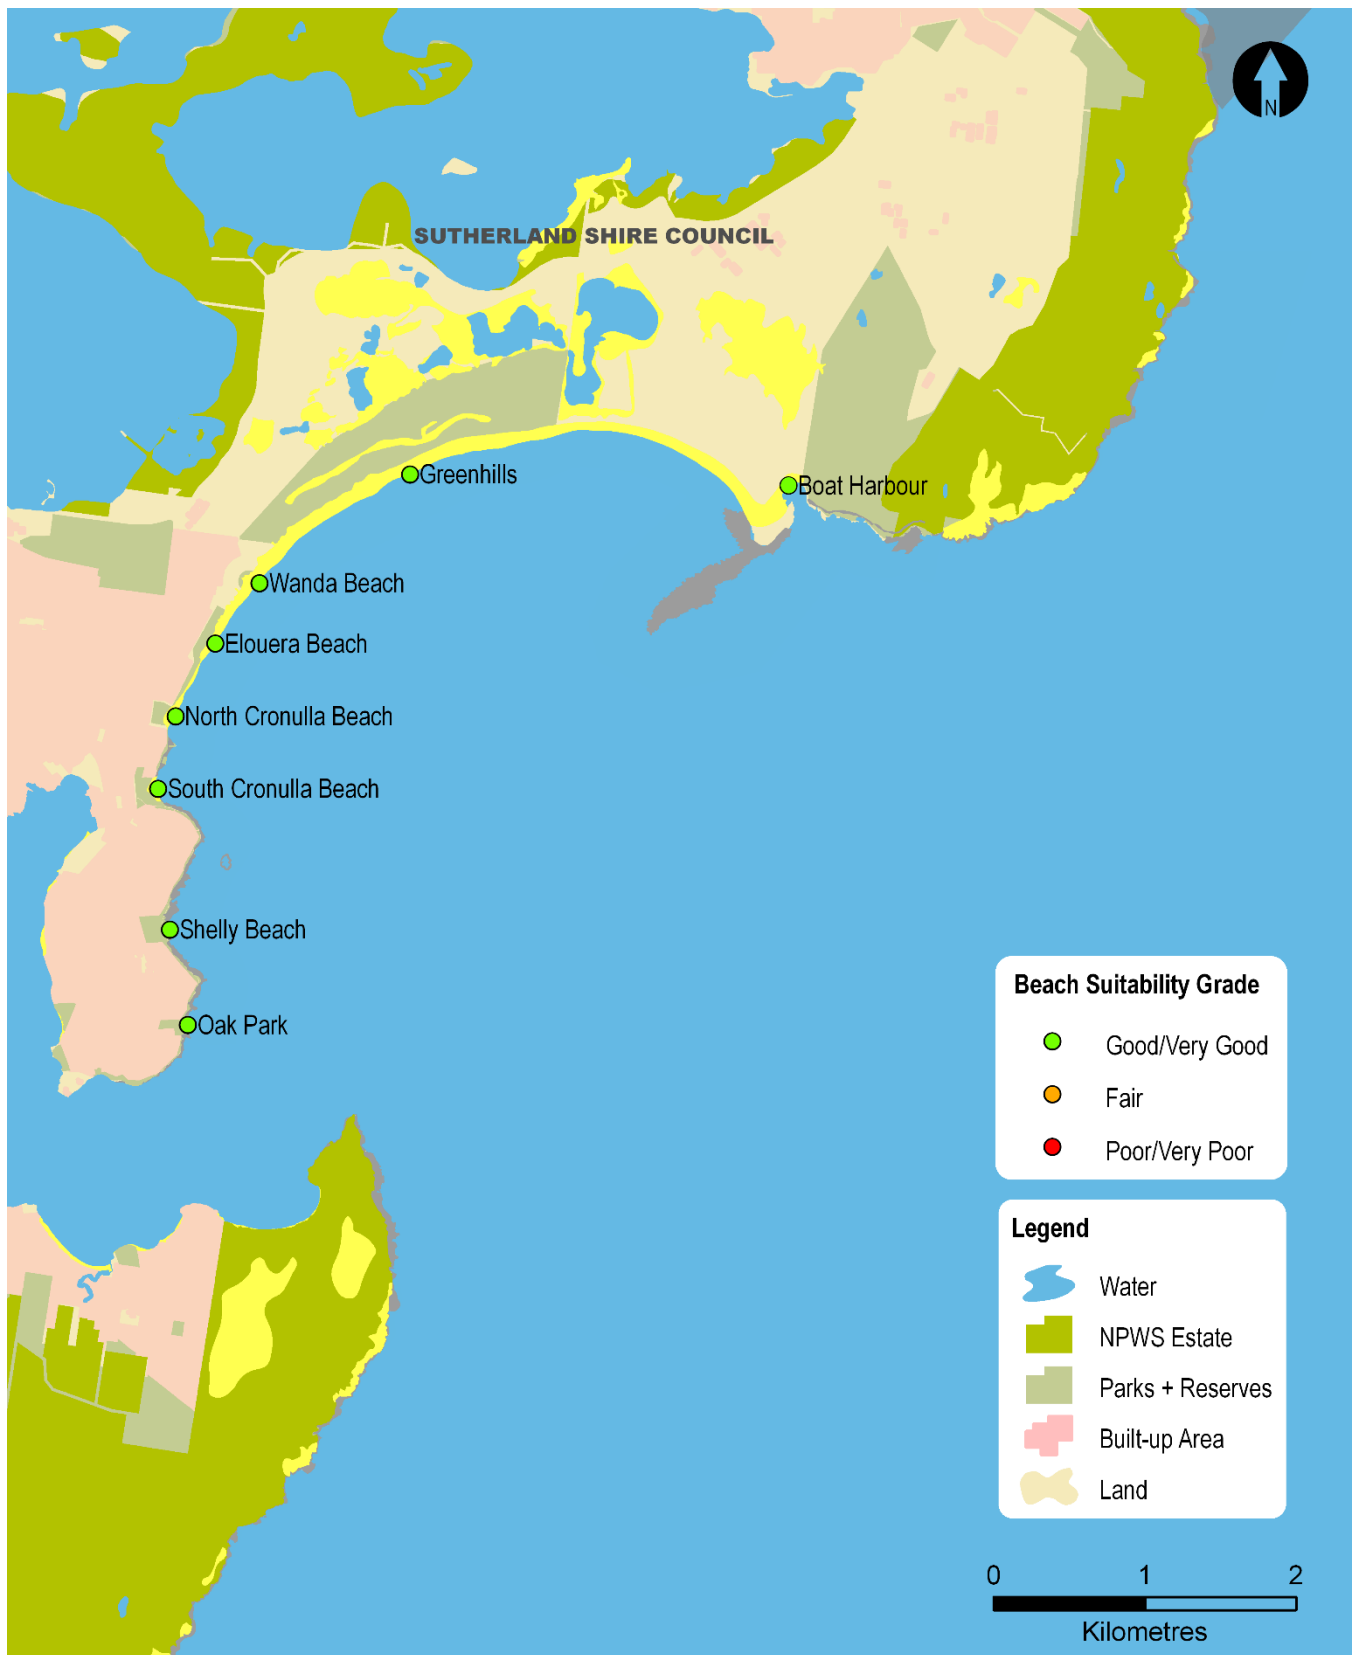
Sampling sites and Beach Suitability Grades at Sydney’s Southern Beaches
