Landmark NOMINATION Application

Name (common, present, or historic): Wayne Apartments

Street and Number: 2224 2nd Avenue

The Wayne Apartments - 2224 2nd Avenue
Seattle Landmark Nomination

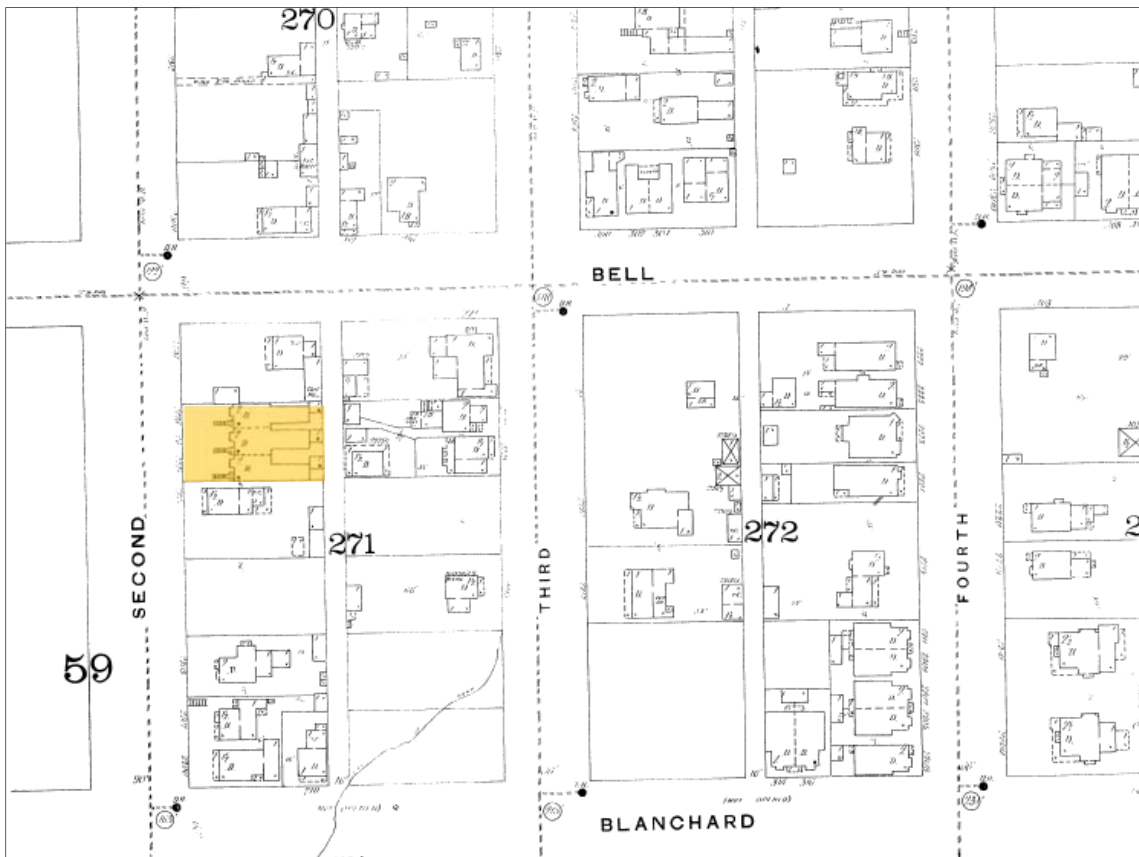
Fig. 10 – 1893 Sanborn map, showing subject rowhouses constructed by Lewis and Miranda Rowe. Subject site indicated by shading. Note rowhouse front stairs; this is prior to regrading of Second Avenue. North is up.

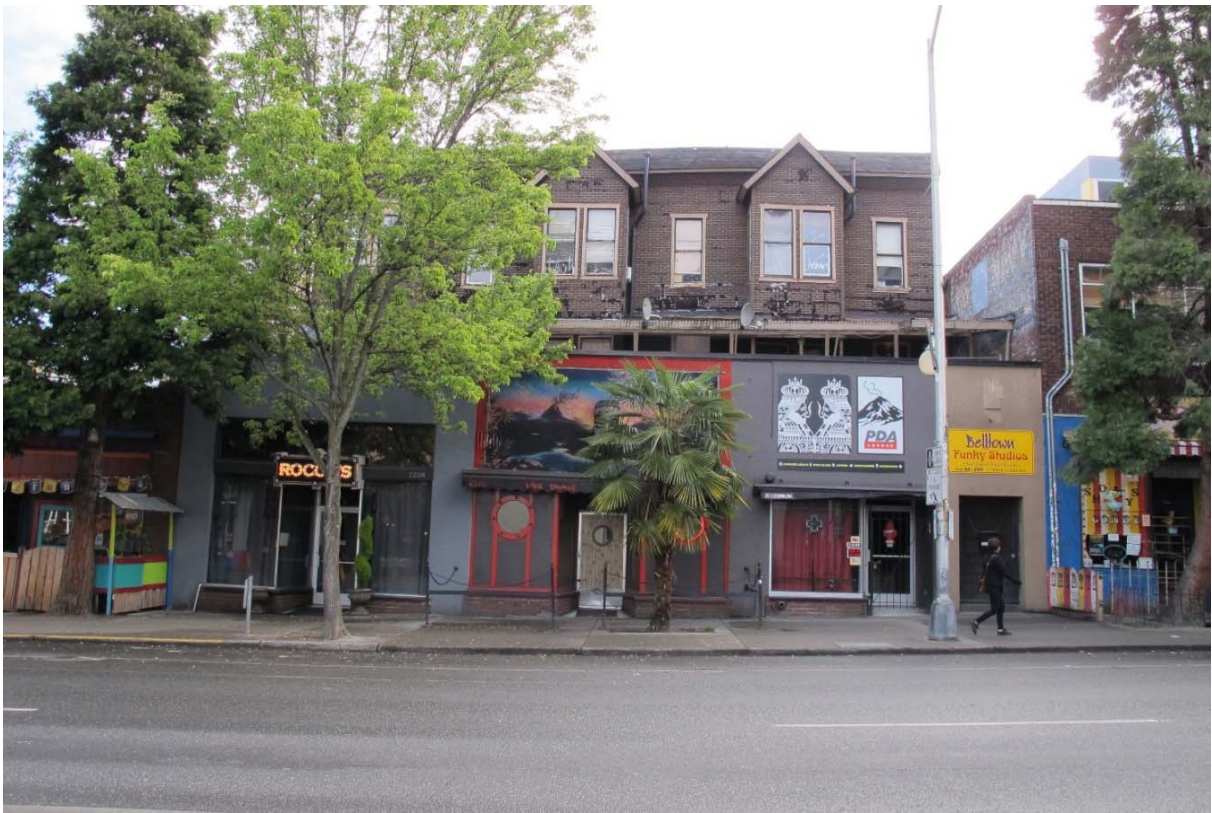
Fig. 55 – West elevation.

Over time, the commercial storefronts have been altered to suit tenants; according to building permits, major updates to the storefronts occurred in 1957. Today, the west elevation features a textured and painted stucco finish, perhaps over the original brick, and the projecting entablature portion of the parapet is no longer extant. Storefront bulkheads are now brick. Storefront windows are now aluminum sash, except for the center store, which replaced its storefront glazing with a solid wall and porthole windows probably in the 1980s. The recessed entries feature white hexagonal tiles with a Greek key pattern surround in gray square tiles, of unknown date. Only the far left storefront retains an apparently original wood sash transom; the others have been covered over or removed (the far right storefront’s covered transom is visible from the interior). Beyond these features, each storefront has been customized with different exterior painting, signage, and awnings.

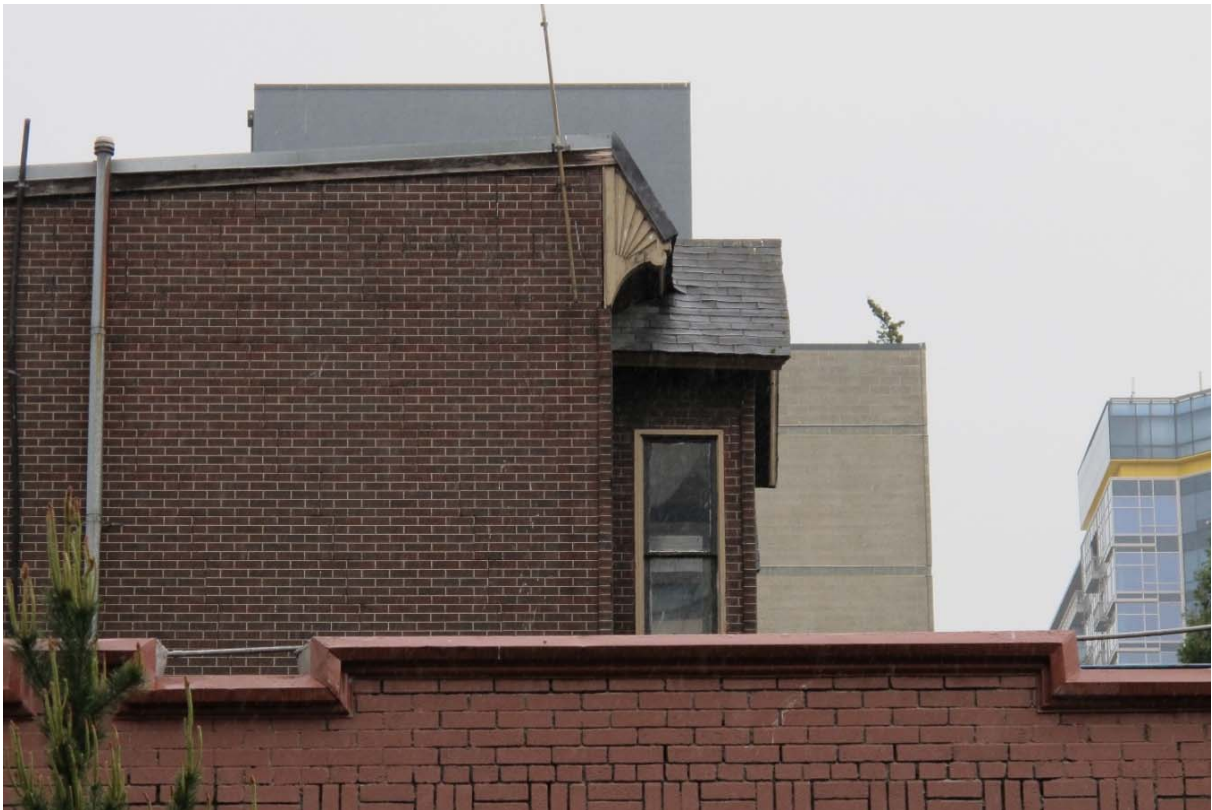
Fig. 62 – North elevation, in distance, showing remaining architectural detail at parapet.

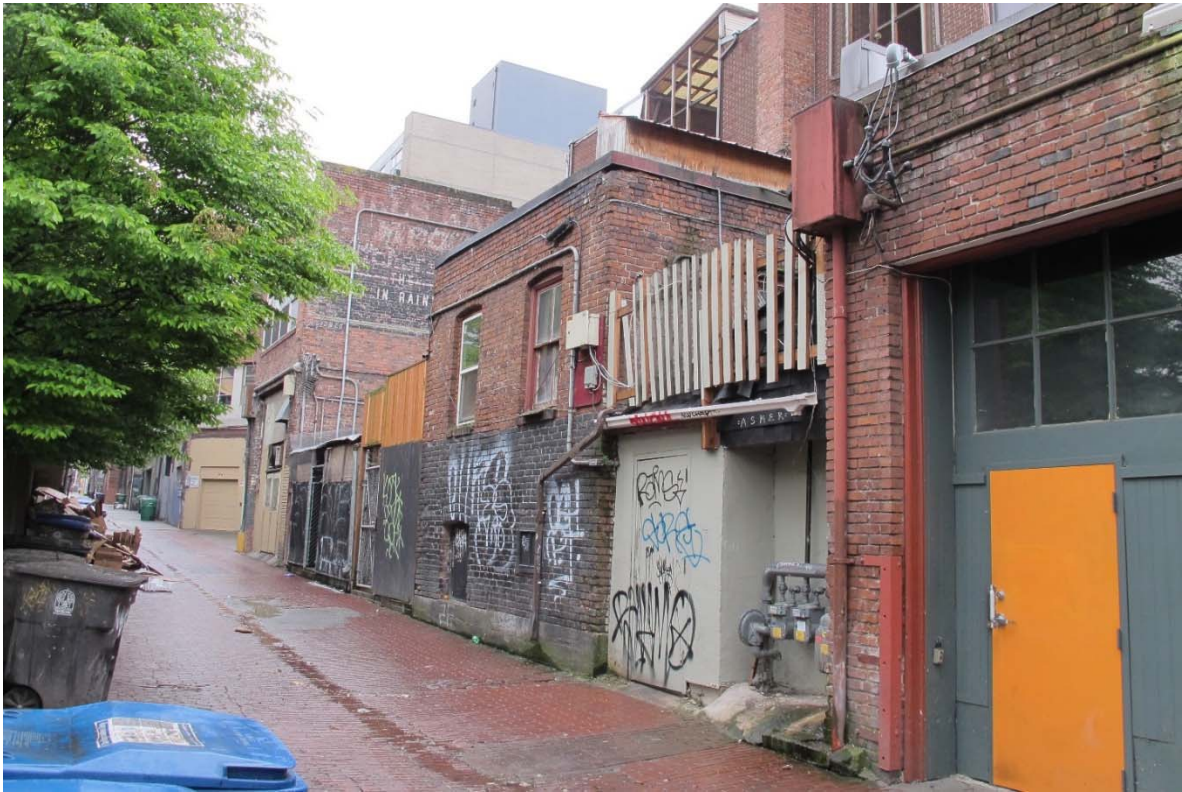
Fig. 65 – East elevation, partial view.

Masonry building element with two windows was originally a laundry and trunk storage room, and is today a residential unit and mechanical space.

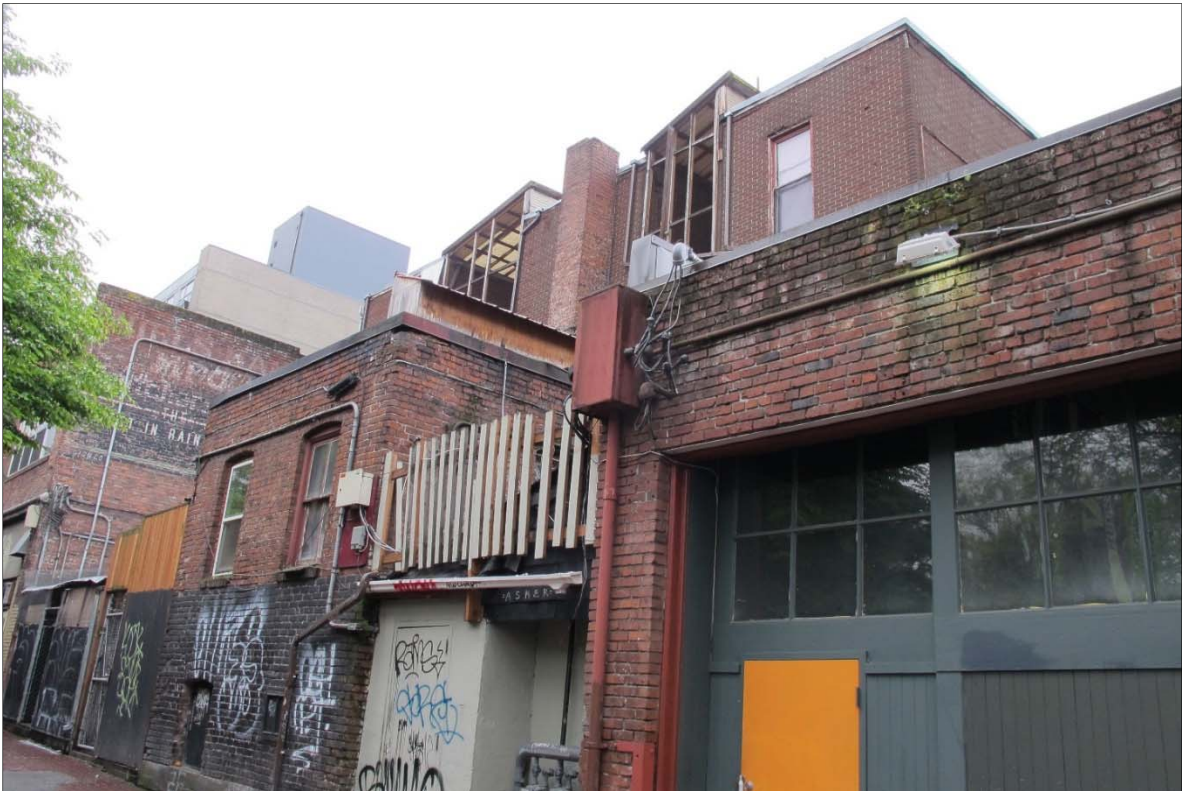
Fig. 66 – East elevation, partial view.

Brick structure in lower right quarter of picture is not part of the site.

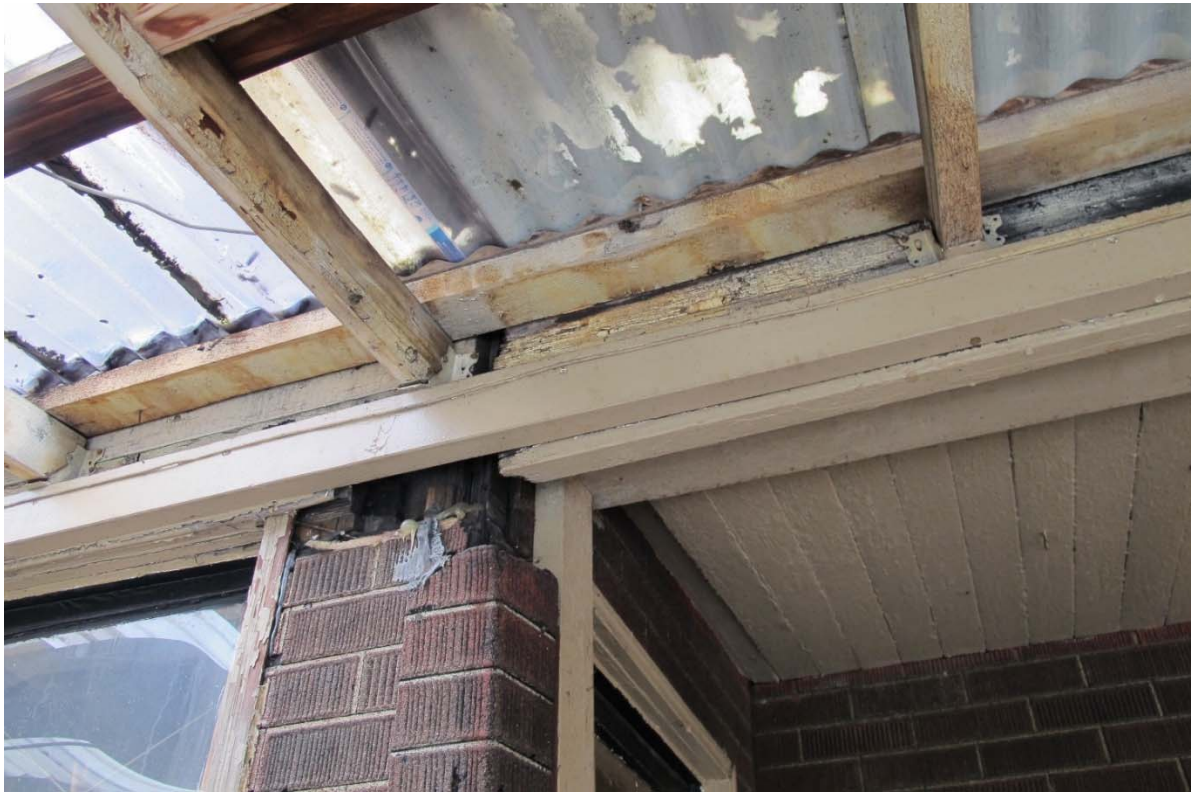
Fig. 75 – Detail, cladding and weather protection at second floor west elevation.

The exterior of the upper floors is clad in faux-brick asphalt sheet siding, which was installed sometime after 1937, likely in the 1950s or 1960s. The siding may be on top of the original horizontal wood siding, but this could not be confirmed as there were no clear locations observed where this occurred. The building today is largely stripped of original exterior architectural details, visible in the 1937 tax photographs. Features removed or covered include scalloped shingles at the projecting window bays, decorative jig-cut aprons wrapping the base of the bay window glazing, and recessed wood panels at the top of the window glazing. Decorative, projecting bracketed gables over the third floor between-bay smaller windows were also removed at some time after 1937. The only remaining decorative architectural element is an end bracket supporting the parapet pent eave roof, visible on the south elevation.

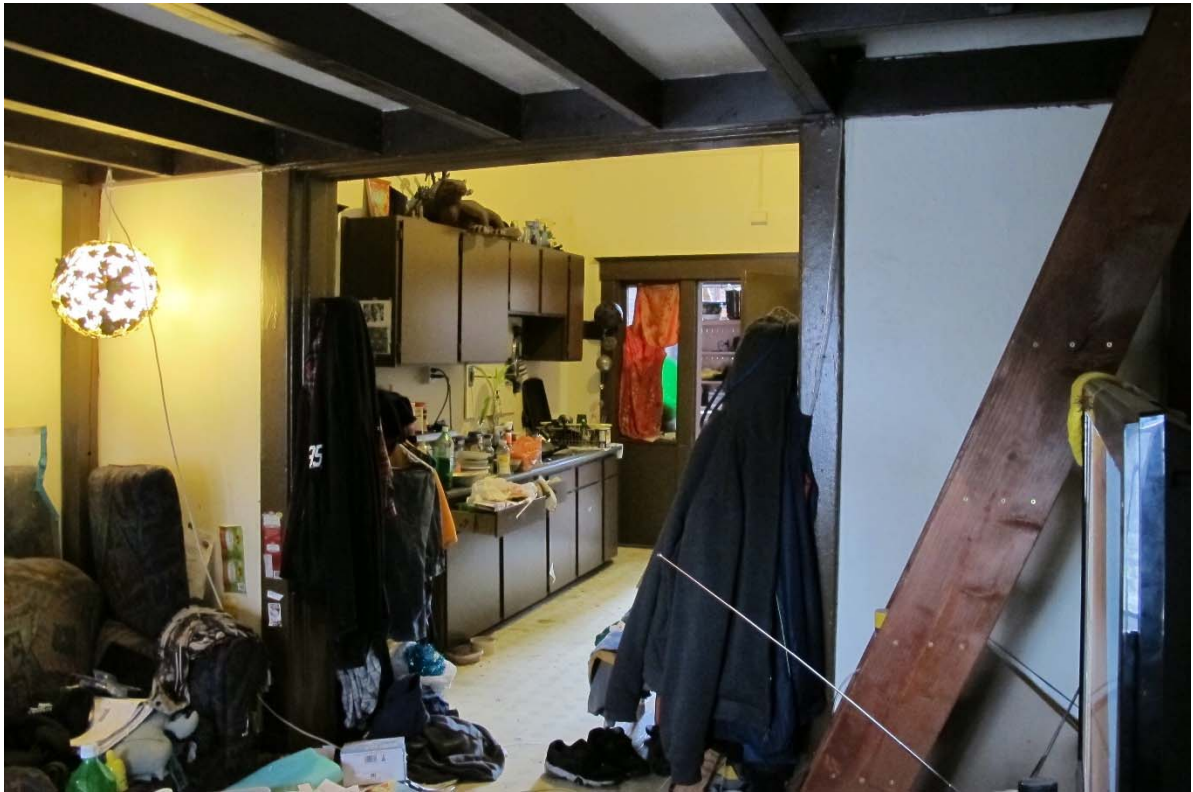
Fig. 79 – Interiors, typical units.

Visible joists are a platform constructed by tenants to increase usable space, possible due to 10' ceilings.

Ceiling heights at the second and third floors measure 10 feet, allowing some tenants to construct loft-bed or bunkbed-like platform structures inside the units to increase usable living space. Not all units have kitchens; those that do appear to have been updated in the past several decades. Some units now have private bathrooms, but others still share a bath in the stairhall as was the original condition. In at least one location, the former stairhall bath had been converted into a sleeping room at a very early date.

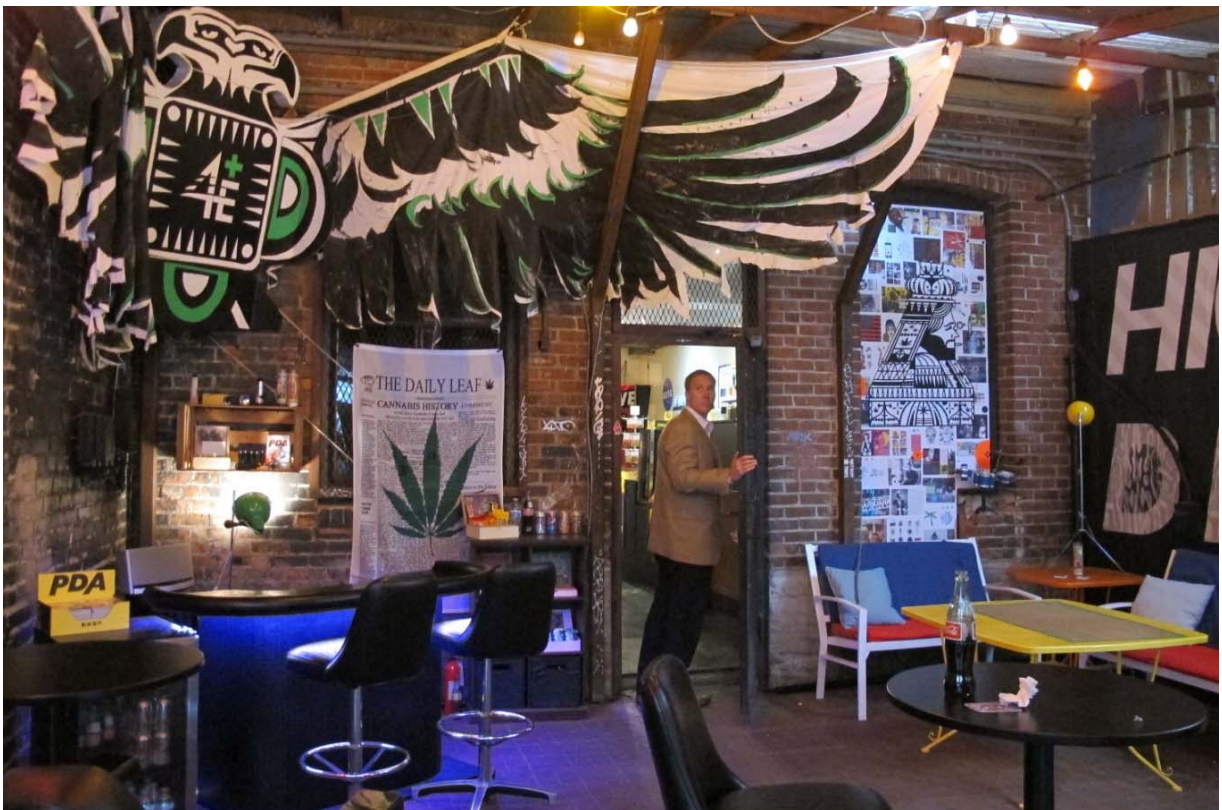
Fig. 95 – Interior, southernmost commercial space covered porch at alley side (not conditioned space). Brick wall shown is an exterior wall of the commercial space. Portion of corrugated fiberglass ceiling visible at upper right.

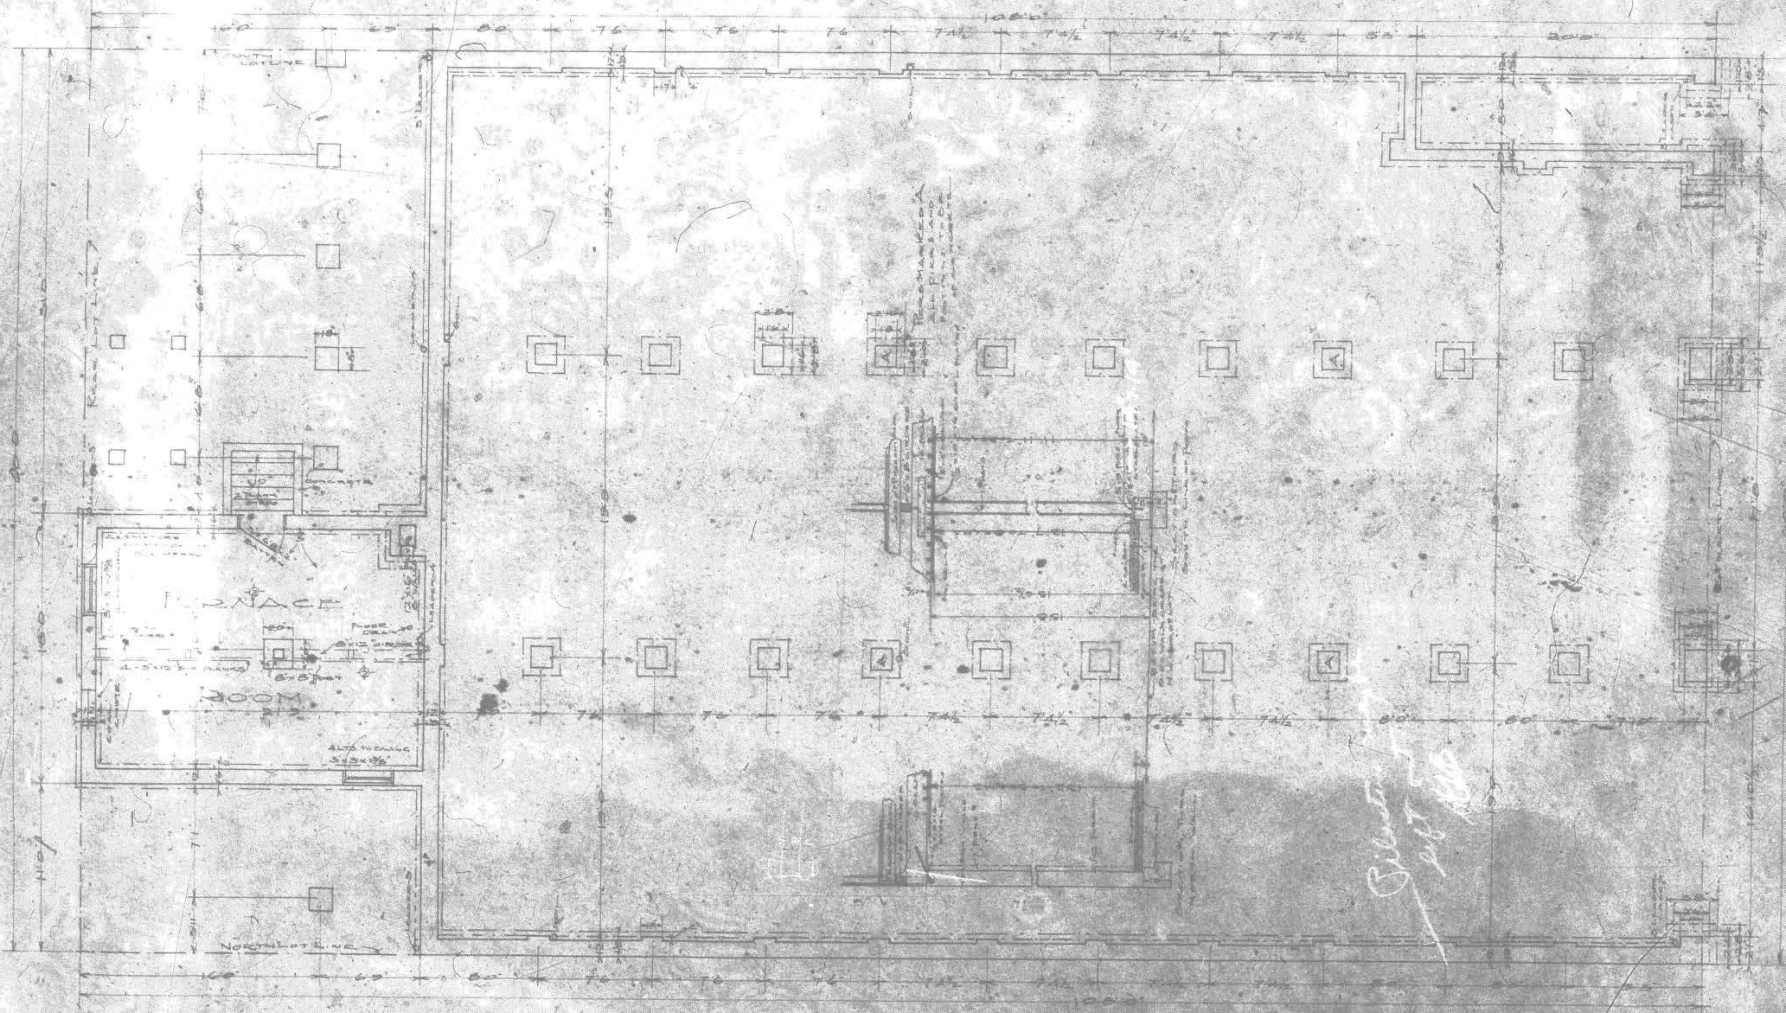
ALTERATIONS IN STORE BUILDG.
 FOUNDATION PLAN
 ON LOT 5, BLOCK A, FIFTH DENNY'S
 AS SHOWN IN ATTACHED PLAN
 MR. C. F. ELLIOTT
 1115 HAYNES COURT
 SICKBULLION BLDG.

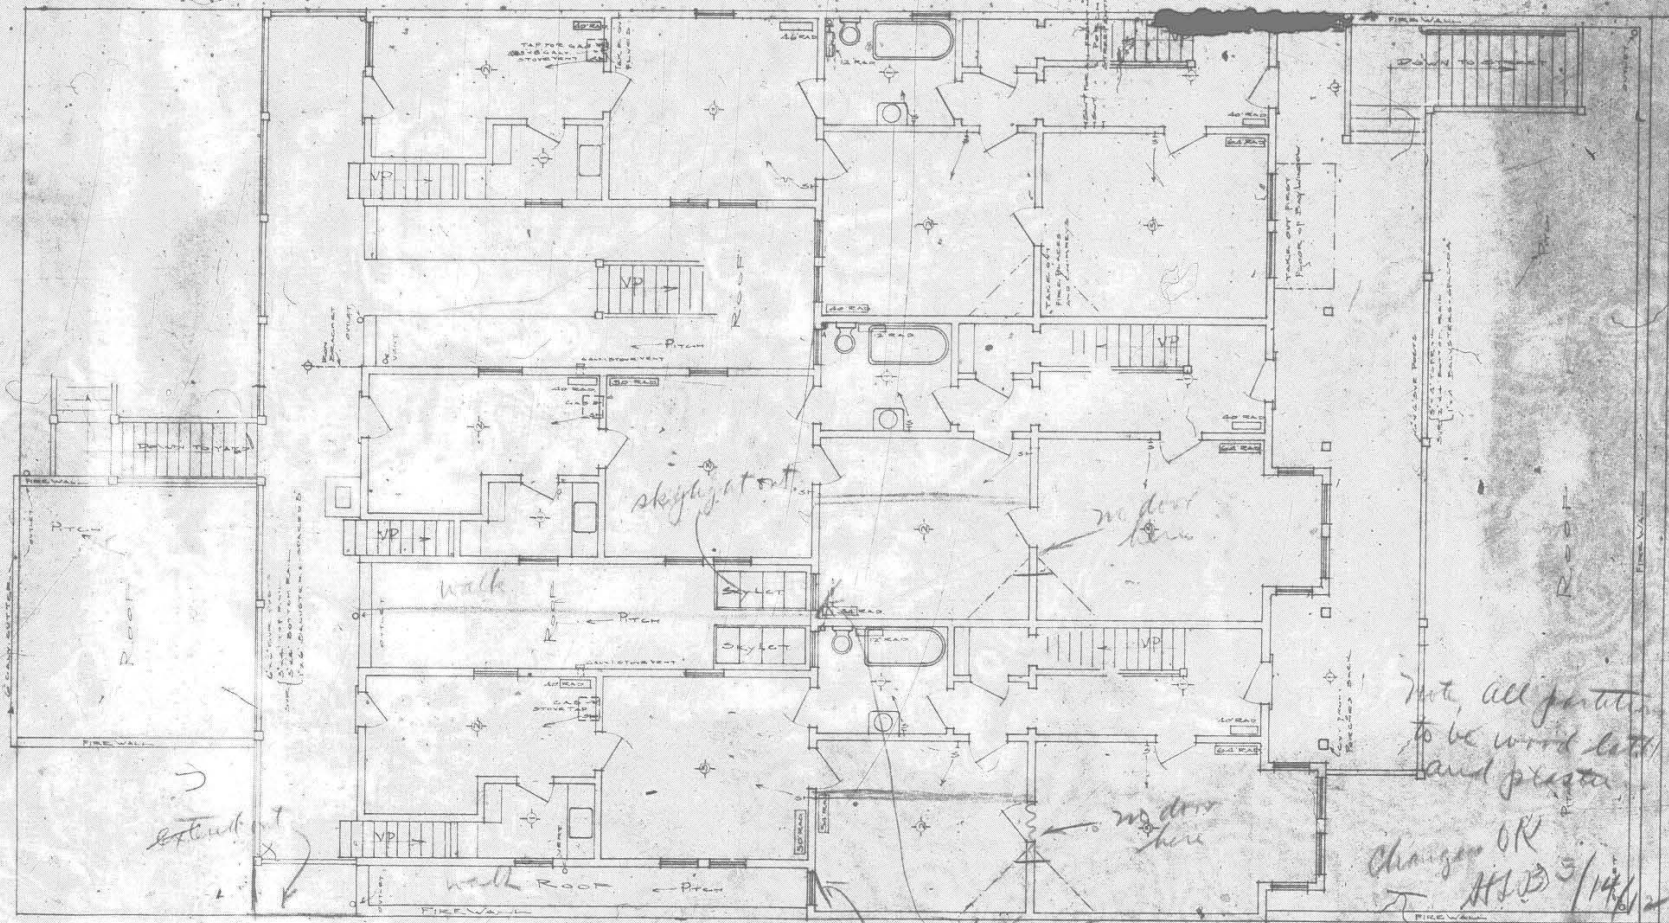
PLAN OF FIRST FLOOR OF OLD BUILDING

ALTERATIONS TO STORE BLDG.
ON LOT 1 BLY A. BELL DENNIS
SHOULD BE SEATTLE FOR
MR. C. F. SCHNEIDER
511 MILLHOORN BL.

The 1911 drawings show what had presumably been three single-family rowhouses were now physically altered for use as multiple apartments. The building specifications noted that all interior walls were to be stripped to the lath and re-plastered, and that the “old building is to be made to correspond to the plans as nearly as possible.”¹¹ They further stated that all new wiring, plumbing, gas piping, and finish hardware was to be newly installed to replace that which had been there.

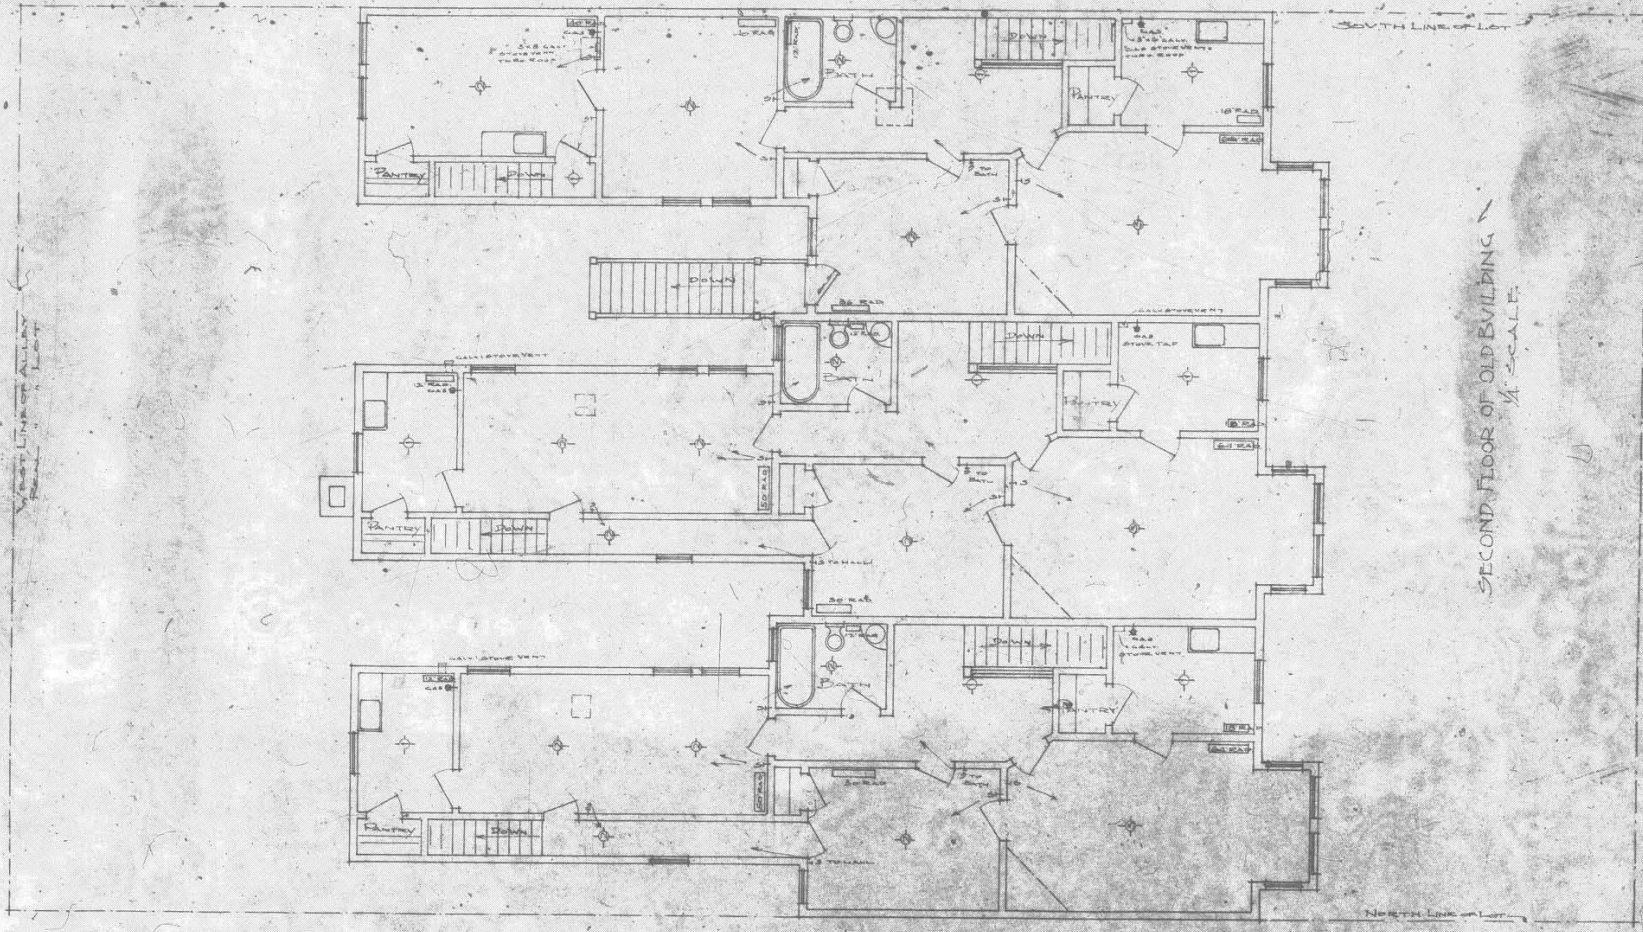
SECOND FLOOR OF OLD BUILDING
 1/4" SCALE

ALTERATIONS TO STORE BLDG.
 ON LOT 5-BLK A BELL PENNS
 2ND ADD TO SEATTLE - FOR
 MR. C. F. SCHNEIDER
 CHAS. HAYNES ARCHT
 517 HILLBORO BLDG.
 Sheet No. 2
