# **Maquiladora Health & Safety Support Network** **Red de apoyo sobre salud ocupacional en las maquiladoras**

February 24, 2011

## **Health and Safety Evaluation Report Alta Gracia Project garment plant Villa Altagracia, Dominican Republic**

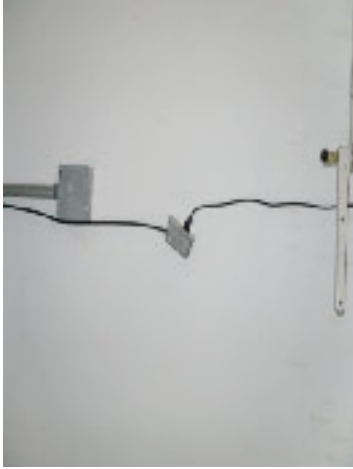
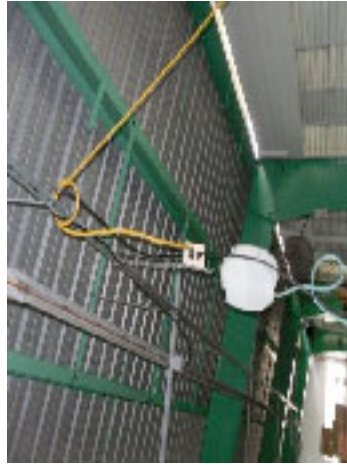
1. Receptacles with flexible cords.

Located on front wall on east side of plant to office

These are wall receptacle boxes /plates connected to flexible cords being used as fixed wiring (Title 8, 2500.8). The wall receptacle boxes are designed to be fixed and attached, not as a component for a portable cord set (Title 8, 2305.4 Approvals). Also conductors and cords that pass through openings in boxes and cabinets must be protected from abrasion (Title 8, 2473.1).

An evaluation of electrical power needs has to be made based on location of permanent equipment in relation to mounted receptacles. To minimize the use of extension cords, additional permanently mounted receptacles should be installed by a

qualified electrician using approved components for anticipated voltage and current loads.

The above items have all been corrected and the temporary use of extension cords was only observed by maintenance personnel cutting wood strips.

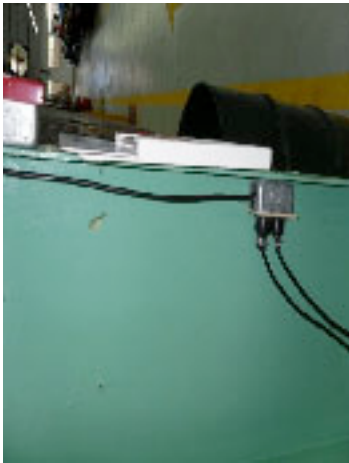
Located on east side of plant.  
Cord coming out from box has no protection from sharp edge of knockout.

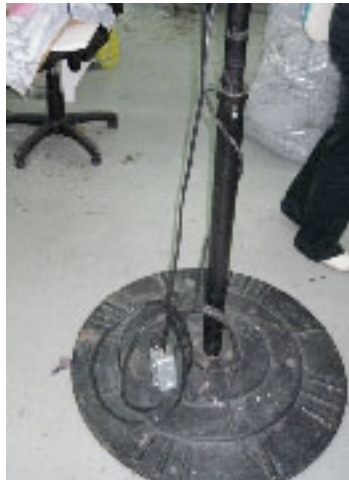
Pedestal fan in module area

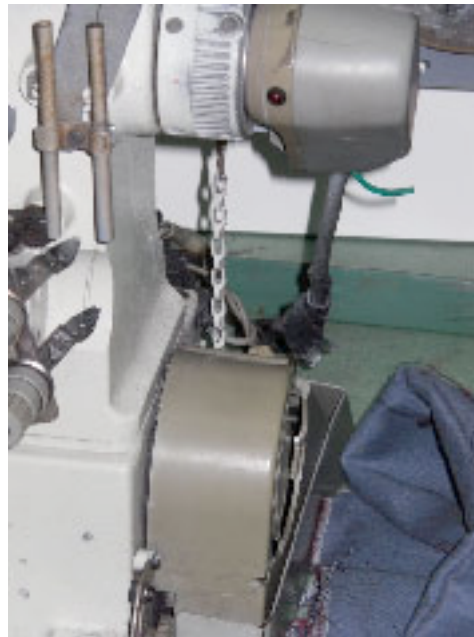
4. Taped power cord and disconnected equipment ground on Pegasus sewing machine

Power cord is wrapped with tape which is coming off, exposing conductors (Title 8, 2500.25). Equipment ground on power cord is disconnected (Title 8, 2395.59).

This item has been corrected.

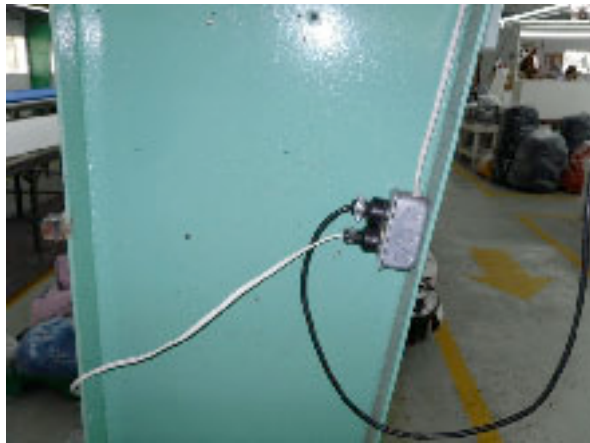
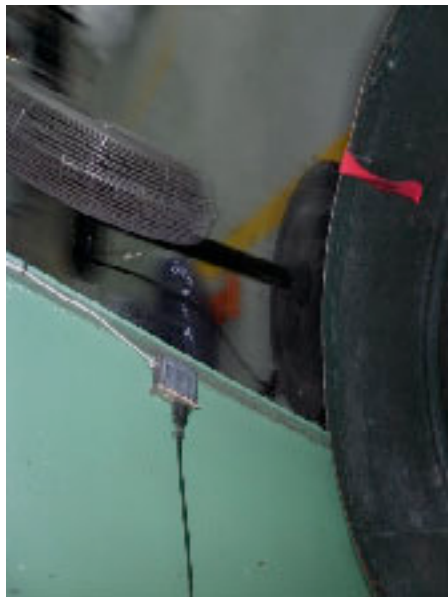
5. "14 AWG Duplex" cord being used instead of industrial SO-rated cord as a power cord and to supply power to a receptacle. Location on column between module area and cutting area.

Flexible cords must be approved for use and location (Title 8, 2305.4, 2500.7) There is not enough information on the cord to determine type and whether acceptable for this installation (Title 8, 2340.21). Flexible cord cannot be used for fixed wiring (T8, 2500.8).

Power cord should be replaced with industrial SO-rated cord and cord supplying fixed receptacles should be installed in conduit.

These items have been corrected by placing wiring in EMT metal conduit. However, there was open Romex observed between the two outlets located in the

“Lavado” room and fluorescent lighting/switches located in the generator and compressor room.

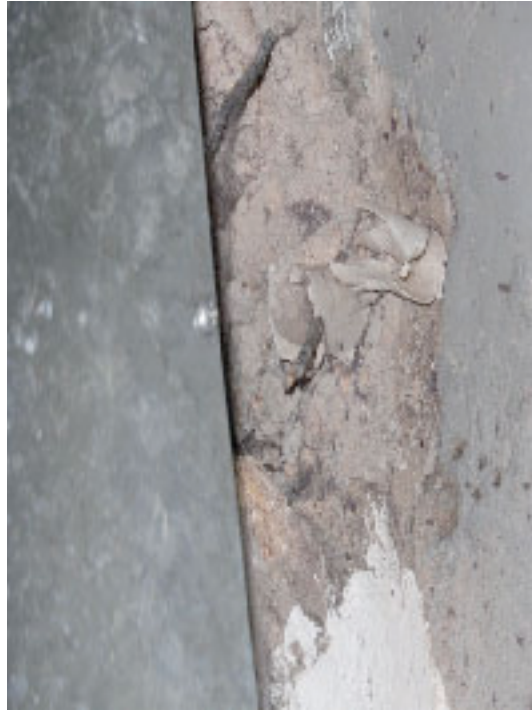
6. Discontinued circuit/conductors located on wall next to water dispensers (loading dock side)

Discontinued circuits must be completely removed or maintained as if in use (Title8, 2340.24)

Recommend that they be covered with a plastic or metal plate.

This item has been covered by a metal plate.

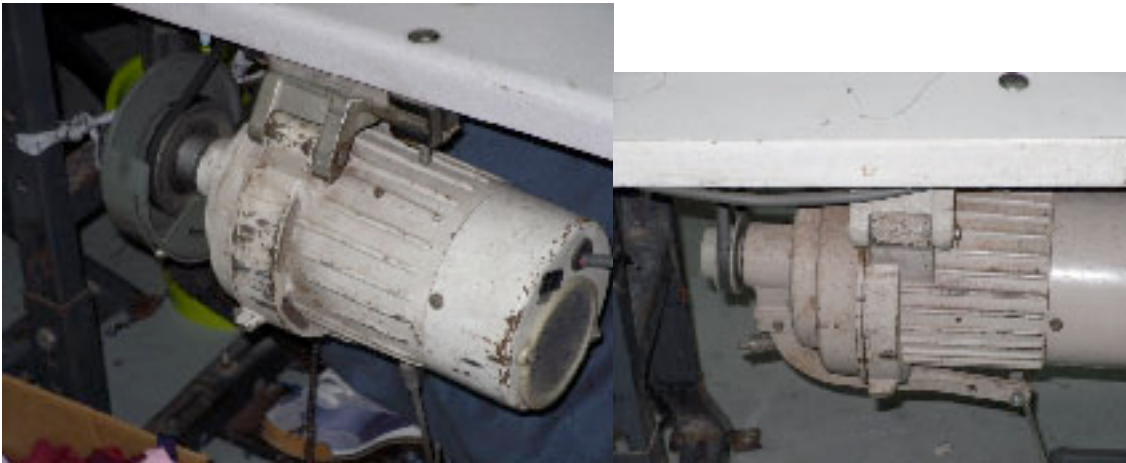
8. Unguarded lower pulley nip points on several sewing machines in Module area

The lower pulley nip points need to be covered to prevent inadvertent contact (Title 8, 4475). The following is an example of a guard that was made and installed on one of sewing machines at AltaGrcia which accomplishes full enclosure.

**February 18, 2011:**

These items have been corrected. Management has made an excellent effort in providing additional sheet metal guarding, obtaining full enclosure of hazardous belt/pulley nip points. This photo is an example.

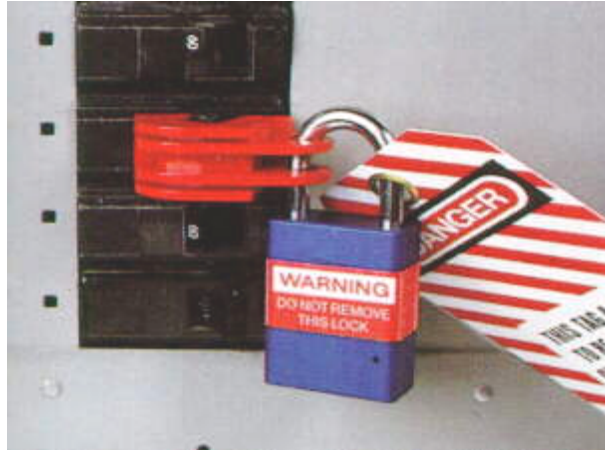
To prevent re-energization, the subpanel should be able to accept a lock whose key would be in the custody of the repairer until the task is completed. Another option would be the use of specifically designed LOTO devices that can be placed on the individual circuit breaker. The following is a photo of such a device.

Locks have been installed on the doors of all circuit breaker panels (observed) with maintenance personnel in control of the key. Maintenance personnel will lock the circuit breaker after isolating power when working on overhead lights or other equipment that requires lockout.

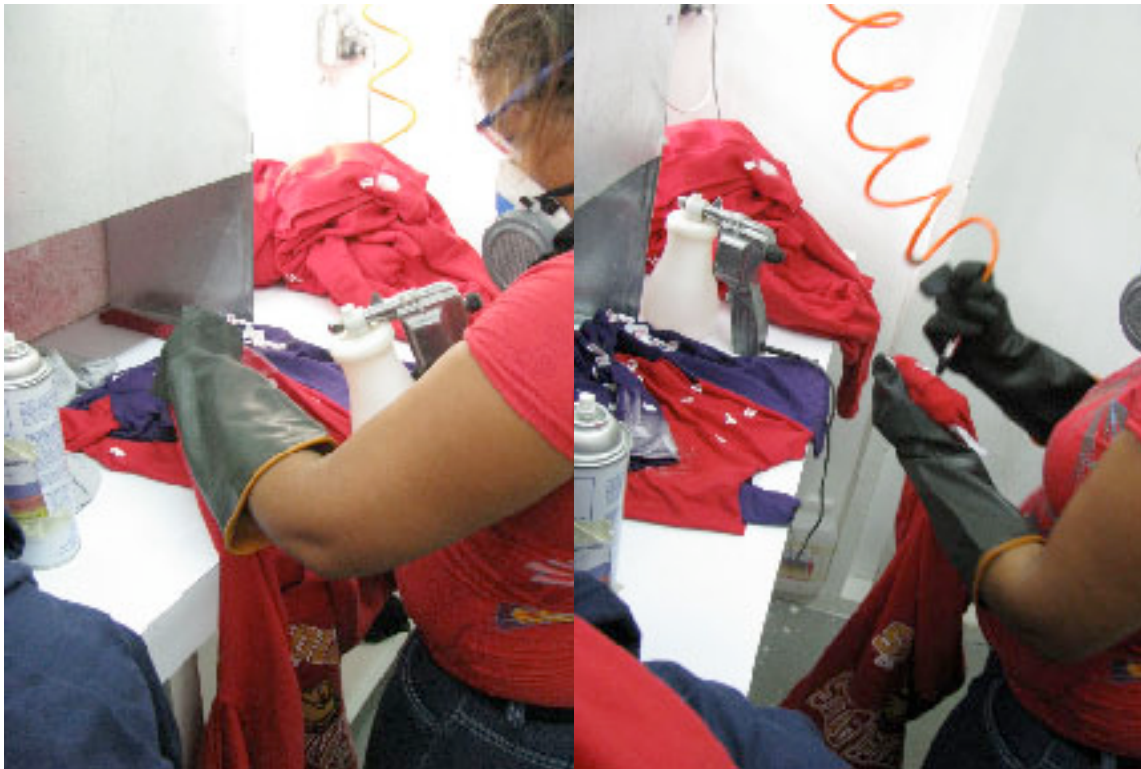
The current local exhaust ventilation (LEV) system (as of June 18<sup>th</sup>) is ineffective because the sheet metal hood in the room is too small or narrow to allow the work to be done INSIDE the hood so that the airborne contaminants are exhausted outside the building.

The spot remover operation involves using a pneumatic spray gun to apply the solvent onto the garment (above left) and then drying and removing the solvent with a compressed air line (above right). Both these operations need to be done inside the hood.

- Redesign and rebuild the LEV hood so that all the work can be done inside the hood and contaminants exhausted to the exterior. The exhaust stream from the fan should be prevented from re-entering the room, either by installing a chimney from the fan exhaust to the roof, or by sealing the other windows in the spot remover room;

- Cutting small holes into the right-hand side of the hood to allow the air line for the pneumatic spray gun and the air line for drying to pass into the hood for easier use of the spray gun and drying airline inside the hood;

The plant is has changed chemicals and is currently using Tide Liquid Laundry Detergent (See Attachment 5) as their spot remover. According to the manufacturer’s MSDS normal/general ventilation is acceptable and in an industrial setting chemical goggles and rubber or neoprene protective gloves should be used. Management has required the use of chemical goggles and neoprene protective gloves for spot removal.
