North Wales Police headquarters

First published October 2011

by Roderic Bunn

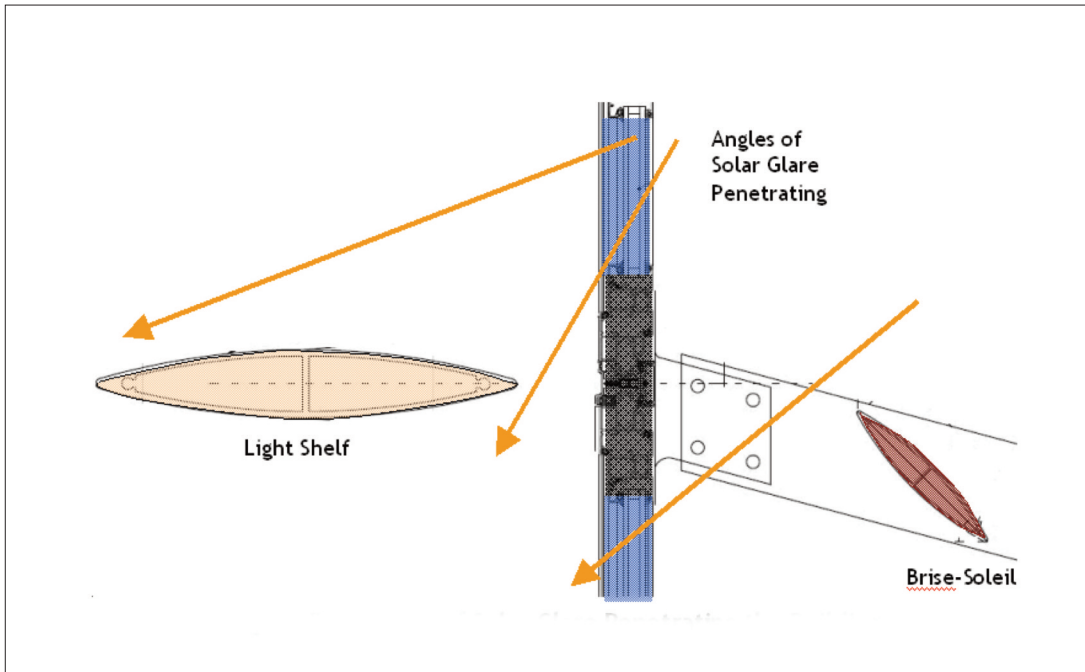
Angles of solar glare calculated to enter the building.

Despite the brise soleil, building users initially suffered glare problems. The combined brise-soleil and light shelf were found to be ineffective at blocking the sun at certain angles. A gap between the light shelf and the window was wide enough to enable solar rays to penetrate into the office. The lack of a blind for the toplight caused the glare.

Also, the height of the top pane window and/or the width of the light shelf itself were not appropriately sized: low solar angles would penetrate the room and disturb occupants seated next to the room back wall. Again, the lack of an internal blind didn't help. Some building users found it necessary solve the problem by taping strategically-positioned sheets of cardboard to the toplight.

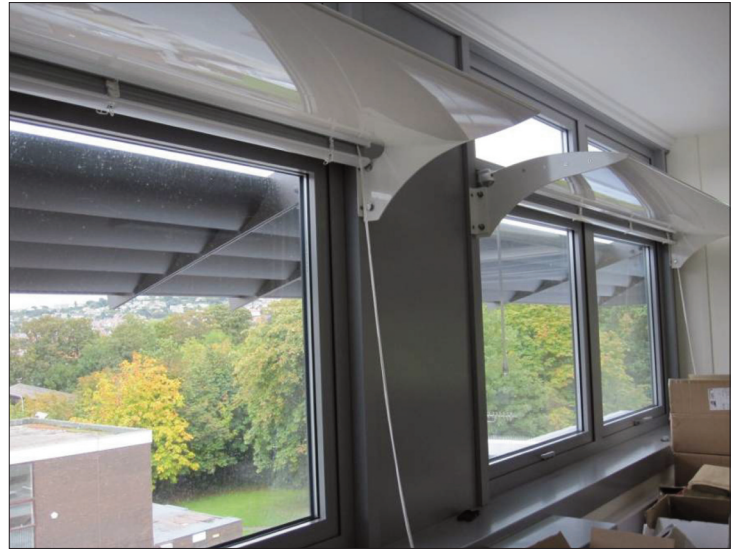
A system of brise-soleil solar shading was provided for the East, South and West facades. Combined with the reduced area of glazing, the brise soleil reduced the solar gains enough to avoid the need for mechanical cooling and for the natural ventilation strategy to be retained.

The designers opted to separate the two windows by an internal light shelf designed to reflect daylight to the ceiling, assisting in the penetration of daylight and improve the consistency of daylight across the room. The electric lighting is controlled by occupancy sensors, and is automatically dimmed using daylight detectors. The lighting load was

The external brise soleil and internal light shelves.

The problem was treated as a defect by the sub-contractor, and the difference between the design drawings and the installation were managed and fixed. The gap between the light shelf and the top pane window was reduced in accordance with the tender drawings.

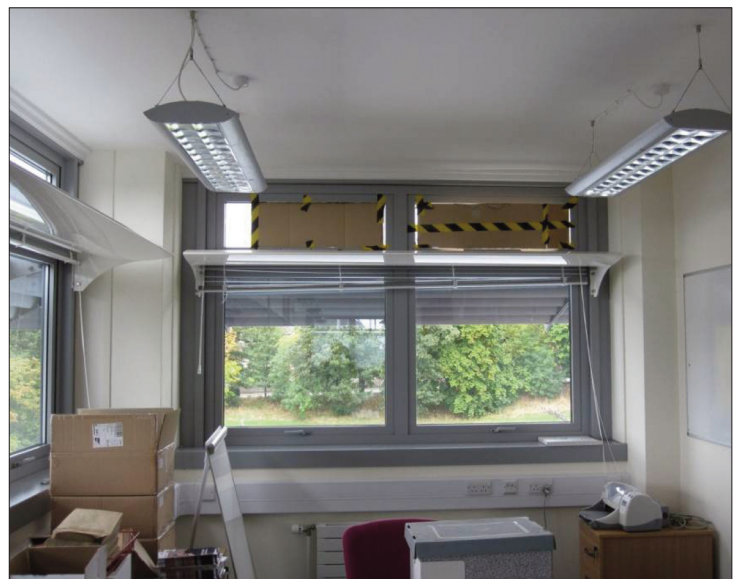
Some building users found it necessary solve glare problems by fitting sheets of cardboard to the toplight.

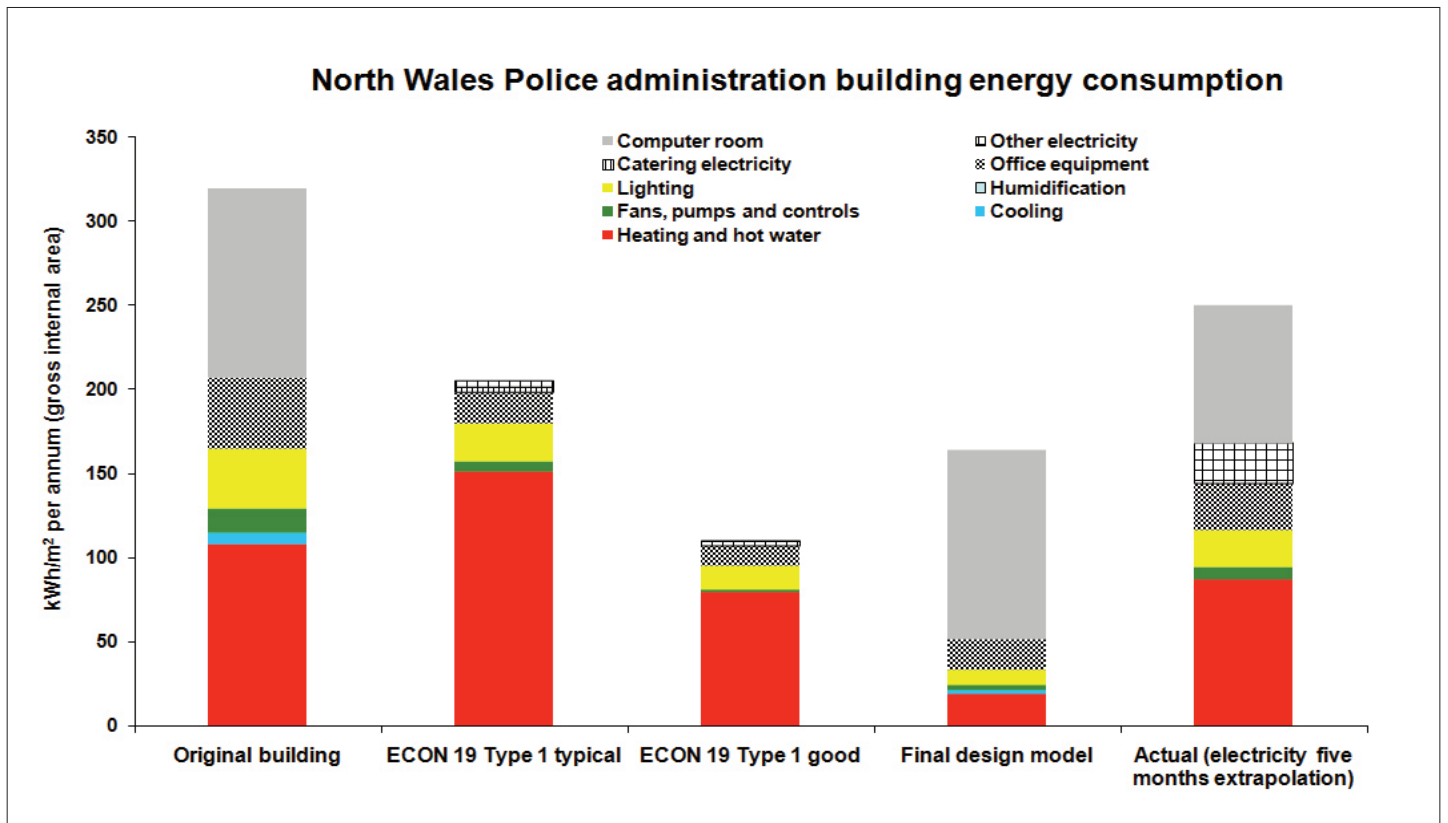
Figure 1 shows the calculated energy consumption breakdown for the refurbished building against the building's Energy Performance Certificate and various benchmarks. The administration building can be classified as an *Energy Consumption Guide 19 (ECON 19) Type 1 building*: a naturally-ventilated cellular office.

However, as Figure 1 illustrates, electricity usage is around 22 per cent higher than the design prediction – a 128 MWh disparity. Current performance also shows that the administration block consumes 288 MWh more gas than expected, an approximate 350 per cent increase over the design prediction.

Figure 1: Energy breakdown of the NWP administration building compared with relevant benchmarks and the design prediction. Consumption is based on a gross (treated) floor area of 4267 m².

While gas consumption has fallen by 9 per cent compared with the old building, the new system has a number of defects that prevent it from performing as well as it could. Once the problems are fixed and the heating system re-commissioned, gas consumption could be more in-line with the 'typical' benchmark (Figure 1).

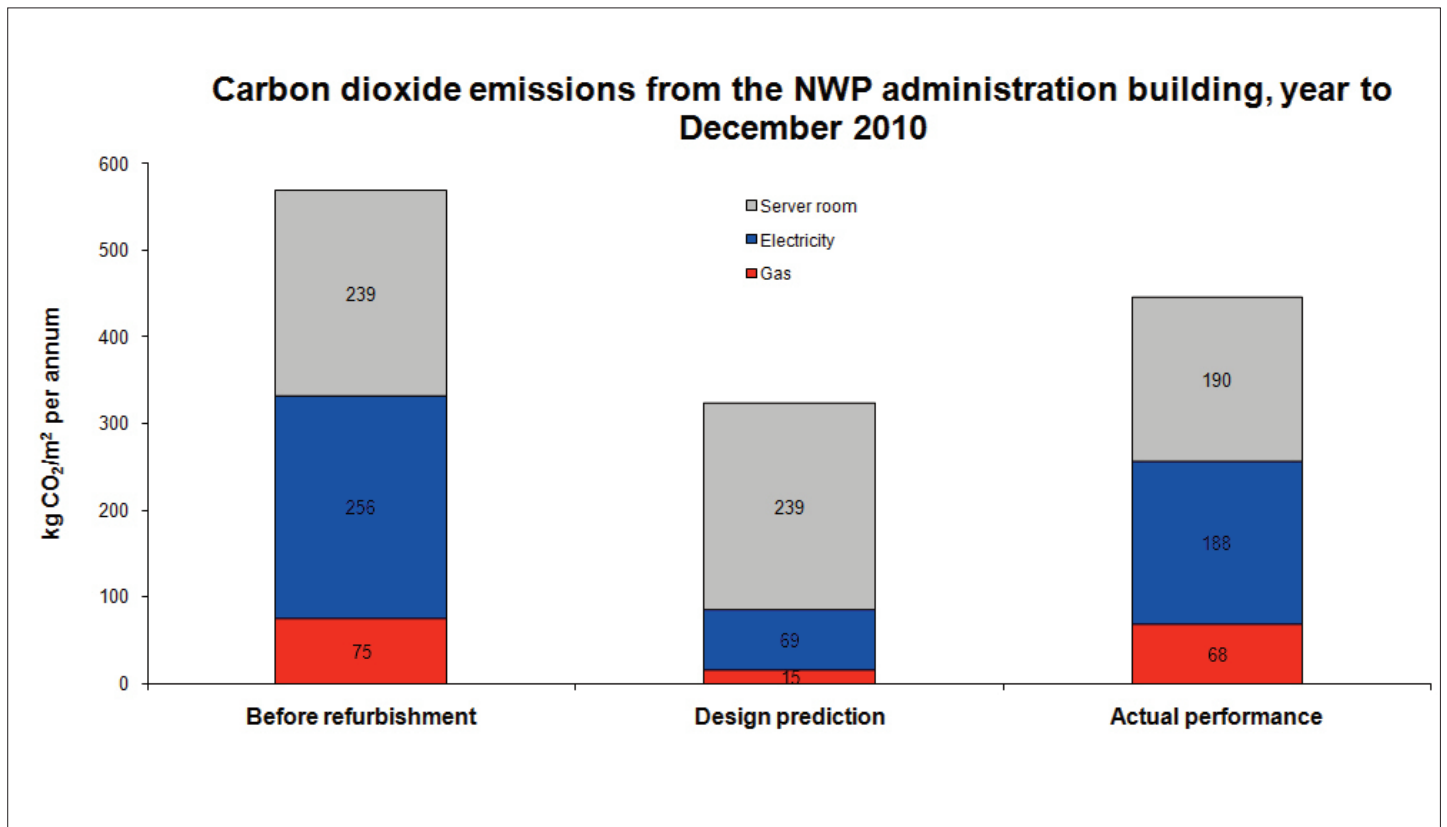
Excluding the computer suite, the building's overall carbon dioxide emissions are 18 per cent lower than the old building (Figure 2) - a significant improvement. However, the large disparity between the modelled prediction of a 47% reduction and actual performance begs serious questions of the validity of the modelled values, and the process by which energy and carbon dioxide targets are created.

Carbon dioxide emissions due to gas consumption are 17 kgCO₂/m² per annum compared with 20 kgCO₂/m² per annum. This is an improvement, but nowhere near the estimation of 3 kgCO₂/m² per annum. Similarly, emissions due to electricity use are 44.6 kgCO₂/m² per annum compared with the design estimate of 18 kgCO₂/m² per annum.

Figure 2: The carbon dioxide emissions for the NWP building compared with design calculations and the pre-refurbished building

Overall, the disparity between estimated and actual emissions is 65 per cent.
