Biotechnically engineered designs

Case Study 4: Monk Bretton, River Rother, East Sussex (completed 2004) Grid Reference: TQ 925 206

Case Study 5: River Severn, Purton, Gloucestershire (completed 1998)
Grid Reference: ST978 632

Estuary Edges: Ecological Design Guidance

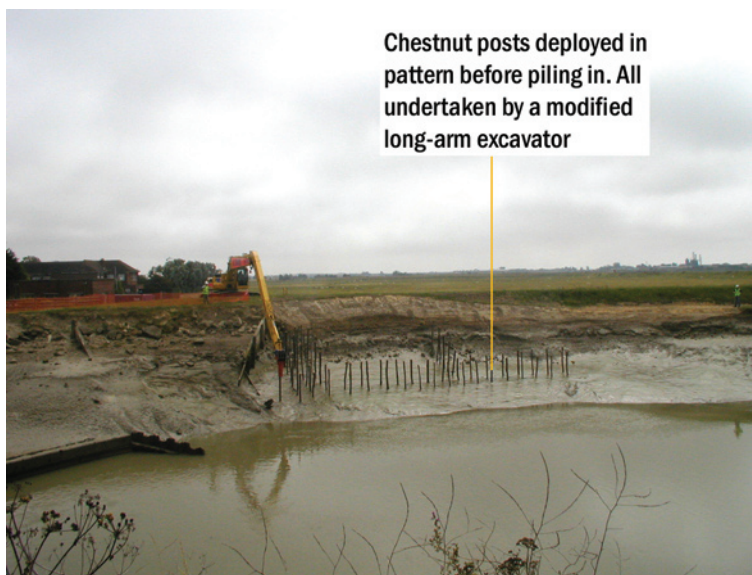
Monk Bretton site near bridge: Installation of posts for fascines

- Some reprofiling of clay embankment was carried out to ensure overall final smooth edge profile.
- Hardwood posts (125mm) were piled using long-reach excavator with modified hydraulic rammer typically to 1.5m depth.
- Posts created framework at 600mm centres to support a brushwood 'fascine' layering revetment.
- Hazel fascines were installed in 30-40cm layers at 90 degrees to each other to create a 'brushwood mattress'.
- Initially retained under a wire 'rocknet' fixed over piled wooden posts and looped under at the edge nearest the river centre.

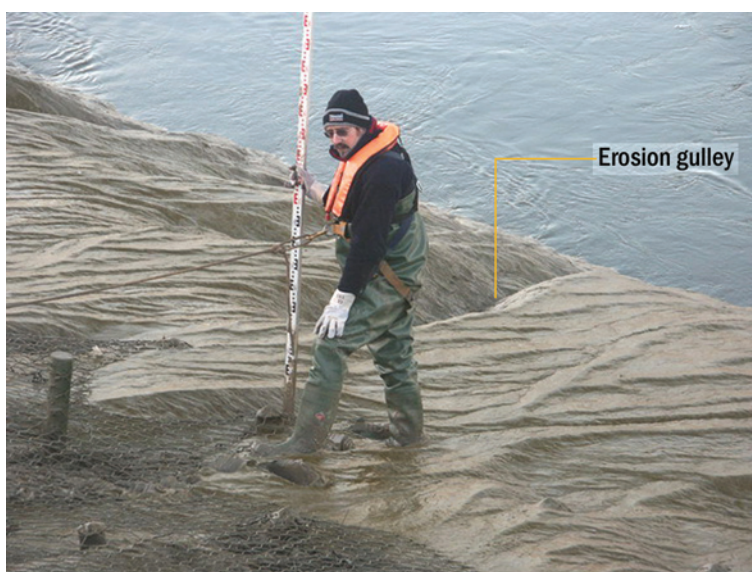
Monk Bretton site near bridge: Rocknet and fascine detail showing drainage pattern

- Sedimentation rapidly effective on the lower half of the slope but slow in the upper parts of the slope.
- Settlement of the brushwood and sediment resulted in the exposure of the surface rocknet risking rapid exposure and decay of the brushwood and posts causing a potential maintenance, visual and health and safety issue.

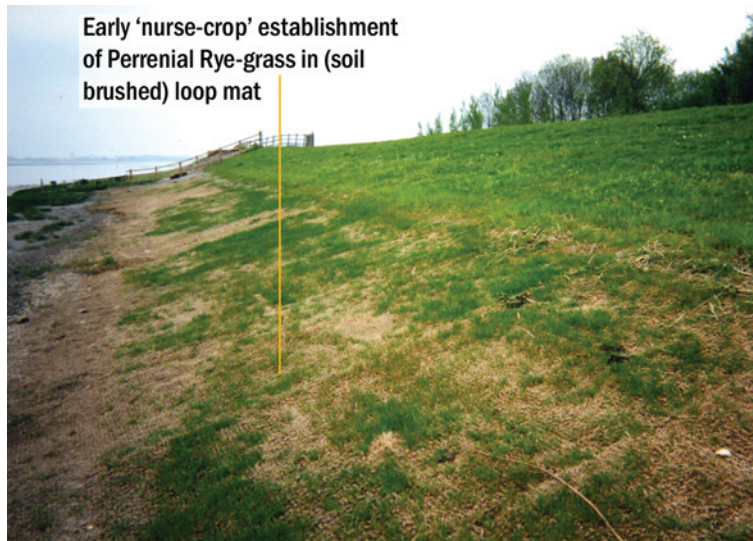
Gabion mattresses installed in SSSI bank: Early colonisation at high tidal levels

- Initially the coir loop matting was incorrectly attached to the upper surface of some mattresses. This resulted in loss of soil infill and stone movement in the gabions. These were repaired.
- Local vegetation soon colonised the properly installed stone mattresses and no subsequent significant erosion problem was noticed.
- Overall considered to be a highly successful design appropriate to the SSSI.

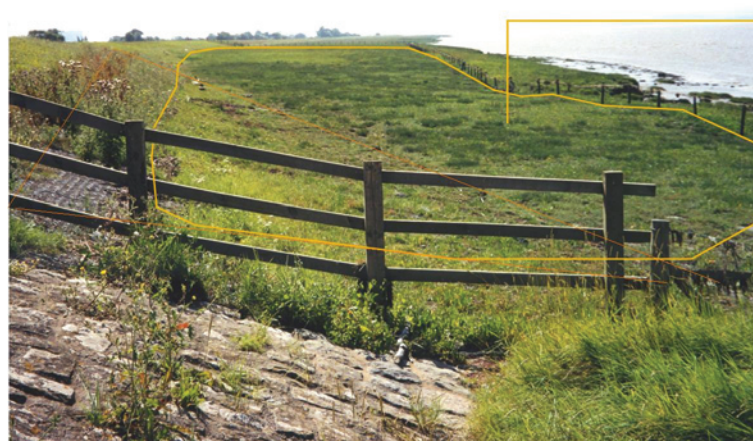
Gabion mattresses installed in SSSI bank with full successful colonisation by species characteristic of the SSSI
