Structurally engineered designs

Case Study 6: Greenwich Peninsula Terraces (completed 1997)
Grid References: (1) TQ 399 794 (2) TQ 390 805 (3) TQ 391 803

Case Study 7: Battersea Reach Terracing (completed February 2005)
Grid Reference: TQ 261 755

Case Study 8: Mill Pool, River Roding (completed March 2006)
Grid Reference: TQ 439 837

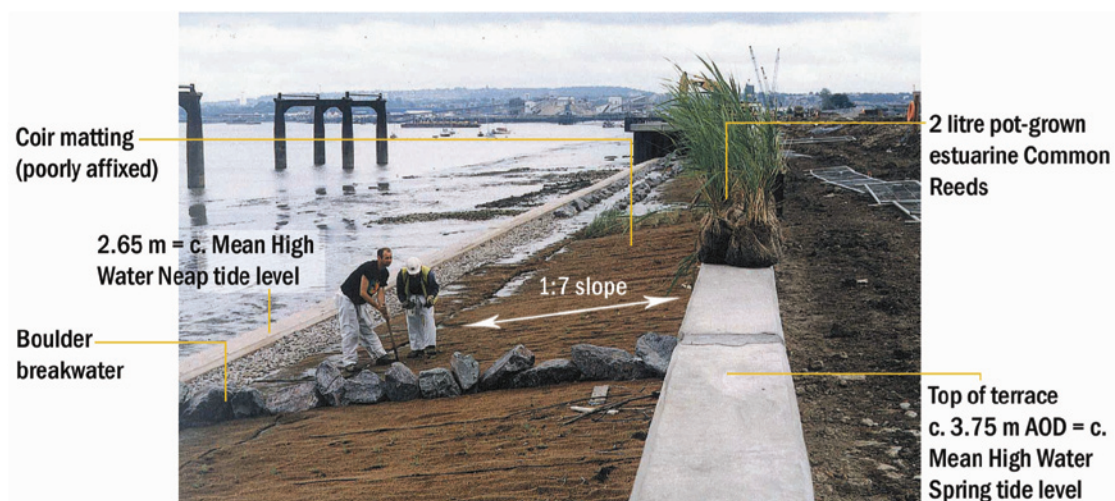
Eastern wall, Greenwich Peninsula, London: Site 2 during construction

In Case Study 6, Site 2, simple stepped terraces were created with gabions. Locally, at the highest tidal levels, wooden palisade was used to create the terrace, a technique also illustrated in Case Study 8 at the River Roding Mill Pool in a more protected location. Case Study 6, Site 2, also illustrates some of the issues relating to terrace substrate stabilisation using coir matting before planting. It is possible that the coir

matting may help to retain the material in severe storms prior to natural sorting and packing of infill material. If, however, the matting is not firmly installed, it may lift. Any plants planted early through the matting may be ripped out of location and lost, and require replanting. It may be appropriate to allow the substrate in the terraces to reach a stable equilibrium under such matting, and then remove the matting (if there is no accretion above it) and plant the terrace. Planting, however, through exposed protection matting is not recommended in an intertidal environment.

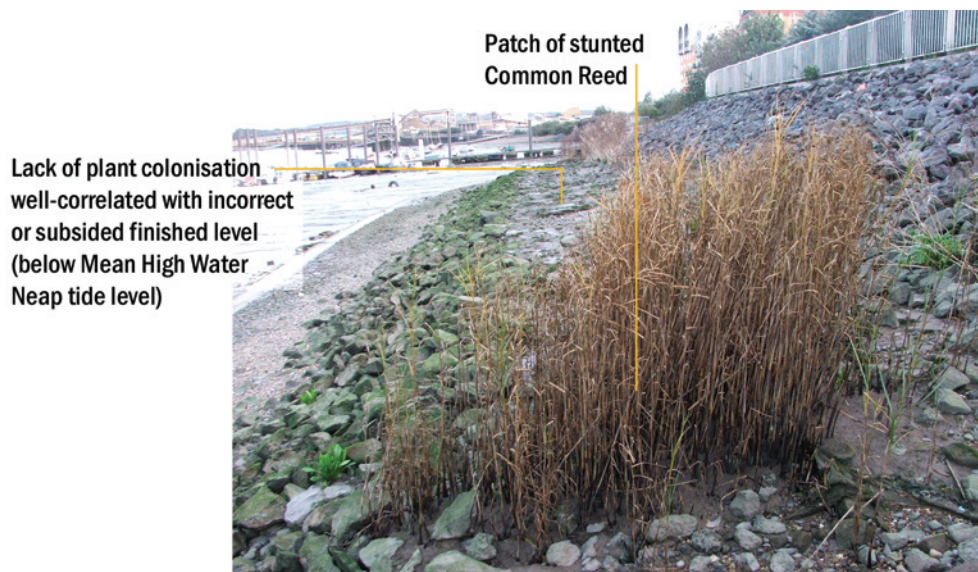
Greenwich Peninsula, London: Site 1 from south, eight years after implementation (winter)

Greenwich Peninsula, London: Site 1 from north, eight years after implementation (winter)

- In all locations, the existing sheet pile wall was cut down to near beach level and capped.
- Approximately 7–15m inland, either sheet pile or an L-shaped concrete wall were installed.
- Site 1: infill material was installed over wide area at stable angle of repose and allowed to colonise naturally.
- Sites 2 and 3: terraces were created between the new wall and the foreshore using gabions and wooden piles, maximising the area between Mean High Water Neap and Mean High Water Spring tide levels wherever possible at slopes of 1:7 or less. Growing medium initially protected under coir matting.
- Sites 2 and 3 were planted with a variety of saltmarsh plants through coir matting. Substrate particle size distribution was a close match to foreshore for both stability in local area and habitat value.

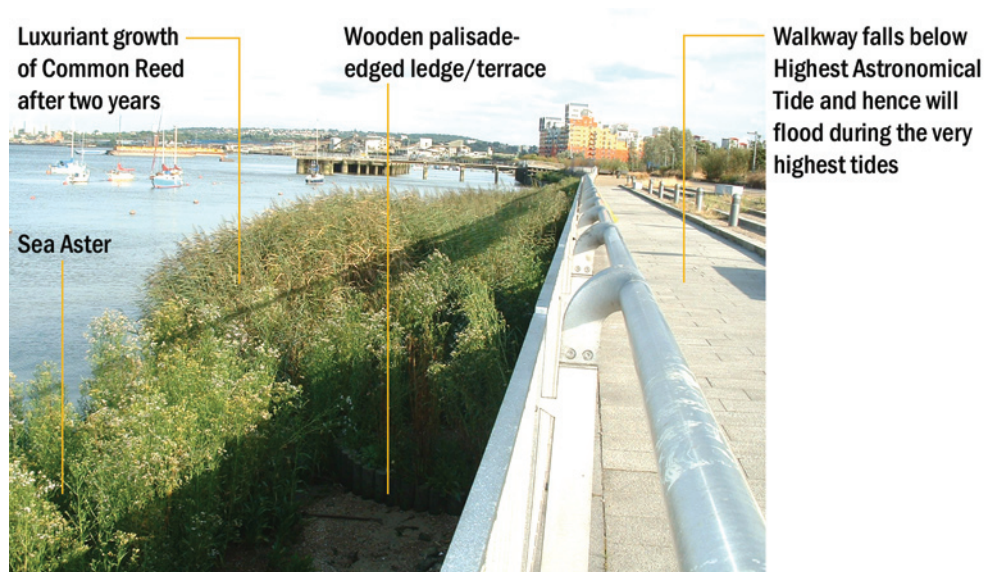
Eastern wall, Greenwich Peninsula, London: Site 2 north end, six years after implementation (autumn)

Eastern wall, Greenwich Peninsula, London: Site 2, south end, three years after implementation

- Wave action led to lifting of the matting and extraction of many young plants, necessitating some replanting, though there was also considerable natural colonisation.
- Re-planting of Sites 2 and 3 directly into substrate without erosion matting was most successful with Common Reed, Grey Club-rush Sea Club-rush and Sea Aster, several species surviving well below or above the main ‘saltmarsh zone’.
- Failure to install rhizome breaks has led to excessive dominance by Common Reed, which may need to be corrected.
- Freshwater outfall locations became areas bare of much vegetation, and reinforced geotextile mat used at these locations eventually looked unsightly.
- Extensive monitoring has shown intense use of the terraces by Sea Bass and other species.
- Flounder and adult Common Goby did not appear to ascend submerged terrace steps. One solution

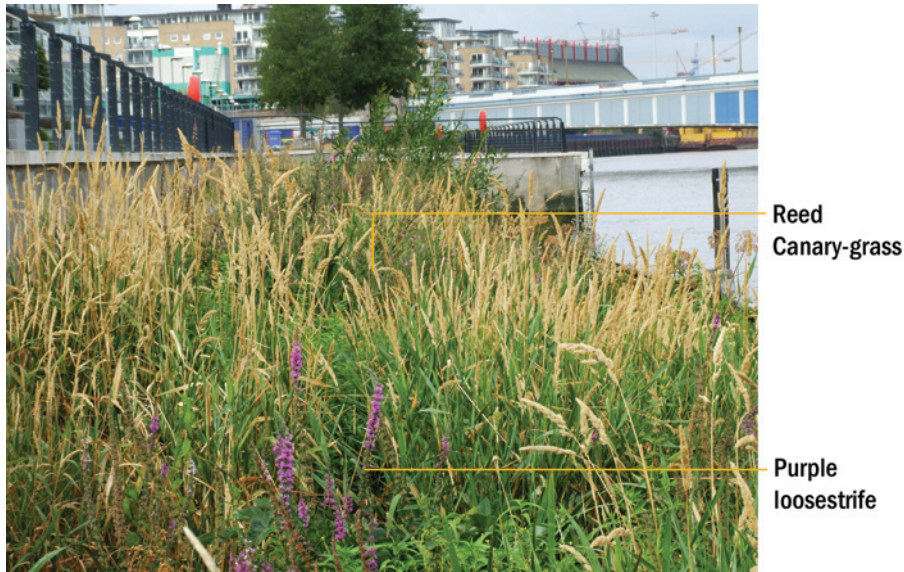
Battersea Reach, Thames, London: Top of slope after one year

- After two growing seasons the upper half of the terrace had established well. The coir pallets used in the upper terrace were more mature than those used in the lower areas and this may have affected their establishment.

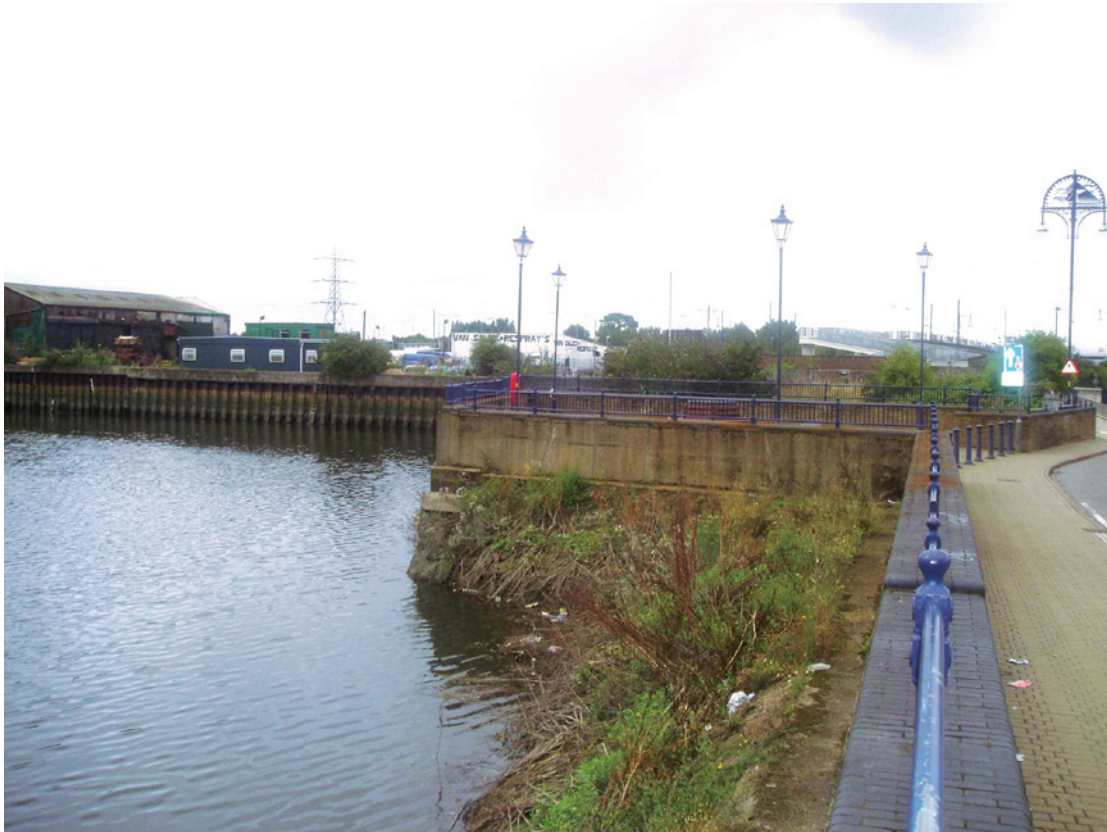
River Roding, London: Mill pool before enhancement

- River Roding opposite the town quay in Barking.
- Decaying concrete slope with invasion of common weeds and relatively low ecological value.

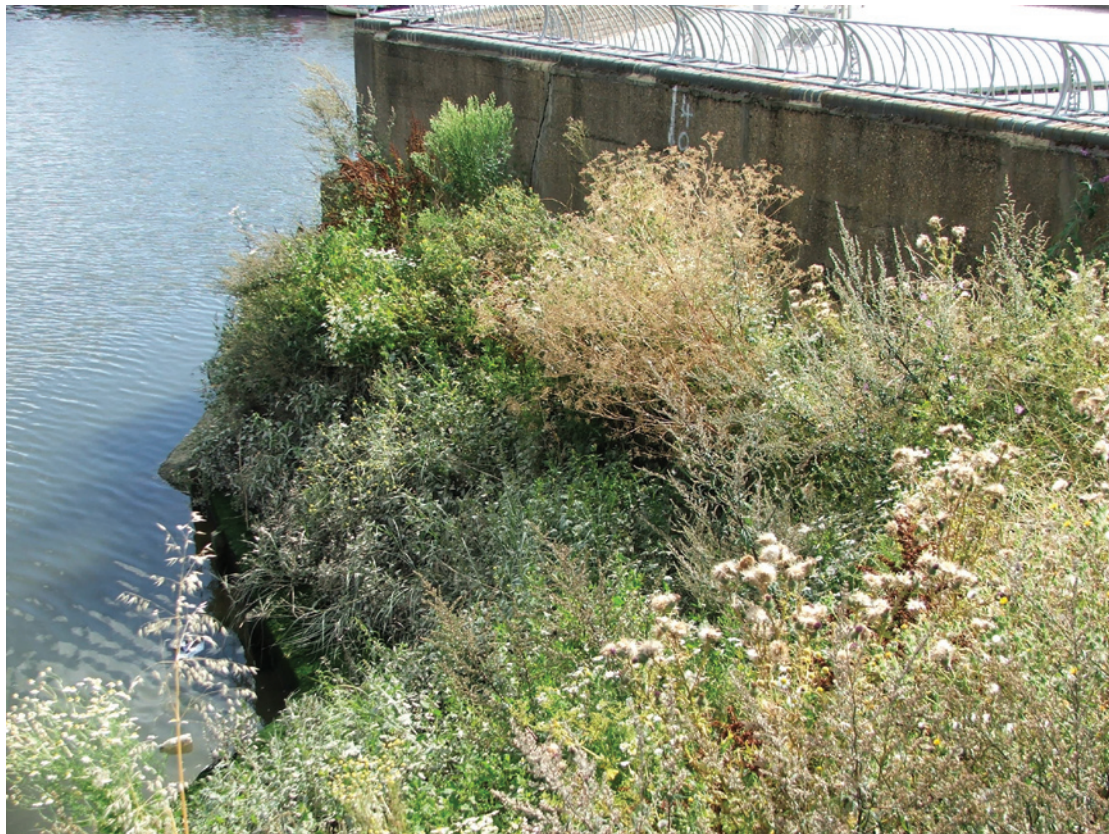
River Roding, London: Mill pool 16 months after vegetation establishment

- Very poor establishment of Sea Club-rush and Common Reed after 16 months, but dense vegetation of tall species of London brownfield sites. Lowest tidal level dominated by Amphibious Bistort.
- Nearby ledges on the river supported good stands of Branched Bur-reed and Common Reed.
- Not clear why intended planting was unsuccessful.
- Final design with reasonable ecological value, but relatively poor aesthetic value for its setting and planting strategy with pot-grown riparian stock may have produced better results.

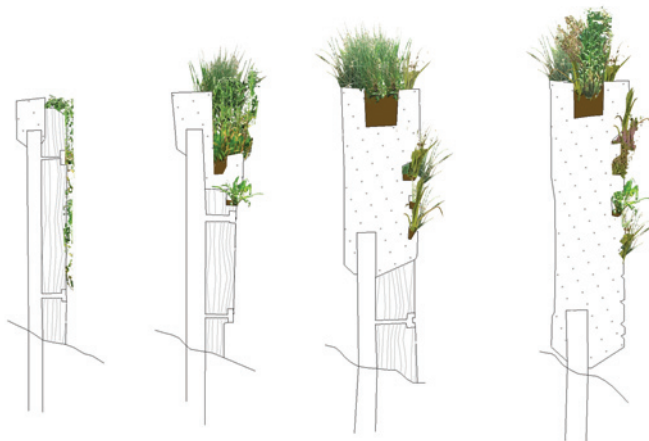
Different concepts for modified timbers to promote silt accumulation and plant growth

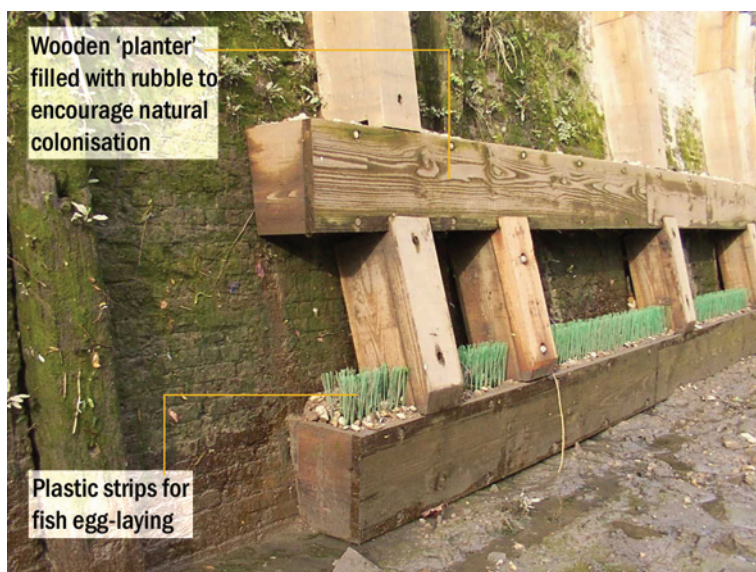
Deptford Creek, London: Timbering to river wall

If considerations such as inspection requirements, aesthetics or other functional requirements preclude panelling, it may still be possible to install wooden timbering. This is generally vertical and/or horizontal as shown in Case Study 9 where the timbering was actually designed as intertidal planters that were filled with rubble. Horizontal timbers will be most beneficial when located in the main intertidal plant growth zone. Timbers need not, however, be placed only in vertical and horizontal directions. Other features that may be added included grab ropes and chains and also plastic fronds or 'brushes' as substrates for egg laying by fish. As long as the time that these 'fish egg brushes' are exposed to the air is limited to a few hours each day, no harm comes to several species of fish egg laid on them.
