Rhode Island Department of Environmental Management  
Office of Water Resources – Shellfish Program

# 2019 Shellfish Program Classification Report

# Growing Area 1

## Upper Narragansett Bay 2019

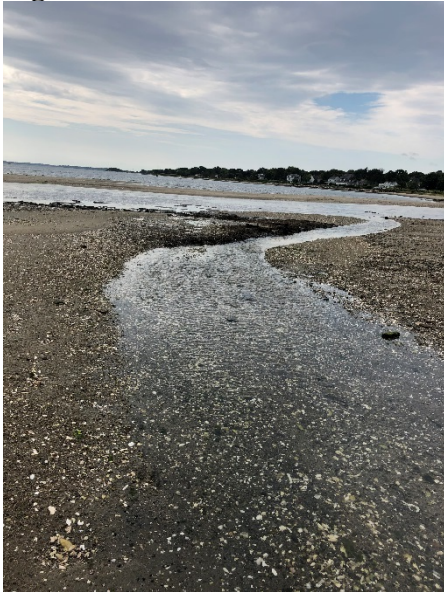
**Figure 2: Source 2019-1-001**

Source 2019-1-001 (Figure 2) is a stream that's 10 ft wide by 3 inches deep draining a small marsh that flows into the downstream portion of Buckeye Brook also referred to as Old Mill Creek before entering Upper Narragansett Bay. In 2018 this source was sampled with a fecal coliform result of >1600. When resampled in 2019 the source had a result of 100 cfu/100ml. The receiving waters of source 2019-1-001, Old Mill Creek, are prohibited. Old Mill Creek which is the outlet of Buckeye Brook flows into the Conditionally Approved waters of Upper Bay Conditional Area D. Since source 2019-1-001 was less than 240 cfu/100 ml this source does not require annual follow up sampling.

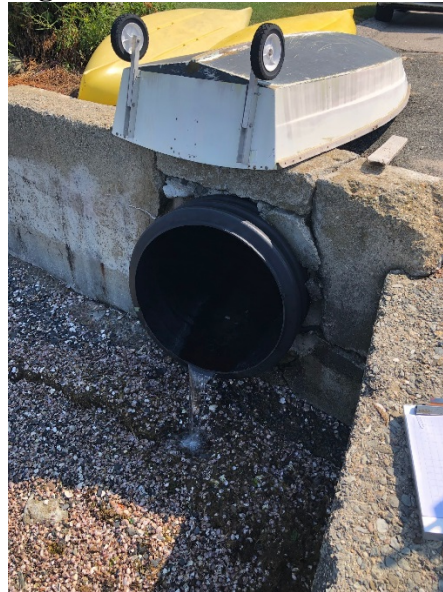
**Figure 3: Source 2019-1-075**

The only source sampled during this annual survey that was over the 240 cfu/100mL threshold was source 2019-1-075 (Figure 3), with a result of 300 cfu/100ml. This source is a 36" diameter corrugated plastic pipe that is placed in a seawall at the end of Fales Road in Bristol RI (Figure 4). The source flows directly into conditionally approved waters of Upper Narragansett Bay Area A. However, the flow of this source is very minimal, 0.02 cfs and must flow across a short portion of sand before reaching receiving waters. This source had a flow rate of only 0.02 cfs during dry weather and is not believed to impact the waters of GA1 when it is in the open status (dry weather). This source will be followed up on the next annual survey.

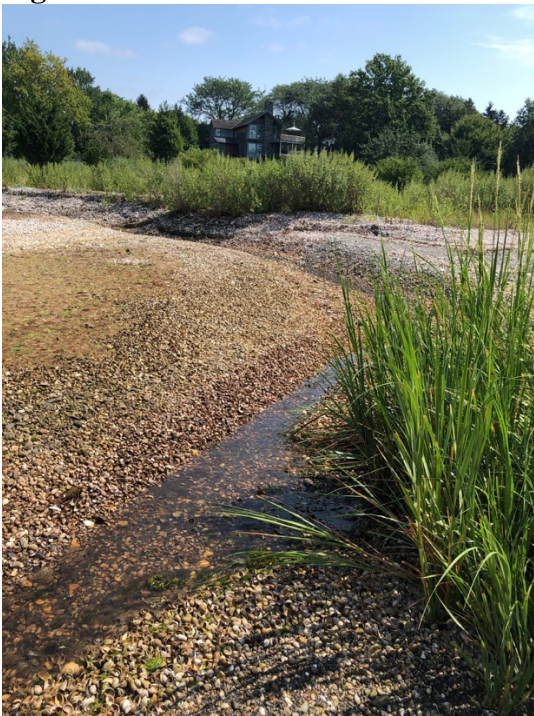
**Figure 3: Source 2019-3-039**

Follow-up sampling took place in October 2019 and three sources were actively flowing and able to be sampled (2019-3-039, 2019-3-201, and 2019-3-303 which was a new source found in 2018; Table 1). The locations of these sources relative to the growing area is shown in figure 2.

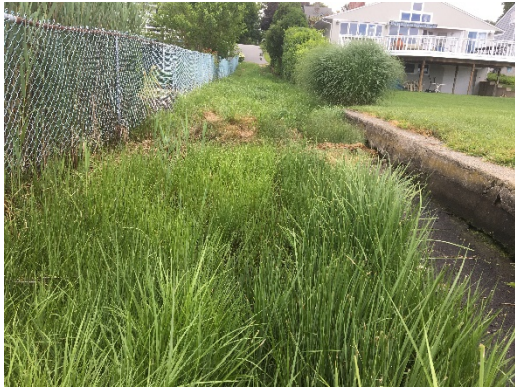
Two (2) sources were examined as part of the 2019 annual update. Source 5-013 (Figure 1) is a broken PVC pipe within the extension of the ROW of Chace Lane in Touisset. Originally identified as a groundwater seep, erosion has shown that this source is actually a broken pipe. Original sample results in 2015 had a result of 8,000 cfu/100ml. When sampled in 2018 Source 5-013 had a result of 720 cfu/100mL and when sampled in 2019 this source had a result of 100 cfu/100mL.

**Figure 1: Source 5-013, a seep at the end of a right-of-way at extension of Chace Avenue.**

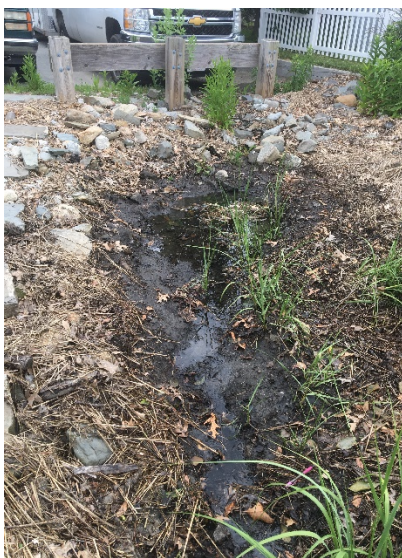
The second source examined during the 2019 annual update was source 5-030 (Figure 2) which is an 18” corrugated metal pipe at the end of Smith Street in Warren, RI. This source was initially sampled on 10/17/2017 and had a high FC result of 2,900 CFU/100ml. The flow was only a slight trickle and the area the pipe discharges to was filled with debris. Because of the high bacteriological results, this source was resampled on 11/2/2017 with a result of <100 cfu/100 ml. 2018 follow-up sampling at source 5-030 on 10/16/2018 showed a fecal coliform level of > 1,600 cfu.100 ml. 2018 Shoreline source sampling was completed on 10/16/2018 while the conditionally approved GA5 was in the closed status. Sampling was done four days after 1.66” rain at the Taunton rain gauge. At this time source 5-030 was only a trickle and the source was not reaching the receiving waters of the Kickemuit River (GA5). In 2019 this source was also sampled with a result of 5,000 cfu/100mL, this source was not flowing and was considered “stagnant”. The source was not reaching the receiving waters. The limited impact of source 5-030 on the receiving waters of GA5 is evidenced by the fact that nearby GA5 shellfish monitoring station 5-4 which is ~500 feet east of source 5-030 was in compliance during 2019 with a geometric mean fecal coliform of 2.9 cfu/100 ml with 0% of samples exceeding 31 cfu/100 ml when the area was open to shellfish harvest.

**Figure 2: Source 5-030, 18” corrugated metal pipe at the end of Smith Street, Warren, RI.**

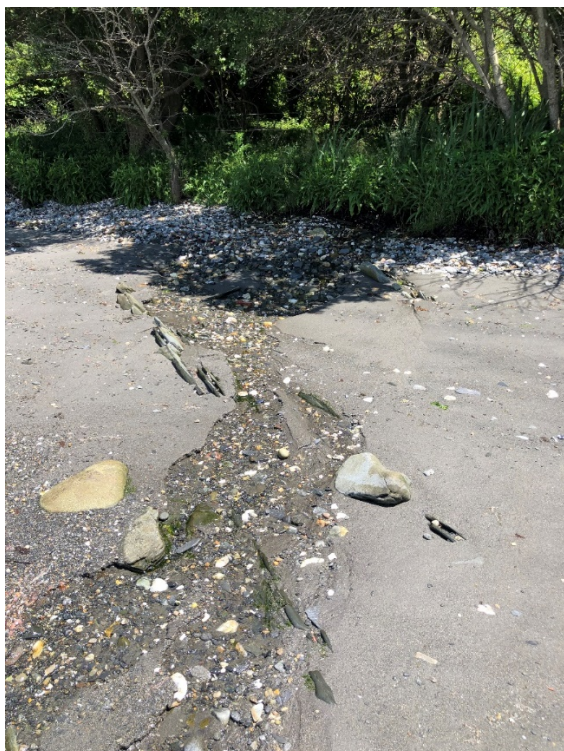
**Figure 3: Source 2019-7-1004**

Source 2019-7-1004 is a stream from an uphill wooded wetland on Jamestown Island. This is the only source that flows into the approved waters of the West Passage. In 2016 this source yielded bacteria results of 760 CFU/100 ml, and in the 2019 survey it yielded bacteria results of >1,600 CFU/ 100 ml. The flow rate at the time of this sample was 0.0015 cfs (Table 1). Given the minimal flow, bacteria from this source are rapidly diluted and are not expected to impact the growing area. This source will be closely monitored moving forward.

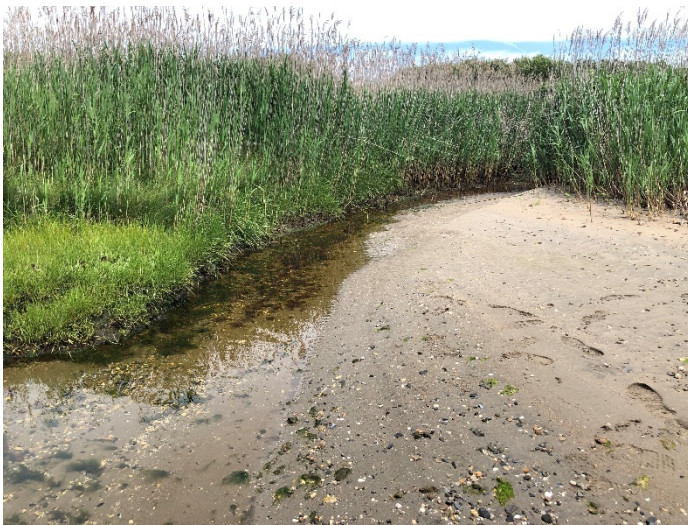
**Figure 2: Source 7-2-028 a small seep flowing out of uplands, through a *Phragmites* stand. Photo taken 7/1/2019.**

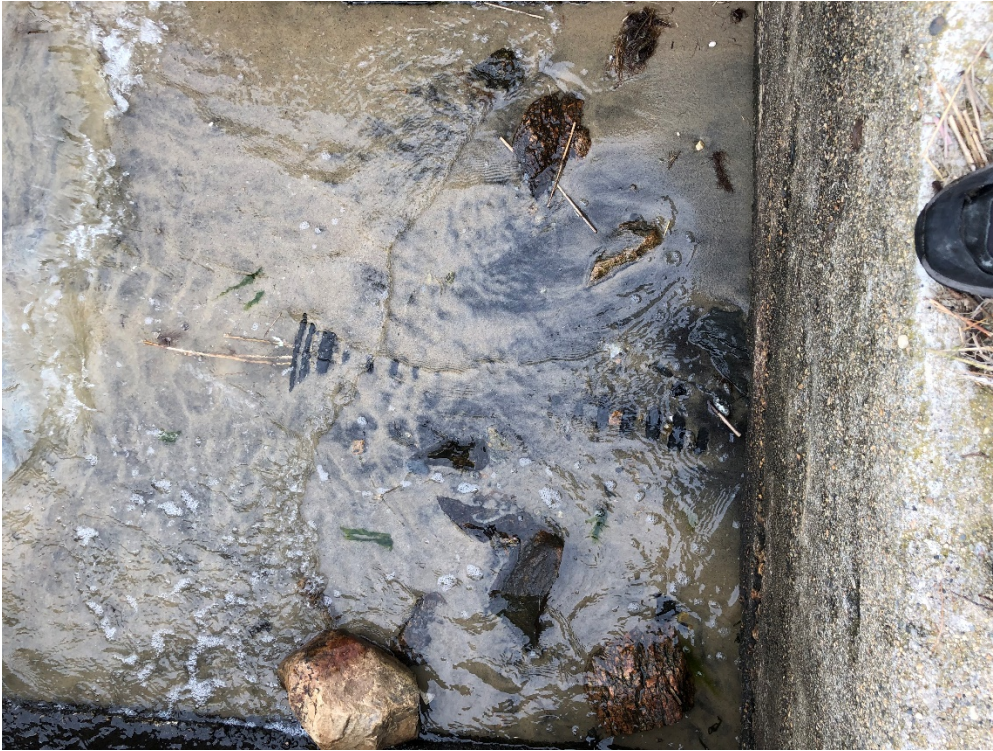
Source 2019-8-5-508 (Figure 3) had a fecal coliform level of 1,000 cfu/100ml during the 2017 12-year survey and a similar result when sampled in 2018 (1,100 cfu/100ml). For the 2019 annual survey this source was not sampled because it was non flowing as sand had filled in the source (a 15” corrugated metal pipe in the sea wall; Figure 3).

**Figure 3: Source 8-5-508, 15” pipe (filled with sand, no flow in 2019).**

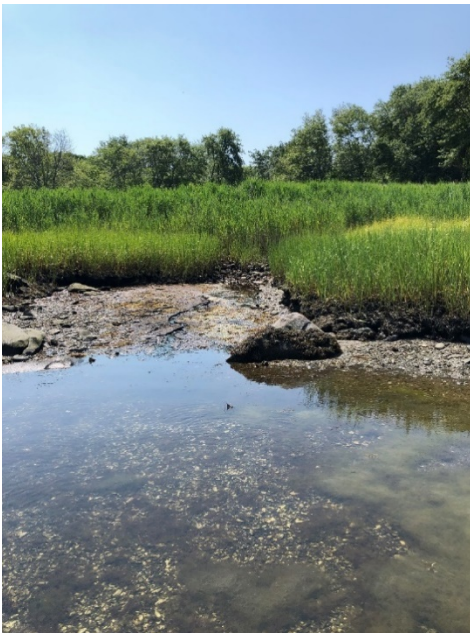
**Figure 5: Source 9-721**

Only one (1) source exceeded the 2,400 CFU/100 ml benchmark during the 2019 survey. This source (source 2019-9-721; Figure 5) was a small groundwater seep draining a wetland on the southern side of Sheep Pen Cove on Prudence Island that had a 3,600 cfu/100 ml on 7/29/19. The source was shallow had a low flow rate (.06 cubic ft/sec) and it is possible that the sample was contaminated with sediment during sample collection which may have contributed to the elevated results. However, instream samples collected north and south of where the seep enters the receiving waters had results of 9 cfu/100 ml (north of source) and 2 cfu/100 ml (south of source) demonstrating that this low-flow seep had little impact on the bacterial water quality of the growing area. This source should be resurveyed during the 2020 annual evaluation.

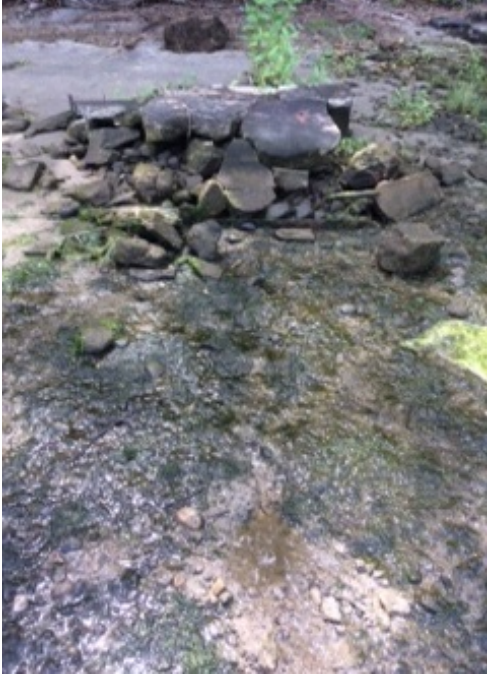
**Figure 6: Source 9-009**

Six (6) other sources had fecal coliform results of greater than 240 cfu/100 ml but less than 2,400 cfu/100 ml. These sources are highlighted in yellow in Table 1 and are described below. Source 2019-9-009, with a result of 300 CFU/100 ml, was a groundwater seep on the south bank of the Potowomut River. The flow was only a trickle (.0067 cubic ft/sec) and the source enters waters that are classified as prohibited. There is sufficient dilution in prohibited waters to mitigate this source before it could impact approved shellfish harvest waters.

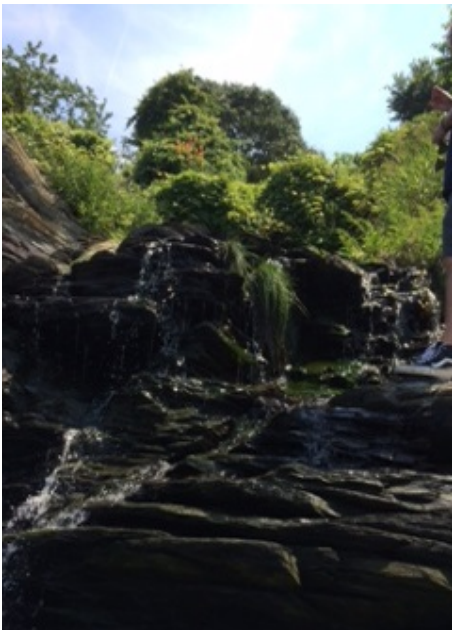
**Figure 7: Source 9-602**

The second source which exceeded the 240 cfu/100 ml limit was source 2019-9-602. This source is a small stream on the southwest side of Prudence Island that flows over a rock ledge directly into the water of GA9 that had a fecal coliform concentration of 300 cfu/100 ml. The stream had a low flow rate (0.18 cubic ft/sec) and the receiving waters are relatively deep and open to the West Passage of Narragansett Bay. This suggests that the fecal coliform from this source would be rapidly diluted and have little impact on the growing area.

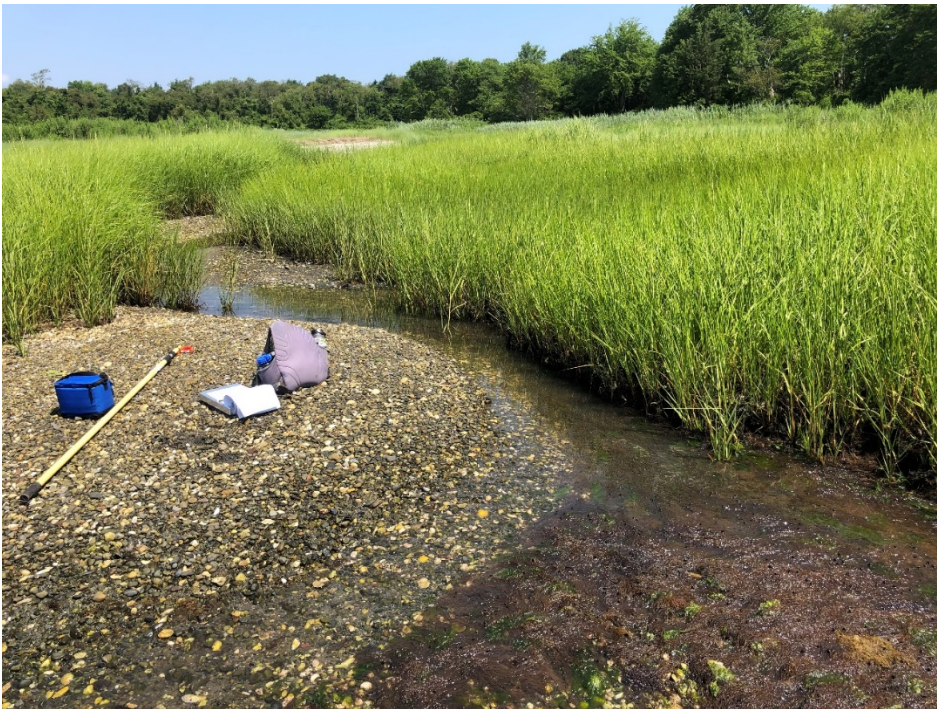
**Figure 8: Source 9-703**

Source 2019-9-703 is a tidal stream draining a salt marsh into Coggeshell Cove on the northwest portion of Prudence Island. This source had a fecal coliform result of 800 cfu/100 ml and a low flow rate (.0923543 cubic ft/sec) at low tide. This source flows into an approved area. However, instream samples results showed low fecal coliform concentration (16 cfu/100 ml north of the source; < 2 cfu/100 ml south of the source). The low flow rate of this source and the low in-stream results demonstrated that this source has little impact on the fecal coliform water quality of the growing area.

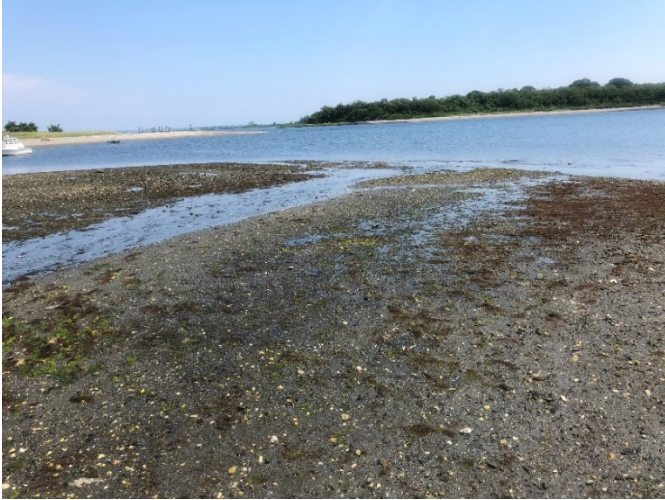
The fifth source which exceeded the 240 CFU/100 ml benchmark was source 2019-9-729. This source is a small stream (flow rate of .79 cfs) draining a marsh on the west side of Patience Island, a small island having no permanent residences. This source had a result of 400 cfu/100 ml. Companion in-stream samples had low fecal coliform results of 2 cfu/100 ml (in stream north) and 2 cfu/100 ml (in stream south). The low in stream fecal coliform results indicated that the source is quickly diluted by the relatively deep and tidally flushed receiving waters.

**Figure 9: Source 9-729 viewed flowing into Coggeshall Cove.**

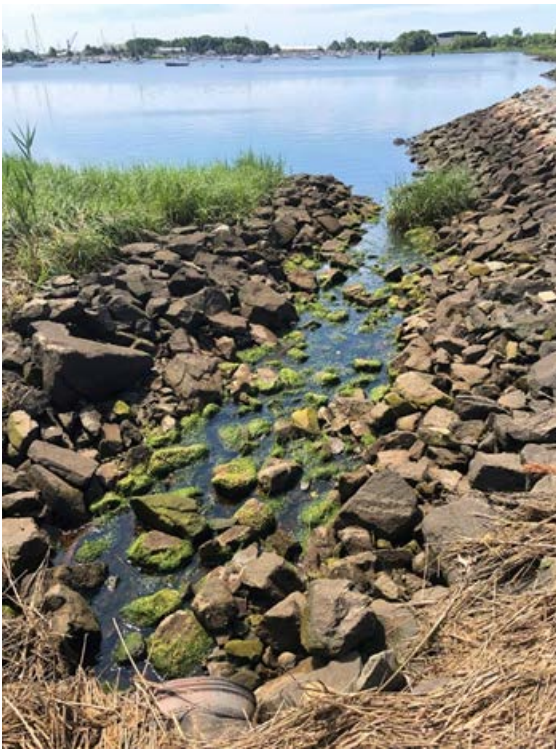
The final source which exceeded the 240 CFU/100 ml benchmark was source 2019-9-800, with a result of 300 CFU/100 ml. This source is a 24” culvert draining a marsh and flowing into the prohibited waters of Allen Harbor in North Kingstown. The flow rate of this source (1.28 cubic ft/s) and the volume of water in the prohibited zone indicate that there is sufficient dilution within the prohibited area such that this source will have no impact on the water quality of the approved portion of the growing area.

**Figure 10: Source 9-800 flowing into Allen Harbor.**

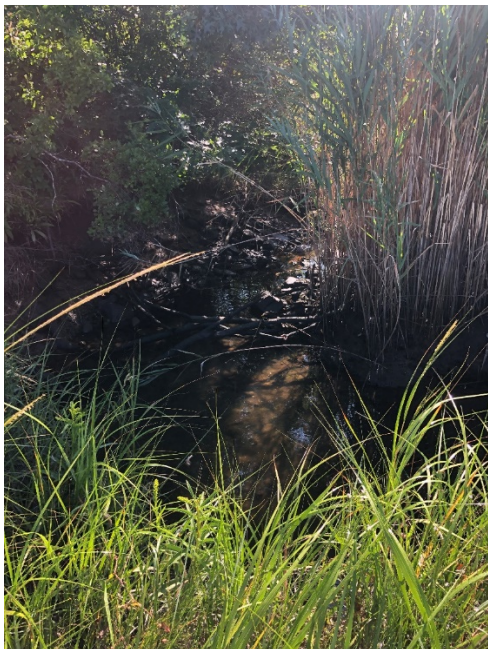
**Figure 3. Source 2019-10-34, a small stream entering Long Cove, Narragansett.**

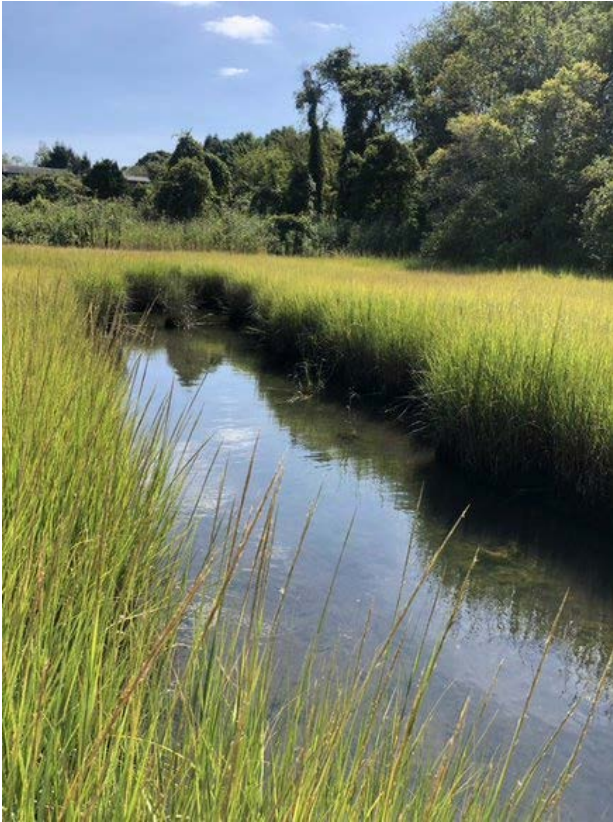
**Figure 4. Source 2019-10-50**

Source 2019-10-50 is a small stream (1.02 cfs) that flows into the Prohibited waters of Upper Pt. Judith Pond. This source had a fecal coliform concentration of 300 cfu/100 ml on 9/9/2019. This source is approximately 1.2 k (0.75 miles) from the Conditionally Approved waters of GA10. There is sufficient dilution within the Prohibited zone so that this source is not negatively impacting the Conditionally Approved waters of GA10.

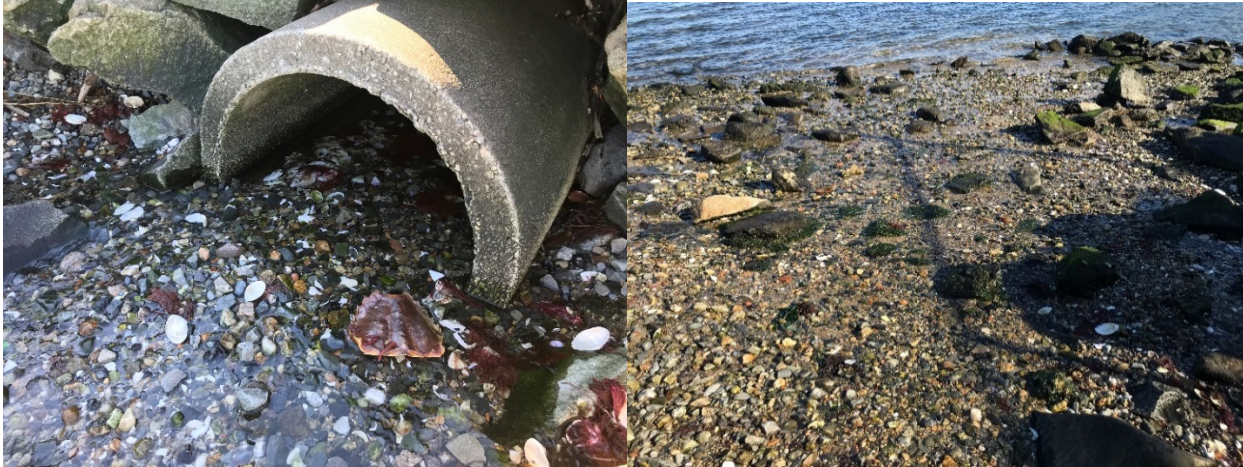
**Figure 3: Source 16-001**

Source 16-001 (Figure 3) is located on the western side of the growing area just north of Conimicut Point. Source 16-001 is a 24” reinforced concrete pipe that discharges onto the shoreline near the northern extension of Symonds Avenue. The flow then crosses the narrow beach in a shallow seep (24” wide by < 1” deep). When sampled the pipe was approximately 50% filled with gravel and sand, considerably decreasing its potential flow rate. When sampled on 12/27/2019, the flow was a trickle and a fecal coliform concentration of <100 cfu/100 ml was observed. This source flows into waters that are currently classified as prohibited.

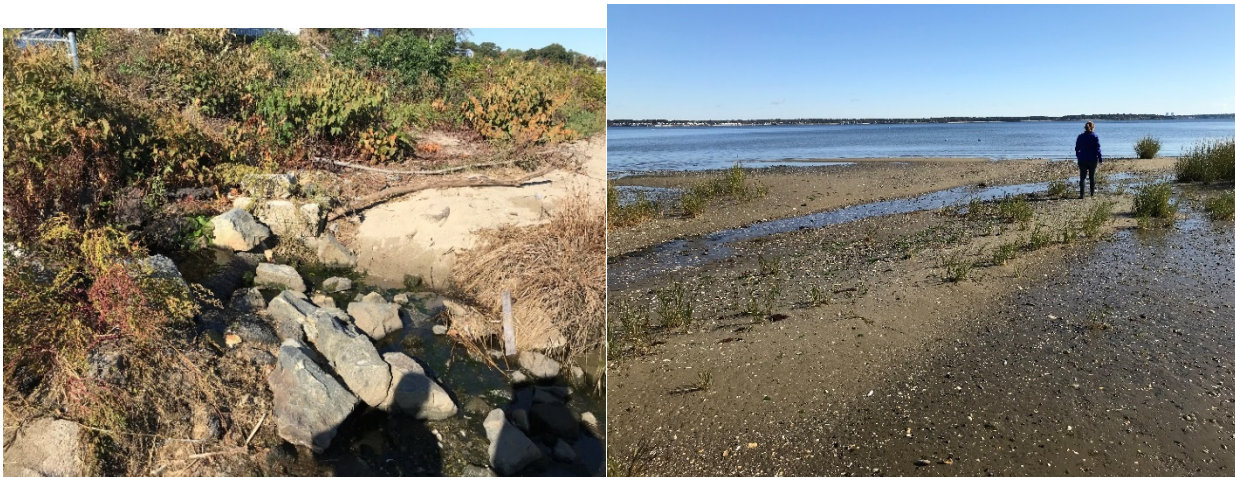
**Figure 4: Source 16-022**

Source 16-022 (Figure 4) is a small stream (approximately 1 foot wide) that drains a vegetated area near the end of the northeast extension of Rock Avenue in Warwick, RI. On 12/27/2019, the fecal coliform level was 6,700 cfu/100 ml in the trickle/stream as it crossed the beach. Most of the flow dissipated into the sand before reaching the receiving waters. In 2018, an in-stream sample in the nearby receiving waters yielded a fecal coliform result of <100 cfu/100 ml indicating rapid dilution of this source in the receiving waters.

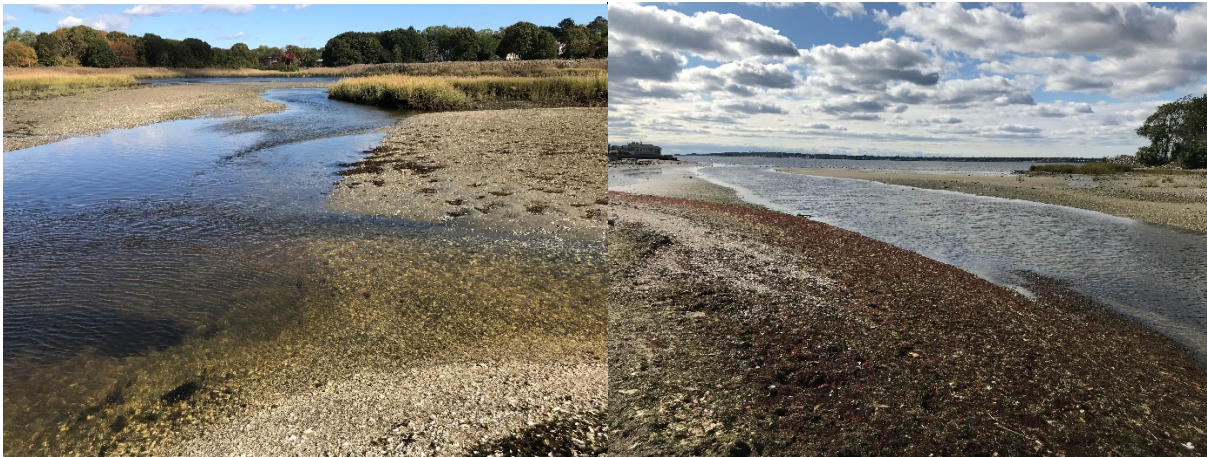
**Figure 5: Source 16-087A**

(<http://www.edc.uri.edu/restoration/html/intro/stories.htm>) in an effort to improve habitat conditions in the area. A sample collected at the mouth of this tidal stream during ebb tide yielded a fecal coliform result of 40 cfu/100 ml on 10/22/2018 and <100 cfu/100 ml on 12/27/2019. The receiving waters of GA16 are classified as prohibited to shellfish harvest.

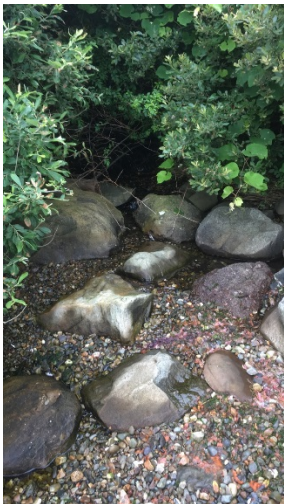
**Figure 2: Source 17-012**

The 2019 annual survey sampled one (1) source: source 17-012. Source 17-012 is a small stream (0.002 cfs flow) that flows into the conditionally approved waters of Mt. Hope Bay (Figure 2). This source had elevated results during the 2018 survey, but a fecal coliform concentration of 300 cfu/100 ml was observed during the 2019 survey (Table 1). Given the low flow rate, the recent reduced fecal coliform result and the fact that the receiving waters to which this stream flows are conditionally approved and close after 0.5” rain, this source is not currently negatively affecting the microbial water quality of growing area 17. In addition, nearby monitoring station 17-16 had acceptable water quality (geometric mean of 3.1 cfu/100 ml and 0% of recent 15 observations exceed 31 cfu/100 ml) during 2019, further demonstrating that this source is not negatively impacting the fecal coliform water quality of GA17 when the area is in the open status.
