NASA-MSC-G-R-65-5
Supplemental Report 1

GEMINI AGENA TARGET VEHICLE 5002 SYSTEMS TEST EVALUATION (45 DAY REPORT)

This report, prepared by Lockheed Missiles & Space Company in compliance with Contract AF 04(695)-545, documents the flight performance evaluation and failure diagnostic analysis of Gemini Agena Target Vehicle 5002 launched from the Air Force Eastern Test Range on 25 October 1965.

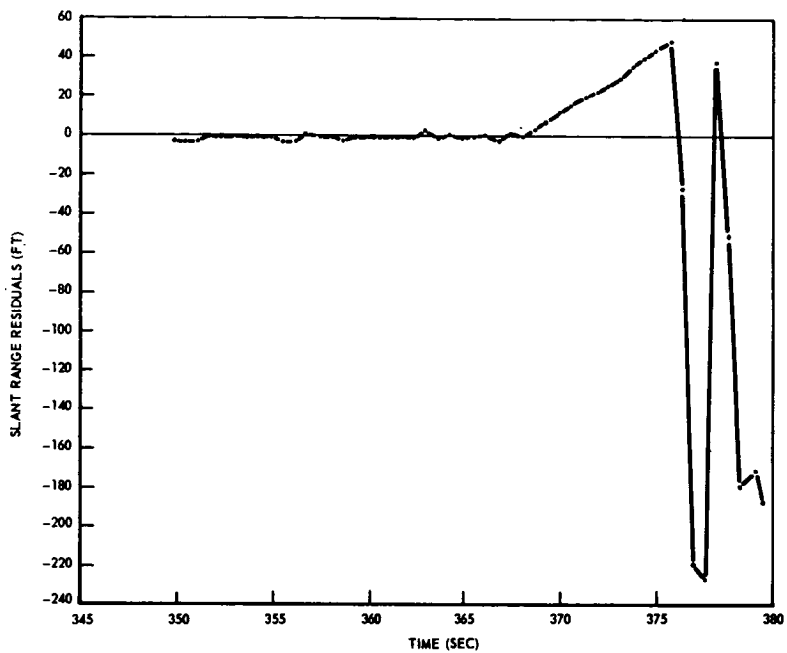
Fig. 2-3 Slant Range Residuals vs Time With No PPS Impulses (Average Between 345 and 380 Sec)

From this plot it was deduced that the adjusted postflight simulation provided an adequate representation of the system performance from the start of the SPS up to approximately ~~268~~³⁶⁸ sec from liftoff, at which time a short duration impulse introduced a velocity not included in the simulation. This is consistent with an impulse from the PPS shortly after ignition was commanded. In addition it is apparent from Fig. 2-3 that an anomaly was introduced at a time consistent with the loss of signal experienced on telemetry channels.

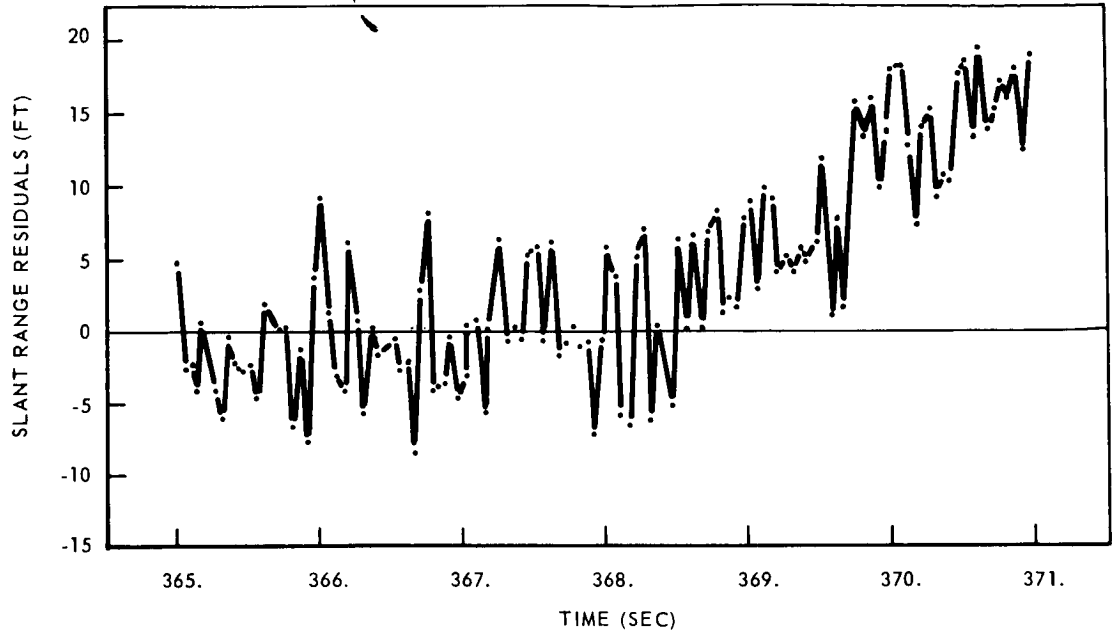
Fig. 2-4 Slant Range Residuals vs Time With No PPS Impulses (Detail Between 365 and 371 Sec)

The residuals for the individual data points for a 6-sec interval spanning the discontinuity at 368 sec are plotted on an expanded scale in Fig. 2-4. From the slopes of these residuals before and after the impulse, it was determined that the velocity deviation was 6.4 fps corresponding to an impulse from all sources of 3550 lb-sec. To determine the time of the start of the impulse and its duration, reference was made to the X-axis accelerometer trace, and the impulse was simulated by a square-wave function starting at 368.15 sec and lasting for 0.5 sec. The residuals obtained with the PPS simulation are plotted in Fig. 2-5 for comparison with Fig. 2-3.

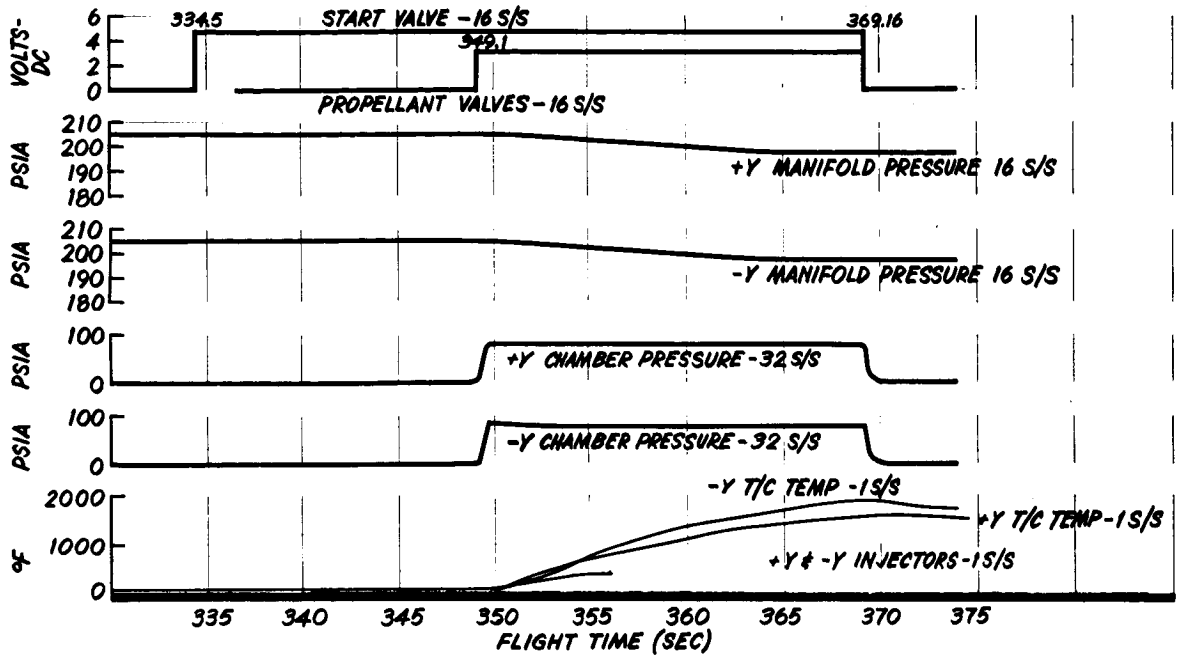
Fig. 3-3 Secondary Propulsion System Performance

3.3.1.2 Discussion. The operational characteristics of the important SPS parameters are presented in Fig. 3-3; operation of both SPS's was limited to one Unit I TCA operation each, for propellant orientation for the main engine. The prelaunch gas and liquid pressures were within nominal limits. During ascent, gage pressure readings, showed an increase with the corresponding drop in reference pressure on the gage transducers. During the boosted phase of ascent, the propellant feed pressures on both systems changed for vehicle acceleration, as expected, and the gas pressures held constant, also as expected. The start-valve lead period was normal, except propellant tank pressures did not increase as expected, but remained at a constant value. For regulator lockup conditions, propellant tank pressures should have been approximately 212.5 psia for both systems (see Table 3-3). Since propellant tank pressures were approximately 205 psia prior to start-valve actuation, and for a 16-sec lead it is expected that a regulator lockup will occur, the propellant tank pressures should have increased on both systems. (This anomaly is discussed below.)

The thrust-chamber skin temperature (TCST) recorded for the +Y system was approximately 1615° F at shutdown. (See Fig. 3-3.) Since expected temperature at shutdown for a 20-sec firing would be in the 1800° F to 2000° F range, it is concluded

expected during the start transient, but the peak experienced was about 6 percent above the steady-state value as compared with the nominal peak of about 3 percent over steady state. The normal peak endures for approximately 1 sec, whereas the discrepancy noted had a duration of approximately 3 sec. (See Fig. 3-3.) For the remainder of the thrust-chamber operation, TCP was normal and decayed as expected, reflecting the decay in feed pressures.

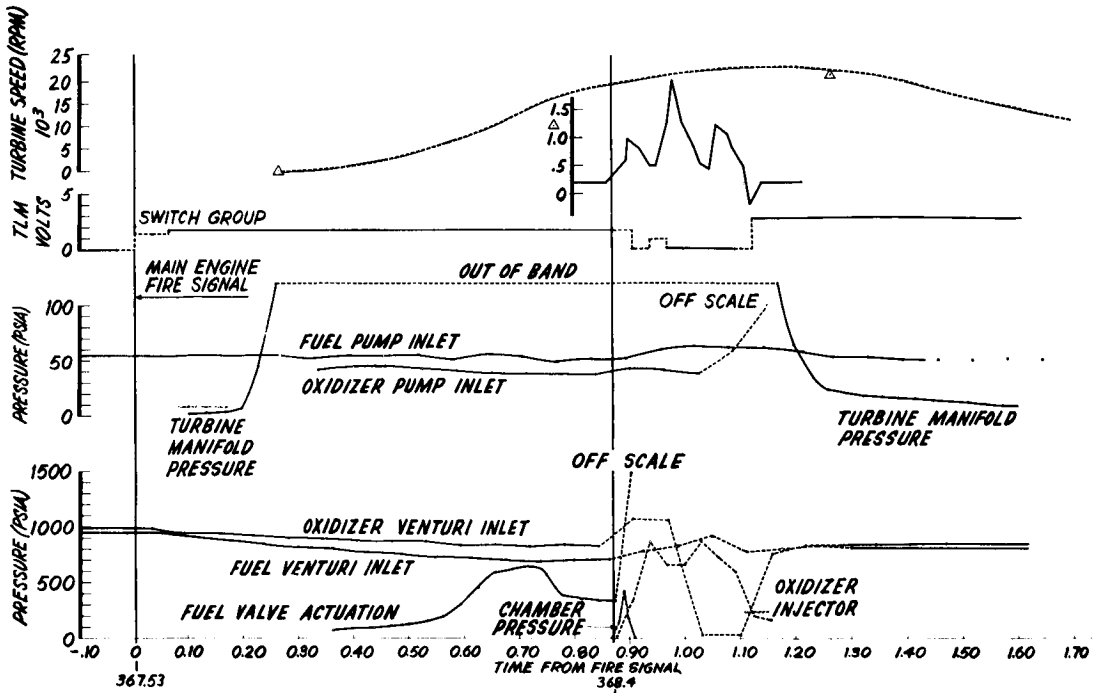
Fig. 3-4 Primary Propulsion System Start and Shutdown Data

Plots of significant PPS data and temperature measurements in the aft rack area during the time period between fire signal and loss of the telemetry are presented in the following pages. An expanded time scale plot of significant PPS data during the engine start/shutdown period is presented in Fig. 3-4. Individual measurements and the significant PPS data they provided are as follows:

- a. P139, "Engine Switch Group" Measurement (Figs. 3-4 and 3-5). B139 rose normally from zero to 1.75v at fire signal and indicated that pilot-operated solenoid valve (POSV), the oxidizer gas generator valve (OGGV), and the fuel gas generator valve (FGGV) were drawing power. At 368.44 sec, B139 abnormally dropped to zero volts, indicating removal of power from the engine solenoid valves. B139 continued to present the abnormal indication of zero volts until 368.62 sec, except for a single 0.8v reading at 368.47 sec and another single 0.15v reading at 368.50 sec, then rose to 2.90v at 368.66 sec and remained at 2.90v until loss of telemetry. To date, no single electrical malfunction mode has been found that offers a satisfactory explanation for these data.

- h. B11, "Oxidizer Venturi Inlet Pressure" Measurement (Figs. 3-4 and 3-6). B11 began to blow down normally due to oxidizer flow into the gas generator following the engine start signal. It showed a sudden rise from 830 psi to 1080 psi at 368.44 sec, a drop to almost zero psi at 368.56 sec, a recovery to 760 psi at 368.69 sec, and a final rise to 840 psi at 368.75 sec. It remained at 840 psi until loss of telemetry, which indicates closure of the oxidizer gas generator valve. The pressure fluctuation began approximately at the same time as the beginning of thrust-chamber area measurement anomalies (thrust-chamber-pressure, oxidizer-injector-pressure, and fuel-valve-actuation-pressure anomalies). This measurement may actually be reflecting a pressure surge that had been distorted and elongated by the start tank acting as an accumulator. The relatively large mass of the start-tank bellows makes the bellows continue to move, once it has been set in motion by a pressure surge, because of inertia. Once the surge has passed, movement of the bellows away from the liquid for a finite period of time would account for the zero psi indications for the referenced period.

- i. B12, "Fuel Venturi Inlet Pressure" Measurement (Fig. 3-4 and 3-6). B12 began to blow down normally due to fuel flow into the gas generator following the engine start signal. It showed a rise from 715 psi to 920 psi between 368.39 and 368.58 sec and a decrease to 780 psi at 368.64 sec, which is similar to what is normally observed on engine shutdown. A rise normally occurs between the time of main-fuel-valve closing and oxidizer-gas-generator-valve closing (fuel pump is unloaded). A decrease normally

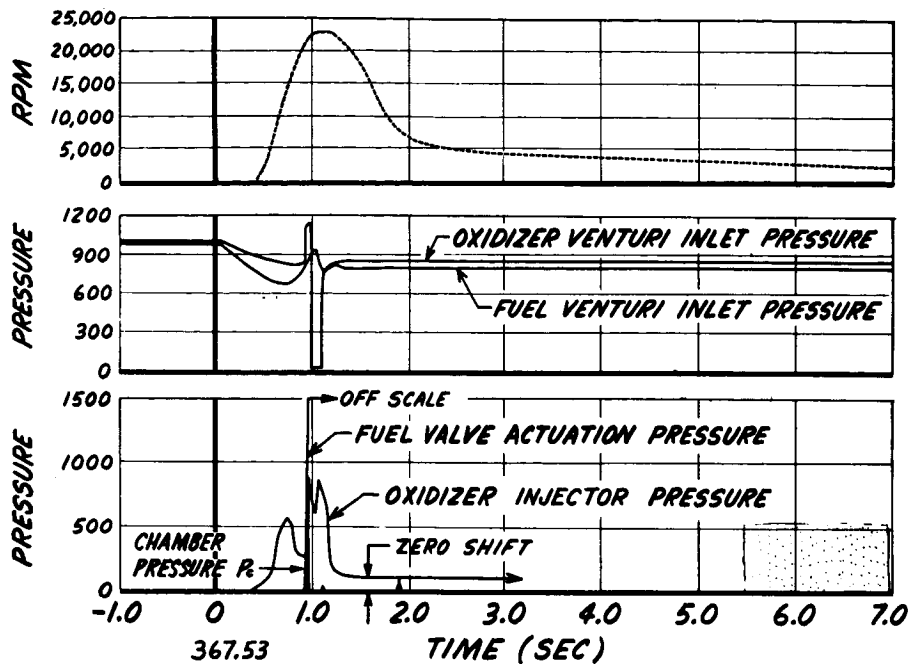
Fig. 3-6 Turbine RPM and Venturi-Inlet, Fuel-Valve Actuation, Oxidizer-Injector, and Thrust-Chamber Pressures

occurs between the time of oxidizer-gas-generator-valve closure and fuel-gas-generator-valve closure (power is removed from turbine, pump speeds decrease, and fuel flows into the gas generator from the fuel start system).

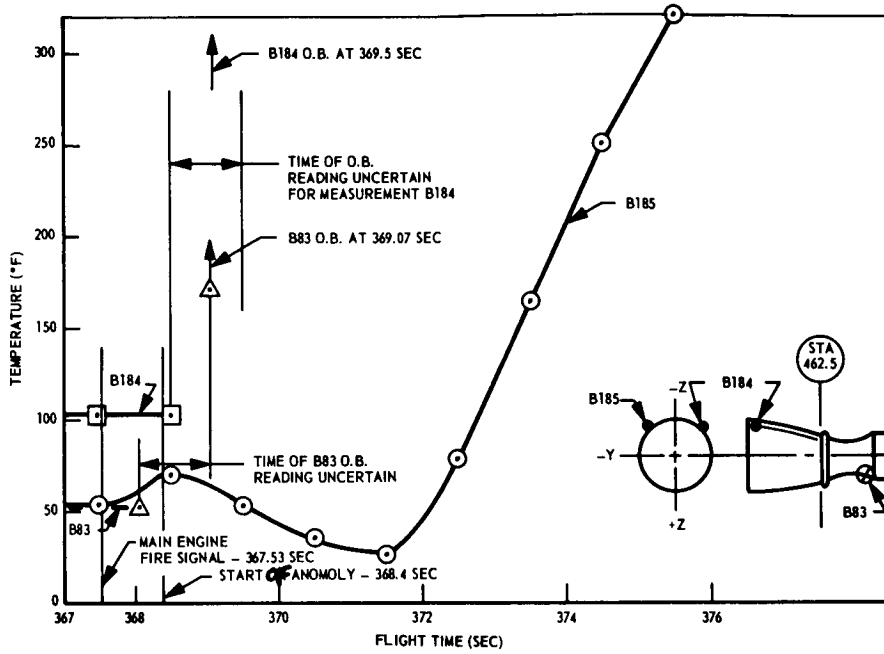
Fig. 3-7 Nozzle-Extension (B184 and B185) and Thrust-Chamber (B83) Surface Temperatures

- n. B184 and B185, "Nozzle Extension Temperature" Measurement (Fig. 3-7). These measurements are located on the exterior of, and approximately 2 in. from, the exit plane of the thrust-chamber-nozzle extension. B184 indicated a temperature approximately 50° F higher than B185 prior to engine start; its performance is considered normal because of its proximity to one of the operating SPS chambers. B184 abruptly went full scale and was lost at approximately 369.00 sec (coincident with SPS shutdown); during the engine start period, it showed a rise from 52° F to 70° F, followed by a decrease to 27° F, terminating with a rise to 340° F during the last 4 sec of data. This last rise raises the question of a possible fire in the area of the measurement.

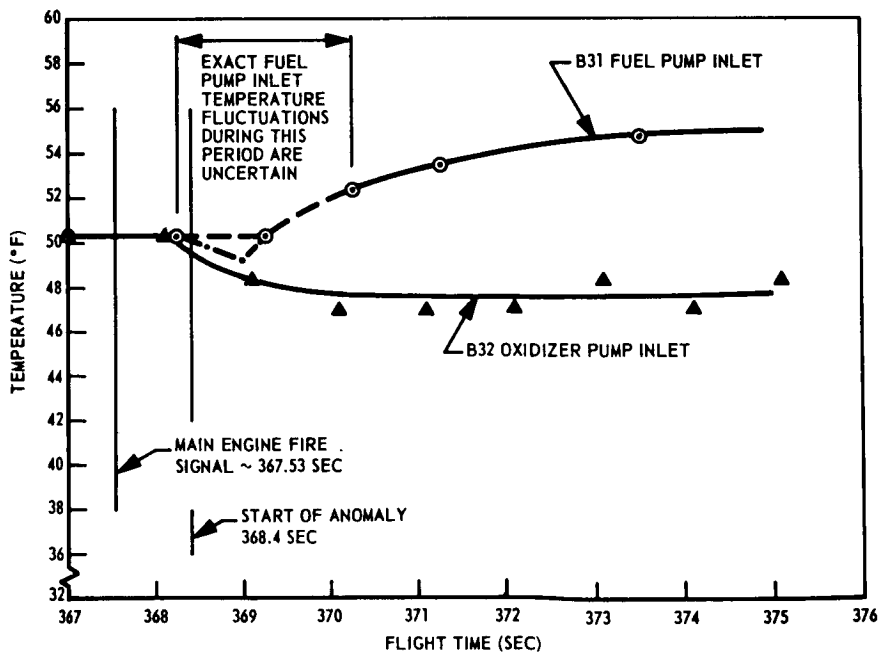
Fig. 3-8 Propellant-Pump-Inlet (B31 and B32) Temperatures

- o. B31, "Fuel Pump Inlet Temperature" Measurement (Fig. 3-8). B31 showed a slight rise between fire signal and loss of telemetry, which is indicative of little or no fuel flow.

- p. B32, "Oxidizer Pump Inlet Temperature" Measurement (Fig. 3-8). B32 showed a slight decrease between fire signal and loss of telemetry, which is indicative of oxidizer flow during engine start and shutdown transient.

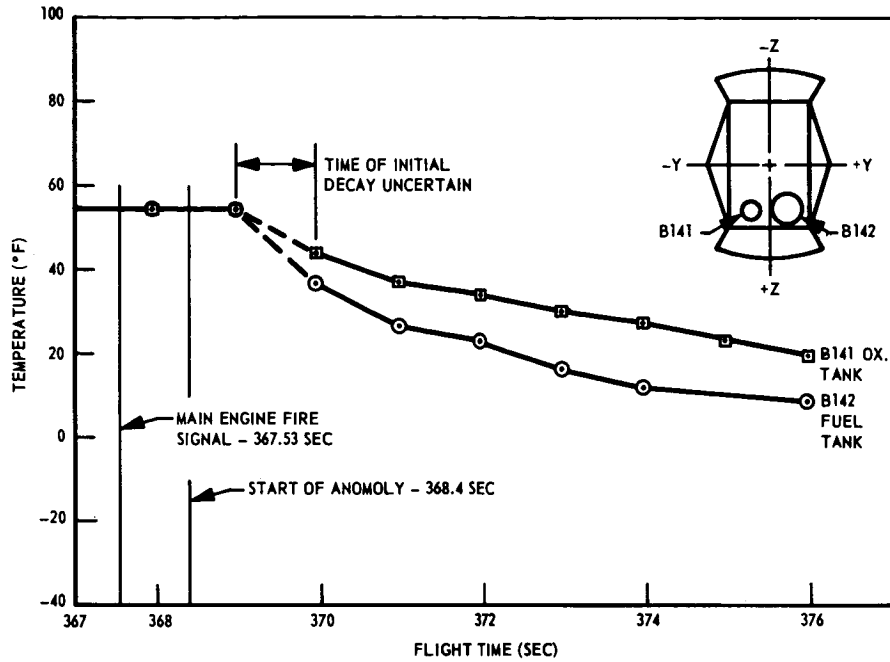
Fig. 3-9 Propellant Start Tank (B141 and B142) Temperatures

- q. Aft Rack Temperatures (Figs. 3-9 through 3-13). Temperature measurements in the aft rack that were not significantly shielded from the engine area showed a marked decrease during the time period from thrust chamber area measurement anomalies to loss of telemetry. These decreases could have been caused by propellant leakage, but it has not been possible to establish firmly whether the leak started before, coincident with, or after the thrust-chamber-area-measurement anomalies because of uncertainties in predicting time periods for transfer of liquid from leak point to measurement area, boiloff, and measurement response.

portion of the aft rack as noted by the drop in temperature on the shear panels, the aft bulk-head, and the start tanks. (See Figs. 3-9, 3-12, and 3-13.)

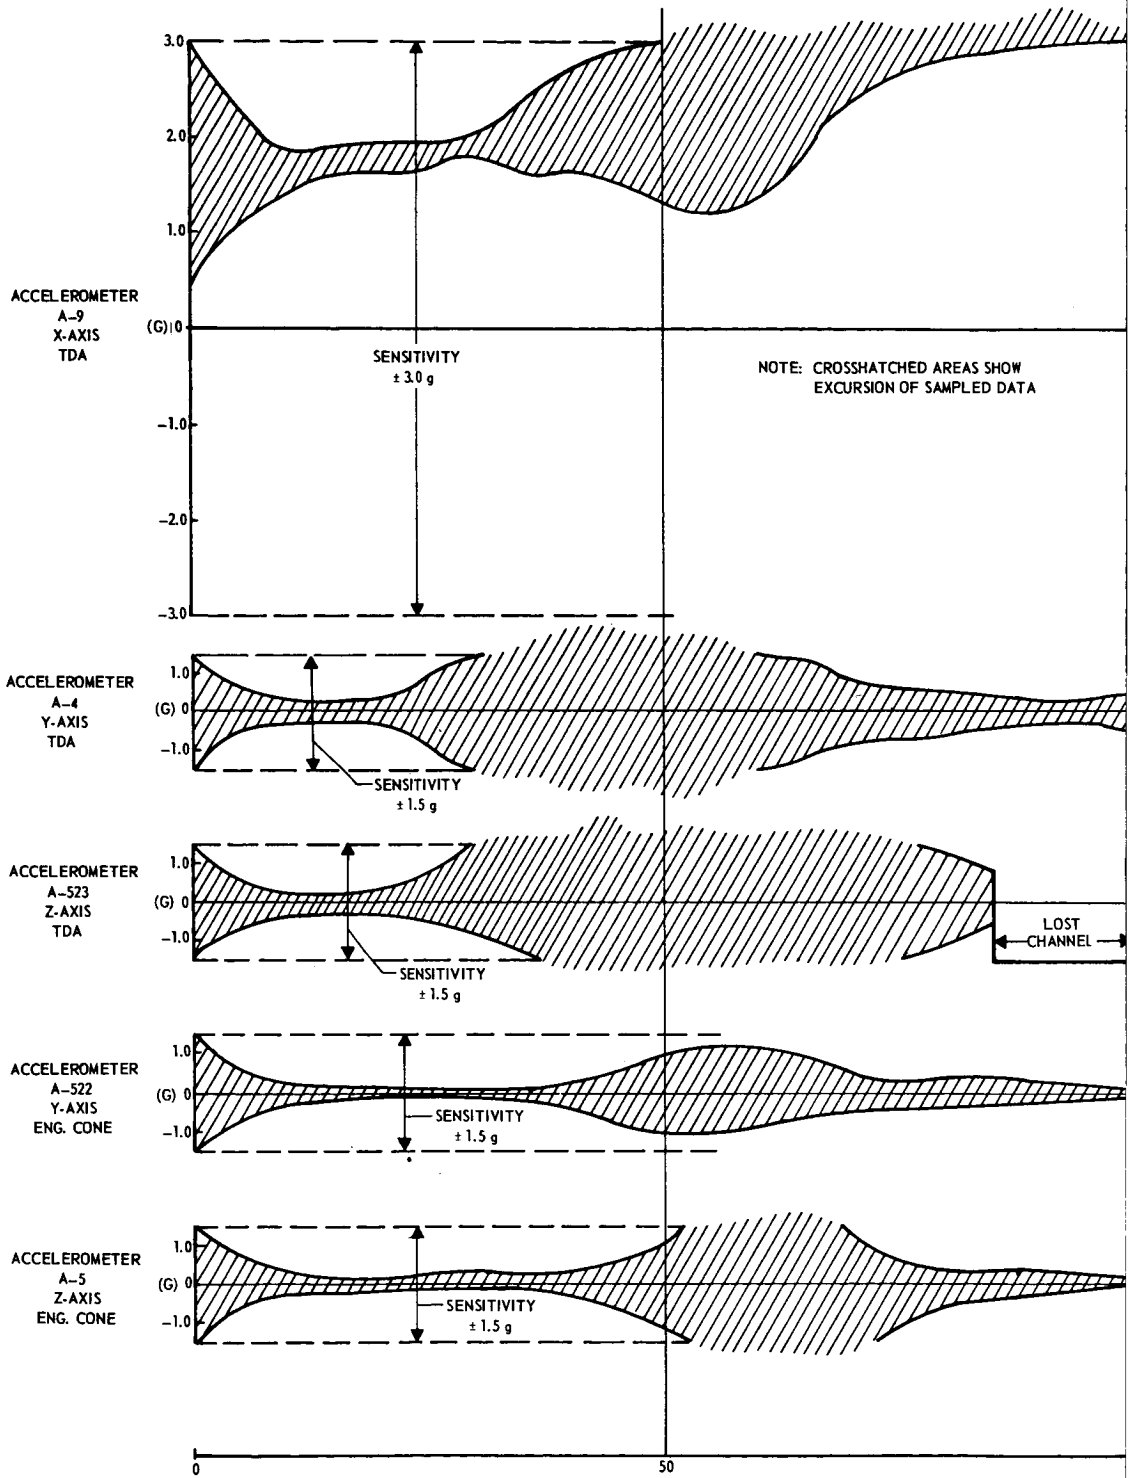
Fig. 3- 20 Accelerometer Status Time History

Figure 3-20 shows the results of this data analysis in the form of envelopes of the maximum and minimum signals from each of the five accelerometers versus flight time. This "broad-brush" treatment of the dynamic activity occurring throughout flight indicates the expected high activity at liftoff and during the transonic phase. The low sensitivity of the longitudinal instrument caused it to become saturated at about 50 sec after liftoff when the steady state acceleration approached +3 g. Details of the SECO, VECO, and separation events do not appear in Fig. 3-20 because of the large time scale. However, examination of the high-speed records of these events indicated no abnormalities. High-speed records of the PPS startup for the three forward accelerometers, which will now be discussed, are shown in Figs. 3-21 and 3-22. (The rear-mounted accelerometers became inoperative at Agena-Atlas separation.)

As illustrated in Fig. 3-20, three accelerometers exhibited partial or complete failures during various stages of flight. The TDA Z-axis accelerometer (A523) was intermittent but operation otherwise appeared normal. The two accelerometers (A5 and A522) mounted in the engine cone were lost completely during the pyrotechnic separation event. The loss of A5 and A522 appears to be a clearcut case of pyrotechnic shock at separation.

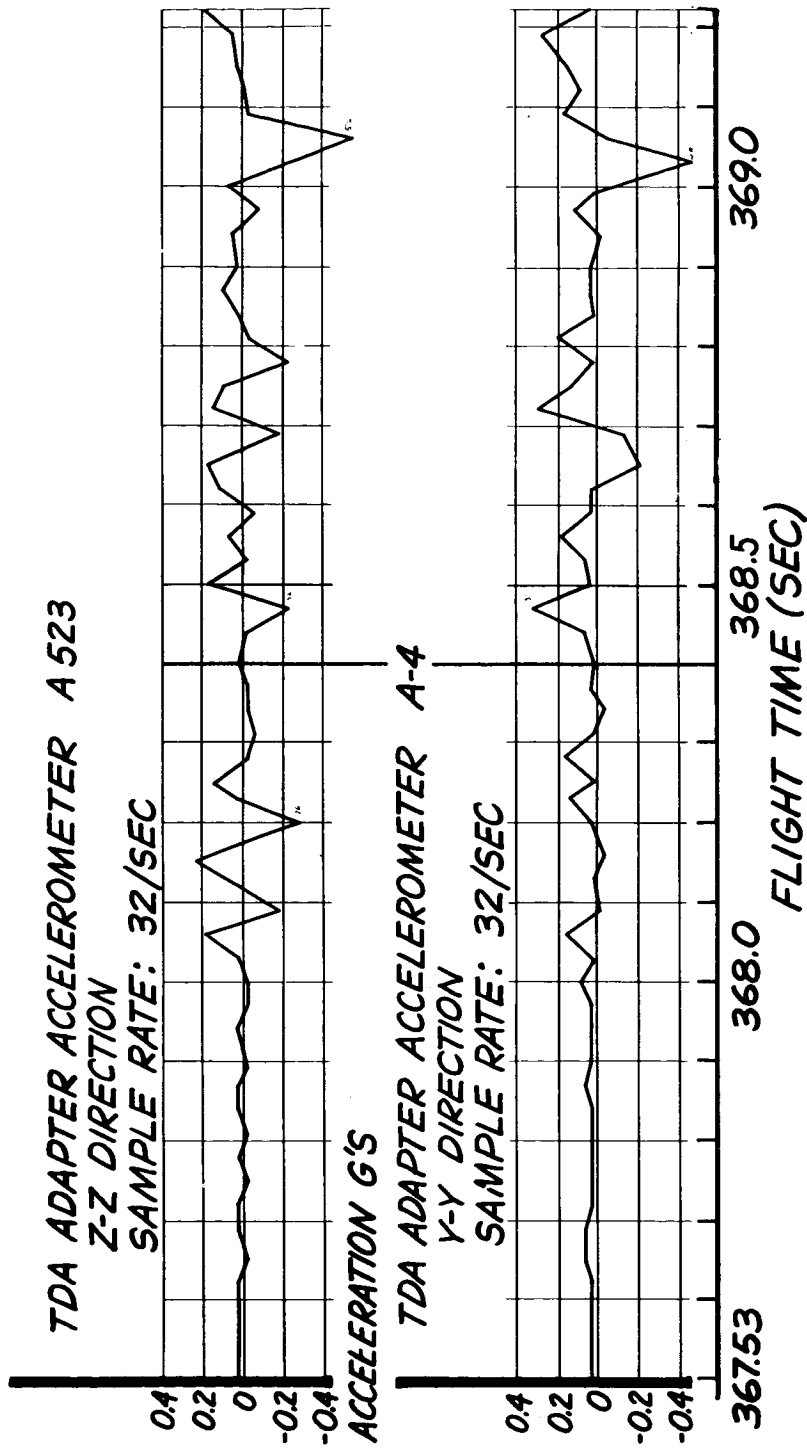
All the acceleration values obtained at discrete times on each side of the time of commencement of the flight anomaly (368.4 sec after liftoff) have been joined by straight lines, and the resulting plots are shown in Fig. 3-21 for the two operational lateral instruments, and in Fig. 3-22 for the longitudinal instrument. These plots, represent, at best, a mean line through the oscillations, and quite large deviations from this line could have occurred between sampling points and gone undetected. Figures 3-21 and 3-22 will be discussed in more detail in the paragraphs that follow.

Fig. 3-21 Target Docking Adapter Accelerometers A523 and A4 (Z and Y Axes) During Anomaly Phase

A detailed analysis of the Y and Z-axis accelerometers in the TDA was not attempted. The uncertainties involved in interpreting the commutated data points are certainly no less prevalent than in the X-axis case. The general character of the lateral responses during the anomaly phase seems reasonable enough when reviewing Fig. 3-21. The disturbance in the traces just prior to the anomaly is ordinarily seen on other flights and is known to be caused by the propellant-pump turbine spin-up. The peak samples found on both accelerometers following the main anomaly activity are directly attributed (in time) to the firing of the pyro-actuated helium valve. The levels shown are higher, however, than are normally seen with continuously monitored signals for this event. This may be due to the fact that the commutated system is used to sample and transmit the higher-g, higher-frequency components of structural response. The commutated system is unfiltered at the source, while the continuous FM-FM system has inherent low-pass filter characteristics.

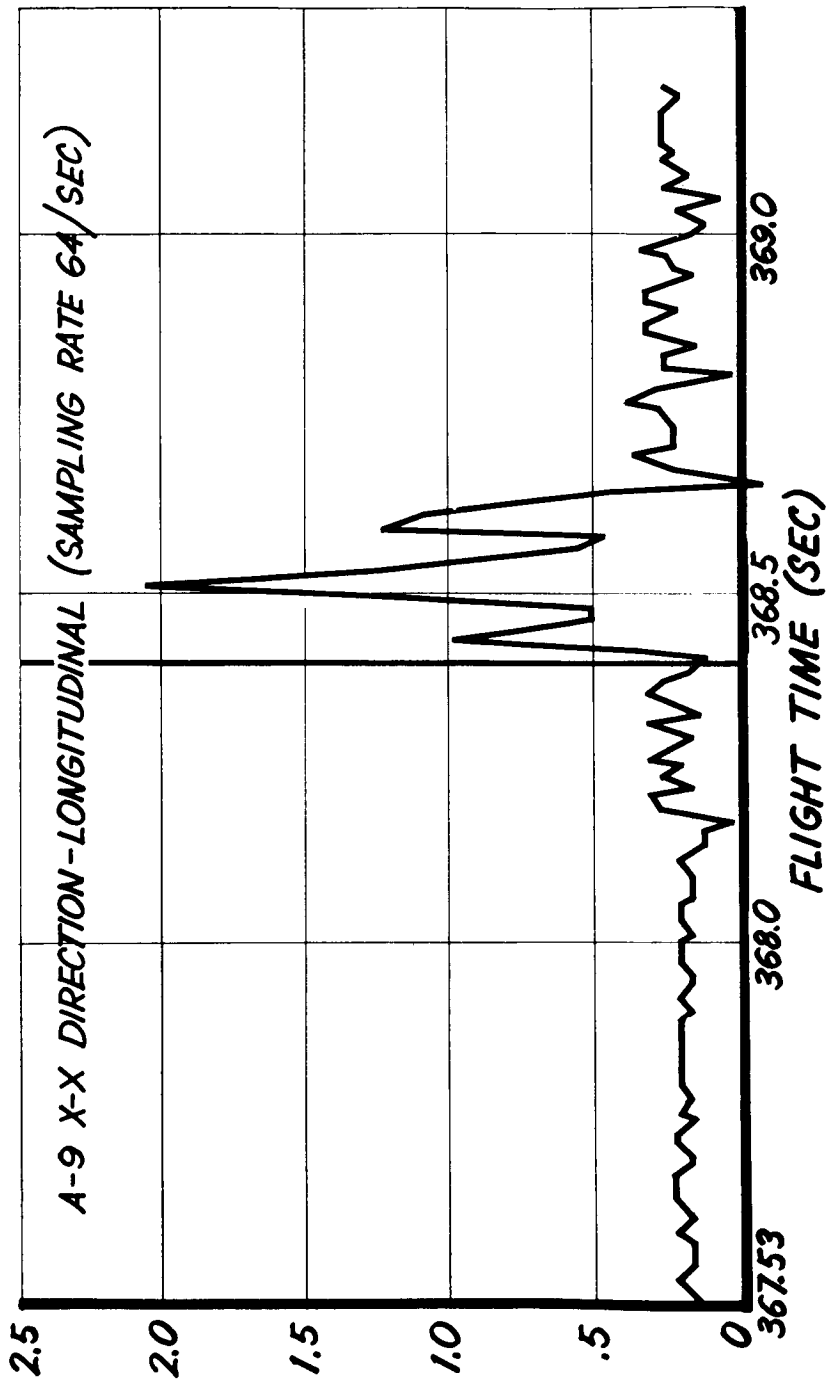
Fig. 3-22 Target Docking Adapter Accelerometer A9 (X Axis) During Anomaly Phase

- a. Basic Observations. Figure 3-22, the X-axis accelerometer sampled data plot, shows the following:
 - (1) A bias error in acceleration of about 0.2 g
 - (2) No evidence of accelerations occurring in the negative g region

Using hypothesis A, it was found that at the Agena station of the X-axis accelerometer (Fig. 3-19) the maximum structural dynamic response is about 0.37 g maximum for the first elastic mode, and about 1.0 g maximum for the second elastic mode. The time response envelope exceeded the 1.85-g level measured in flight by about 0.1 g at the corresponding time.

Using hypothesis B, it was found that a thrust level of about 27,700 lb would have to be realized with the normal buildup rate to produce the 1.85-g level sampled during flight. The elastic response obtained from the first and second longitudinal modes contributes less than 0.1 g, each. The absence of data overshoot (structural elastic) into the negative g region is indicative of a gradual rather than a sudden tailoff rate.

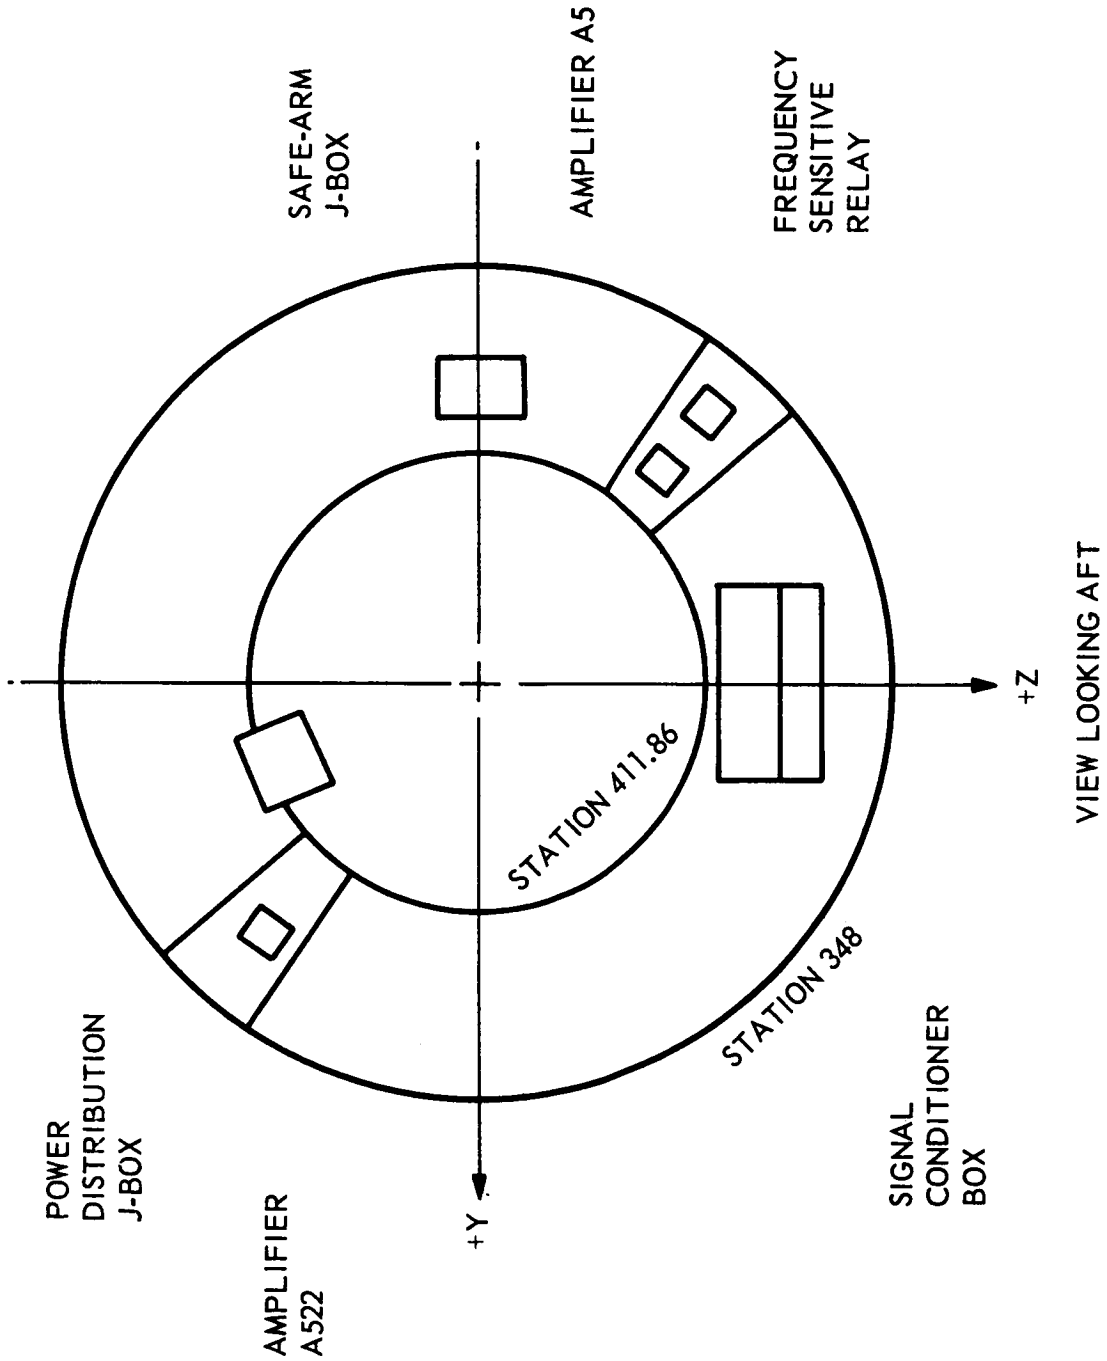
Fig. 3-23 Locations of Aft Area Equipment and Instrumentation of Interest for the Pyrotechnic Shock Event

Primacord separation, as used on the 5002 vehicle, produces a severe shock environment in the engine cone area. The effect becomes rapidly less severe with rearward movement along the aft rack. Agena vehicles 1171 and 1172 flew accelerometers mounted just aft of Sta 412, with their associated amplifiers also mounted to the aft rack. Although these vehicles were also subjected to primacord separation, loss of the measurements did not occur - most likely because the amplifiers were placed in a shock environment several orders of magnitude less severe than the amplifiers on the engine cone of GATV 5002. (See Figs. 3-18 and 3-23.)

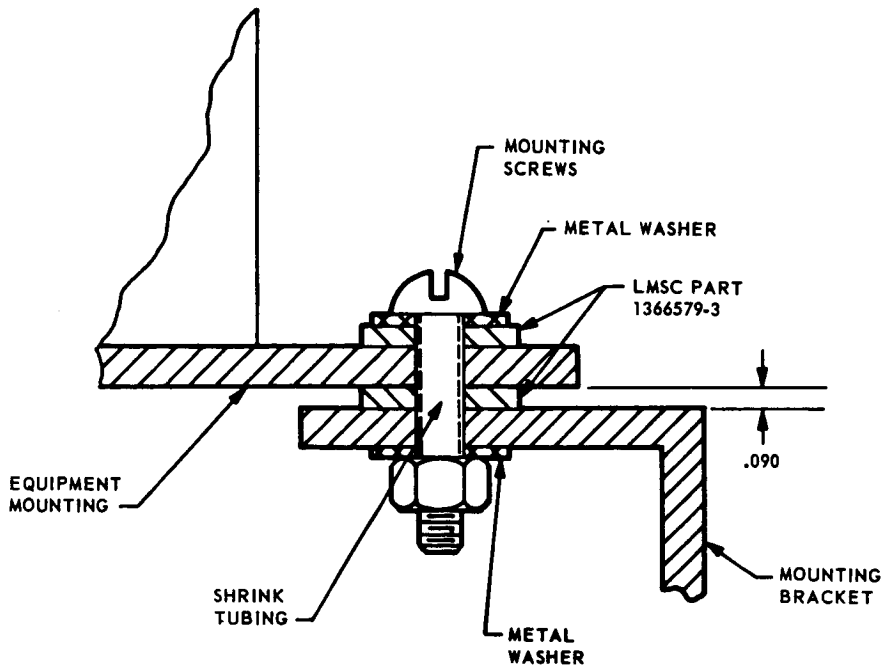
Equipment components are normally exposed to a half-sinewave pulse-shock test during flight qualification (Environmental Test Specification, LMSC-6117B). Ascent shock spectrum analyses of this type of shock have shown that this test is inadequate as a simulation of the pyrotechnic shock environment. Figure 3-24 shows a comparison between the spectra generated by a typical half-sine pulse shock and by the pyrotechnic shock. This illustration also shows the estimated shock environment for equipment mounted on isolators of the type shown in Fig. 3-25.

Fig. 3-25 Shock Isolation Installation

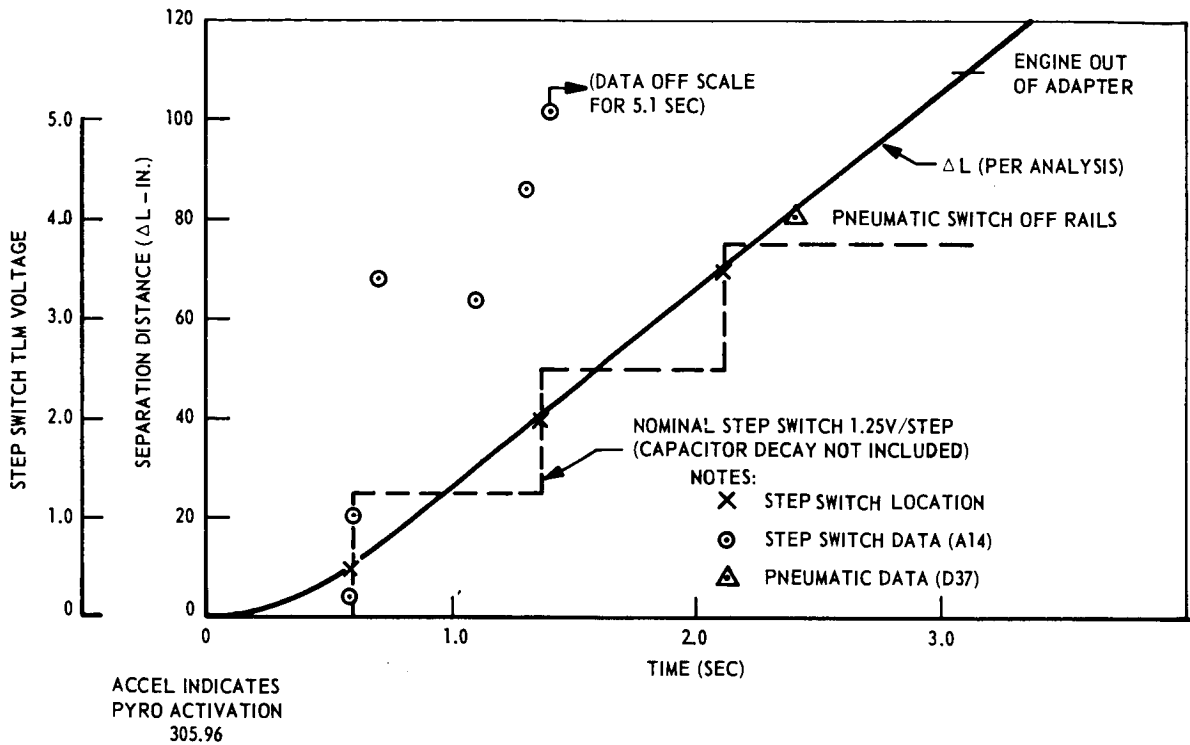
The step switches appeared to have voltage level problems; the voltage exceeded the telemetry limits of 5v as the second switch was contacted. (See Fig. 3-26.) No usable data were obtained from the step switches thereafter.

Fig. 3-26 Relative Separation Velocity

The pneumatic actuation switch indication functioned approximately 2.4 sec after the first pyrotechnic shock was noted on the accelerometers. To verify the expected separation time, an analysis was performed. It was assumed that the separated mass consisted of the Atlas wet mass and 100 percent effective residual fuel mass; the retrorockets were assumed to provide a nominal impulse output as prescribed by Rocket Power, Incorporated; a recent analysis concerning effective retrorocket angles was also incorporated. The results showed that the expected time for actuation of the pneumatic switch was 2.36 sec, which was considered in excellent agreement with the 2.4 sec observed (Fig. 3-26). The relative separation velocity was approximately 40 in./sec.

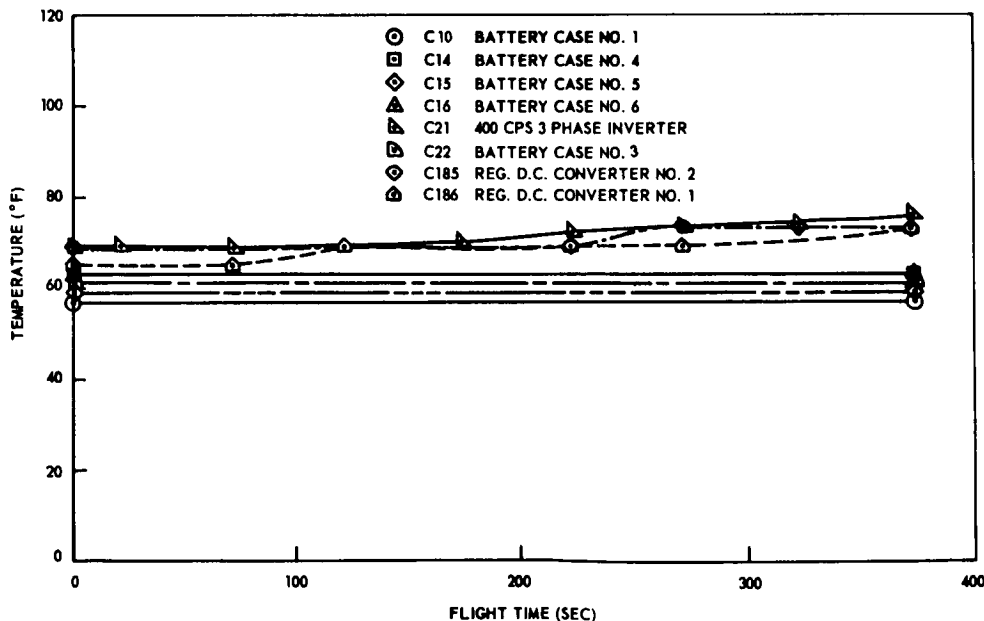
Fig. 3-32 Temperature Histories of Subsystem C Components in Forward Rack (C13, C14, C15, C16, C21, C22, C185, and C186)

3.5.4.1 Power-Supply Temperatures. The inverter temperature and the two converter temperatures were nominal. A temperature increase of approximately 7°F for these units occurred - from the upper midsixties to the near midseventies. (See Fig. 3-32.) This temperature rise resulted from equipment operation in a near vacuum environment - after exposure to atmospheric convective airconditioning.

3.5.4.2 Battery Temperatures. All six battery temperatures were nominal; the indicated reading of battery temperature No. 2 was faulty. The temperature sensor for battery No. 2 was found, prior to liftoff, to be indicating about twice that of normal. A poor or damaged solder joint, with its corresponding increase in resistance, is the most probable cause. All battery temperatures held practically constant at around 60° F because of the relatively large heat-sink mass of the batteries (Fig. 3-32).

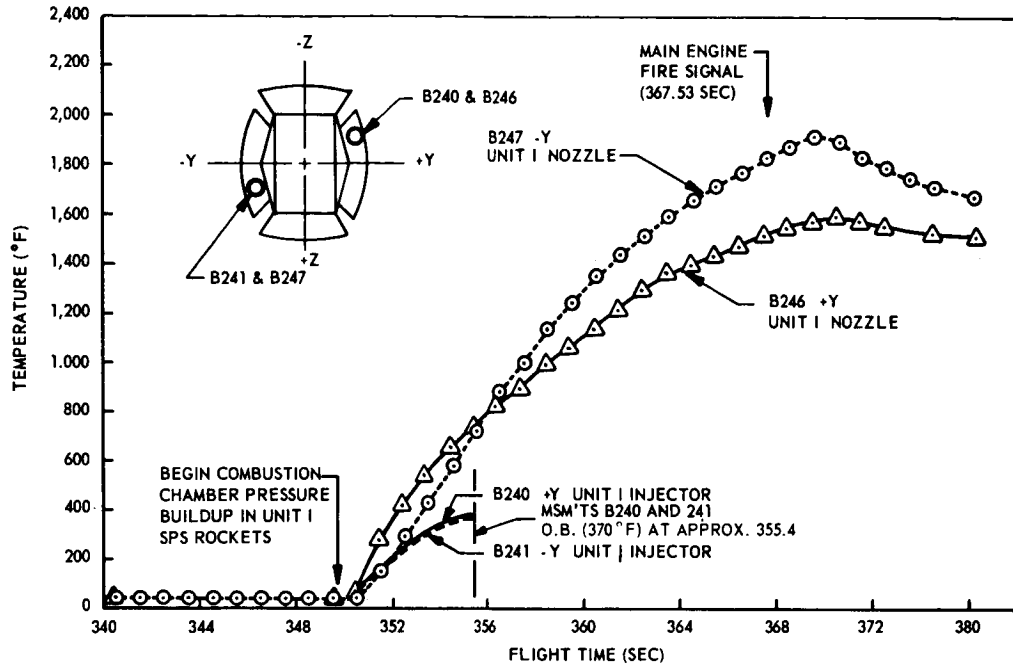
3.4.4.4 SPS Ignition. Temperature histories of both Unit I SPS thrusters indicated ignition and normal operation (Fig. 3-39). These two thrusters remained at a constant 40°F temperature from liftoff to initiation of Unit I firing at approximately 350.4 sec at which time the temperature began to increase normally. The output of B246 (the measurement for one of the two Unit I thrusters) indicated a maximum temperature of 1590°F at approximately 370 sec. At the same time, the measurement for the other thruster (B247) reached a maximum of 1910°F, then cooled to 1670°F at loss of signal while measurement B246 cooled to 1510°F (Fig. 3-39). The 320°F difference in maximum temperature reached by the two thrusters was attributed to a difference in thermocouple locations on the respective thrust chambers. Measurement B246 was broken off at the launch base and rewelded to a slightly different location.

Fig. 3-39 Unit I SPS Nozzle and Injector (B240, B241, B246, and B247 Temperature Data)

The two Unit I injector temperatures (B240 and B241) began to increase simultaneously with the thruster skins at approximately 350.4 sec. These temperatures are also shown in Fig. 3-39. Both of the injector temperatures went out of band at approximately 355.4 sec and remained above the maximum calibrated temperature (379°F at a telemetry voltage of 5.0v) until telemetry loss of signal. The out-of-band voltage did not indicate an abnormal SPS thruster operation.

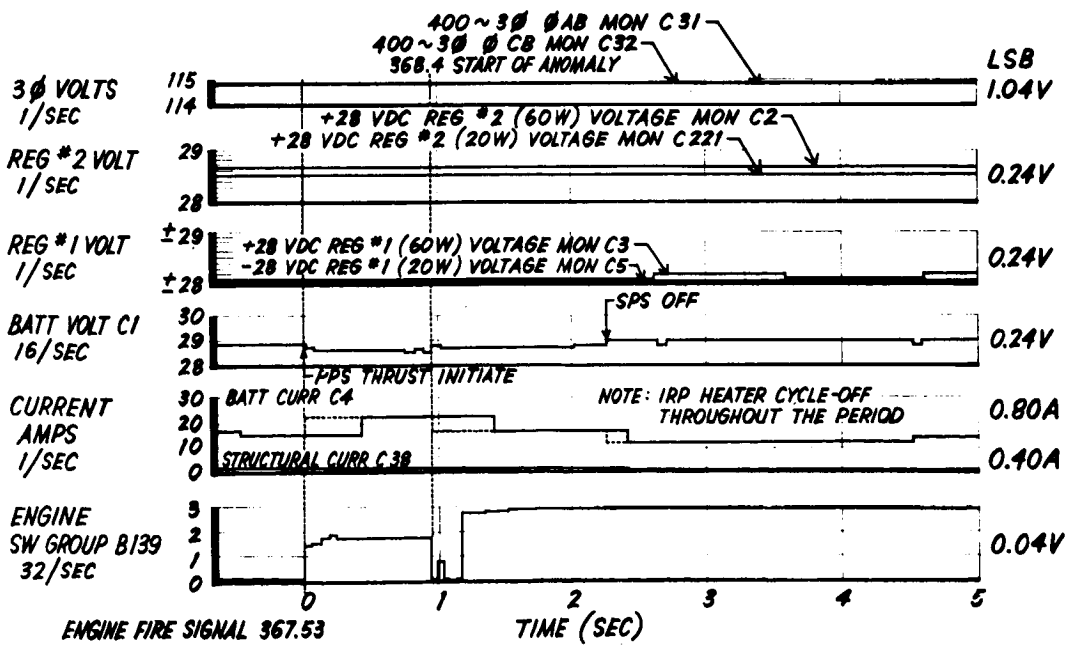
3.5.7.1 Engine Switch Group. The operation of the engine switch group was closely analyzed from an electrical performance viewpoint; no one evaluation can be considered conclusive since the monitored data do not appear to support a definitive solution.

Figure 3-43 presents the most important electrical system flight performance data.

Fig. 3-43 Electrical System Performance

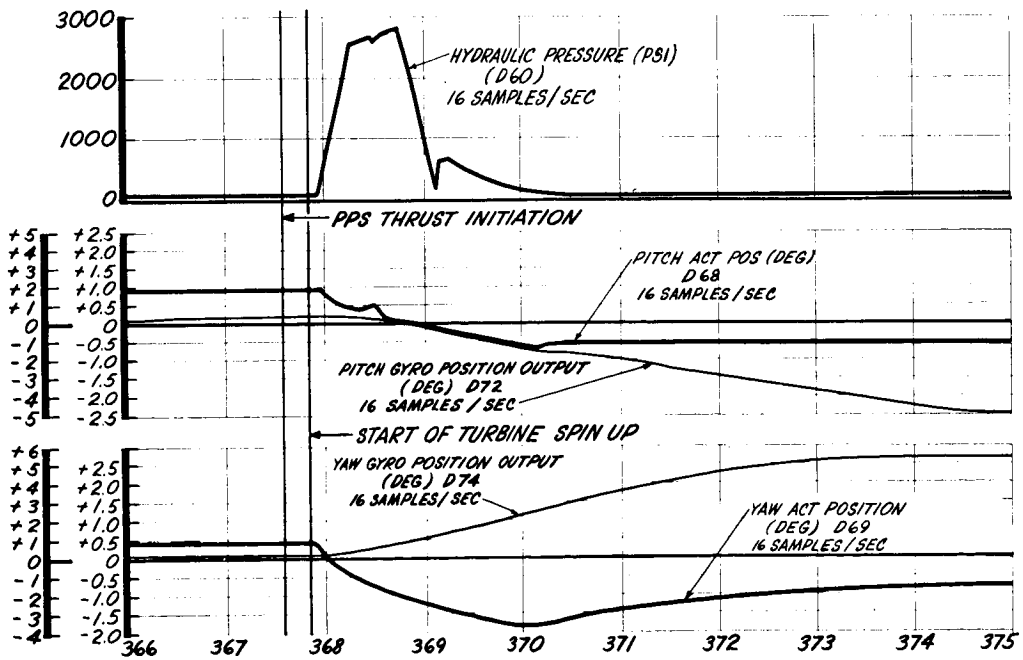
Hydraulic pressure buildup was coincident with turbine spin-up and looked nominal. (See Fig. 3-47.) Buildup started at 367.8 sec, reached 2600 psi by 368.25 sec, varied from 2600 to 2720 psi at 368.7 sec, and then decreased rapidly to 240 psi at 369.12 sec; this indicated loss of UDMH pressure to the hydraulic power package.

Fig. 3-47 Yaw and Pitch Actuator Positions Between 366 and 375 Sec

Yaw channel performance (Fig. 3-47) was nominal. There was no gas valve activity after the PPS thrust initiate signal. The initial actuator offset was +0.46 deg. Coincident with turbine spin-up (at 367.8 sec), the yaw gyro indicated an acceleration from 0 deg/sec to approximately 1.2 deg/sec by 368.75 sec. This yaw motion is initiated prior to any evidence of engine thrust. The gyro position indicates no slope reversal due to engine gimbal position, leading to the conclusion that the correction force during the short thrust period was approximately equal to the transient disturbance force. (See Figs. 3-47 and 3-49.) The hydraulic channel polarity was correct, the dynamic response nominal, and the static gain approximately correct; but no accurate gain calculation was possible due to gyro motion.

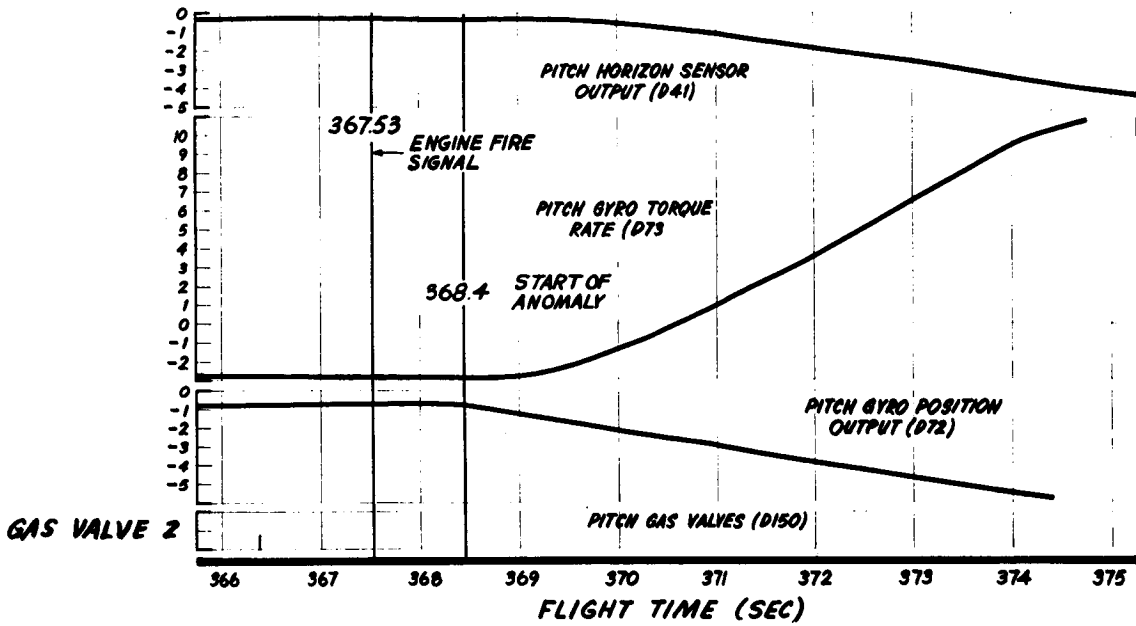
Pitch channel performance was nominal. There was no pitch-gas valve activity after PPS thrust-initiate signal. The initial actuator offset was +0.94 deg. The actuator dynamic response was nominal, with correct polarity. Assuming a 20 percent overshoot, the pitch hydraulic static gain was calculated to be approximately 2.04 deg engine/deg vehicle (2.1 ± 0.21 allowed). An accurate calculation was not possible because of the short duration of hydraulic pressure. At 368.4 sec, the pitch actuator applied initial correction to the vehicle just prior to loss of hydraulic pressure. The initial motion in pitch is detected at 368.25 sec. After loss of pressure, the vehicle moved nose down at approximately 0.8 deg/sec. (See Fig. 3-48.)

Fig. 3-48 Pitch Channel Output Between 366 and 375 Sec

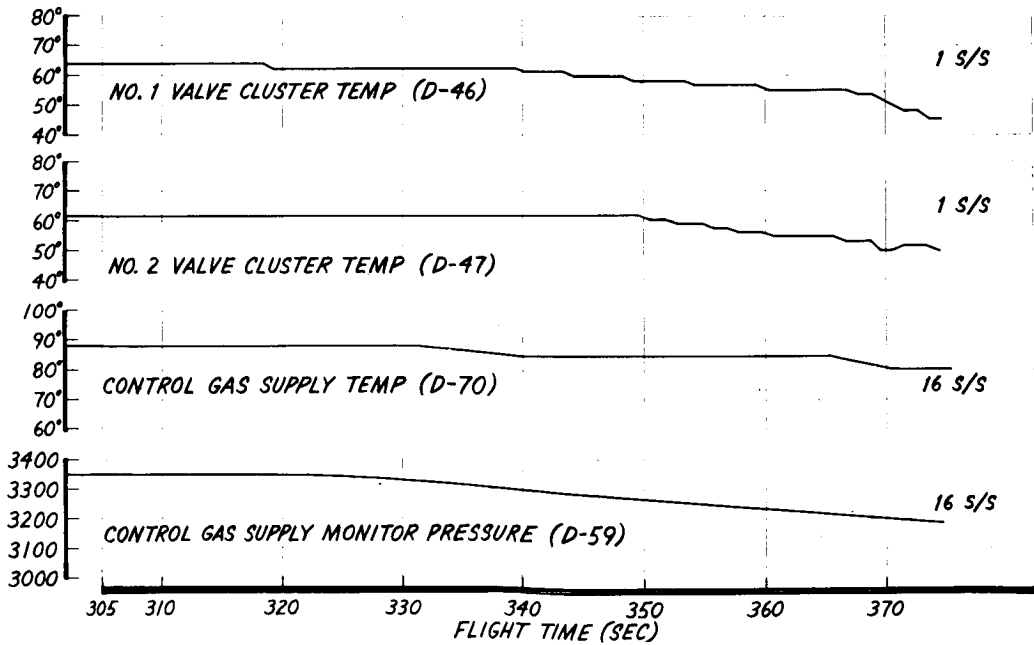
All other parameters operated normally. (See Fig. 3-51 and Table 3-5.) The decrease in thrust valve cluster temperature was caused by flow of ACS control gas through the nozzles; it cannot be associated with the extreme cooling indicated by the aft rack temperature transducers.

Fig. 3-51 Thrust Valve Cluster Temperature and Control Gas Supply Pressure
