NASA-MSC-G-R-65-5
Supplemental Report 1

GEMINI AGENA TARGET VEHICLE 5002 SYSTEMS TEST EVALUATION (45 DAY REPORT)

This report, prepared by Lockheed Missiles & Space Company in compliance with Contract AF 04(695)-545, documents the flight performance evaluation and failure diagnostic analysis of Gemini Agena Target Vehicle 5002 launched from the Air Force Eastern Test Range on 25 October 1965.

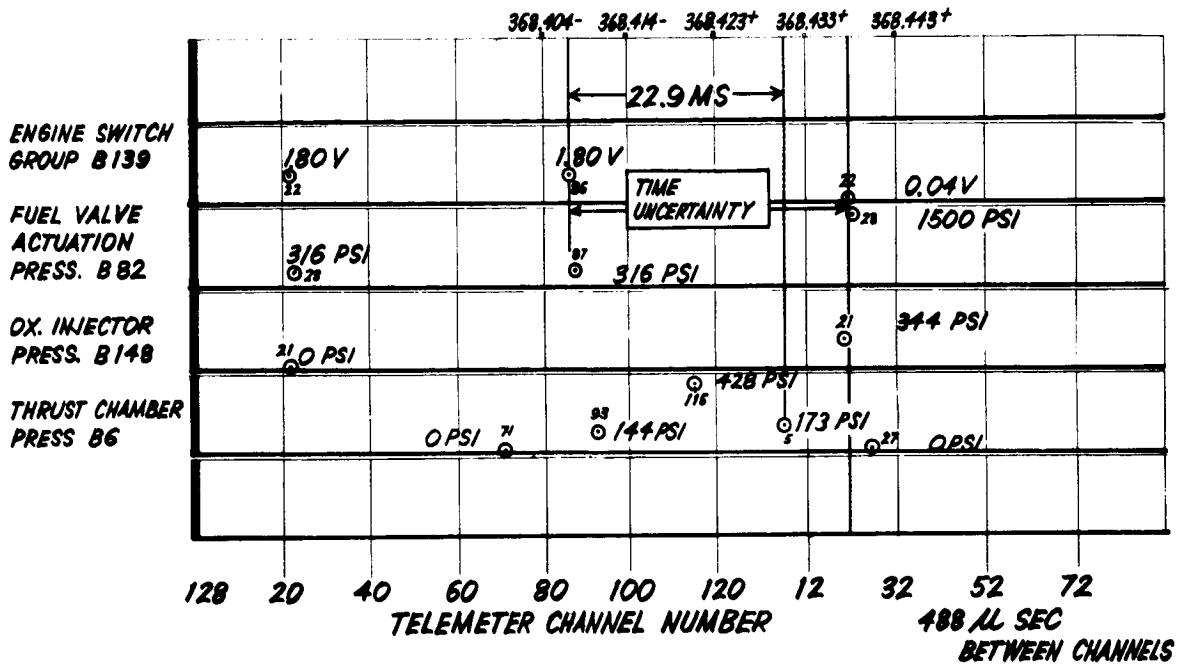
Between 368.404 and 368.435 sec, an event occurs that results in removal of power from the gas generator valves and POSV. This is shown by the decrease of voltage on the engine switch group from its normal 1.8v to zero volts. Due to the sampling rate (32 per second), this voltage change could have occurred at any time within this interval, and it is necessary to examine other events that fall within the interval to determine the time relationship of the anomalous events.

Thrust-chamber pressure appears to rise normally after 368.404 sec but starts to decrease well before 368.435 sec, indicating that the entire thrust-chamber pressure pulse has occurred within this interval. The peak of the pulse occurred either prior to or after the Channel 115 indication of 428 psi.

Fig. 3-52 Possible Sequence of Events

To establish the supposition that the mechanical failure (which was indicated as a pressure pulse) occurred prior to the electrical failure, it will be assumed that the reverse is true; i. e., the engine shutdown was caused by a power failure in the engine circuitry. This premise would assume that the switch group voltage went to zero immediately following 368.404 sec, and the thrust-chamber peak pressure was reached immediately prior to Channel 5, which occurred at 368.427 sec. This allows 22.9 ms for the main fuel valve to close after the POSV is de-energized. In actual tests, the minimum time for this event to occur was observed as 22 ms. Since this hypothesis places both events at their extreme times and allows no time for the peak pressure (which was at least 428 psi) to fall to 173 psi (Channel 5), the remaining 0.9 ms time increment is insufficient to support this hypothesis. In addition, this assumed failure mode (electrical leading mechanical malfunction) does not

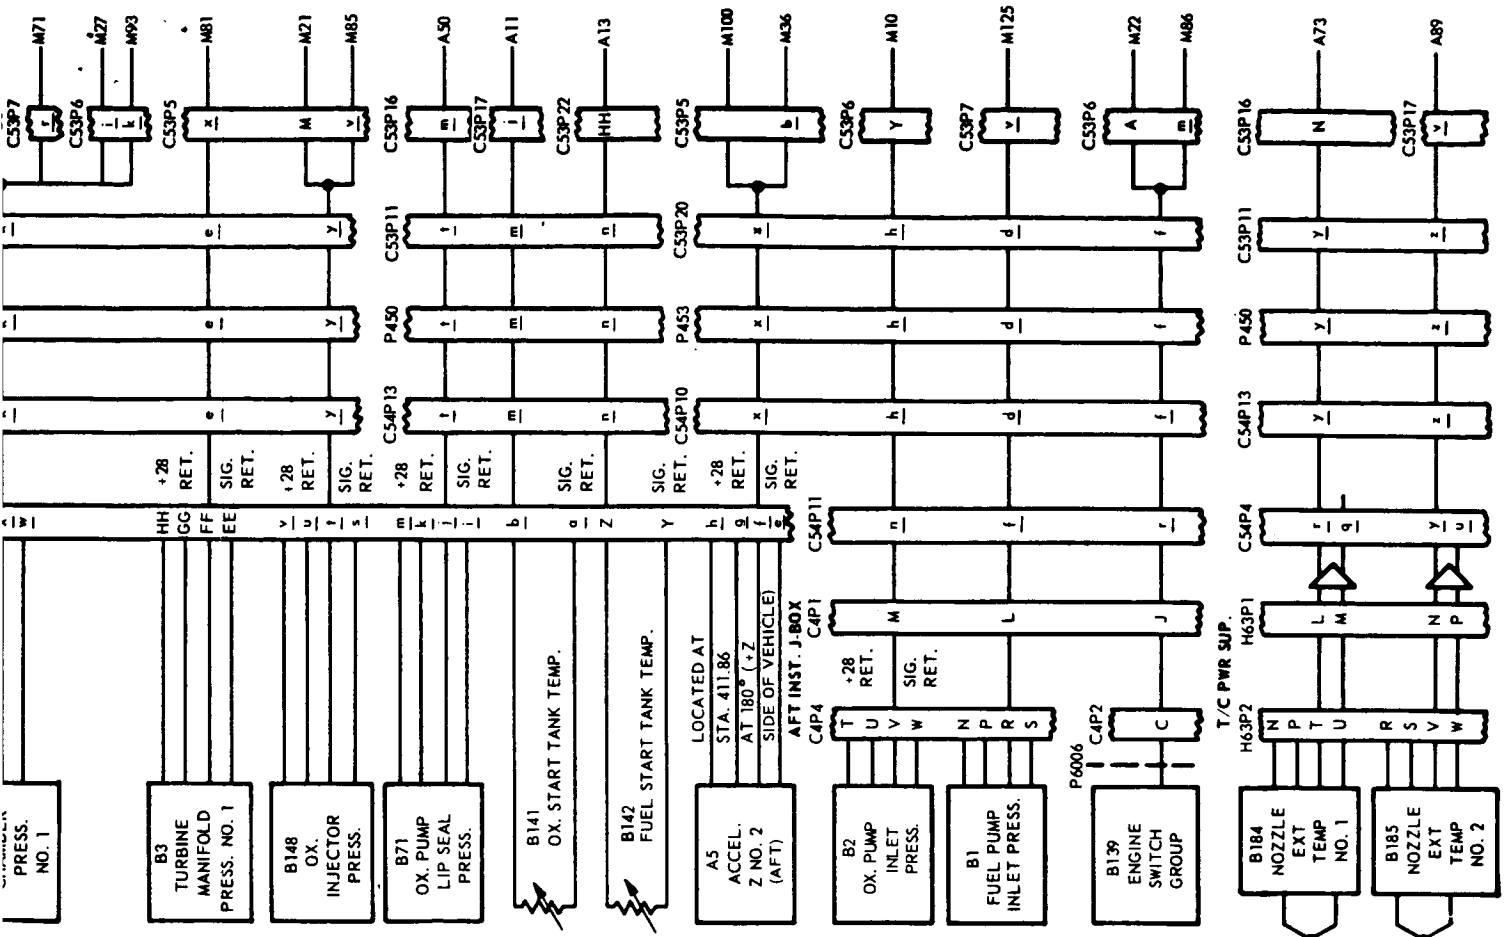
11. Measurement read zero until +150 sec then drifts to 42 psig by 187 sec. Does not change at engine firing - should follow measurement B132. Reading indicates a failure in the electronics package of the transducer. Failure of transducer then becomes intermittent. Failure is attributed to excessive pressure surge on element.

12. Measurement reads zero until 367 sec. Increases to 900 psi by 367.85 sec, then comes back to 100 psi at 368.8 sec. This probably indicates a zero offset of the pressure element caused by excessive pressure surge.

19. SEE Q. ON PAGE 3-23.
20. Measurement indicates normal operation. Reading increases during SPS firing, which is normal. Reading goes to full scale at 368 sec. Failure mode indicates an open thermocouple.

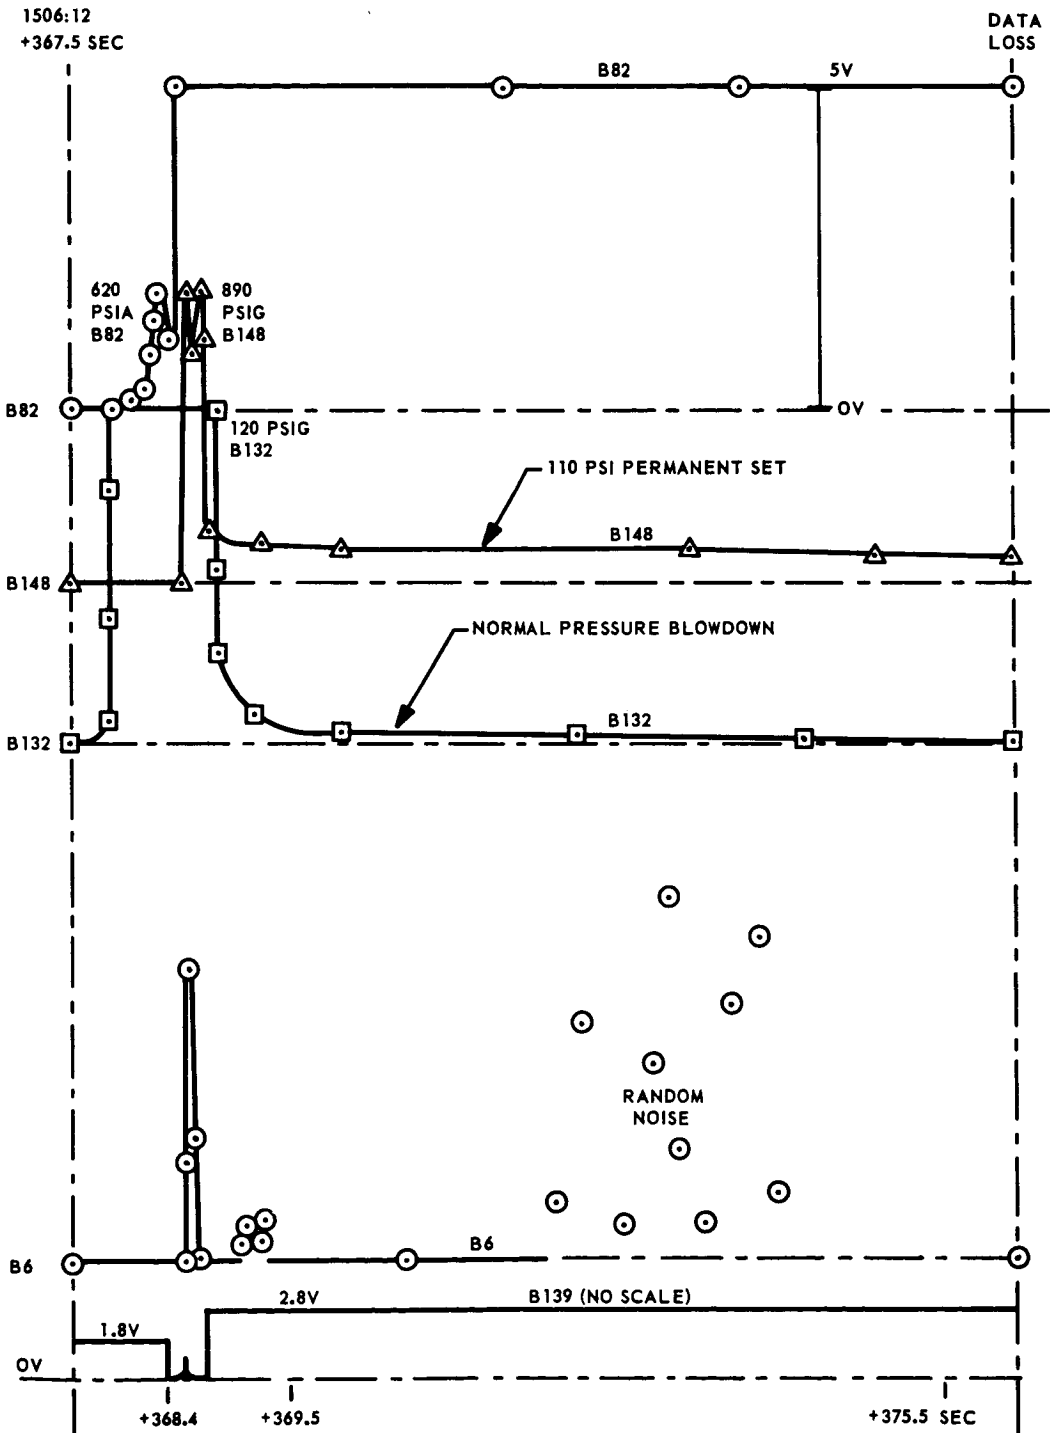
Fig. C-2 Gemini Pressures from Switch Group Actuation to Data Loss

Figure C-2 shows the pressure rise sequence on four selected transducers at, and immediately following, the activation of the engine firing sequence. This sequence is started by an electrical signal to the engine switch group (measurement B139).

Measurement B132, "Turbine Manifold Pressure No. 2," showed an increase to 120 psia, which is fullscale and normal, inasmuch as this transducer was especially selected to study start transients and could be safely overpressured. However, after approximately 1 sec, the output fell sharply and then gradually decreased until flight

termination. As a result of these data, it can be concluded that this transducer operated normally until flight termination.

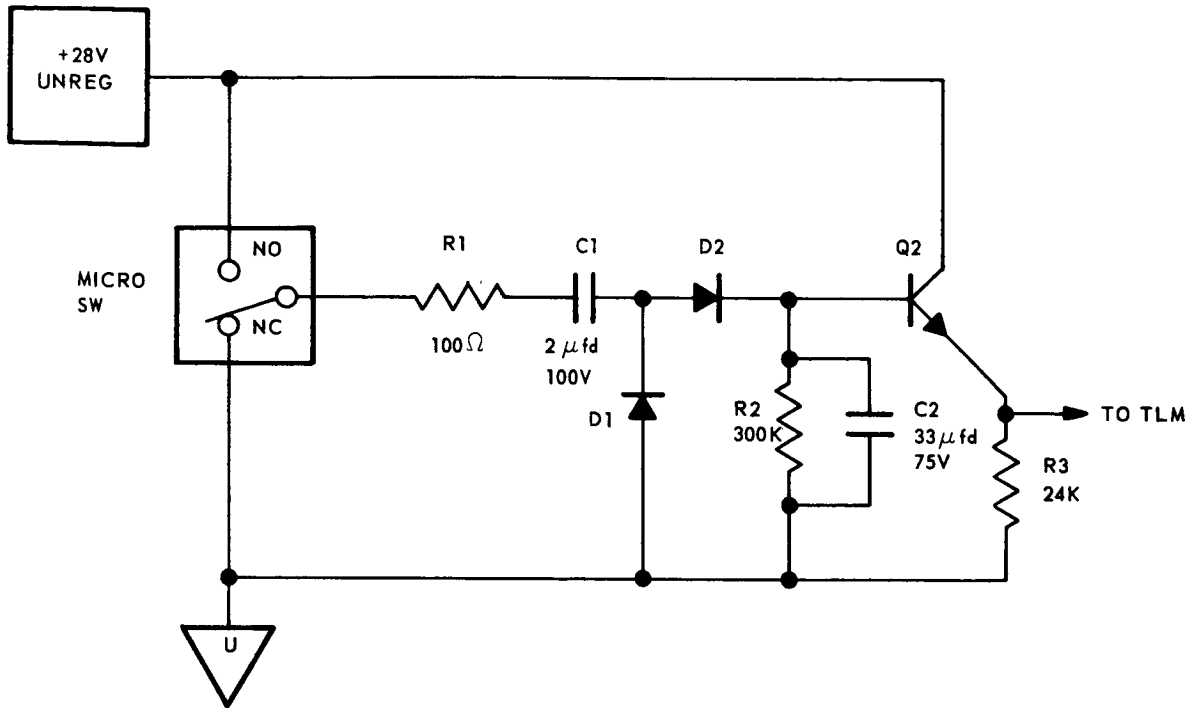
Fig. C-11 Schematic of Atlas/Agna Separation Monitor

A14, the "Atlas/Agena Separation Monitor," measurement indicated excessive voltage increase, about 3.5v instead of the 1.25v normally expected, during the first closure of the microswitch. The second closure occurred about 0.75 sec after the first closure, giving a separation rate of 40 in./sec. The voltage increased beyond the 5v telemetry input limit during the second closure of the microswitch. The third closure of the microswitch was not observed on the telemeter because the voltage had increased above 5v during the second closure of the microswitch.

Fig. C-11 shows the schematic diagram of the Atlas/Agna separation monitor. During normal operation, capacitor C_2 is charged to about 1.2v, 2.4v, and 3.6v during the first, second, and the third closure of the microswitch, respectively. The flight data for Vehicle 5002 show that capacitor C_2 charged to about 3.5v during the first closure and above 5v during the second and third closures of the microswitch. The cause of this excessive voltage is suspected to be leakage of capacitor C_1 . If capacitor C_1 is leaking, capacitor C_2 will accumulate a larger charge, hence a larger voltage during the time the microswitch is closed. This hypothesized failure of capacitor C_1 is random in nature and could be caused by the following:
