# WARFIGHTER SUPPORT

## Independent Expert Assessment of Army Body Armor Test Results and Procedures Needed Before Fielding

Highlights of [GAO-10-119](#), a report to congressional requesters

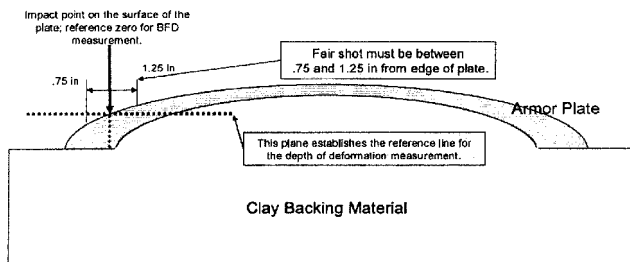
Figure 1. Test setup before test shot.

**Response:** Though ATC deviated from the test protocol in the Purchase Description regarding measuring BFD at the lowest deformation, Army leadership after a deliberative internal process and in consultation with DOT&E, decided to use the BFD point-of-aim measurement as it was determined to be an accurate and repeatable process that did not bias any vendor's design. The following information highlights the rationale for this decision. For clarity and reference, Figures 1 and 2 depict the geometry associated with this issue. Further discussion follows the figures.

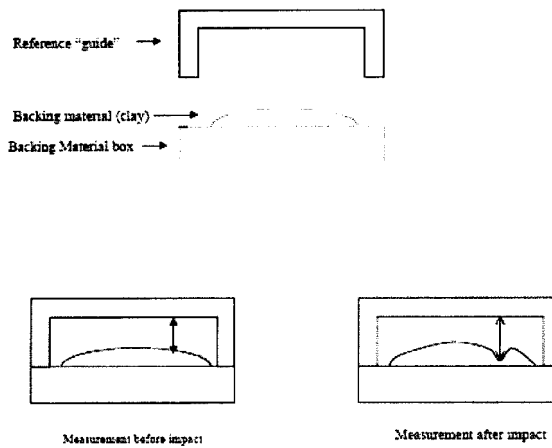
Figure 3. BFD Measurement Reference Guide from Purchase Description.

There are two important considerations pertaining to the guidance in the Purchase Description: First, the lowest point of depression must be subjectively selected by a test technician, and second, measuring perpendicular from the point selected as the lowest point of depression to the reference guide provides the distance between that point and the original undisturbed surface at the aim point, not the original undisturbed surface perpendicular to the lowest point of depression, which is what is required to obtain an accurate measurement. Using the technique described, an accurate measurement can only be made if the measurement is made on a flat surface with a uniform original undisturbed reference surface. However, since the plates are curved and the radius varies between vendor plates and even within vendors for same plate sizes, as shown in Figure 4, the only point at which an accurate measurement can be made with the described measuring device is the aim point.

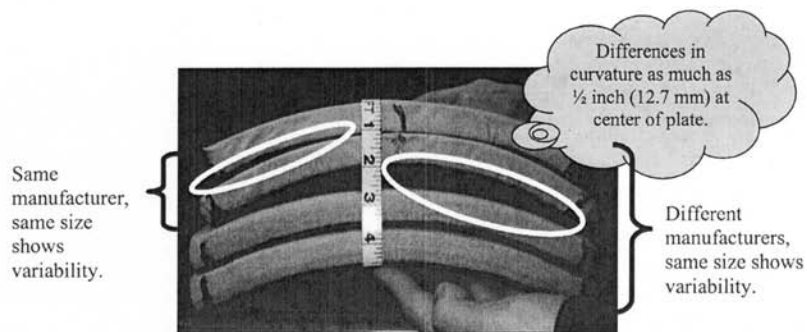
Figure 4. Picture illustrates variance in curvature between same size ballistic plates.

Although not contained in the Purchase Description, PEO Soldier had an internally documented process to account for plate curvature when the deepest point of deformation was laterally offset from the point of aim. However, due to plate curvature variance, a correction factor only approximates the deepest deformation measurement. That is one reason ATC elected to measure BFD at point of aim at the beginning of testing, but also became the rationale for a better procedure using the laser scanner as explained elsewhere in this letter.
