CHAPTER 4: ENGINEERING FOR WATER TRANSPORTATION

EARTHQUAKE DAMAGE TO SEA HARBOR WHARVES AND SHORE SLOPES

Meng Zhaohua and Ye Borong*

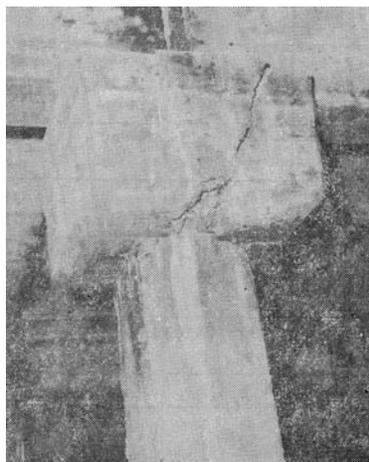
Photo 4. The pile cap of a crossing pile broke and there was disclosure of reinforcements.

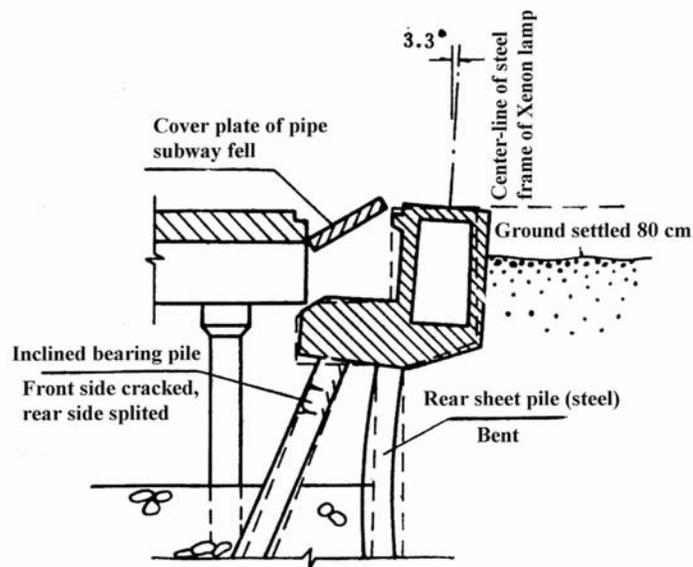
Figure 13. A sketch of a map showing damage to the retaining wall of the No. 20 berth at the New Port of Tianjin (in cm).

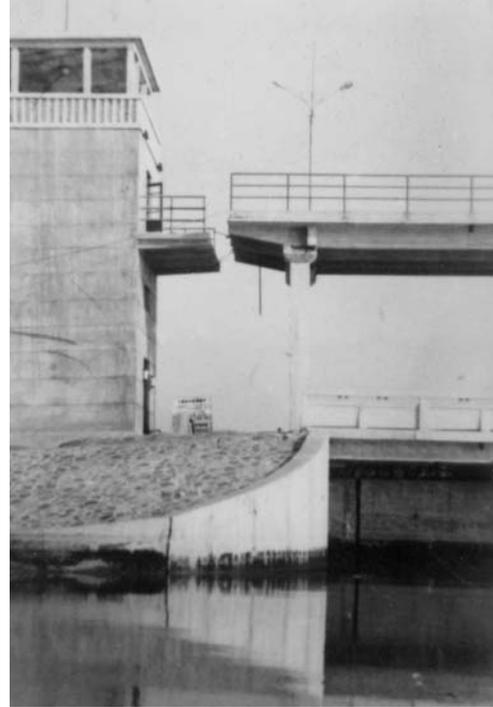
Photo 5. The Beitang shiplock office building was separated by the earthquake.

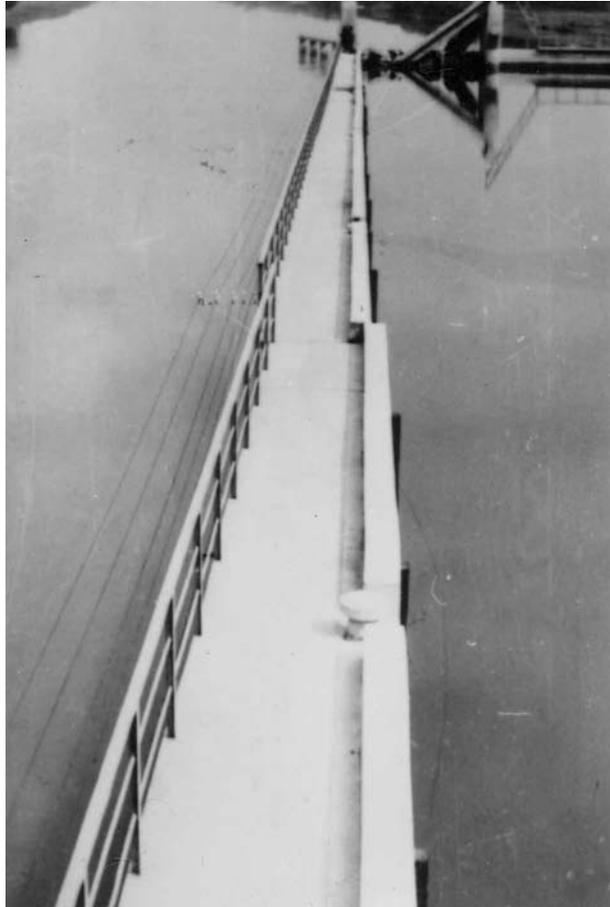
Photo 9. The down lock head of the Peizhuang shiplock collapsed.

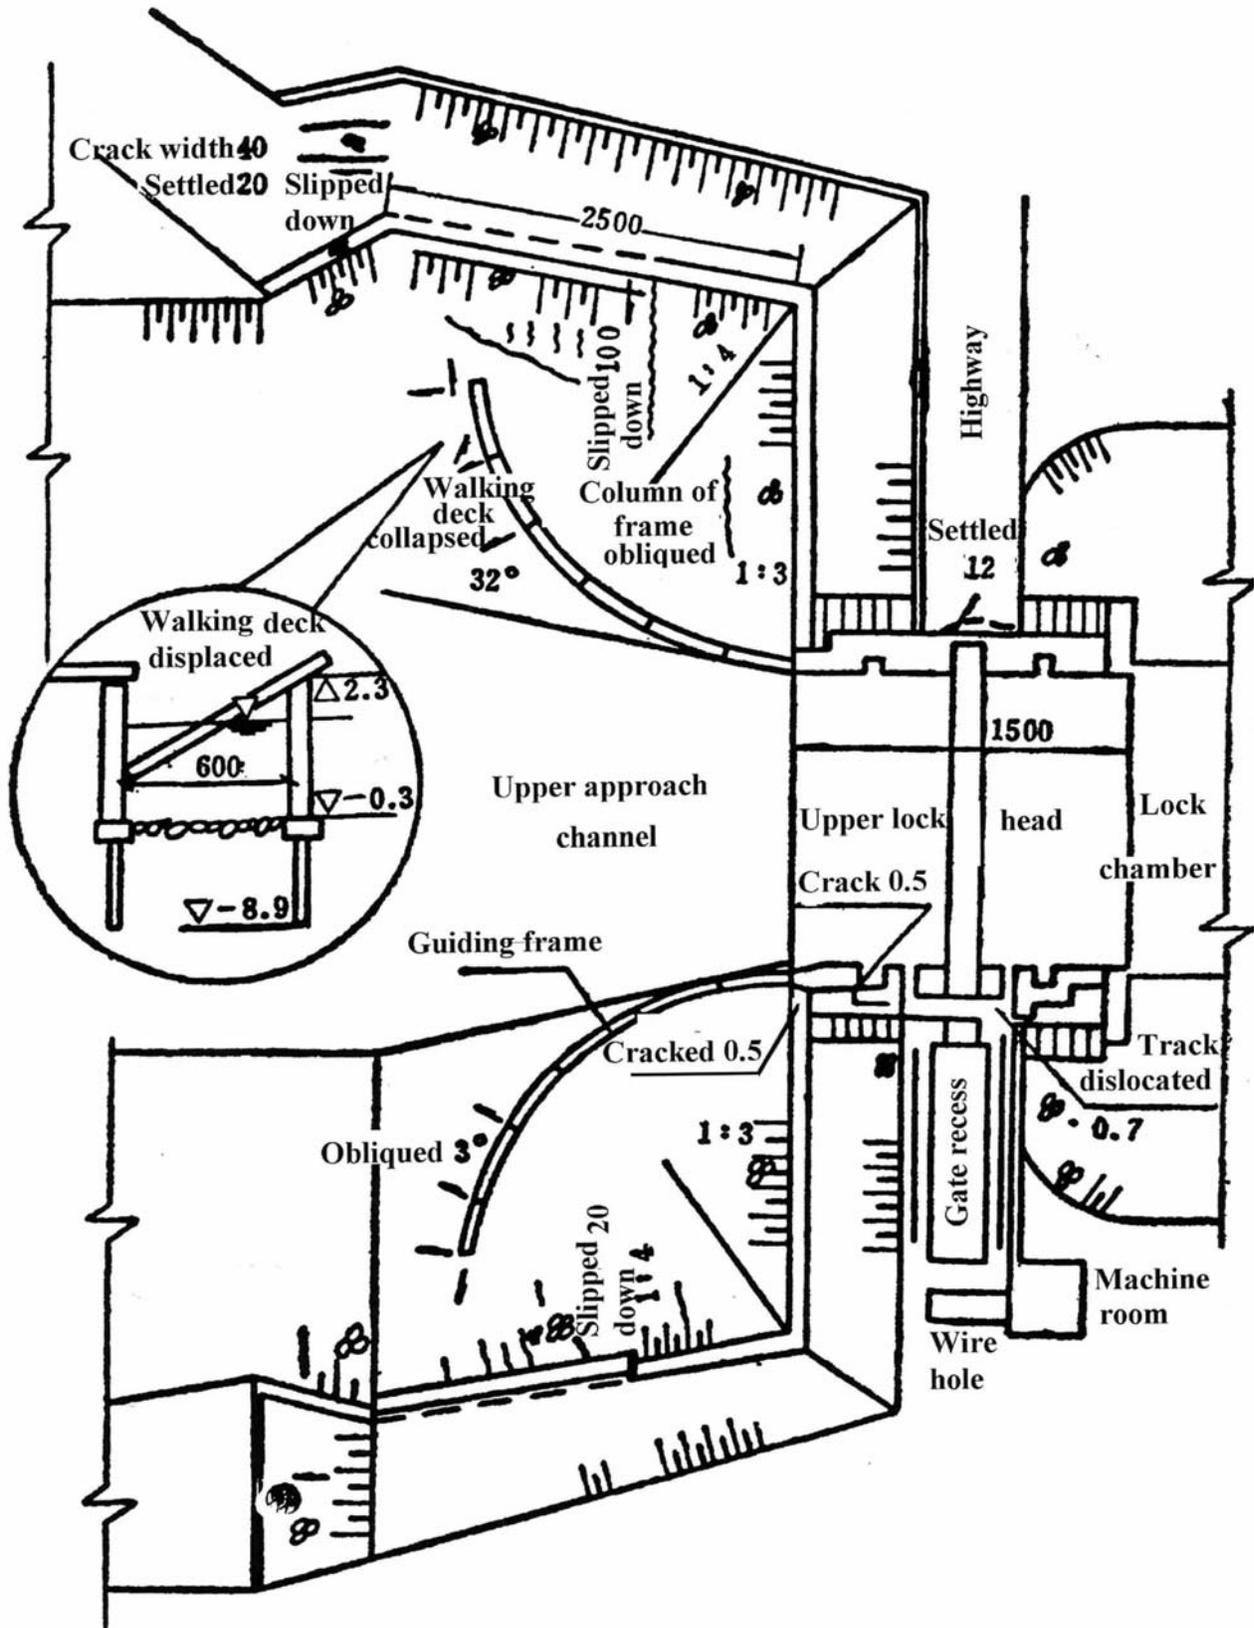
The upper lock head settled non-uniformly (see Fig. 6 and Table 4). The approach pavement on the east side of the highway settled even more, between which the bridge deck formed a 0.12 m step. The lock gate recess moved horizontally. Between the lock head and gate recess the track of the highway bridge dislocated 0.7 cm. On the repair gate recess occurred a crack 0.5 cm in width and between the top of the lock head wall and the masonry pavement there was a 0.5 cm wide crack (Fig. 7).

The mortar bond rubble walls on both sides of the chamber displaced inwards (Photo 2, Fig. 8) and the top level of all the chamber walls settled with a maximum settlement of 42 cm (Fig. 6, Photo 3). Most chamber walls tilted forward slightly and some backward, with a maximum oblique angle of 1.5° - 2.0° .

Figure 6. Settlement of the top level of the lock wall at the Beitang ship lock after the earthquake (in m). (Surveyed level after the earthquake is based on the datum horizon point that had been settled 0.62 m)

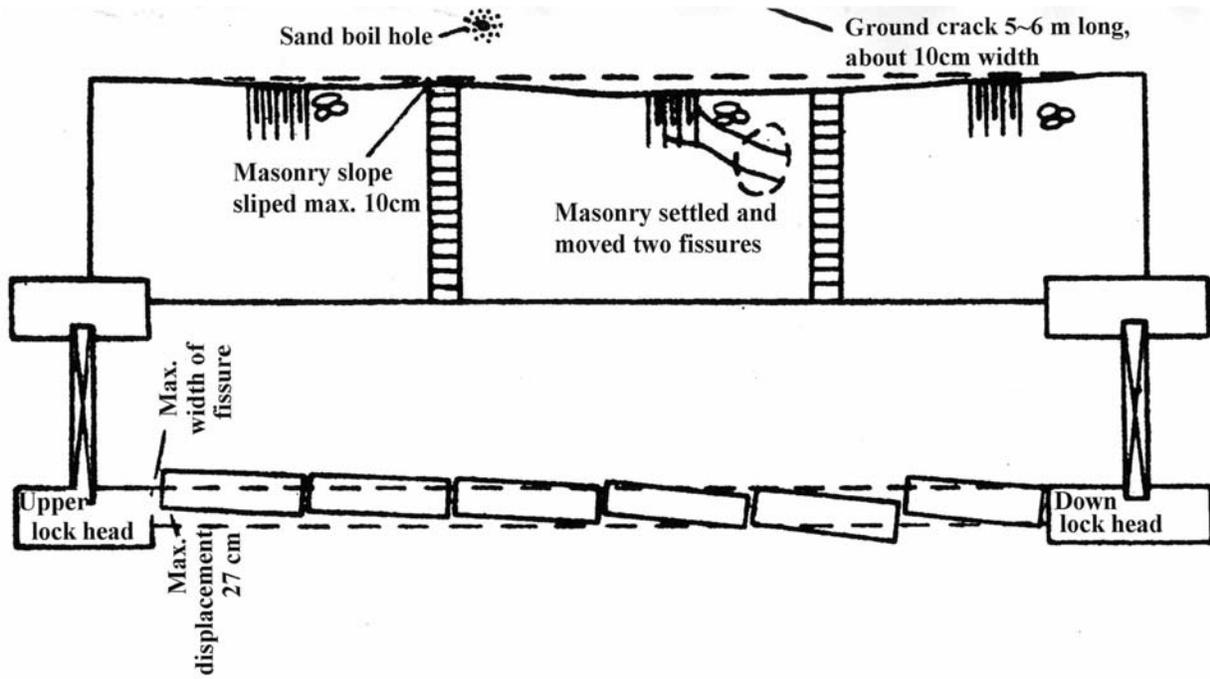
The hinged T-beams of the down lock head highway bridge displaced 1 cm to the left and the frictional trace could be clearly recognized. Under the bridge the reinforced concrete retaining plate was damaged with a 1 cm wide crack from the top to the base (Fig. 13).

Figure 13. A sketch of the damage to the bridge abutment and retaining dam at the Peizhuang ship lock.

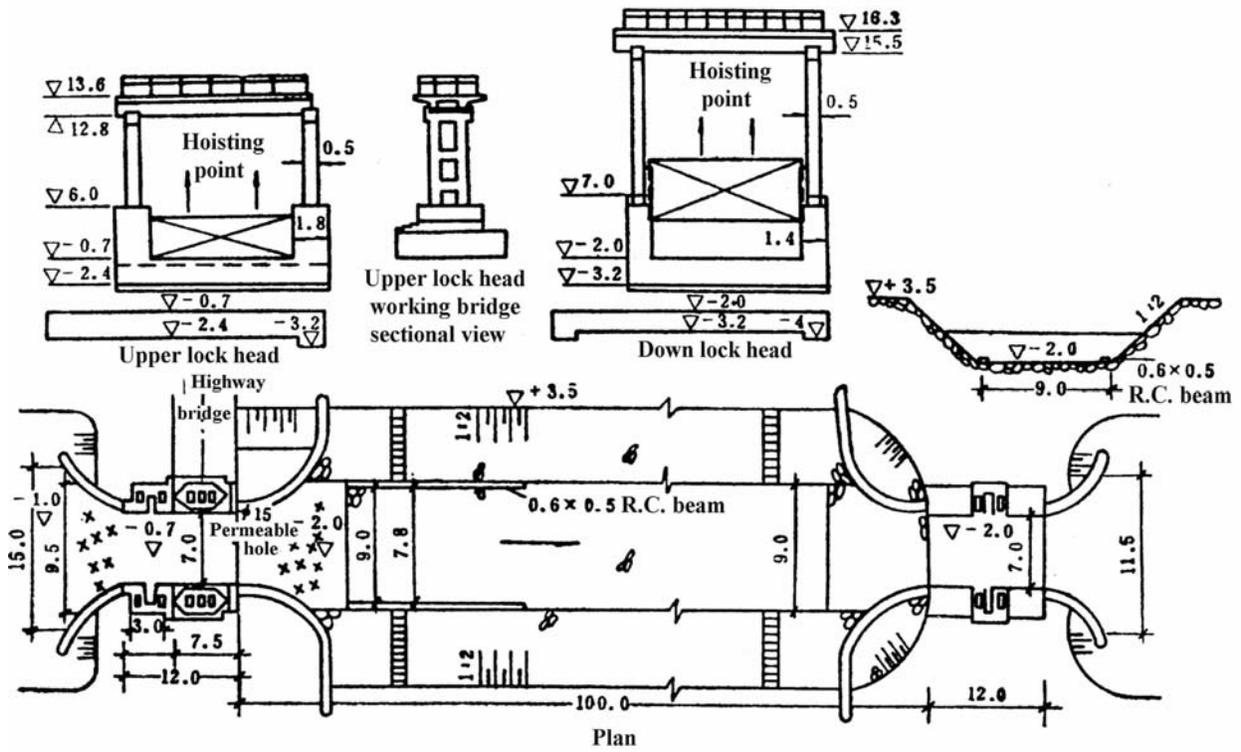
The right lock chamber wall is a reverse T-type and 6 m in height. The base plate is 10.5 m in width. It is divided into 6 sections with a rubber seal between them, each section is 20 m long. During the earthquake the water level inside and outside of the chamber wall were the same. After the earthquake the chamber wall displaced non-uniformly with a maximum displacement of 27 cm. The expansion joints between the chamber walls widened with a maximum width of 6.5 cm. All the sealing strips were broken. On the walking bridge deck on the top of the chamber wall there were over a hundred small cracks (Fig. 14, Photo 10).

Figure 14. Layout of the damaged lock chamber at the Peizhuang ship lock.

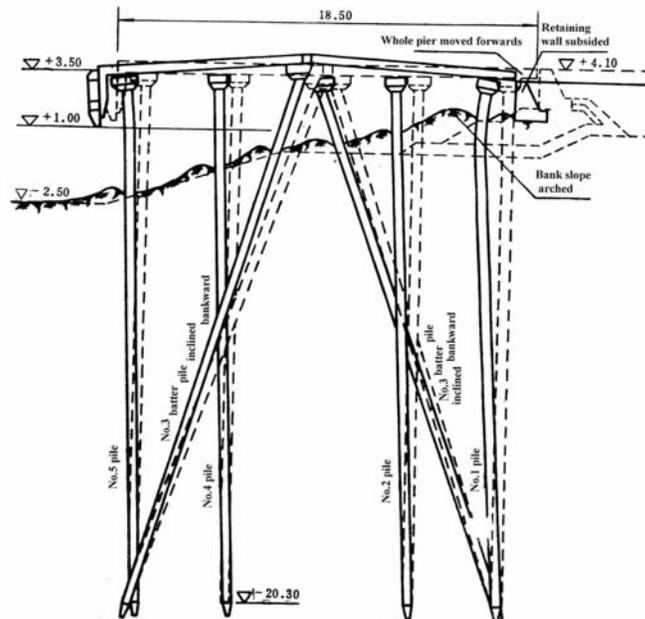
Figure 4. A sketch of damage to the Xinhe external transport terminal (in m).

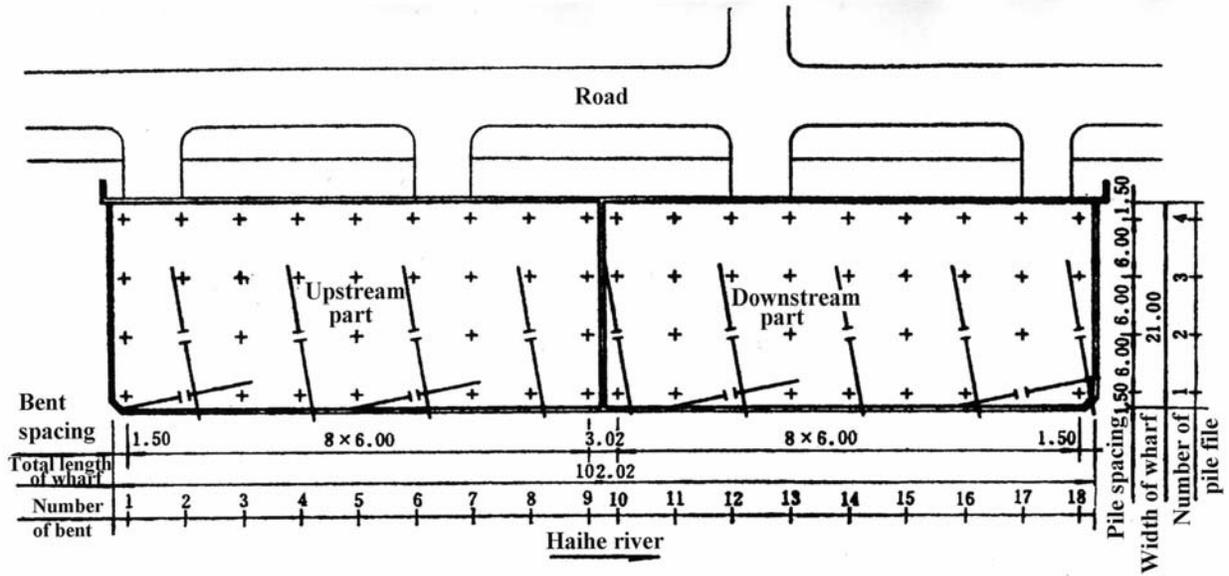
Figure 5. A sketch of damage to the Xinhe external transport terminal (in m).

(The dotted lines show the original situation of members)

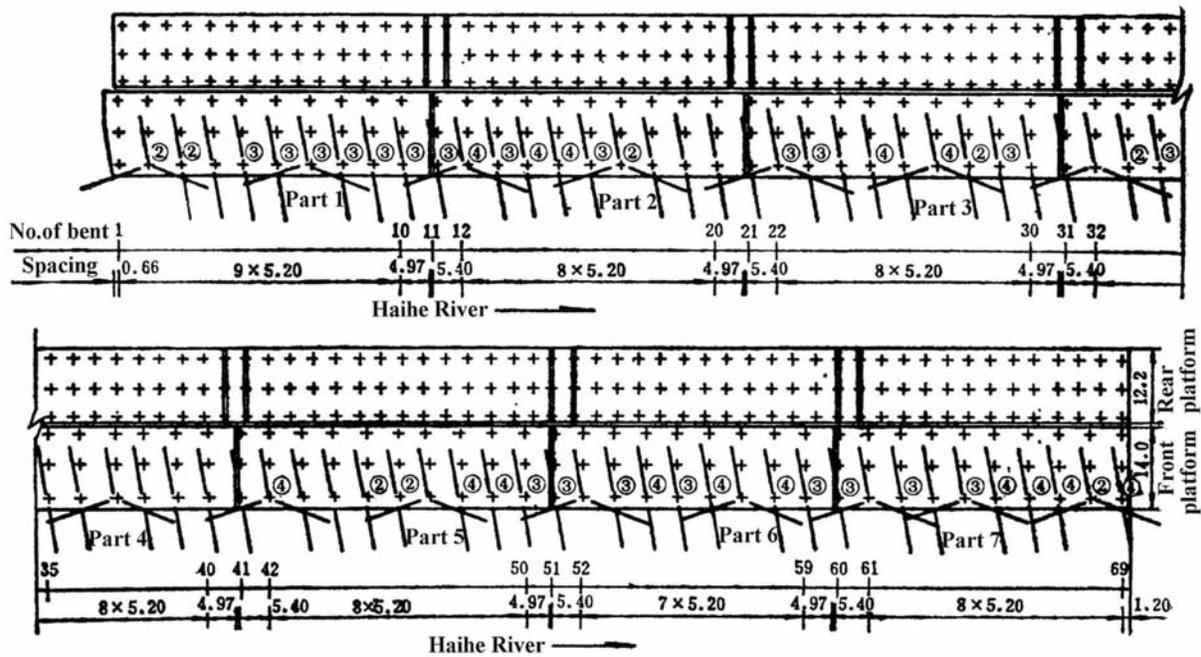
Within the 7 parts of the front platform damage to the 4th part was the least. Among the 10 pile caps of crossing piles there were only two pile caps that had several cracks. Both sides of the 4th part and all parts of the front platform had been damaged seriously, especially the 6th and 7th parts. The damage to pile caps of crossing piles is shown in Fig. 13. Damaged pile caps of crossing piles were mainly cracked; most cracks started at the joint of the crane track girders and cross girders, then progressed from cap top to bottom with a slope of 45°-60° inclined to midstream. The upper width of the cracks was larger than the lower and some cracks ran through the pile caps.

Figure 13. Cracks of pile caps of crossing pile at the front platform of the No. 10 wharf (in m)

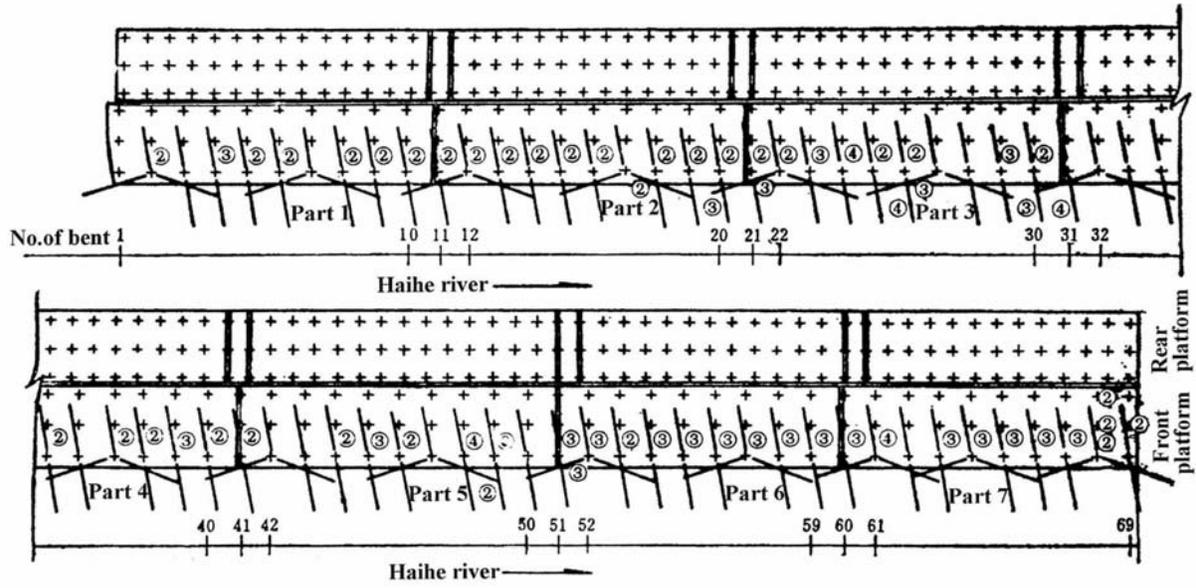
Damage to the foundation piles took place mainly on the forward inclined batter piles. The damage is shown in Fig. 14. Damage characteristics appeared as follows: the side of the pile body facing midstream cracked and the cracks extended to the left and right sides of the pile body; no cracks were found on the back side of the piles.

Figure 14. Crack state of pile at the front platform of the No. 10 wharf.
(Classification of crack width is the same standard with Fig. 13)

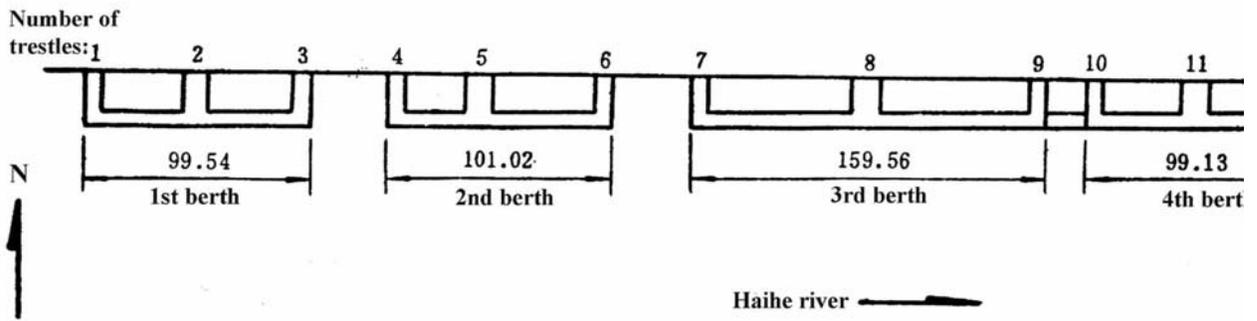
Figure 15. Plan of the No. 4 pier of the Tianjin Channel Bureau (in m).

The No. 4 pier consists of 4 berths (Fig. 15). At the time of the earthquake the construction of the No. 3 and No. 4 berths had just been completed and the back filling behind the retaining wall was underway. All 4 berths are landing piers with approach trestles. These piers are reinforced concrete piles with a girderless slab deck. The connecting structure next to the approach trestles had various types of retaining walls (Table 2).

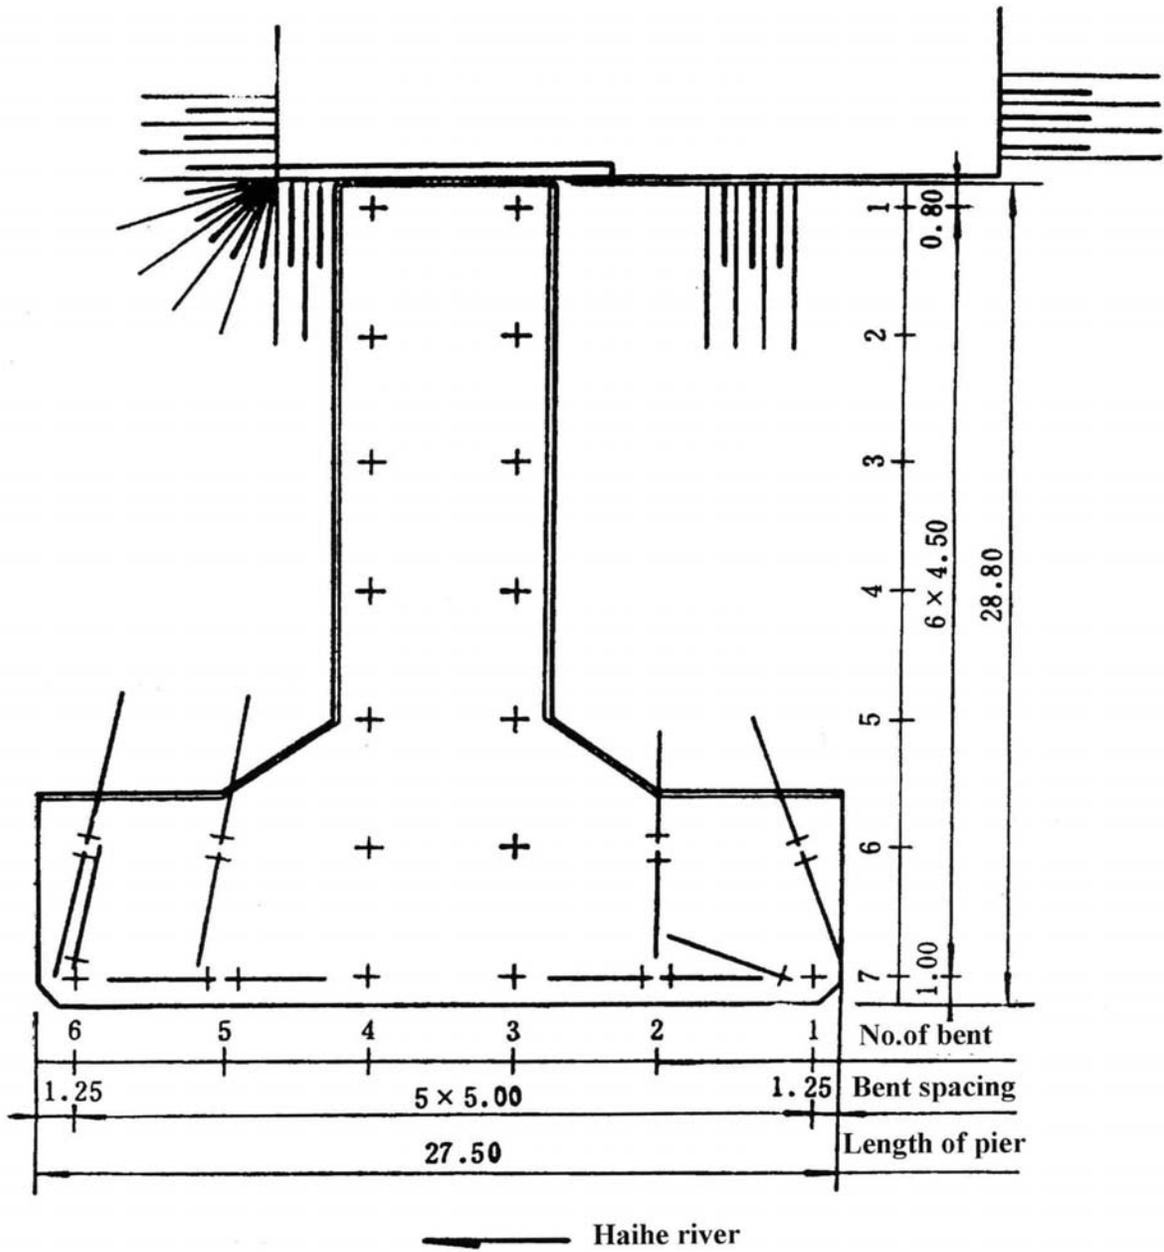
Figure 16. Plan of the pier for the Overhaul Works of TCEB and pile layout (in m).

The pier for the overhaul works is a berthing jetty with a composite structure of a reinforced concrete girderless deck on piles. The entire length is 27.5 m and the width is 7.5 m. The approach trestle is 21.3 m long and 7.5 m wide. Six pile bents are provided. The pier has two wings, each wing contains two pile bents and each bent has two pair of batter piles. The pier connects with the approach trestle in the middle. Vertical piles were installed in the approach trestle (Fig. 16). All foundation piles are pre-stressed reinforced concrete piles with a cross-section of 40×40 cm. The vertical piles are 2,188 cm long and batter piles are 2,300 cm long. The pile point is founded on a stiff clay strata at -18.30 m.

All the piles of the pier were damaged to various degrees. Crossing piles experienced serious damage in which the batter piles that inclined towards the river broke away from the pile cap i.e., the #6, #7 pile in the first bent, the #6 pile in the fifth bent, and the #6, #7 piles in the sixth bent (Fig. 16). All batter piles were damaged seriously except for the #6 inclined forward batter pile in the second bent, which was lightly damaged.

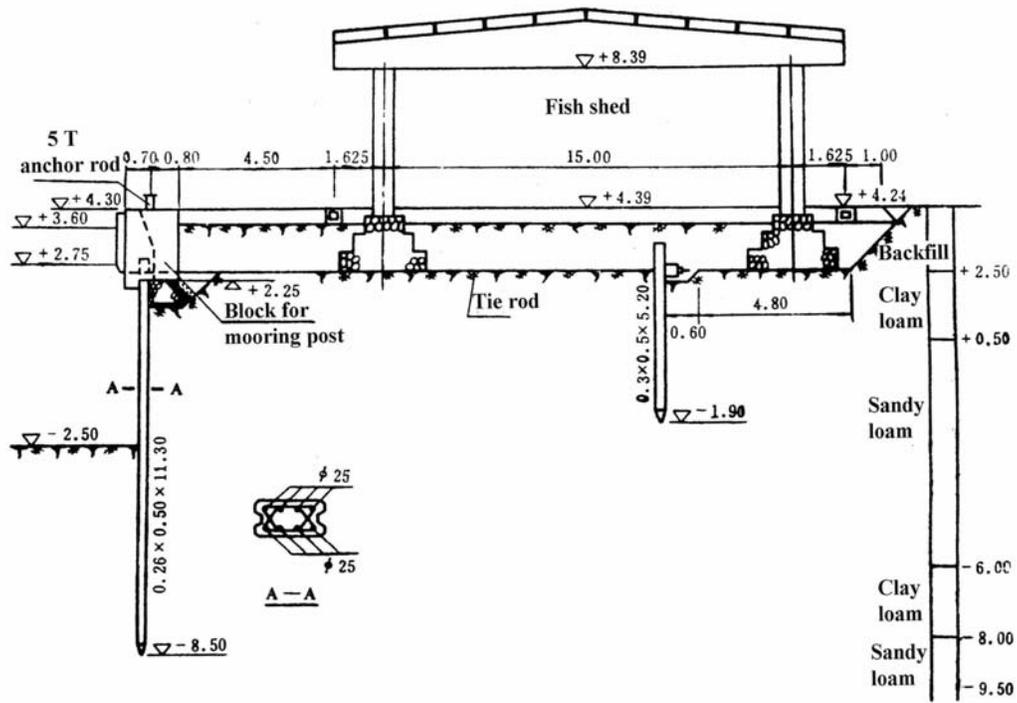
Figure 17. Cross section of the Chentangzhuang Terminal for the OFC (in m).

This bulkhead is an anchored pre-stressed concrete sheet pile type structure (Fig. 17). The imbedded depth of the sheet piles was 6 m and they were capped with cast-in-place reinforced concrete beams. The anchoring system consists of 50 ϕ mm steel anchor rods and reinforced concrete sheet pile. The rods are placed at 2.0 m intervals. The designed normal water level is at 2.75 m and the designed lower water level at 2.0 m. The bottom elevation in front of the bulkhead is -2.5 m.

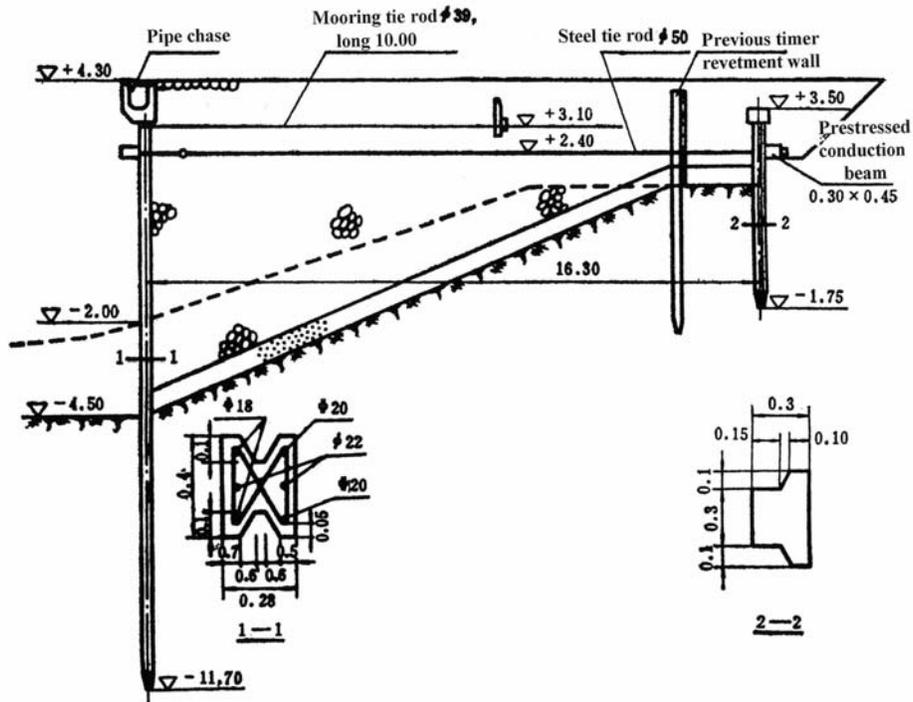
Figure 18. Cross section of the repair wharf for the Xinhe shipyard (in m).

This bulkhead wharf is an anchored pre-stressed I-shaped sheet pile structure (Fig. 18). A reinforced concrete cast-in-place capping beam was provided at the top of the wall. The anchoring system consists of pre-stressed reinforced concrete piles; the spacing is about 80 cm. Steel tie rods are 50φ and are installed at 2.4 m center to center. The design high water level is +3.5 m and the design low water level is +1.7 m; the bottom elevation in front of the wharf is -4.5 m. The depth imbedded of the sheet piles was 7.3 m.

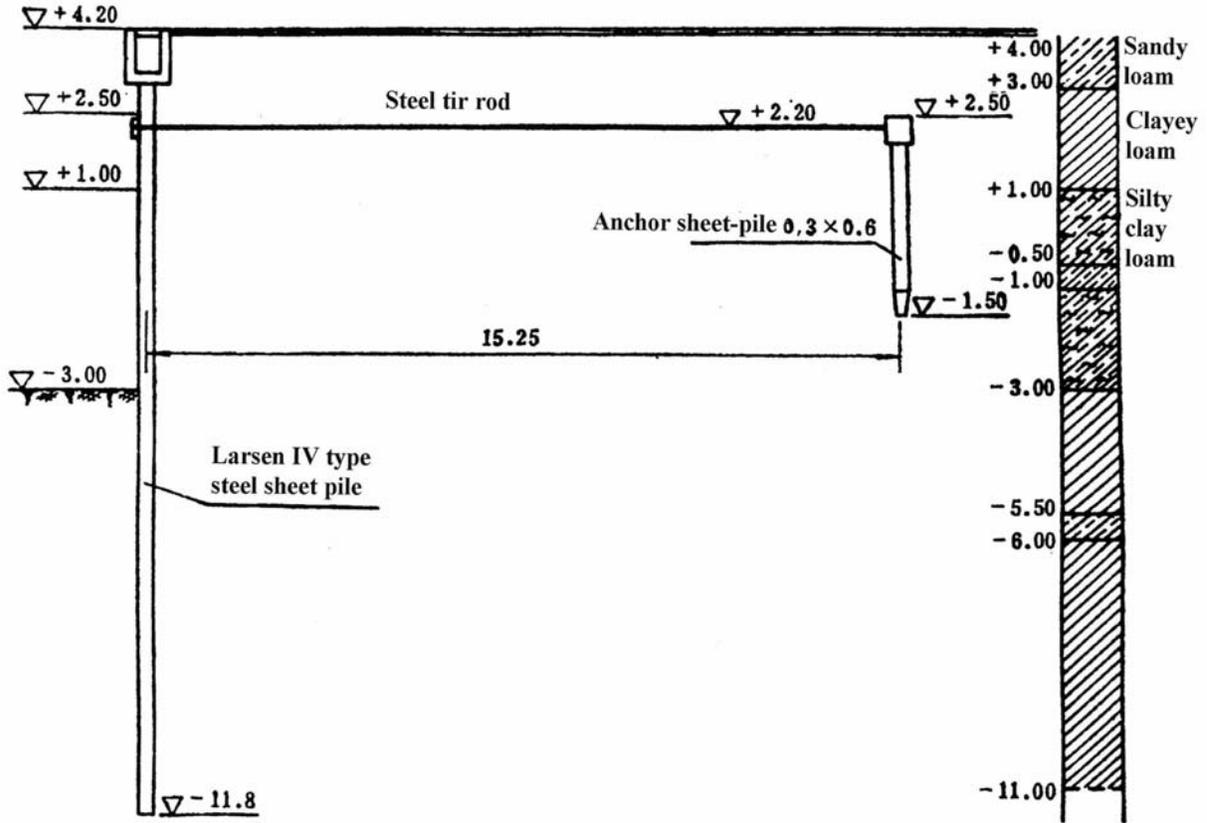
Figure 19. Cross section of the wharf for the FNEB shipyard (in m).

This bulkhead wharf is an anchored sheet pile structure (Fig. 19). The wharf is divided into three parts: east, middle, and west.

After the earthquake a sheet pile wall began to incline towards the river. About three hours after the earthquake the horizontal displacement of the top of the sheet pile wall was about 10 cm. Hereafter, the middle part of the wharf continued to incline forward. On the fourteenth day after the earthquake the largest displacement of the wharf line reached 1.14 m. The previously straight wharf line became curved (Fig. 20). The displacement was larger in the middle part than at the two ends. The sheet pile wall inclined forward seriously, the inclined slope of the capping beam, which was on top of the wall, was about 6° .

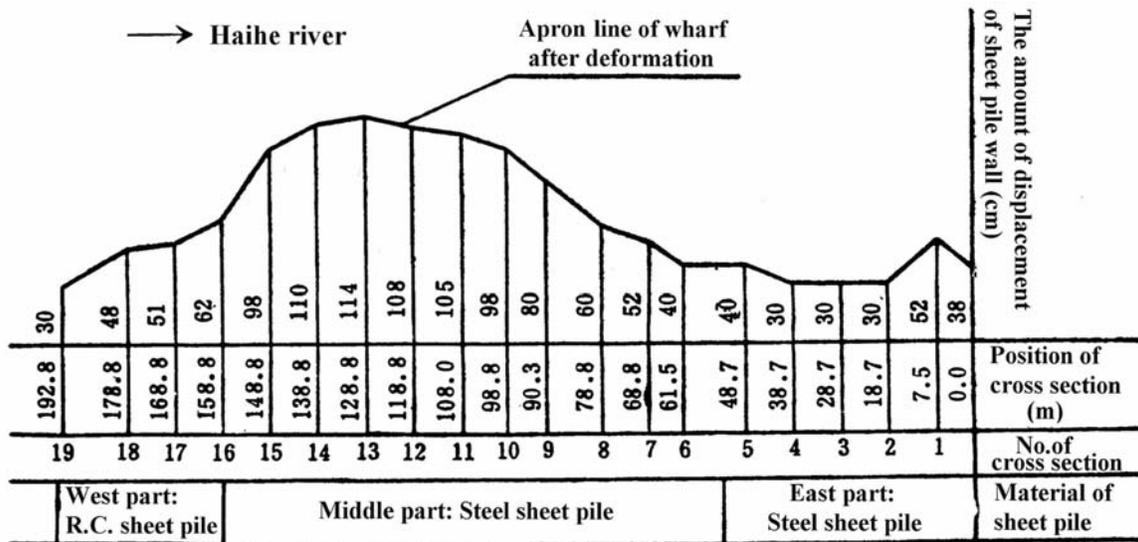
Figure 20. Displacement diagram of apron line of the wharf for the FNEB shipyard.

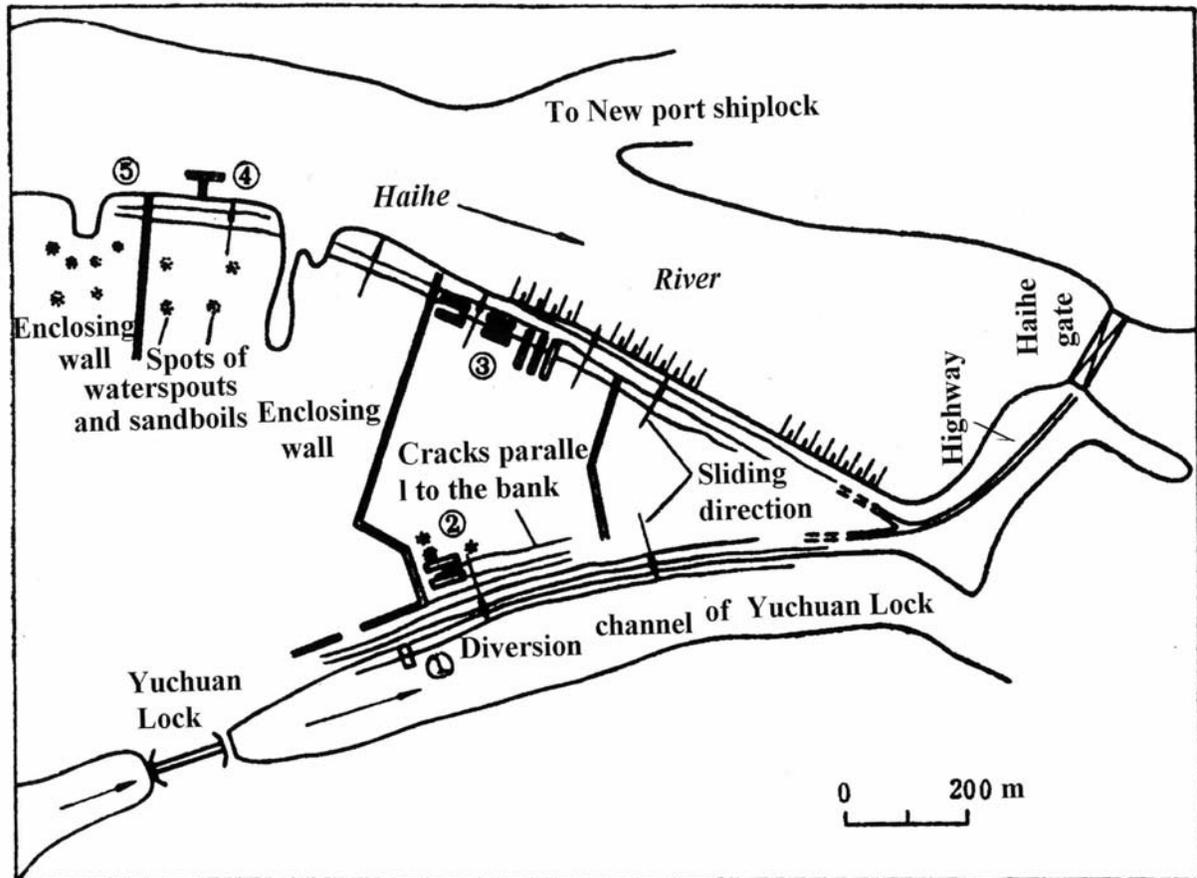
Figure 2. A sketch of a map showing ground cracks and slope sliding around the Institute of Marine Petroleum Exploration Bureau (ground crack width in cm).

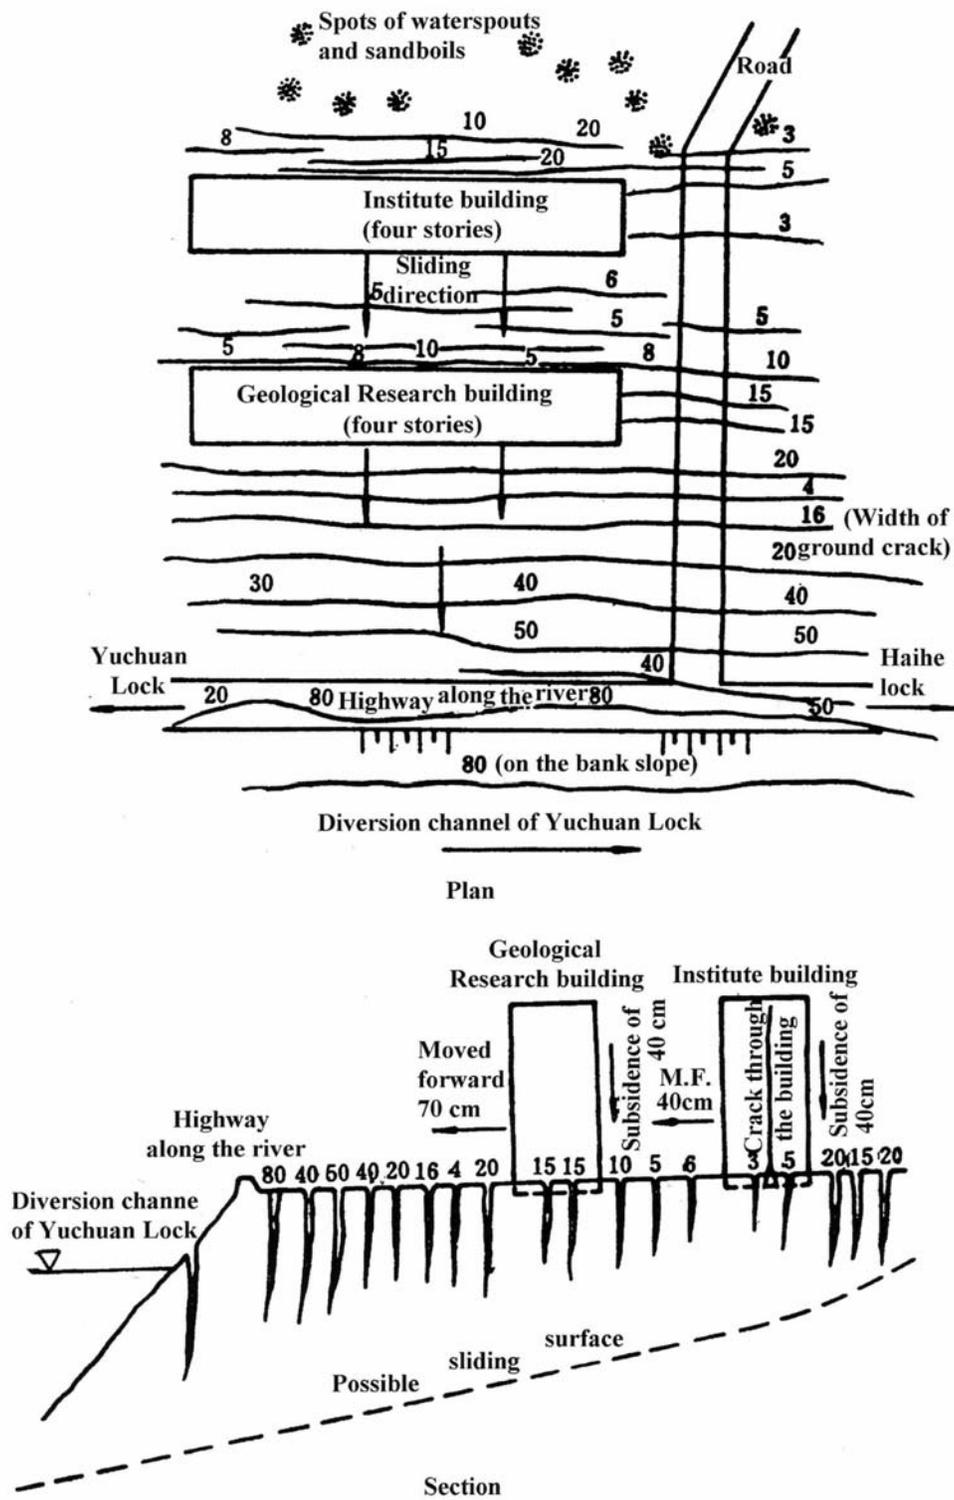
from the wall (Fig. 3). The No. 12 and No. 13 buildings adjacent to building No. 11 were slightly damaged (there were two rows of steel stakes in front of building No. 12).

Figure 3. A sketch of a map showing ground cracks and bank slope sliding in the living quarters of the Marine Petroleum Exploration Bureau.

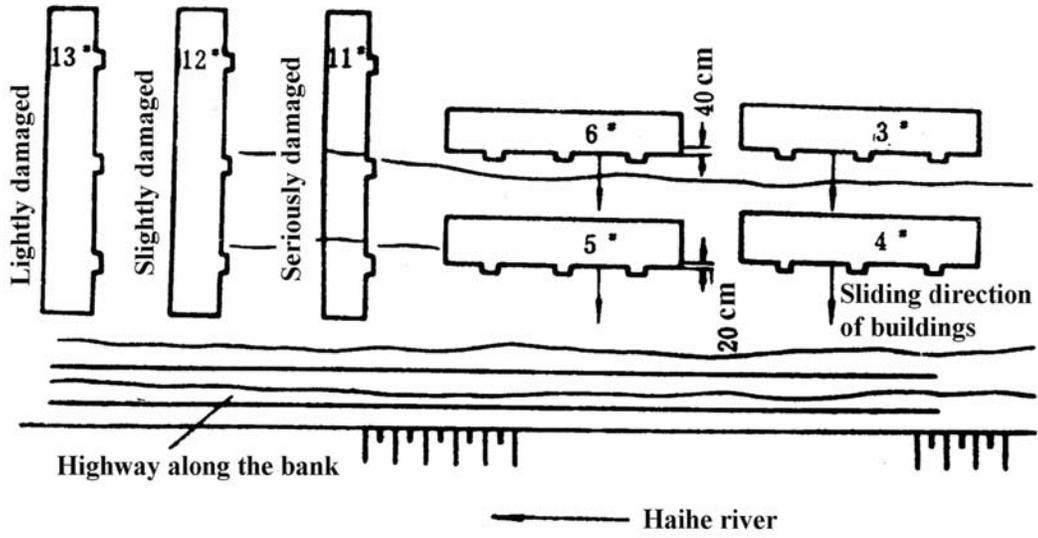
Figure 4. A sketch of a map showing earthquake damage to the bank slope of the Marine Petroleum Exploration Bureau Base.

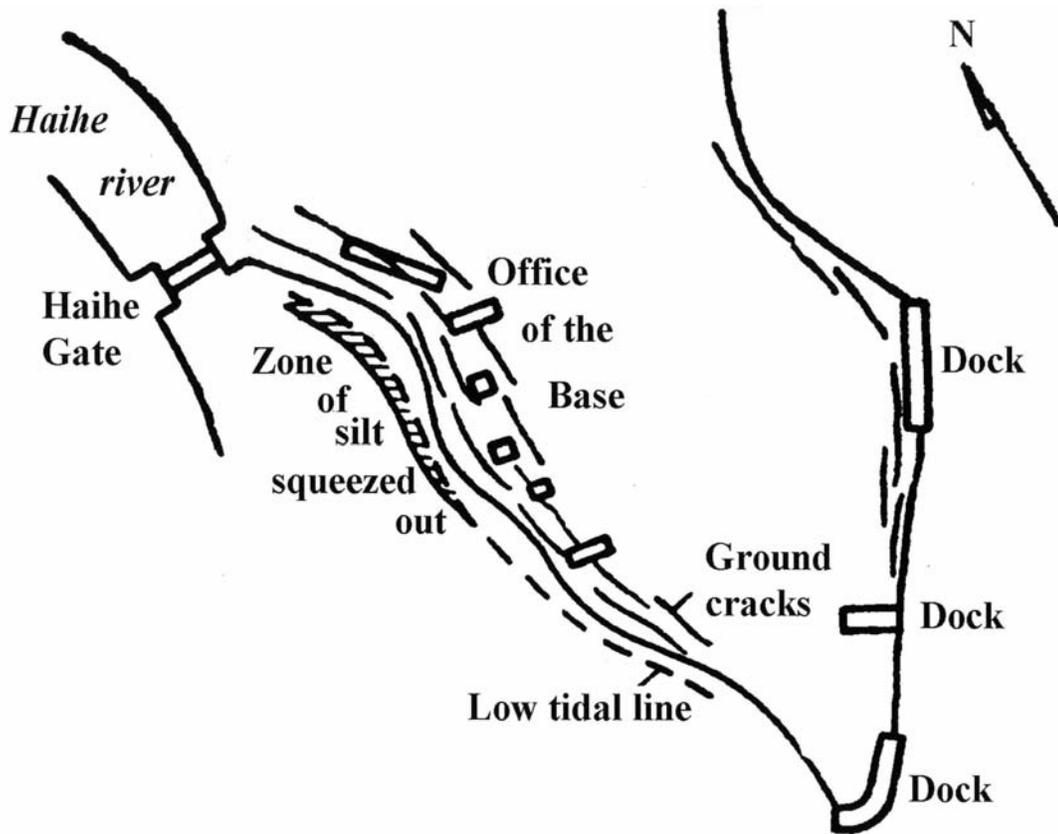
Figure 5. Plan sketch map of earthquake hazards damage to the enclosure wall and foundation pit of the dock for the Marine Petroleum Exploration Bureau.
