NATIONAL TRANSPORTATION SAFETY BOARD
Office of Aviation Safety
Washington, DC 20594

Interim Factual Report

NTSB Case Number: DCA13IA037
Location: Boston, Massachusetts
Date: January 7, 2013
Aircraft/Operator: Boeing 787-8, JA829J, Japan Airlines

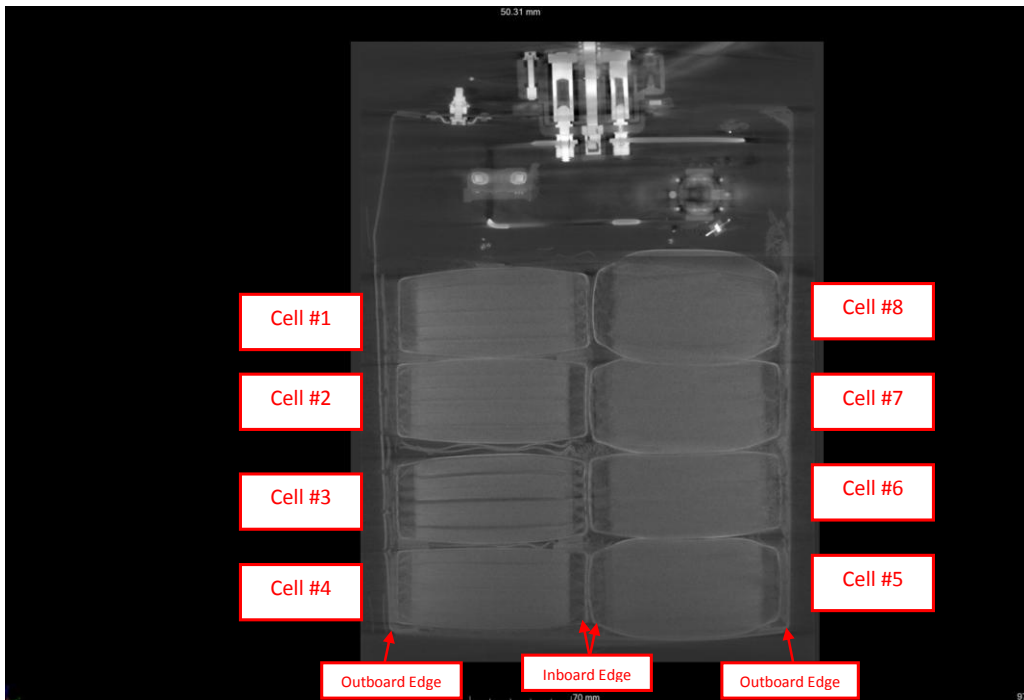
Figure 15. Cross-sectional view of the auxiliary power unit battery.

The CT scans for the main battery showed no anomalies outside the cells. The CT scans for the APU battery showed that (1) several cells were distorted and had an expanded or contracted profile, (2) several current collectors inside the cells were separated, (3) some current collector fingers were out of their designed alignment,³⁶ and (4) a breach of the battery case corresponded with a breach of the cell wall in cell 5. A CT scan of the APU battery is shown in figure 15.

The six individual APU battery cells that were examined were cells 1 and 3 through 7. The CT scans for cells 1 and 3 showed that the cells did not have any breaks in the current collectors, but the cells were swollen, and there were a number of areas where the uniformity of the windings was disturbed. Numerous higher density particles were also noted in and around the electrode assembly in these cells. The CT scans for cell 4 showed that the cell was not swollen and did not have separations within the winding layers.
