Offshore Petroleum Safety Regulation

Varanus Island
Incident Investigation

by
Kym Bills and David Agostini
June 2009

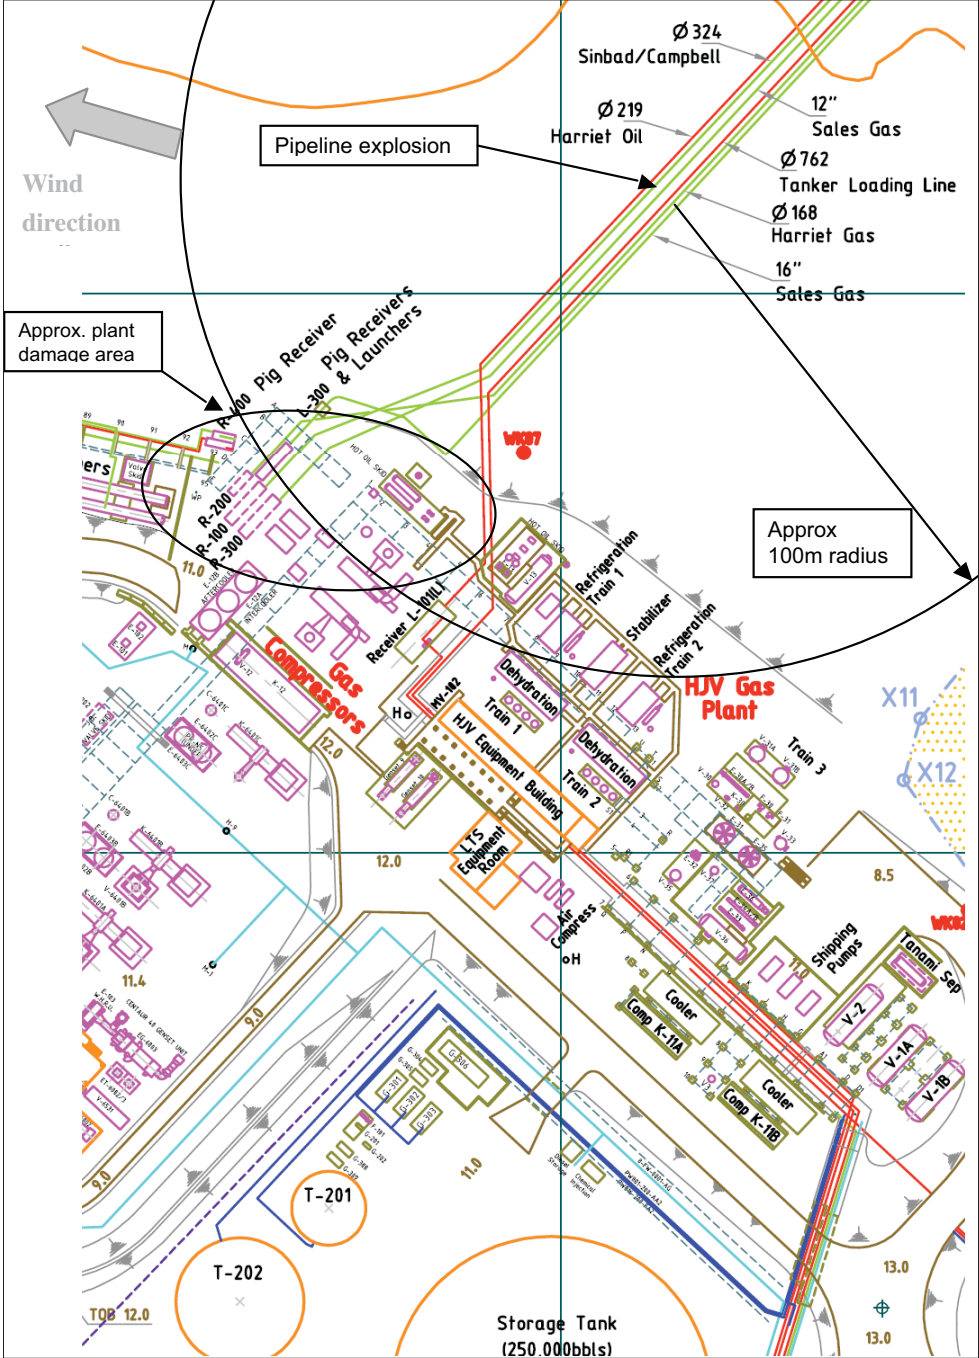
Figure 2: Location of explosion on beach

At around 1330 on 3 June 2008 the 12 inch sales gas line (SGL) from Varanus Island to the mainland ruptured at the beach crossing and the released gas exploded into flame. The rupture of the 12 inch SGL caused the near simultaneous failure of the adjacent 12 inch import gas line from the Campbell and Sinbad offshore facilities located northeast of Varanus Island. The explosions created an 8 m x 30 m crater on the beach to a depth of about 2 m, exposing the buried pipelines and showered the NNE section of the plant with limestone rocks, stones and pieces of concrete weight coating from the ruptured pipelines⁴.

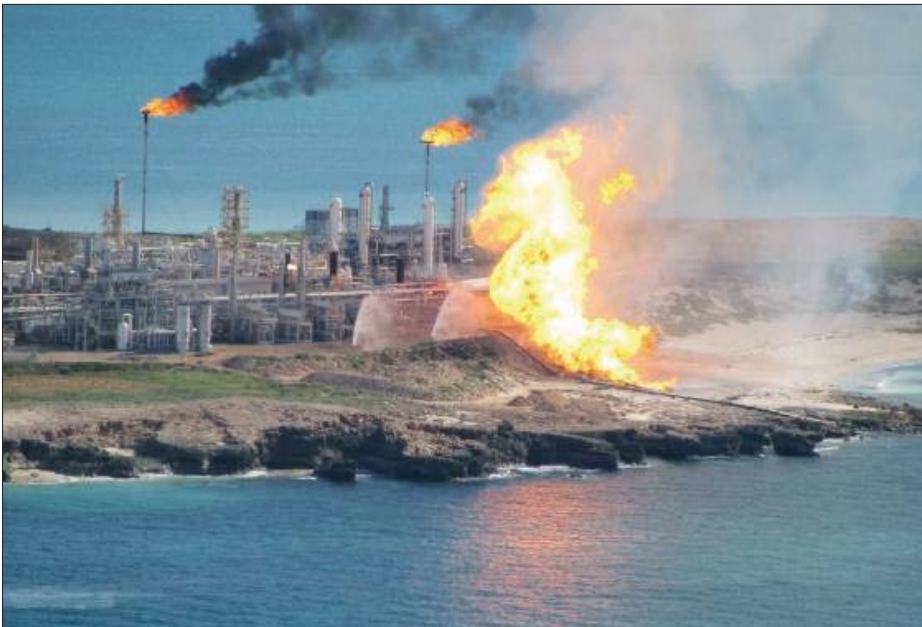
Photo 2 - Varanus Island fire and explosion incident, view from helicopter

- F19. The initial explosions occurred on the beach. The nearest elements of the Apache HJV gas plant are located approximately 75m away, but are approximately 5m above the level of the pipelines on the beach. Because of this, the jet fires from the ruptured ends of the 12" pipelines were deflected by the embankment up into the air, and did not impinge directly into the plant areas (Attachment 5, Photos 2 and 3).

- F26. Following the initial ruptures and fire, three water monitors were activated by the Apache Emergency Response Team (ERT) to create a protective water cooling curtain between the fires and the plant (Attachment 5, Photo 2). This action appears to have been effective in preventing more widespread damage to the Apache HJV gas plant from radiant heat.

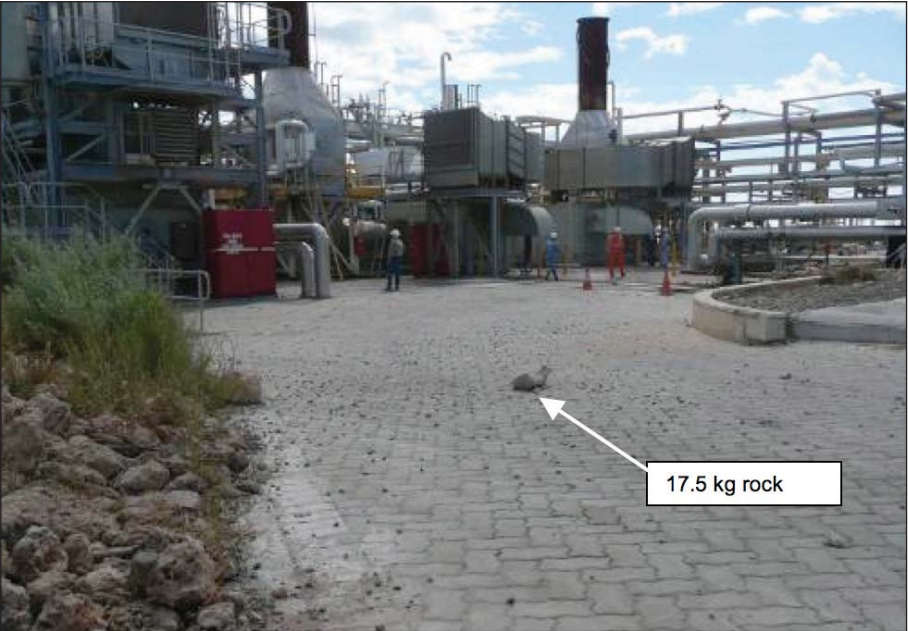
Photo 12 – Debris in HJV gas plant (compressors) area

- F22. As a result of the ruptures, the surrounding areas, including the NNE part of the Apache HJV gas plant, were showered with rocks, smaller stones, gravel, and pieces of concrete stability coating thrown from the pipelines Attachment 5 photo 12 shows the largest rock (17.5kg) found within the Apache HJV plant area. Persons interviewed indicated this rock and other debris, were not present within the plant area prior to the incident.

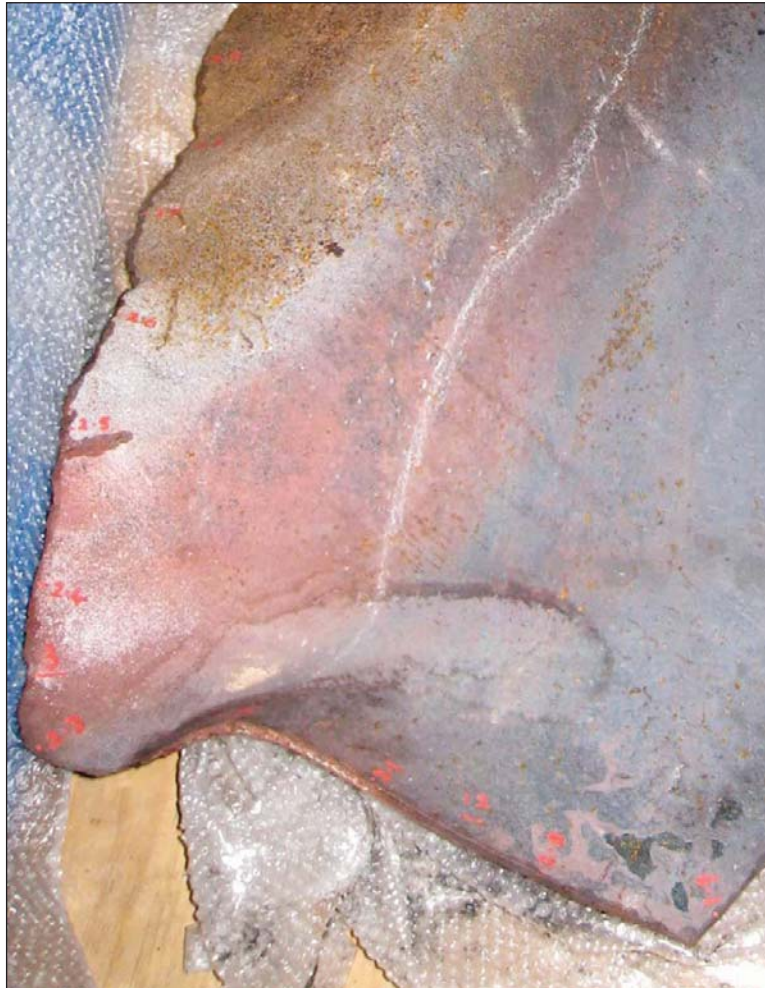
Figure 3.1.2

Closer view of one corner of the approximately rectangular sheet of pipe steel

Reference positions were observed to have been marked in red by others at 100 mm intervals around the perimeter of the sheet.

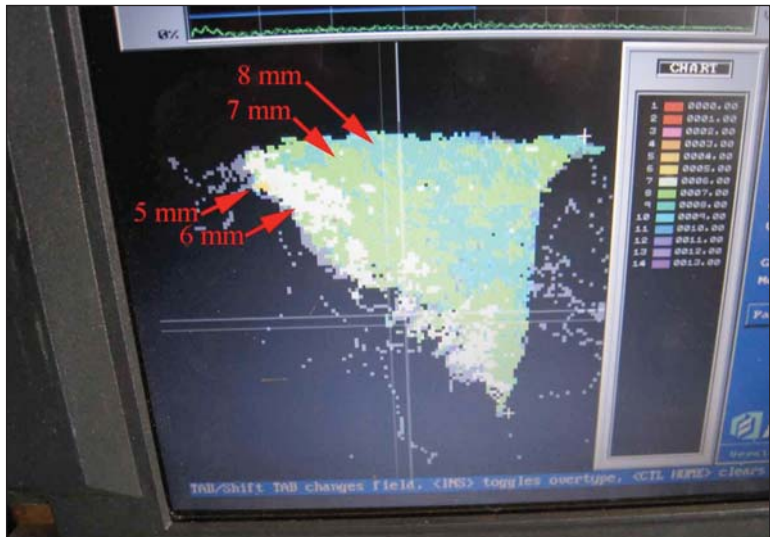
Figure 3.2.3 shows one of the μ maps from sample 12-SG-N-FE. I have marked four different sheet thicknesses on the pixel map using the key shown below the word CHART.

Figure 3.2.3
Monitor screen display showing thickness readings displayed as
2 mm x 2 mm coloured pixels

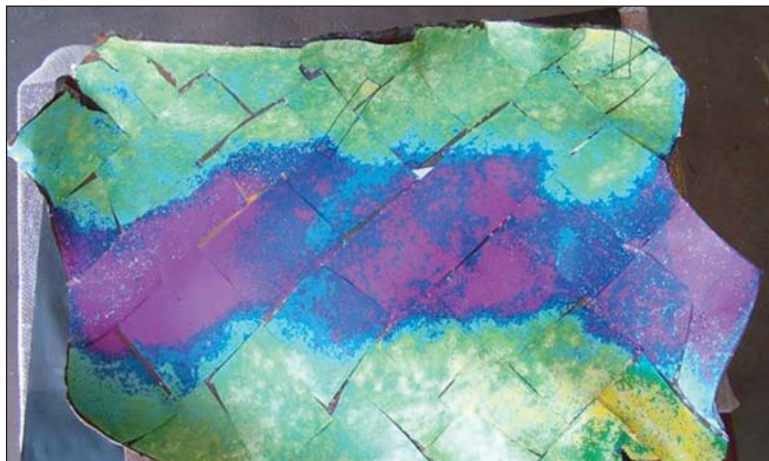
Figure 3.2.5

Colour prints of all μ maps attached to the 12-SG-N-FE piece of flattened pipe

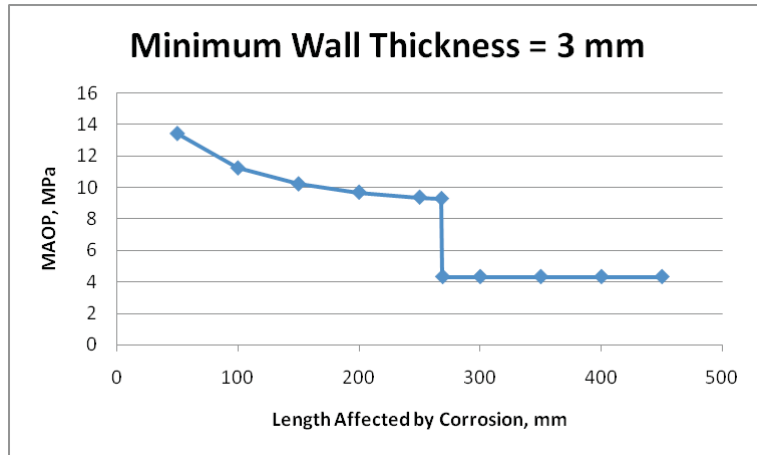
Figure 4.2.1

MAOP for 3 mm minimum nominal wall thickness and various corroded lengths of 12" Sales Gas line.

The MAOP can be seen to drop abruptly at a corrosion affected length of approximately 270 mm. The reason for this is that between a corroded length of 268 mm and 269 mm, the value of K_C reaches 4 (calculated from equation D3, Appendix I). When $K_C > 4$ the MAOP is no longer calculated from equation D4 but is calculated from equation D5. Equation D5 gives a constant MAOP value for a fixed maximum depth of corrosion, regardless of the length of pipe affected by corrosion.

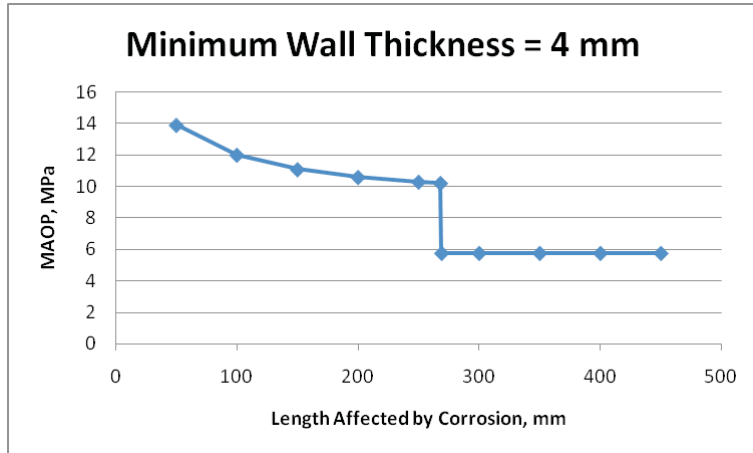
Figure 4.2.2
MAOP for 4 mm minimum nominal wall thickness and various corroded lengths of 12" Sales Gas line.

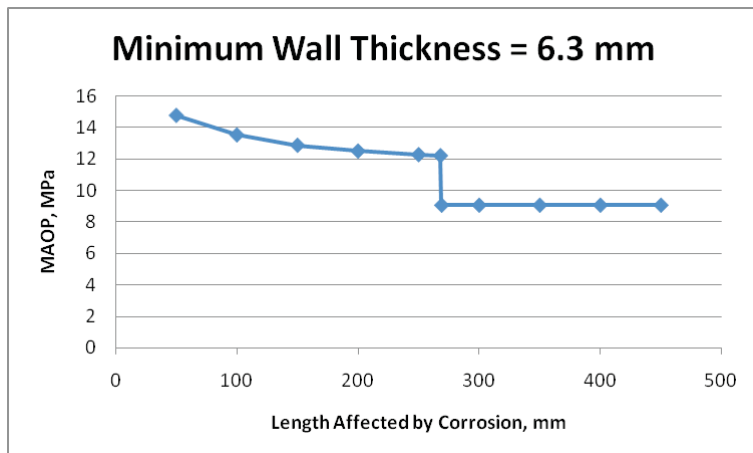
The limiting case for an allowable operating pressure of 9.168 MPa, reported to have been current at the time of the burst, is given by a minimum nominal wall thickness of 6.3 mm.

Figure 4.2.3
MAOP for 6.3 mm minimum nominal wall thickness and various corroded lengths of 12" Sales Gas line.

For cases where the minimum nominal wall thickness is greater than 6.3 mm, the MAOP exceeds the 9.168 MPa operating pressure current at the time of the explosion, regardless of the length of pipe affected by corrosion.

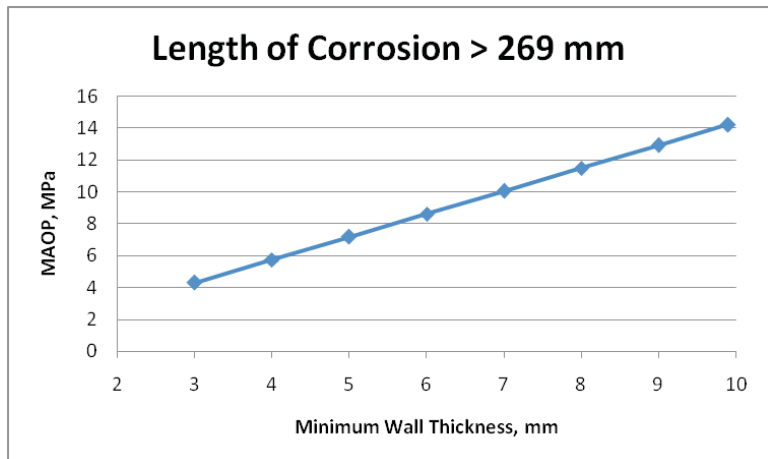
12" Sales Gas line MAOP for projected lengths of corrosion greater than 269 mm and various minimum nominal wall thickness.

It was clear from visual examinations and from thickness measurements that the corrosion on the 12" Sales Gas line was several times greater than a projected length of 269 mm. This being the case, AS2885.3 requires the MAOP to be reduced from the design value of 14.5 MPa and to be determined by equation D5.

Figure 4.2.4 shows the AS2885.3 MAOP requirements for the corroded 12" Sales Gas line.

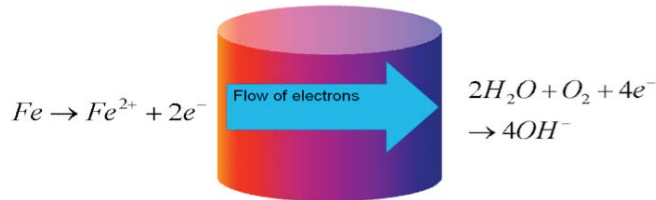
If one assumes that, since the pipelines are of different age, it is likely that the pipelines have different potentials. Alternatively, if some of the installed magnesium anodes are in contact with seawater, others are not, different potentials of the pipelines could be the consequence. This, in turn, could result in a current that has been flowing between pipes at the first point of sufficient soil conductivity: in the tidal zone. The area where the current leaves the pipeline is the area where the steel dissolves (electric definition, the current flows from plus to minus). A schematic is given in Figure 1.

Figure 1: Direct Current Corrosion

This corrosion mechanism still needs the coating to fail first (loose adhesion to the steel surface) or to be initiated at a defect in the coating due to stone chipping or other mechanical damage during installation. The Brian Martin scenario is plausible and the relatively high corrosion rates of 0.7mm/year could be explained through direct current corrosion. It is also possible that the installation of the 16" sales gas pipeline in 1999 could have caused the interference to occur (e.g., disrupted adequate grounding), and the induced direct voltage and current was sufficiently high to lead to the adhesion failure of the coating (cathodic disbondment) and subsequent high corrosion rates of ca. 1mm per year could be responsible for the failure. It is also possible that intermittent DC-stray currents, e.g., due to inadequate welding procedures or grounding during the installation of the new pipeline, have caused the coating to disbond from the pipeline.

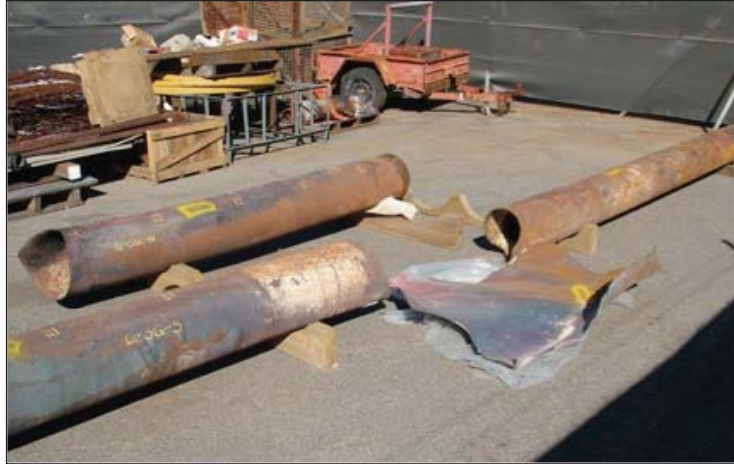
Supporting evidence: The corrosion damage (Figure 2) was observed at the 1 to 10 o'clock (viewed clockwise looking southwards towards the HJV plant) position of the 12 inch Sales Gas Line with datum location of the fracture identified at the 3 o'clock position, as well as the thickness measurements performed on the SGN showed most thinning at the same position (Section 3.3.1 Ultrasonic Inspection, Pearl Street report 8A5/MET10). The 8" Harriet crude oil pipeline could have acted as current collector and sink, as pictures indicate that it was in good condition.

Figure 2: 12 Sales Gas Pipe sections (12-SG-S, 12-SG-N & 12-SG-N-FE) and 12 Sinbad / Campbell Pipe section (12-SBC-N) laid out in similar positions as to that as removed from the Varanus Island site (Pearl Street Report 8A5/MET 9, Appendix 1, Image 5)

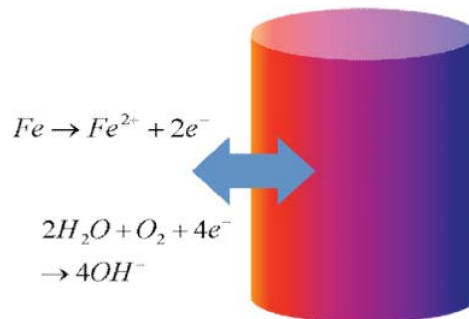
To my knowledge, no measurements have been made to evaluate the risk for AC-corrosion (although named in AS2885 and AS2331 as possible threats for pipelines). In a similar scenario as described under 4.2.1, but this time a faulty grounding inside the facility has induced an AC voltage into the pipe system (Figure 3).

Figure 3: Alternating Current Corrosion

AC-corrosion is often very localised and induced at small coating defects. It is unlikely that AC corrosion would cause the coating disbondment on such a large scale as observed on the 12" Sales Gas Pipe Line. However, AC-currents can pass through a damaged coating at greater ease (depending on the frequency) than direct currents. Taking a loss of adhesion of the coating system as given, a AC-voltage of 30V could have resulted in sufficiently high corrosion rates to cause this failure within a period of 10 years (dependent on
