# Summary of Air Traffic Hijack Events

September 11, 2001

SOURCE: AAT-20

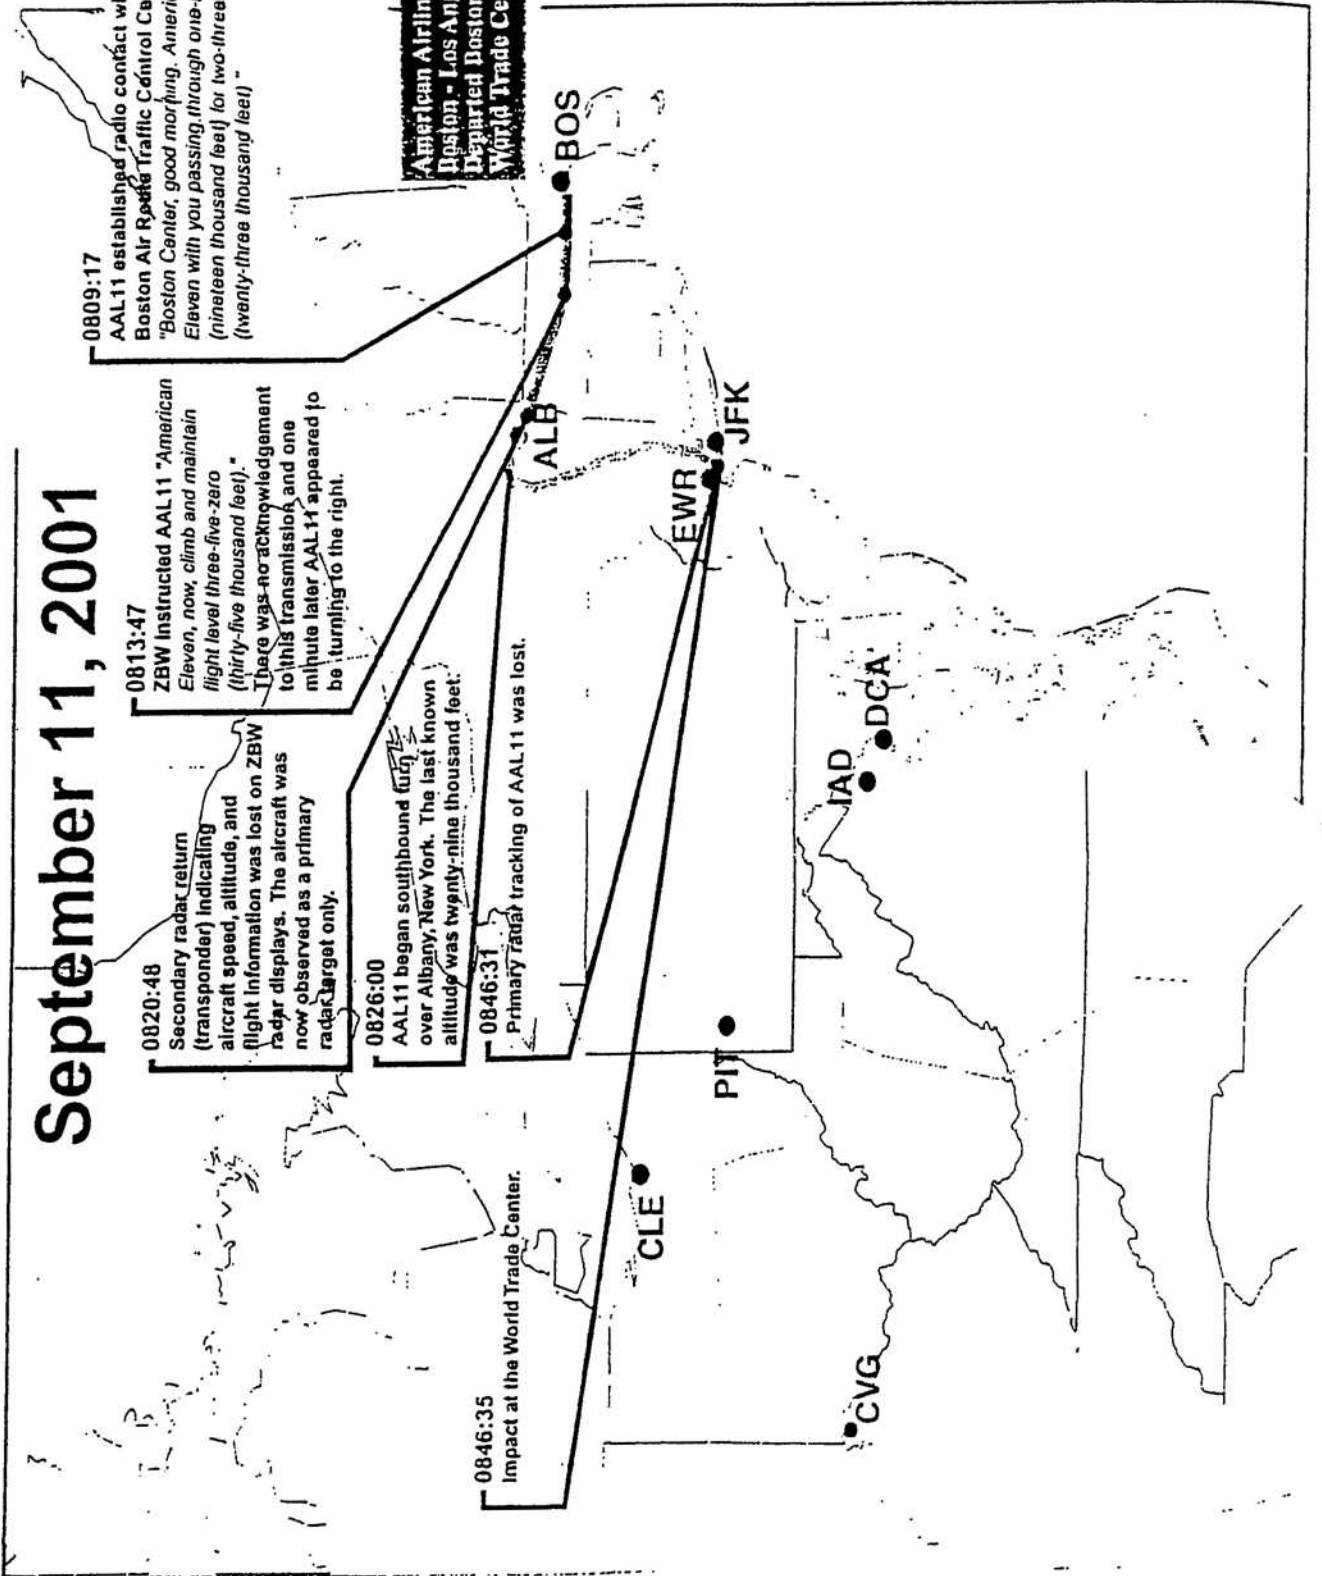
American Airlines Flight 11, B767  
Boston - Los Angeles  
Departed Boston: 8:00 A.M. EDT  
World Trade Center 8:46 A.M. EDT

0809:17  
AAL11 established radio contact with Boston Air Route Traffic Control Center (ZBW).  
"Boston Center, good morning. American Eleven with you passing through one-nine-zero (nineteen thousand feet) for two-three-zero (twenty-three thousand feet)."

0813:47  
ZBW instructed AAL11 "American Eleven, now, climb and maintain flight level three-five-zero (thirty-five thousand feet)."  
"There was no acknowledgement to this transmission and one minute later AAL11 appeared to be turning to the right."

0820:48  
Secondary radar return (transponder) indicating aircraft speed, altitude, and flight information was lost on ZBW radar displays. The aircraft was now observed as a primary radar target only.

0826:00  
AAL11 began southbound turn over Albany, New York. The last known altitude was twenty-nine thousand feet.

0846:31  
Primary radar tracking of AAL11 was lost.

0846:35  
Impact at the World Trade Center.

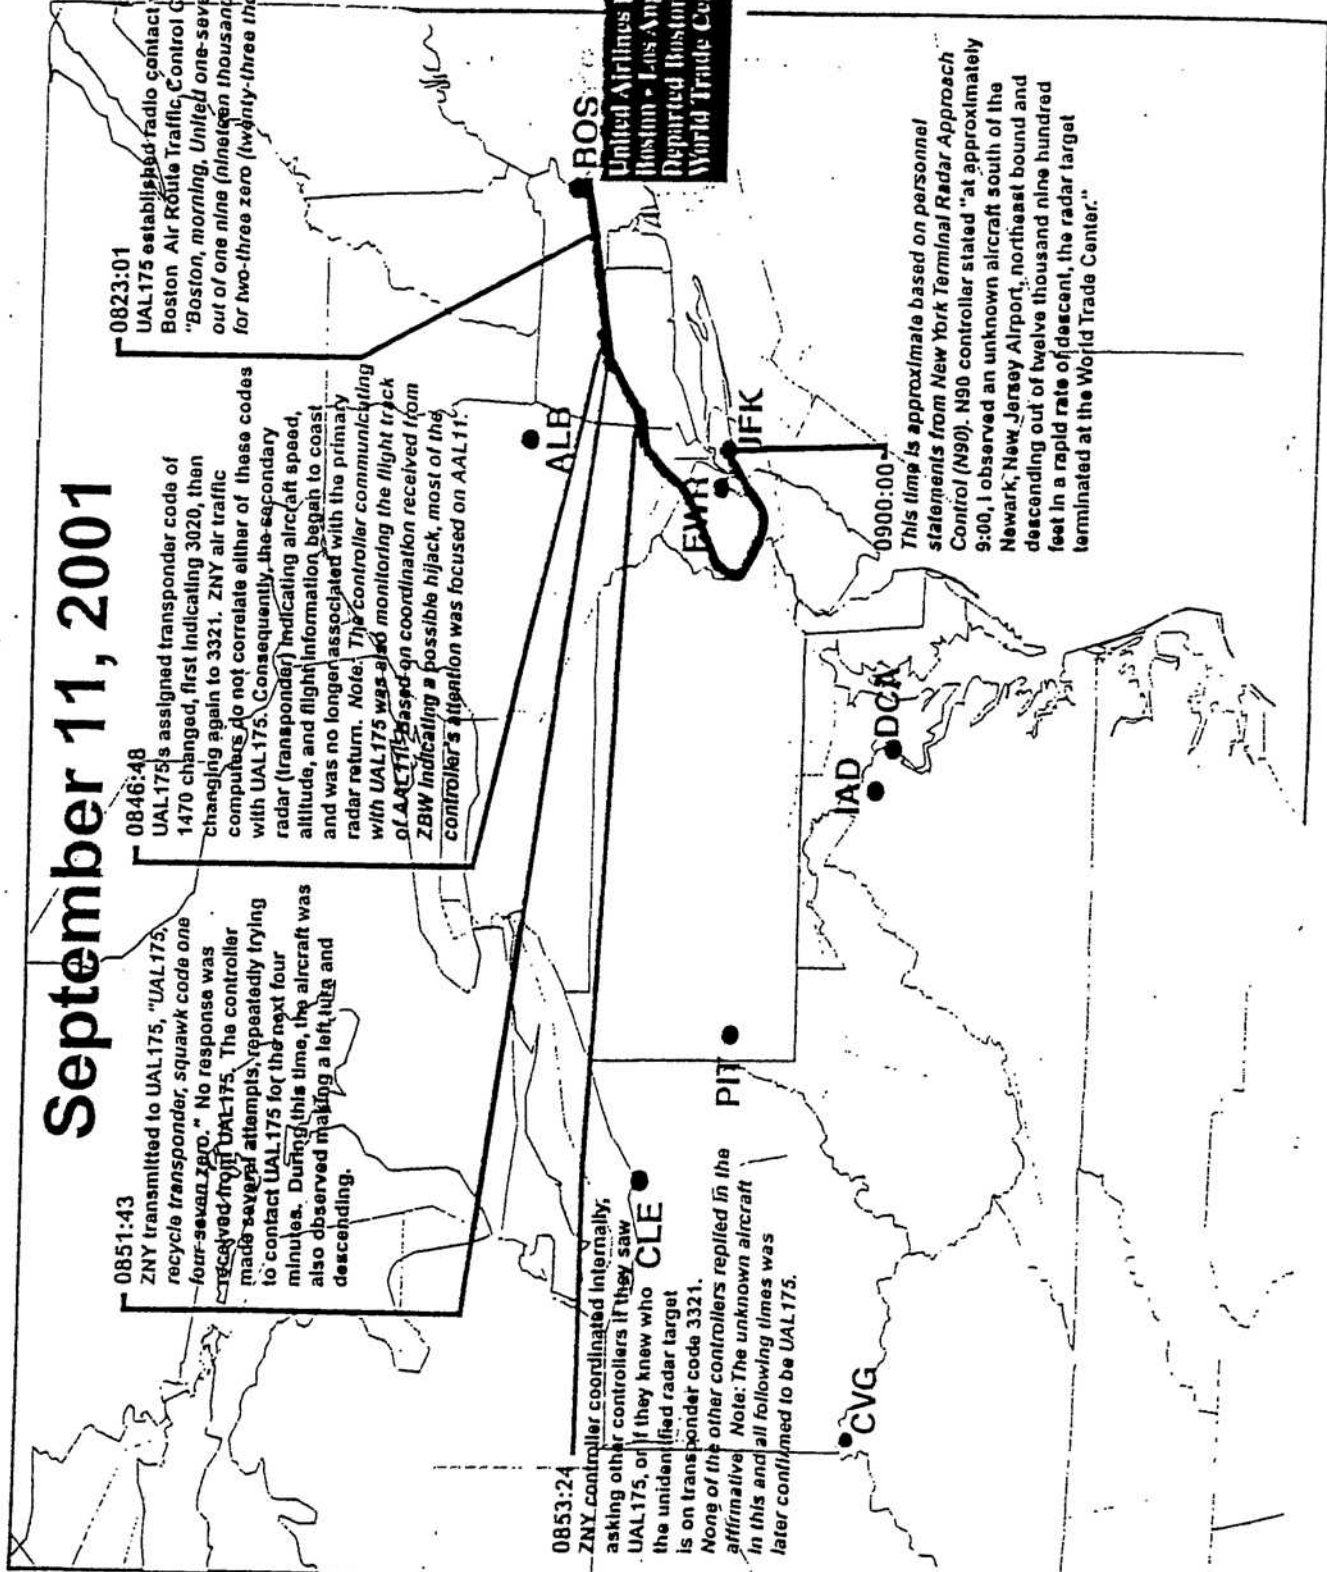
BOS  
United Airlines Flight 175, N767  
Boston - Los Angeles  
Departed Boston: 8:14 A.M. EDT  
World Trade Center: 9:03 A.M. EDT

ZNY transmitted to UAL175, "UAL175, recycle transponder, squawk code one four-seven zero." No response was received from UAL175. The controller made several attempts, repeatedly trying to contact UAL175 for the next four minutes. During this time, the aircraft was also observed making a left turn and descending.

This time is approximate based on personnel statements from New York Terminal Radar Approach Control (N90). N90 controller stated "at approximately 9:00, I observed an unknown aircraft south of the Newark, New Jersey Airport, northeast bound and descending out of twelve thousand nine hundred feet in a rapid rate of descent, the radar target terminated at the World Trade Center."

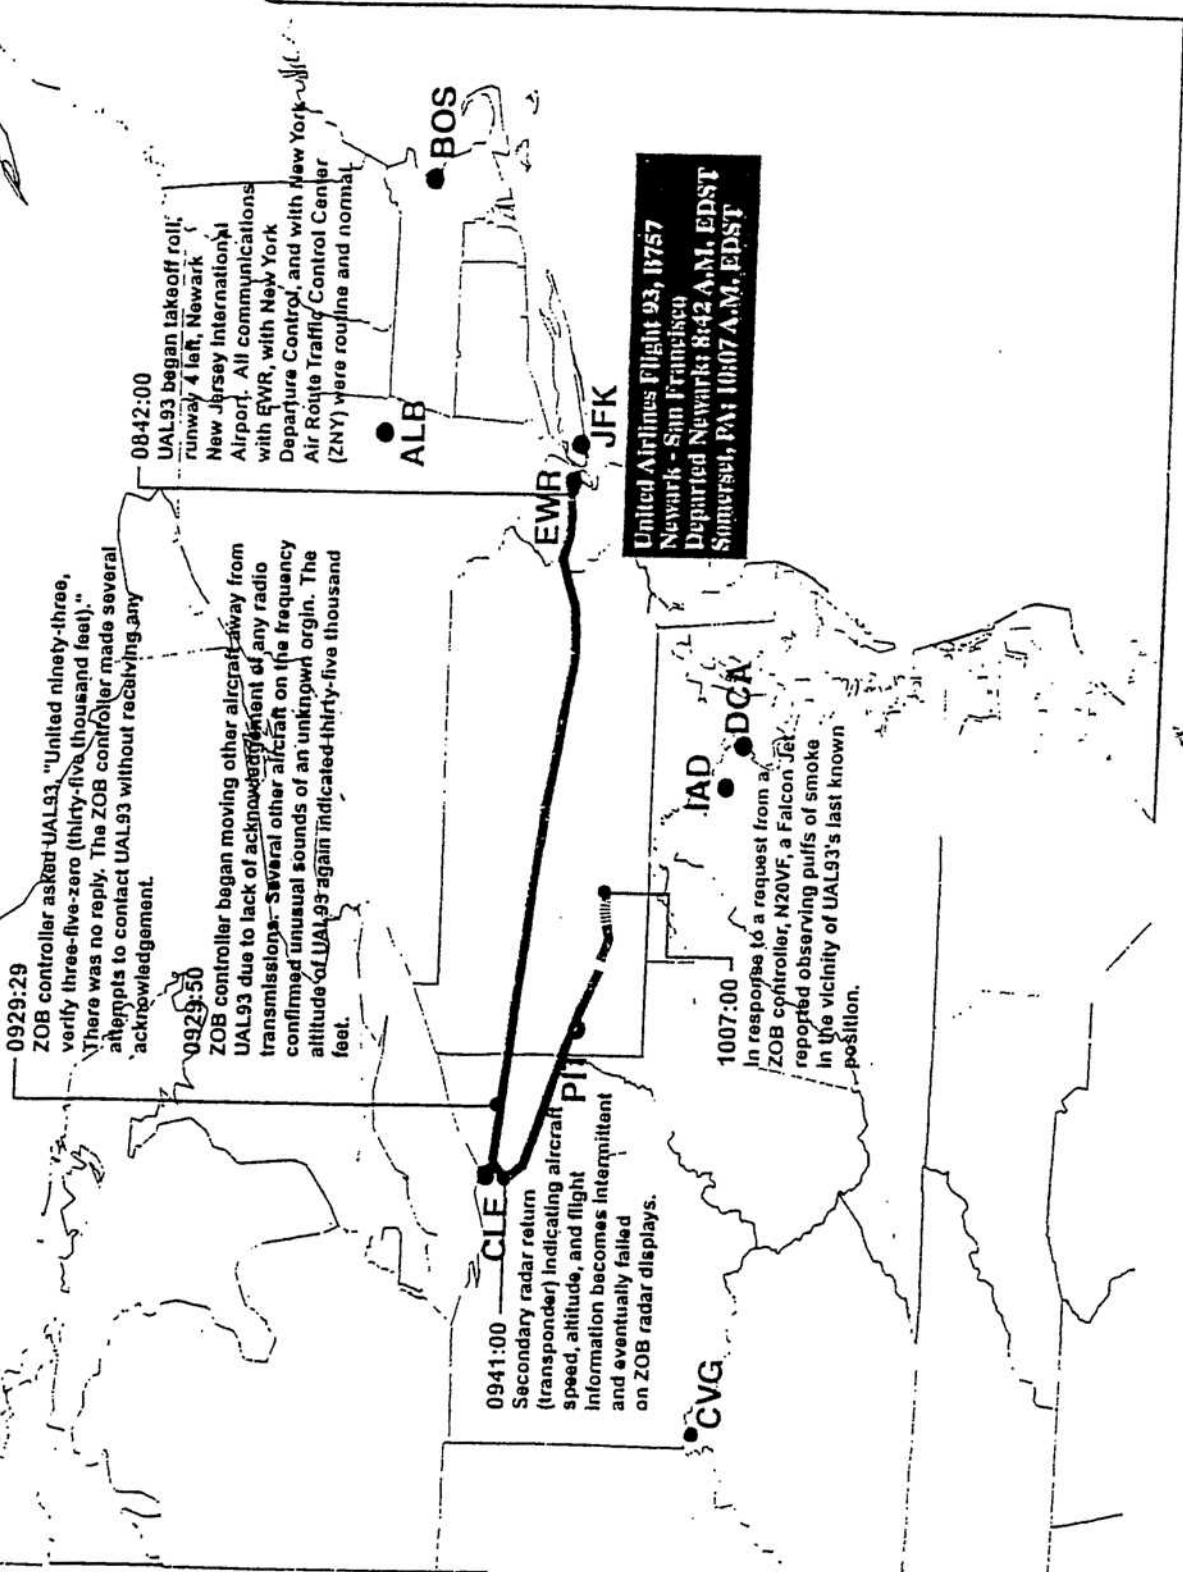
0929:29  
ZOB controller asked UAL93, "United ninety-three, verify three-five-zero (thirty-five thousand feet)." There was no reply. The ZOB controller made several attempts to contact UAL93 without receiving any acknowledgement.

0929:50  
ZOB controller began moving other aircraft away from UAL93 due to lack of acknowledgment of any radio transmissions. Several other aircraft on the frequency confirmed unusual sounds of an unknown origin. The altitude of UAL93 again indicated thirty-five thousand feet.

0941:00  
Secondary radar return (transponder) indicating aircraft PIT. Information becomes intermittent and eventually failed on ZOB radar displays.
