The Pentagon Event: The Honegger Hypothesis Refuted

Victoria Ashley, David Chandler, Jonathan H. Cole, Jim Hoffman,

April, 2016

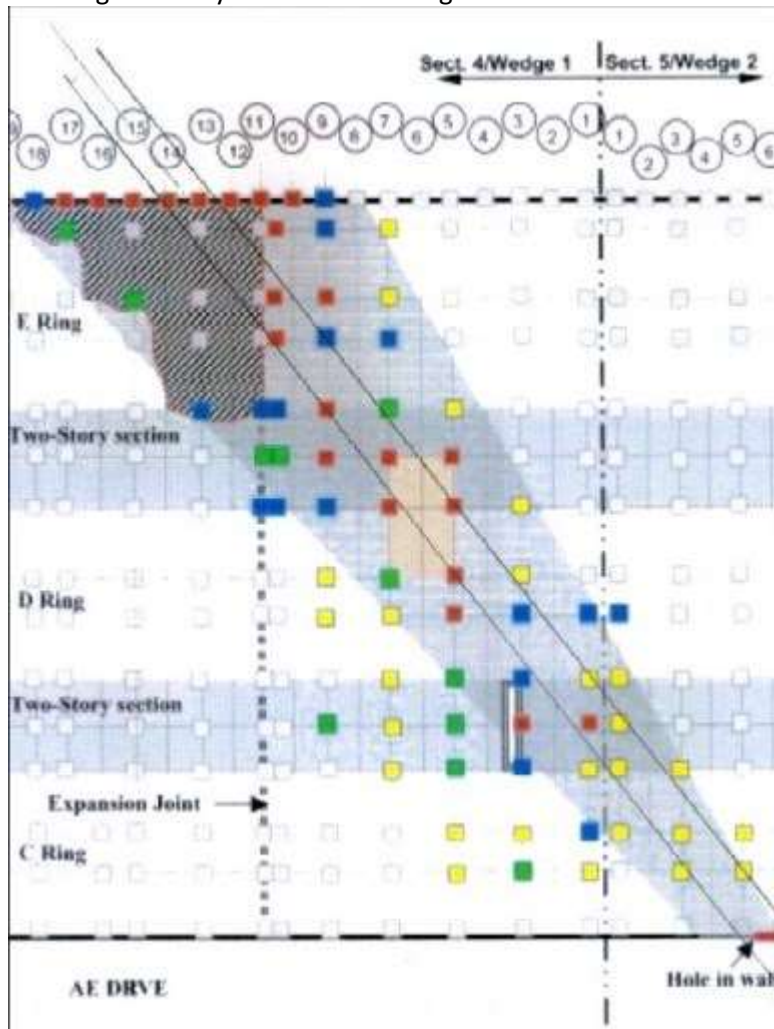
Figure E-7

contention since the main debris flow took out all the columns for 158 feet after which it flowed easily around those few remaining in its way to make the C ring hole.

Plane debris main penetration path (two parallel lines 12.33 feet apart)

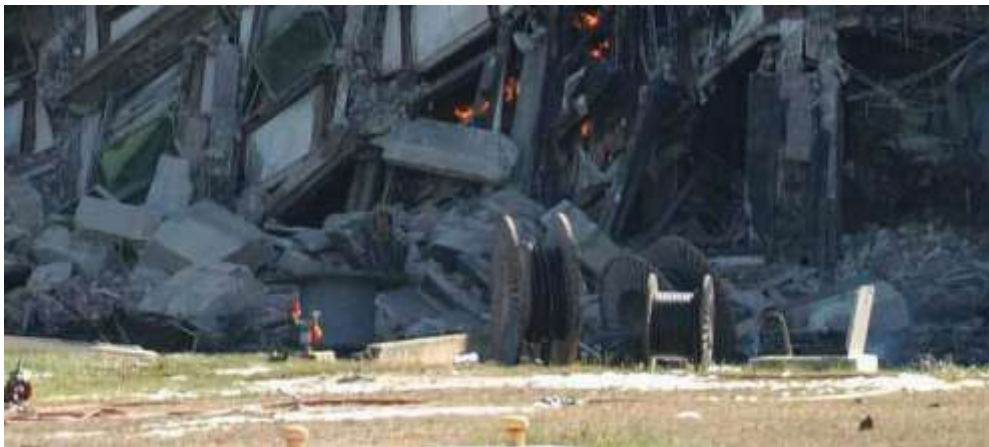
Figure F-7 Low concrete wall and small spool

The gouge indicates that the left engine was very close to the ground at this point. However, as shown in Figures F-9 and F-11 and in these photographs, the ground slopes up as one approaches the concrete wall from the highway and from the generator trailer and then slopes down toward the Pentagon west wall. Thus the left engine did not gouge the lawn as it was just above ground level at a high point. The two red lights to the left of the gouge are warning lights.

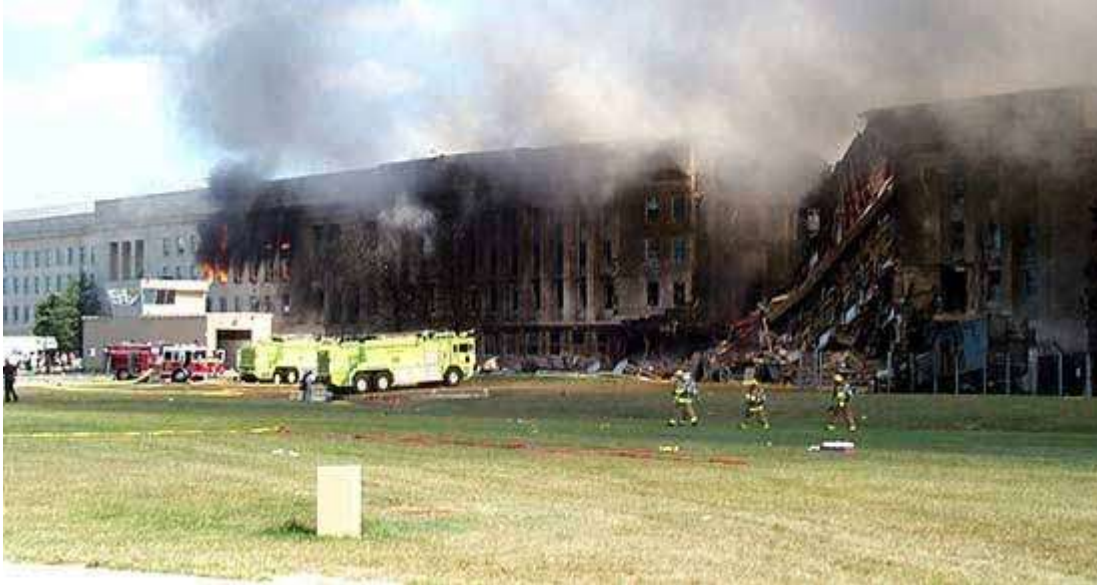
Figure F-11 Pristine lawn

Regarding argument (2), Honegger shows a well-known photograph of the "pristine lawn" at S-00:34:35. This photograph is deceptive because of foreshortening; the lawn appears to reach almost to the Pentagon west wall, but in reality the photograph shows only the lawn up to about 95 feet from the west wall. Other photographs reveal much debris within the space 95 feet from the west wall and in a direction perpendicular to the impact hole.

Examine the photograph in Figure F-11, which shows the same scene as Honegger’s “pristine lawn” photograph but taken from a different angle. The firemen nearest the center are in front of the gouge in the low concrete wall in the background. On their right can be seen a large standing spool. On their left and just visible is the white box that is part of the warning lights. At the right of the photograph can be seen the fence that encloses the generator trailer. Note the incline of the fire truck left of center – the ground rises up, showing that the low concrete wall that was gouged was on higher ground than the surrounding lawn. The plane was rolled to the left, and the left engine hit the low concrete wall almost at ground level there, which was higher than the level of the lawn in the foreground. Given these facts, there is no mystery as to the absence of a gouge in the pristine lawn.

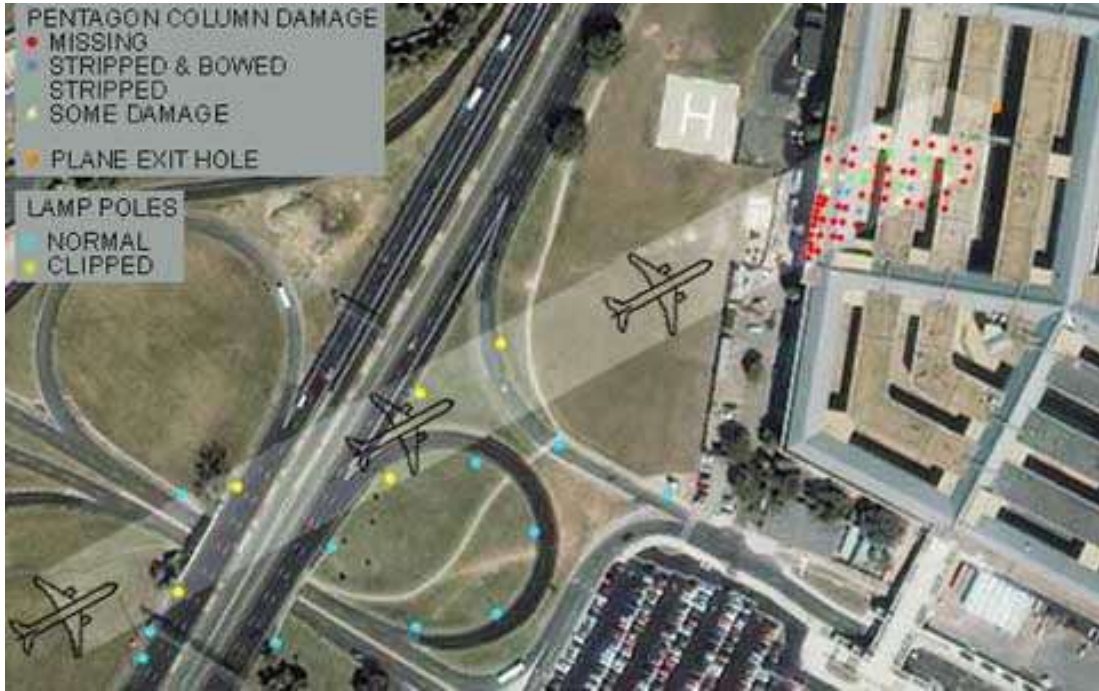
Figure G-6
Aerial photograph showing one exit hole

Hole 1 is a door, hole 2 is a roll-up door larger in width, and hole 3 is the C Ring hole where debris from the large plane broke through into the A & E driveway. In her text (book) version of her Toronto Hearings' talk, Honegger acknowledges that holes 1 and 2 are doorways, but she does not mention this fact in her Toronto or Seattle live presentations where she compares Figure G-5 with a similar figure showing only one "EXIT HOLE," the C Ring hole (see Figure G-6).

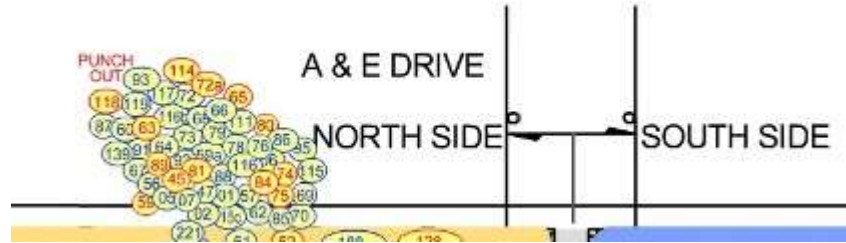
Figure G-9 – Detail of Figure G-10 showing “Punch Out” label

This figure (see Figures G-9 and G-10) shows locations of body or body fragments of victims by number. The words “Punch Out” in very small letters appear at the top and very close to the body numbers in the A & E driveway, further supporting their interpretation as a list rather than a directive to punch a hole in the wall. The list could be of bodies that were removed through the C ring hole.

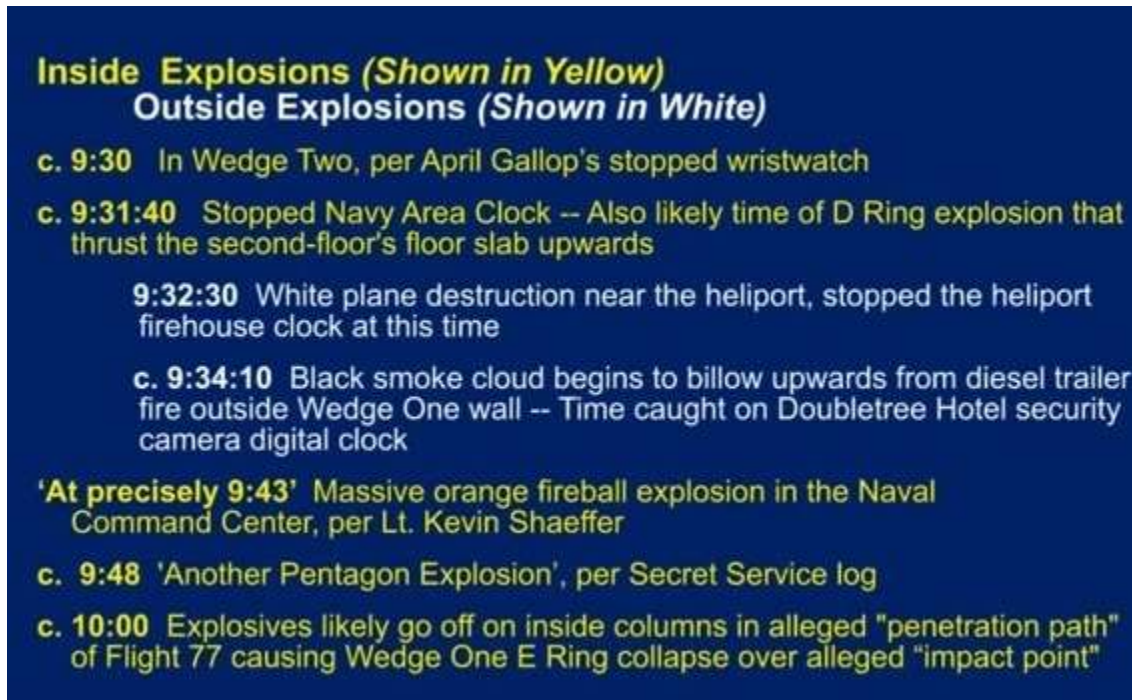
Figure H-5
Honegger’s Seattle slide of “Primary Explosion Times”

Honegger, however, claims that “There were multiple primary inside explosions. Independent of any impact.” According to this claim, plane impact never occurred and there were, according to various timepieces, “multiple primary ... explosions” that created all the observed damage and death. At S-01:50:50 Honegger shows a summary slide (Figure H-5) based on her analysis of the times of inside (yellow text) and outside (white text) “explosions.” As we show by examining individual time entries on this slide, Honegger’s scenario conflicts with witness testimony to plane impact and a main explosion⁹².

⁹² Honegger’s slide (Figure H-5) shows four explosive events within about 4 minutes, starting at 09:30 am, but the “Five Frames” sequence shows only one explosive event in over 3 minutes of recordings from two cameras.

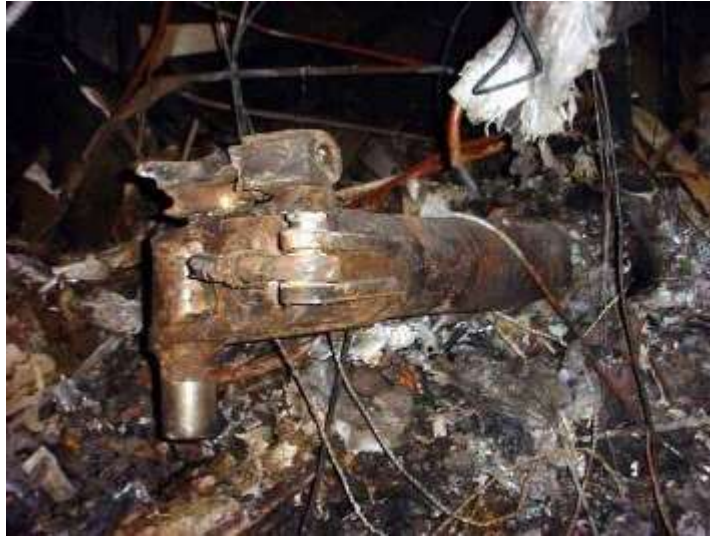
Figure AppE-1 Landing gear

The landing strut shown in Figure AppE-1 was found near the C ring exit hole but on the inside of the Pentagon.

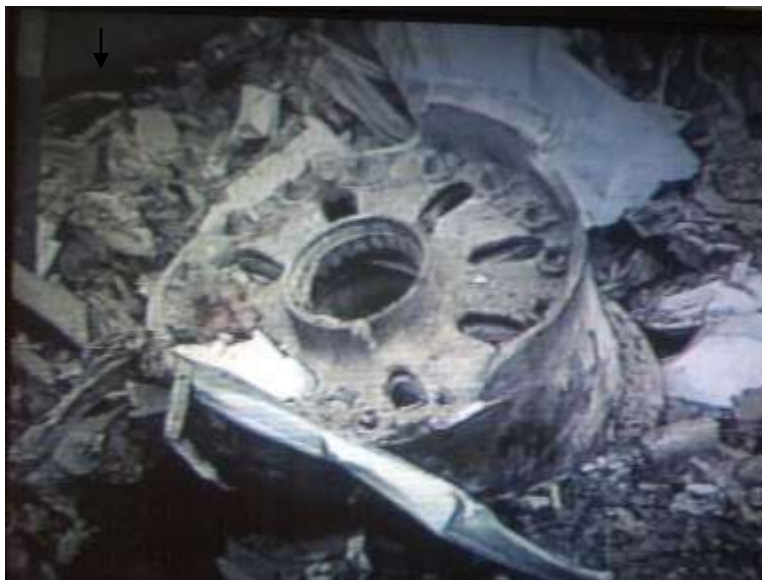
Figure AppE-2 Wheel hub

According to TLC's "Pentagon Under Fire," aired 9/11/02, this wheel hub was found near the exit hole.

The wheel hub in Figure AppE-2 has been shown to be essentially identical to this hub from a Boeing 757 landing gear in Figure AppE-3.

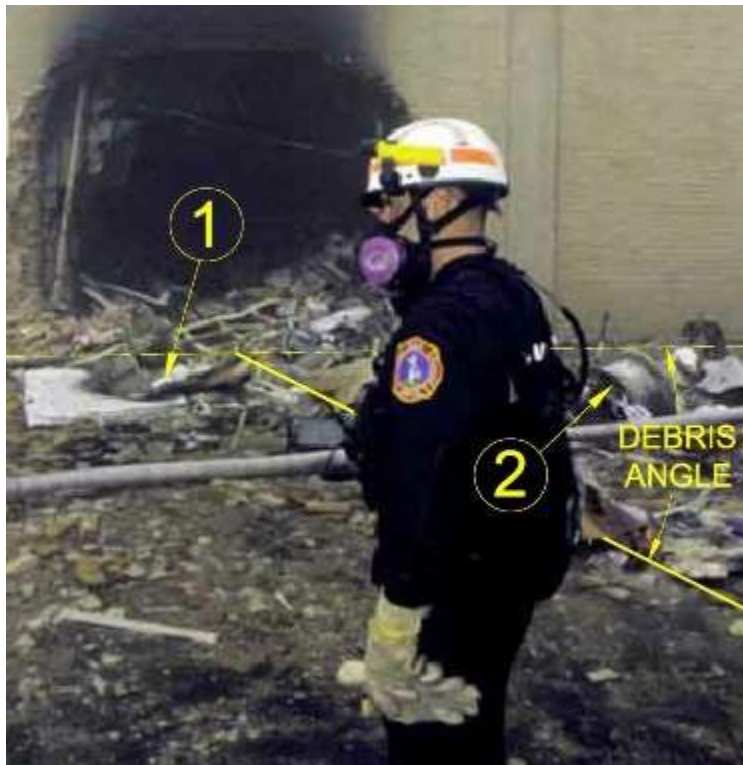
Figure AppE-4 Plane parts and debris angle

In the next photograph, Figure AppE-4, an object that looks like a wheel hub is visible (2). A semi-circular part of the plane appears at left (1). Also notice that the majority of the debris is to the individual's right, or at an angle that is consistent with the flight path direction in relation to the wall. Other evidence shows the plane's path made a 52 degree angle with the wall.

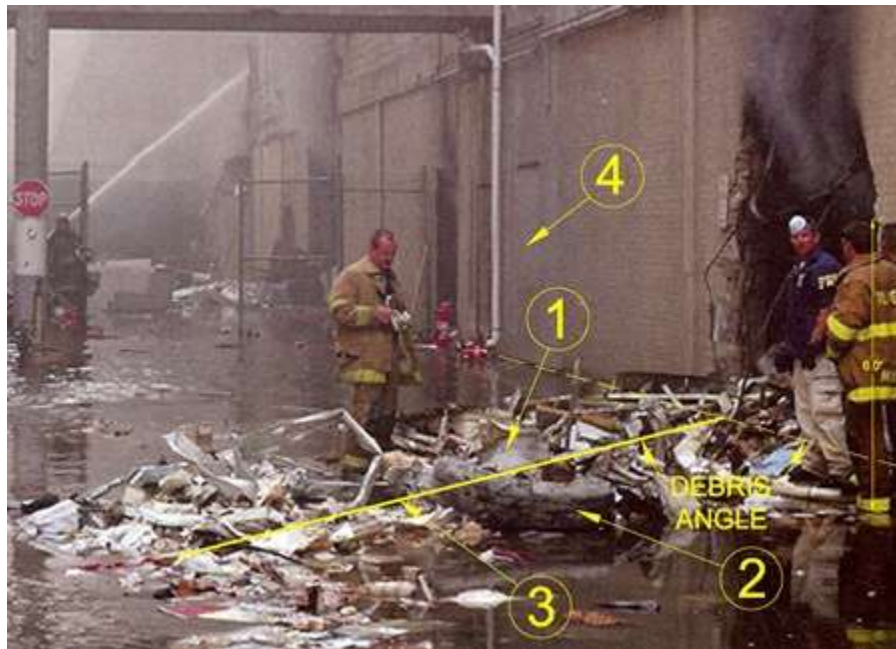
Figure AppE-5 Plane parts and debris angle

In the following photograph, Figure AppE-5, is a large remnant of a tire (2). Also shown is a wheel rim (1). The debris angle (3) is also clearly visible. A single doorway lies in the direction pointed to by (4). Note the black smoke residue on the wall above. Beyond, on the other side of a fence partition is so-called "exit hole" number 2, a large doorway.

Note the spacing of the ribs on the tire fragment (2), which are similar to the ribs found on Michelin aircraft tires shown in the following picture.

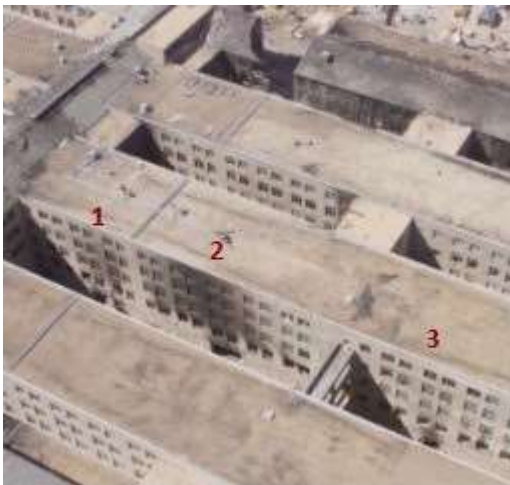
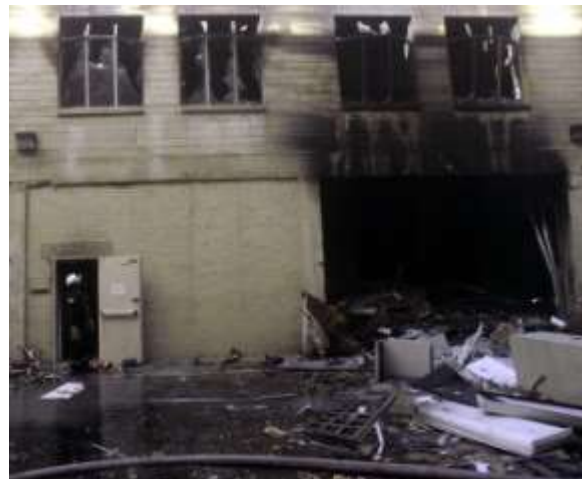
Figure AppE-7

As shown in Figure G-5 in *Section G*, three openings in the C ring wall were originally described by unidentified persons as plane “exit holes.” In Figure G-5 and Figure AppE-7(a) these are numbered 1, 2, and 3. Two of these “exit holes,” numbered 1 and 2, are actually doors for entry and exit. Figure AppE-7(b) shows the large doorway that was numbered “exit hole” 2. There is only one true plane exit hole, the circular-appearing C ring hole numbered as 3. As previously noted, Figure G-6, showing one plane “exit hole” is a more accurate, corrected version of Figure G-5.

(a) The three so-called “exit holes”
1 and 2 are doorways, 3 is the plane exit hole
