## REHABILITATION OF FORMER NUCLEAR TEST SITES AT EMU AND MARALINGA (AUSTRALIA) 2003

REPORT BY THE MARALINGA REHABILITATION TECHNICAL ADVISORY COMMITTEE

DEPARTMENT OF EDUCATION, SCIENCE AND TRAINING

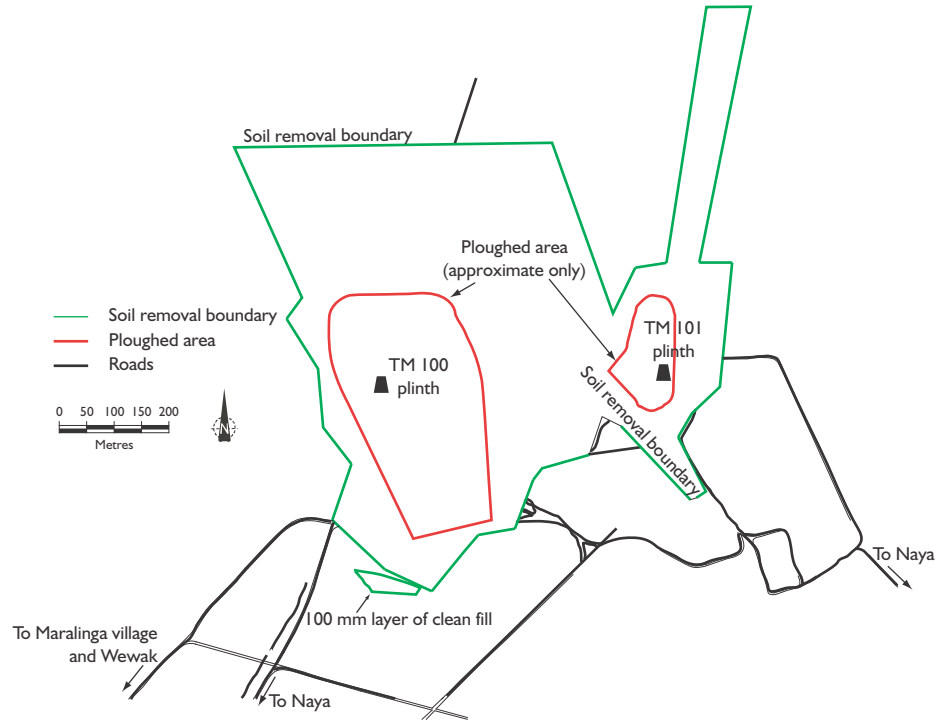
- z 1.8 and 4.0 kBq/m<sup>2</sup> at TM100 and TM101 (see Figure 3.3); and
- z 1.8 and 0.7 kBq/m<sup>2</sup> for the Wewak plumes and the VK33 plutonium burning site at Wewak respectively (see Figure 3.4).

The boundaries to the areas so treated at TM100, TM101 (47 ha) and Wewak are shown in Figures 3.3 and 3.4 respectively. Both also show the area previously ploughed by the UK.

**Figure 3.3** Area cleared of contaminated soil and fragments at TM100 and TM101 and areas previously ploughed.

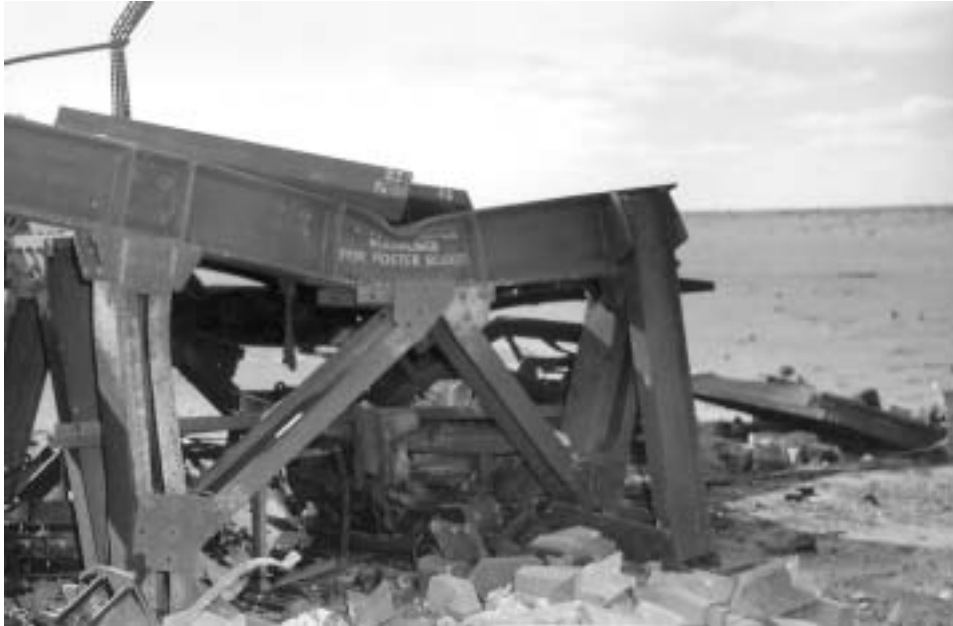
While initially intended for re-use, each featherbed was heavily damaged by the detonation. Figures 3.10 and 3.11 (from Cornish 1987) illustrate the extent of damage done to the featherbeds after detonation.

**Figure 3.10** Featherbed after detonation (Cornish 1987, plate 3, p. 125).

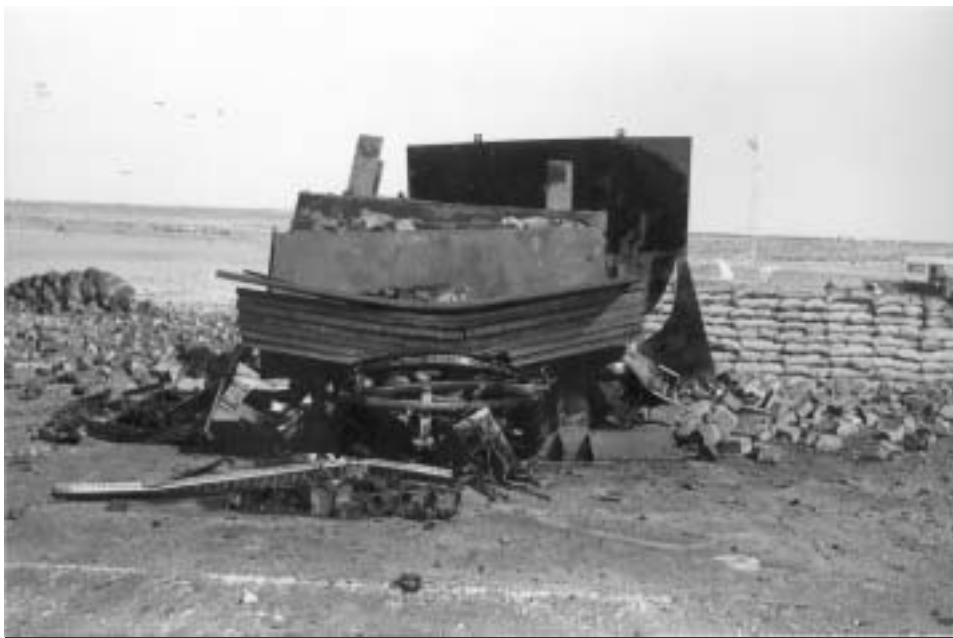
**Figure 3.11** Featherbed after detonation showing sand bags (Cornish 1987, plate 4, p. 125).

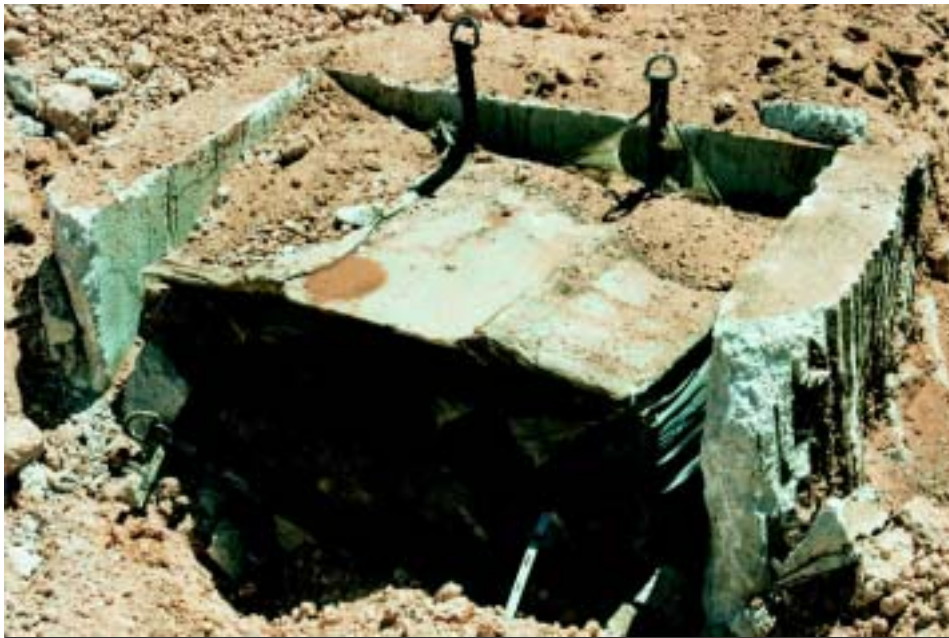
**Figure 3.15** Exhumation of a Category 1 pit at airfield cemetery.

Accordingly MARTAC required the exhumation of the entire Category 1 and 2 waste inventory, and its relocation in the forward area and that it be disposed of in a way that provided several metres of sub-grade clean soil as fill. Figure 3.15 illustrates the retrievability that was designed into the disposal pits for Category 1 and 2 wastes.

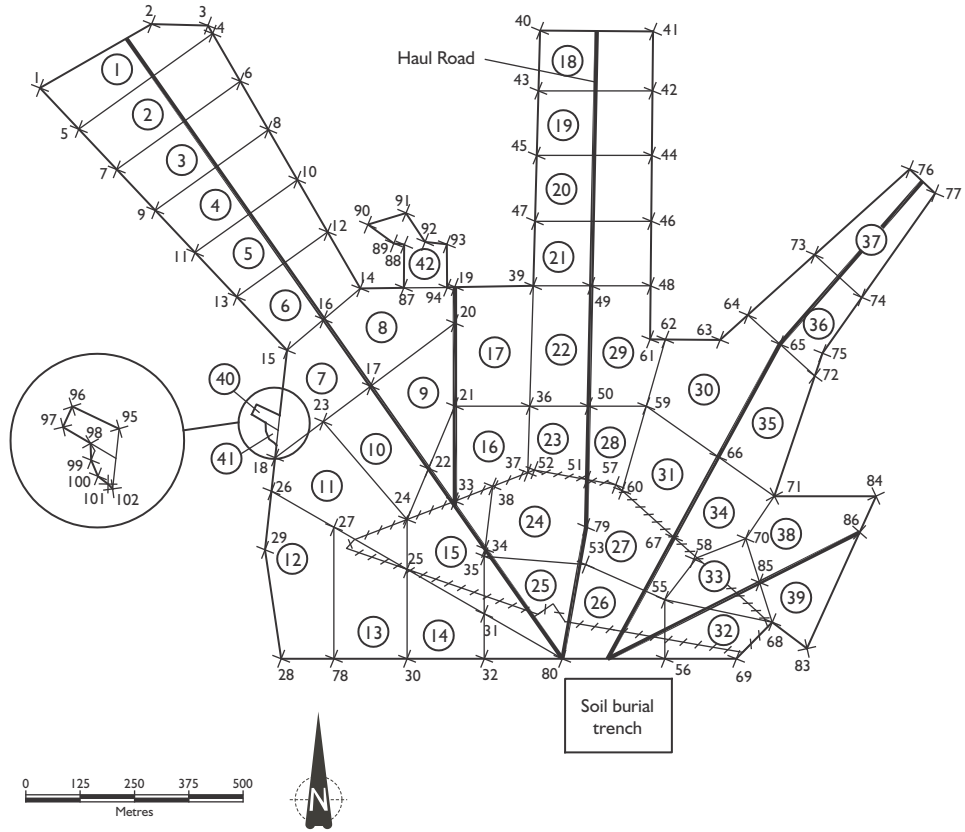
Each of the lots was treated individually during soil removal and verification. Soil was removed from each to a depth of at least 100 mm and transported to the Taranaki soil burial trench, located on the south side of the Taranaki soil removal area (see *Figure 4.5*). Once soil removal was completed on each lot, the Health Physics Provider scanned it for contamination and assessed it for compliance with the end-state criteria. If these appeared to have been attained, often only after several treatment passes, access to the lot was granted to the Environmental Monitor for final verification monitoring. Handover documentation including details of the lot coordinates, how the lot is accessed and any other relevant information were given to the Environmental Monitor.

Figure 4.5 Layout of Taranaki lots.

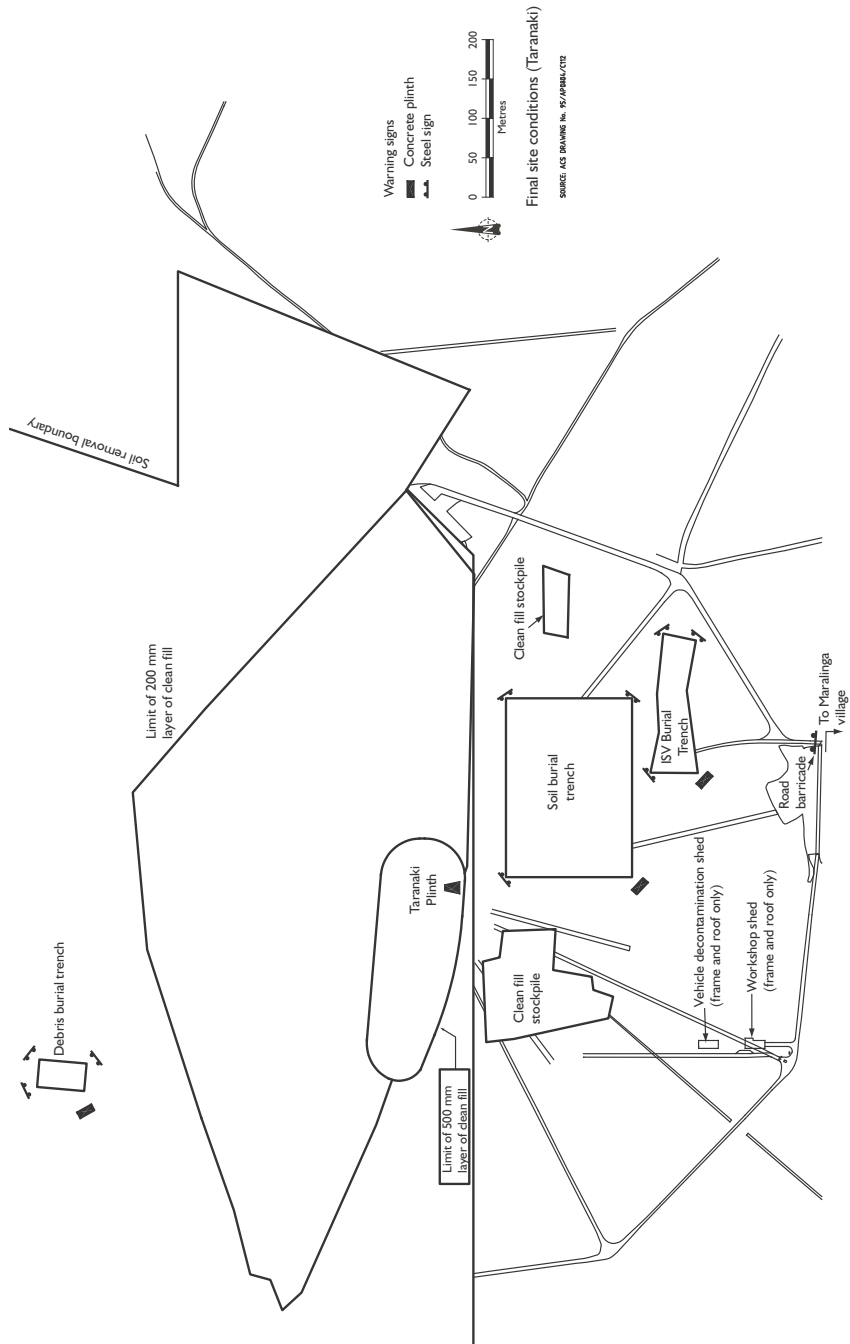
Figure 4.6 shows the area at Taranaki that is covered by this end-state description. [Appendix 6.1](#), Table 6.1.2 summarises the condition of each of the Taranaki lots at the end of the soil removal operation. While several occurrences of individual hectares exceeding the criterion of 3 kBq/m<sup>2</sup> occur within a lot, all lots met the criterion satisfactorily.

**Figure 4.6** The end-state at Taranaki at the completion of operations.

Following the completion of the soil removal, some fresh soil was re-introduced in the form of windrows to serve as seed traps, and the windrows were themselves seeded with local native vegetation. While all lots had met the clearance criterion of 3 kBq/m<sup>2</sup>, further soil was re-introduced to provide some soil cover in that part of the central region (see Figure 4.6), which to achieve the required criterion had been completely denuded to the underlying bedrock.

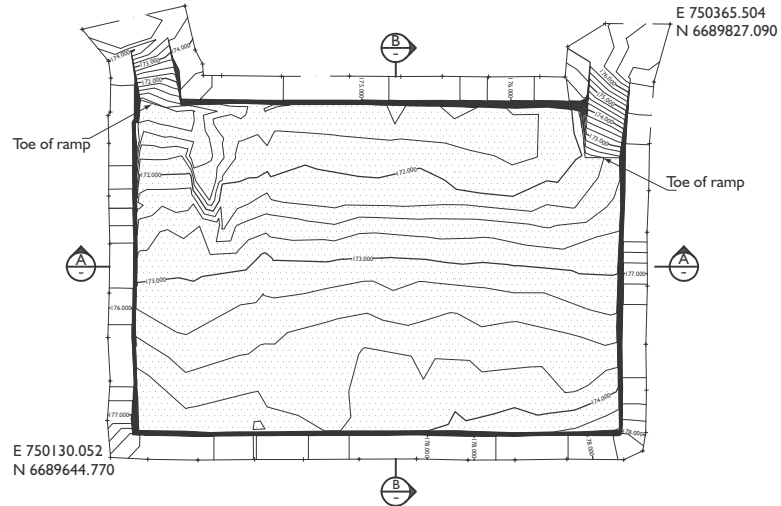
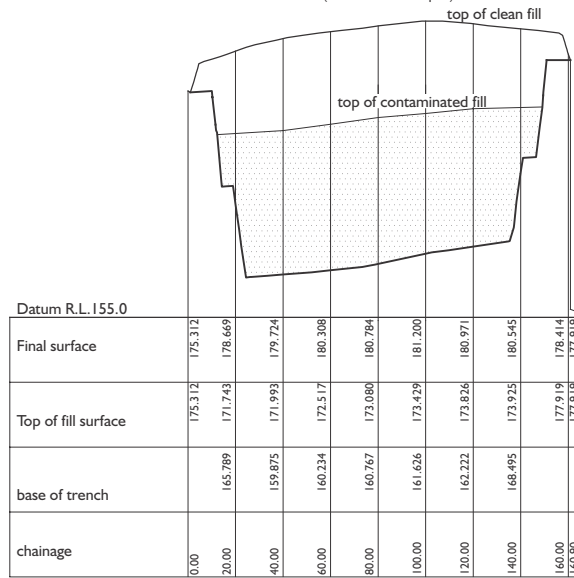
The final contaminated soil surface contours in the burial trench are shown in Figure 4.7. This shows that the soil at the western end of the trench is at the maximum elevation of 3.0 m below grade whereas at the eastern end of the trench it is approximately 4.5 m below grade.

Figure 4.7 also shows a section through the completed soil burial trench. Its GPS coordinates are given in [Appendix 6.1](#), Table 6.1.3. A photograph typical of this end-state trench is shown in [Chapter 6](#).

**Figure 4.7** Layout of the Taranaki soil burial trench.

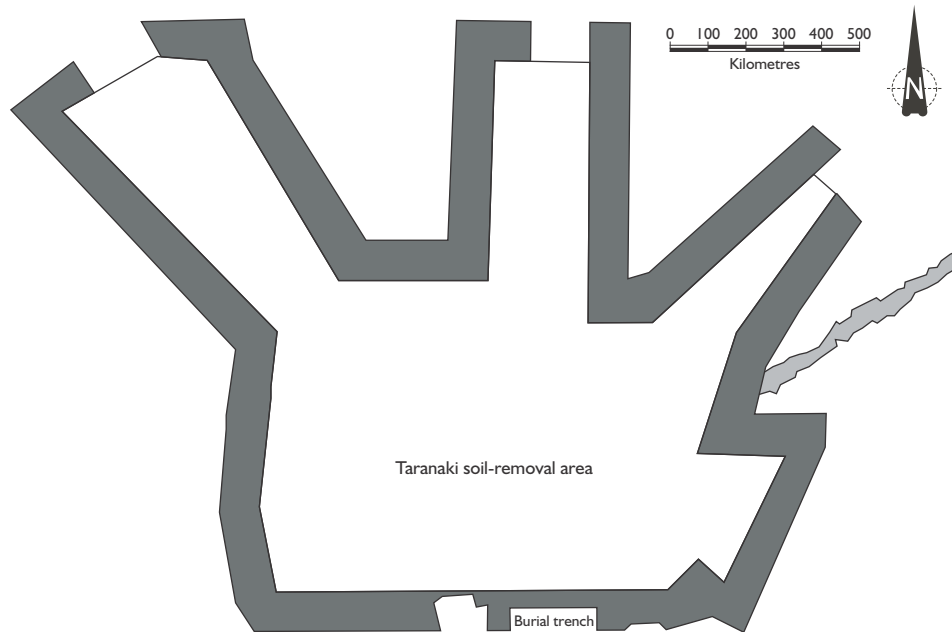
The perimeter of the Taranaki site was divided into 85 'plots' of 100 m x 100 m. Scanning with the Nissan-mounted detection system was performed on these plots around almost the entire soil-removal area (Figure 4.8). The plots at the end of the north-east, north and north-west plumes (a total of six) were not scanned as high-continuum activity (approximately 20–30 kBq/m<sup>2</sup>) made it impossible to differentiate discrete particles with the equipment available. All particles of 80 kBq or greater recorded by the Nissan system were manually investigated. Any particles exceeding 80 kBq, or any visible, contaminated fragments were removed. In total, 23 particles exceeding 80 kBq were detected and individually removed from outside the soil-removal area. A 2 m x 2 m area surrounding each of the removed particles was again scanned with hand-held sodium iodide detectors to ensure that no further particulate

**Figure 4.8** Map showing the area scanned by the vehicle-mounted particle detection system during the verification of the soil-removal boundary at Taranaki. The sparsely covered section in the east is a very narrow plume of dispersed contamination, which was monitored to ensure that this area met the MARTAC criteria.

contamination remained. In scanning these plots, two further areas were found to contain generally high levels of particulate contamination and further bulk soil removal was requested. An area of 0.1 ha south of lot 40, labelled lot 41 (Figure 4.5), contained some particles with activities greater than 100 kBq of Am<sup>241</sup> and therefore exceeded the criterion for residual particulate contamination. This area had been inadvertently omitted from the definition of lot 40. Soil was removed from this lot in the usual way. It was then scanned and verified by the Environmental Monitor using the usual scanning protocol for lot clearance. Coordinates of this lot are included in [Appendix 6.1](#), Table 6.1.1.

The second area where bulk rehabilitation was requested was Plot 31 (subsequently relabelled lot 42; Figure 4.5) and an area north of it. Surface soil was removed from this 1.5 ha area, which was then checked with the Nissan measurement system (see Figure 4.4) to verify that all particulate contamination was reduced to below MARTAC criteria. There was no evidence that this area exceeded criteria, but the high level of dispersed contamination and low activity particles made it impossible to ensure that the windrows did not contain high activity particles. Given the proximity to the disposal trench being constructed for the pit debris, it was considered worthwhile to remove this soil.

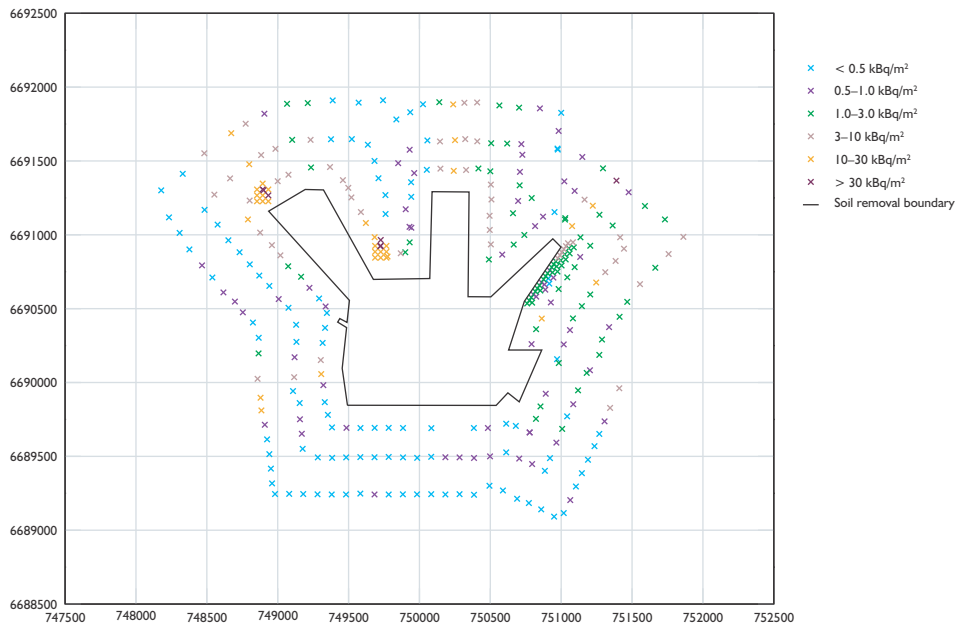
OKA measurements were conducted around the perimeter of the soil-removal boundary (SRB) at distances of 100, 350 and 600 m from the soil-removal area (Figure 4.9). These clearly show that the dispersed activity in the area directly surrounding the Taranaki SRB is well below the 40 kBq/m<sup>2</sup> criterion for Am<sup>241</sup> activity. When conducting these measurements, two areas were located in which measurement points had values of greater than 30 kBq/m<sup>2</sup>. In each of these areas a grid of measurements was conducted and the results averaged over a hectare. Figure 4.9 indicates that when averaged over a hectare, neither of these two areas exceed the removal criterion for dispersed activity.

**Figure 4.9** Location of OKA measurements around perimeter of soil removal area.

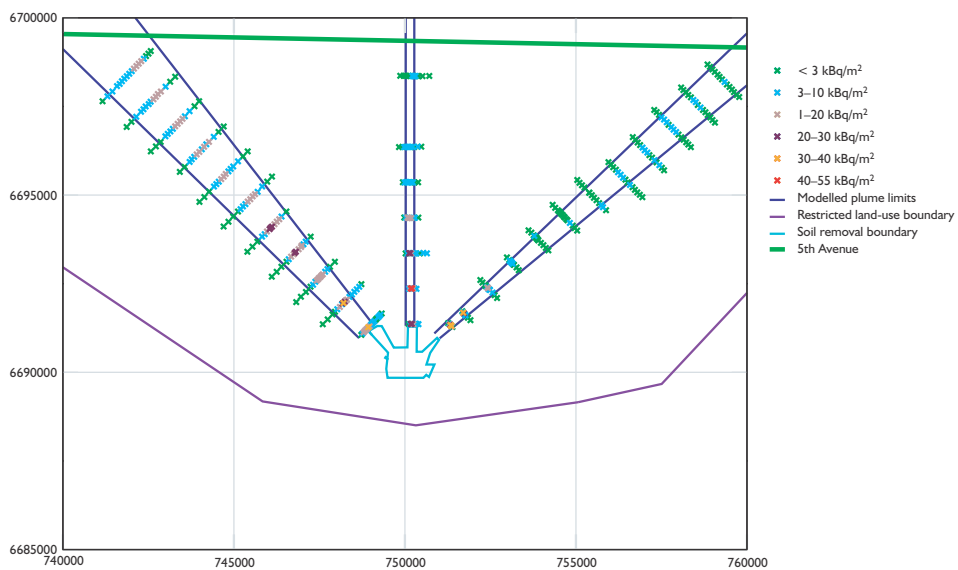
The OKA measuring system was used to determine residual contamination at Taranaki by traverses across the plume at regular spacings down the plume footprint away from the cleared area. The results are illustrated in Figure 4.10. As would be expected from the boundaries of the 'C' contour in the results from the aerial survey (see Figure 1.8), there were individual readings above 30 kBq/m<sup>2</sup> Am<sup>241</sup> along the centre line of the plumes. None of these locations breach the soil clearance criteria specified by MARTAC.

**Figure 4.10** OKA measurement system traverses across Taranaki plumes after soil removal.

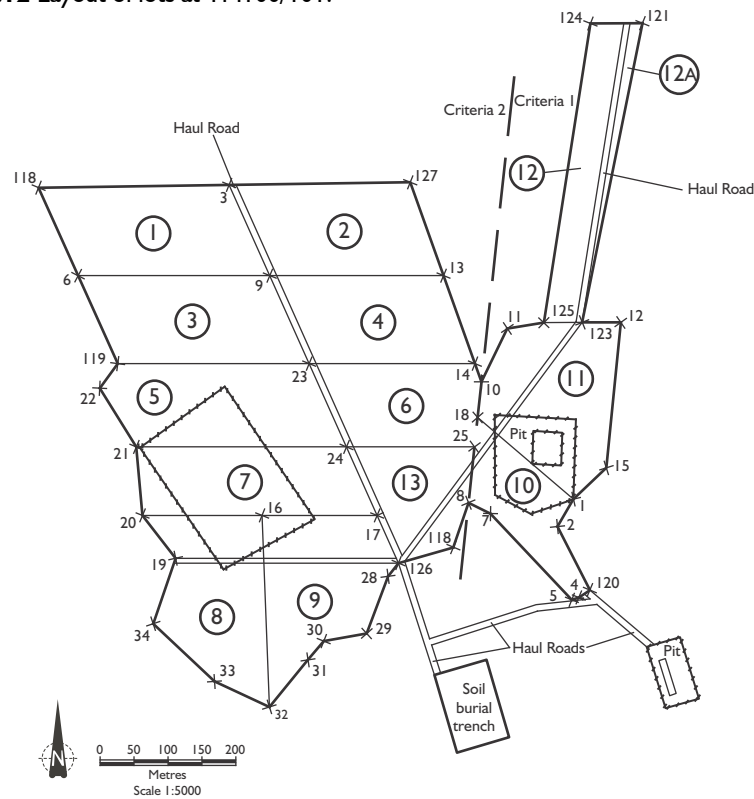
**Figure 4.12** Layout of lots at TMI00/101.

Numerous fragments of contaminated bitumen were detected during lot clearance verification by the Environmental Monitor on TM100/101 lots 10 and 11. The Environmental Monitor's field team halted scanning with the Nissan measurement system and conducted systematic manual searching of the area. In doing this, an area was marked out in which further rehabilitation was requested.

Mechanical ways of removing these fragments of bitumen were not practical as the remaining soil and loose rock was present in between small rocky outcrops. The bitumen was therefore removed manually by the Health Physics Provider in an emu parade. Two hundred fragments were found and removed. The area was then rescanned by the Environmental Monitor and found to meet criteria.

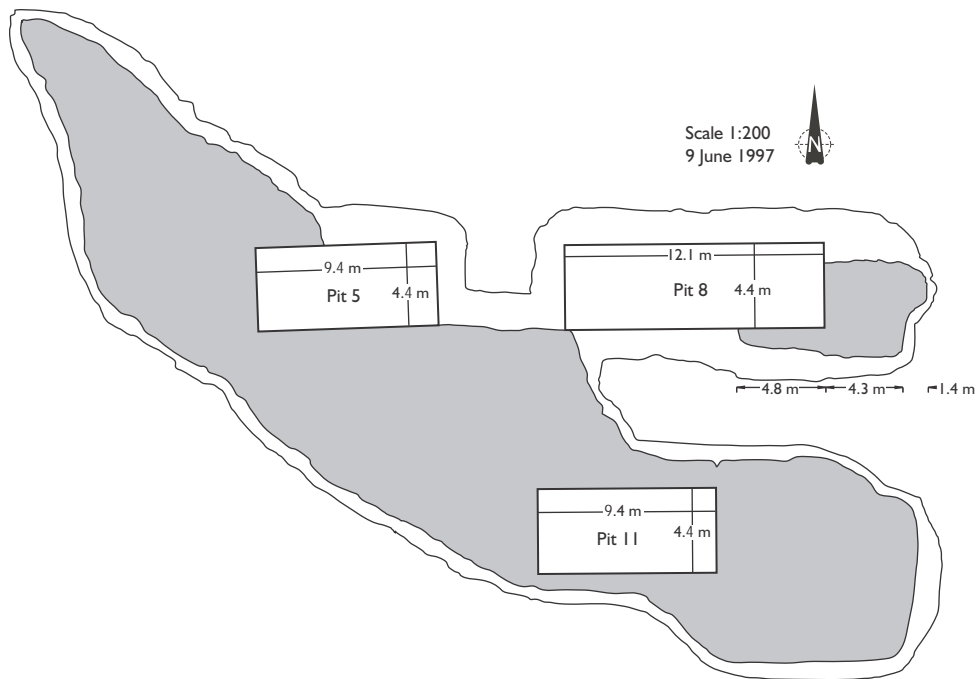
conventional radiation surface contamination survey using the gamma ray from Am<sup>241</sup>. Figure 4.16 shows the degree that the buried radioactivity transgresses the footprints of the concrete slabs that were expected to cover pits 5, 8 and 11. The example is typical although it shows a worst case where the three pits had to be treated as a single conglomerate.

**Figure 4.16** Location of buried contaminated debris in relation to the concrete caps on pits 5, 8 and 11.

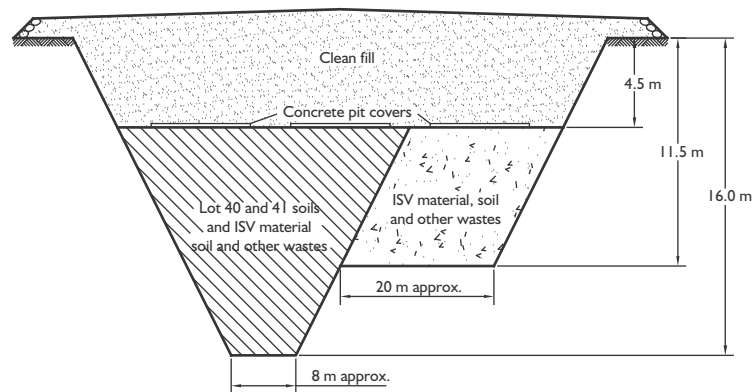
A cross-section through the ISV burial trench is shown in Figure 4.19. This is a cross-section approximately one-third of the distance in from the eastern end, and is not typical, as the trench varies considerably along its length (see [Attachment 4.4, Section 10.6.12](#) for a more complete account).

**Figure 4.19** Cross section through the ISV burial trench.

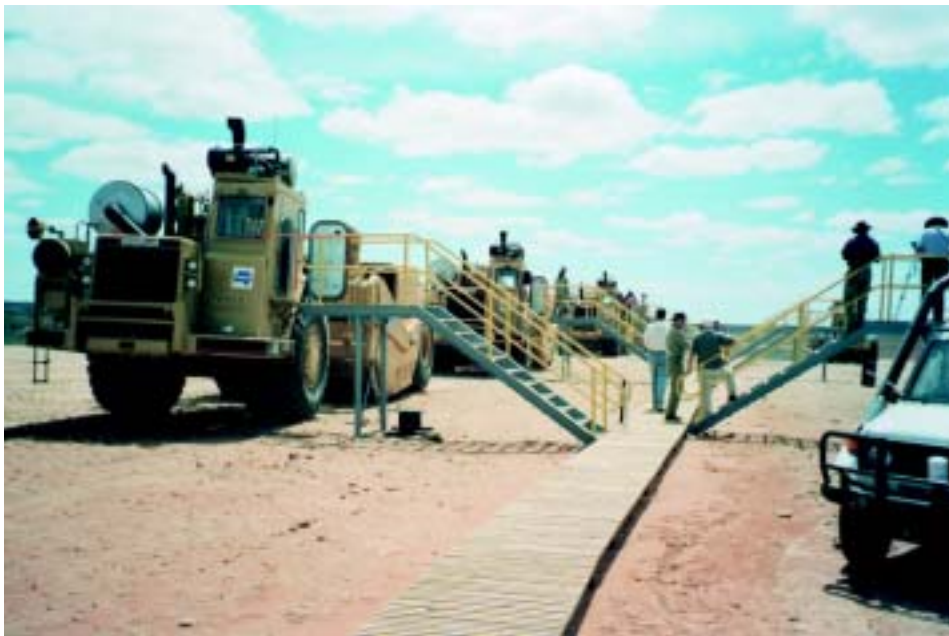
**Figure 5.13** Walkway to provide access to vehicles without walking on ground.

*Extension of blue area along walkway* (see Figure 5.13) to *Class II vehicle cabs*. To be consistent with current practice and provide clarity for workers in the red area, the blue area should be extended from the change room, out through 'door four' along the walkway into the plant cabs. A blue line should be painted on the walkway with appropriate warning signs.

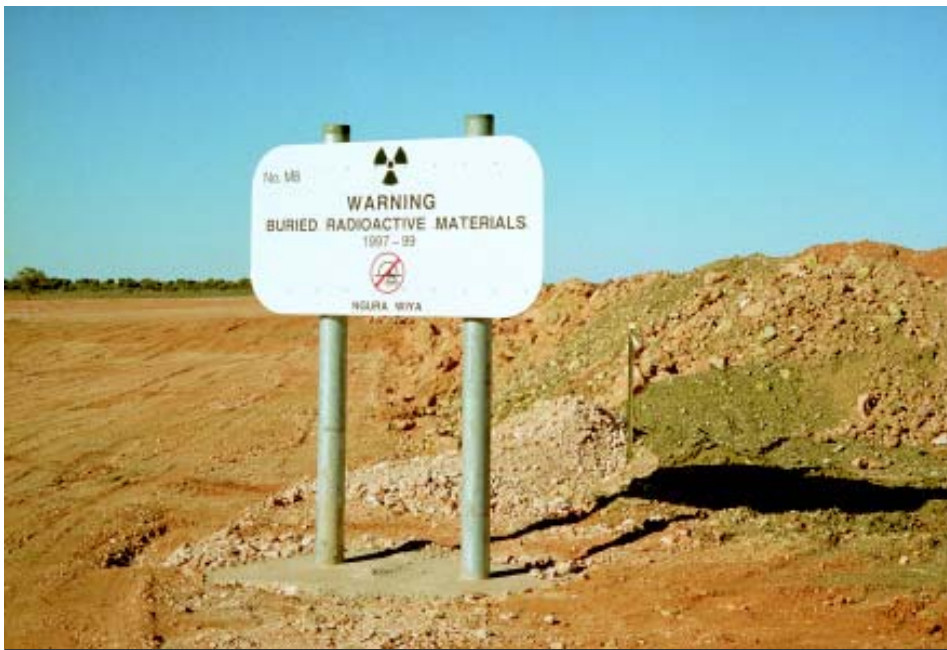
**Figure 6.7** Metal warning sign at Taranaki soil burial trench.

The Taranaki soil burial trench is marked by a concrete plinth in the most southerly corner of the trench. The other three corners of the trench are marked with metal signposts. These burial trench warning signs contain information about the contents of the trench, time of burial, and warnings regarding digging in that area. Figures 6.8 and 6.9 describe the physical attributes of these warning signs. The soil removal trench at Taranaki was operational from 1996 through to 1997. It was closed on 3 October 1997. The trench contains contaminated soil from the Taranaki soil removal area, some steel plates (*Section 4.2.3.3*) and miscellaneous debris, a total volume of 262 840 m<sup>3</sup>. A photograph of a metal warning sign with the burial trench cap in the background is shown in Figure 6.7.

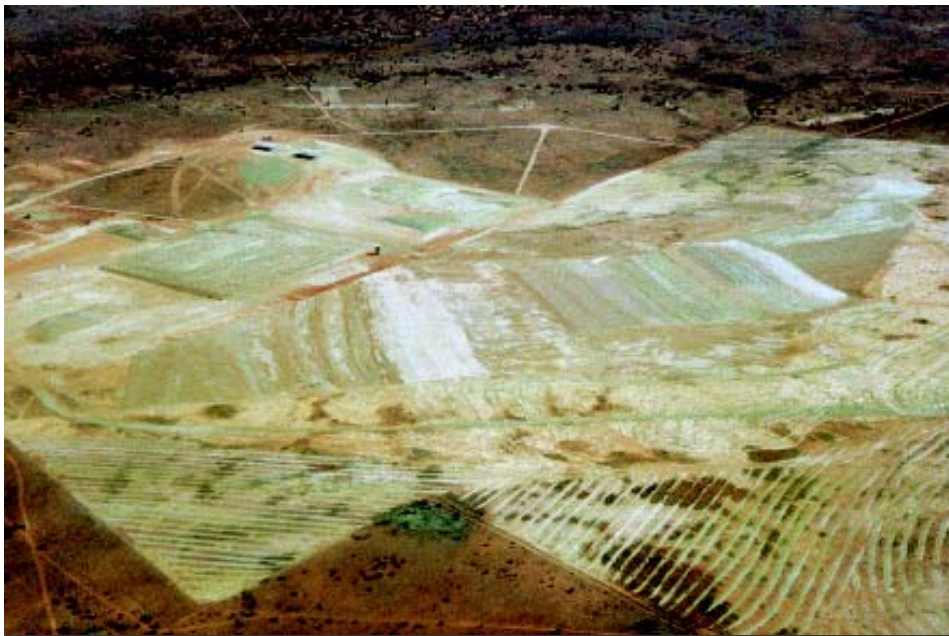
**Figure 6.11** Post-rehabilitation aerial view of central Taranaki.

Although the pits are shown in Figure 6.4, they are now indistinguishable from the rest of the soil removal area (both physically and radiologically) and are considered to be clean. A photograph of the central Taranaki area where these pits were located, as it is post-rehabilitation, is shown in Figure 6.11, where the windrows laid as native seed traps are clearly evident.

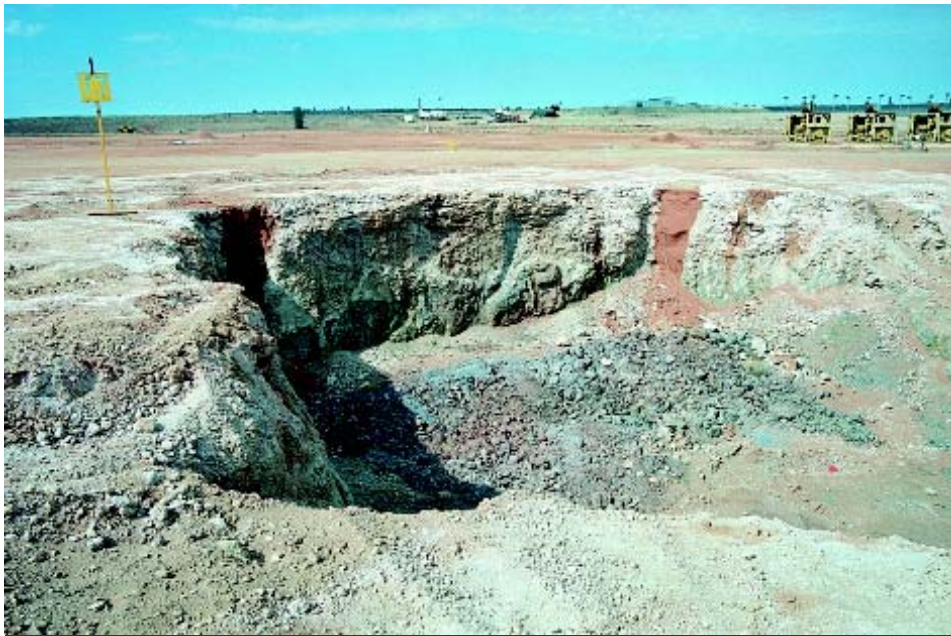
**Figure 6.12** Exhumed pit 17 in central Taranaki prior to backfill.

After the pits had been exhumed they left potentially contaminated empty holes in the ground. Figure 6.12 is a photograph of the exhumed pit 17. Clearance of these areas required different criteria than that for the rest of the soil removal area. Because the pits were to be re-filled with clean material, it was not necessary for them to be as scrupulously clean as surrounding surface areas but, nevertheless, it was not desirable that significant amounts of contamination should remain, buried in a casual fashion in these pits. It was considered that a suitable criterion was that the inside surfaces of the pits should not be more contaminated than those areas remaining at the boundaries of the soil removal area. This corresponded to dispersed contamination of 20 kBq/m<sup>2</sup>.

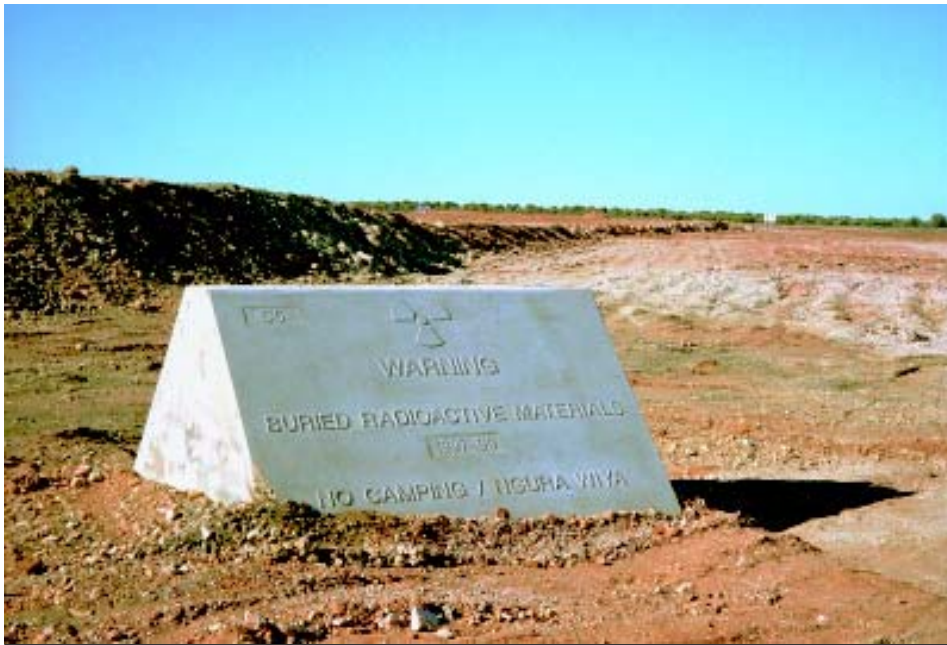
**Figure 6.14** The post-rehabilitation ISV burial trench.

A photograph of the ISV burial trench plinth in front of the trench cap is shown in Figure 6.14. Coordinates of the corners of the ISV burial trench are provided in *Appendix 6.1*, Table 6.1.6.

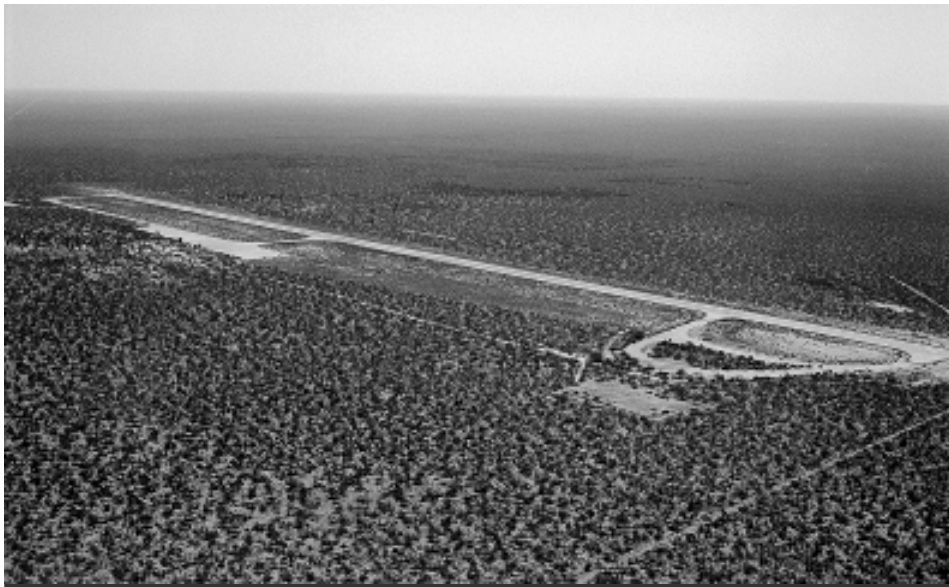
A total of 18 debris pits were located at the airfield cemetery. The contents of all Categories 1 and 2 pits and Category 3 pit C were exhumed, with pits 3A, 3B, and 3D being undisturbed. The exhumed pits were backfilled with radiologically clean soil and concrete rubble from pit caps. The debris was placed in the ISV burial trench. The airfield cemetery has no markings of the remaining pits and the remediated pits are indistinguishable from the surrounding area. The cyclone wire mesh fence has been left at the site as an historic item.

**Figure 6.23** Maralinga airfield—looking towards the north-east, airfield cemetery is located near south-western end of airfield.

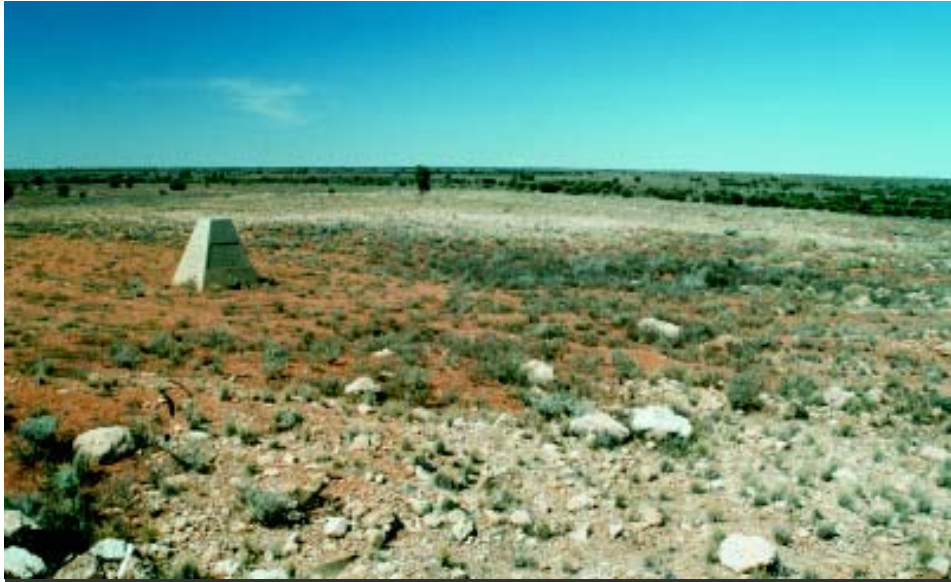
A photograph of the *Marcoo* crater area showing the plinth identifying the ground zero for the *Marcoo* detonation and the surrounding recontoured area is shown in Figure 6.24.

**Figure 6.24** Marcoo after rehabilitation.

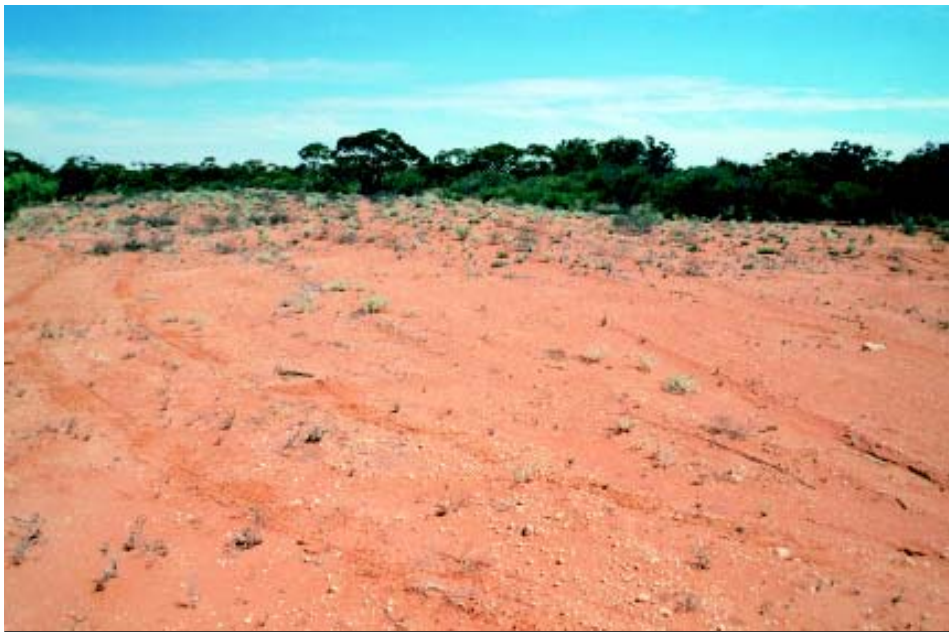
The formal disposal pit 30 was remediated by driving heavy equipment over the pit followed by filling subsidence areas and revegetating. Access to this site was reduced by roadworks that made the roads leading to the site difficult to traverse. There are no markers designating the location of the pit. A photograph of the DC/RB area is shown in Figure 6.25. Operations at this site are detailed in *Chapter 4*.

**Figure 6.25** DC/RB Area after rehabilitation.

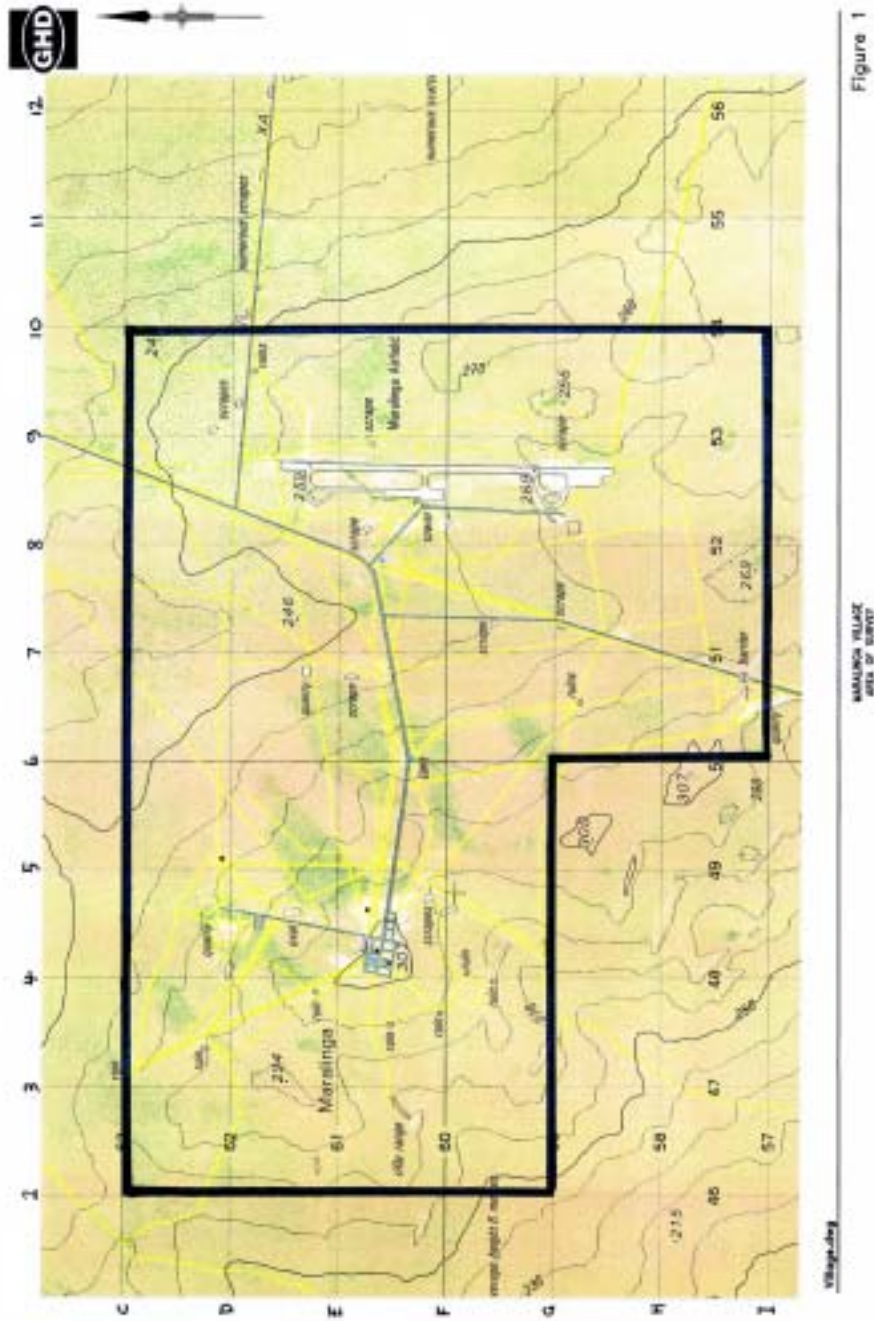
Figure 6.29 defines the limit of the area surveyed. The area was divided into a grid similar to the various soil removal areas. The survey area limits were established to encompass those areas which were the most accessible from the village along existing roads and tracks and therefore the most likely areas to be accessed by future Maralinga residents.

Figure 6.29 Area encompassed by the hazard survey.

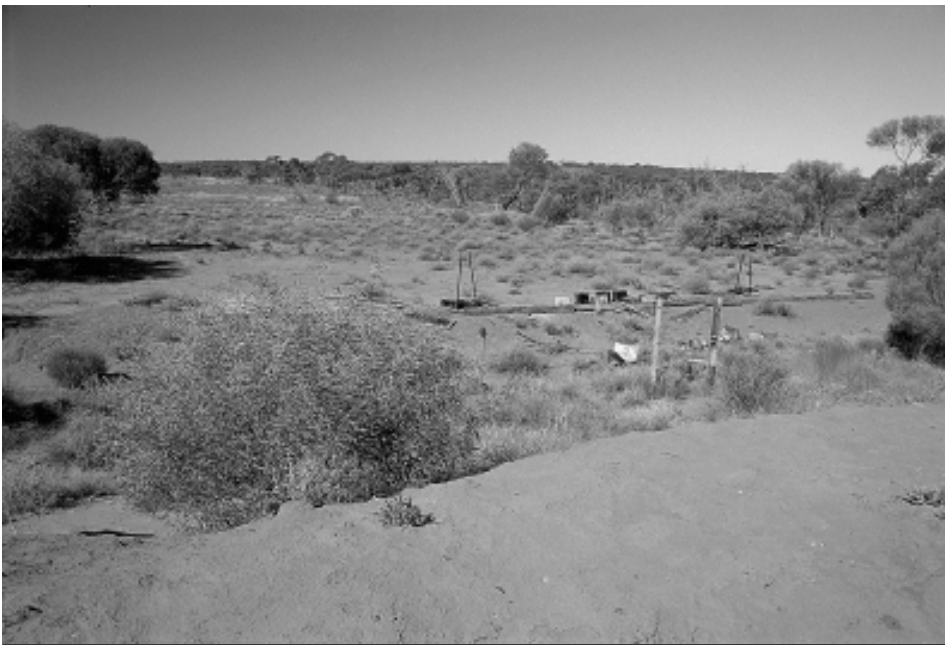
Figure 6.30 illustrates the rifle range as it is currently, following the hazard reduction exercise.

**Figure 6.30** Abandoned rifle range—Maralinga village.

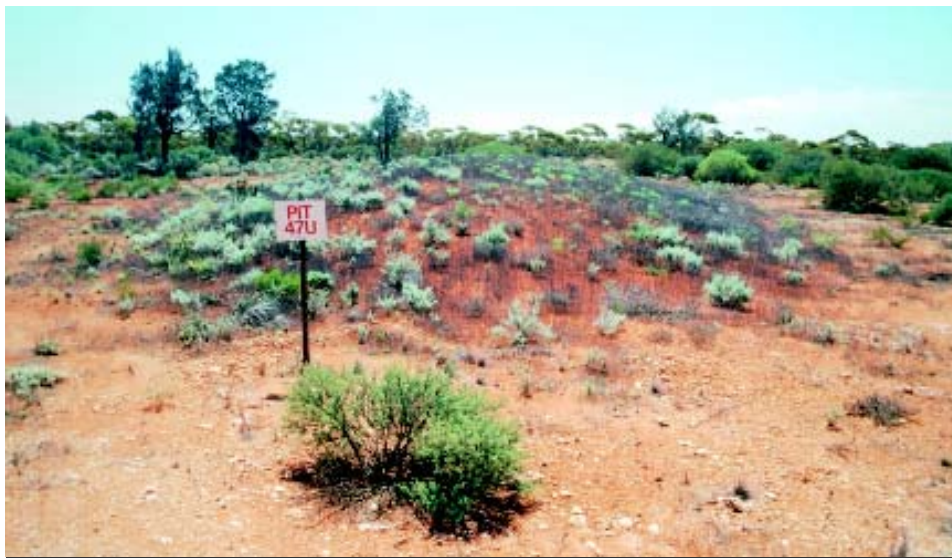
A photograph of a typical pit and marker sign is shown in Figure 6.31.

**Figure 6.31** Marker sign at a typical undisturbed Maralinga informal pit.
