MOUNT POLLEY MINE TAILINGS STORAGE FACILITY BREACH

August 4, 2014

Investigation Report
of the Chief Inspector of Mines

November 30, 2015

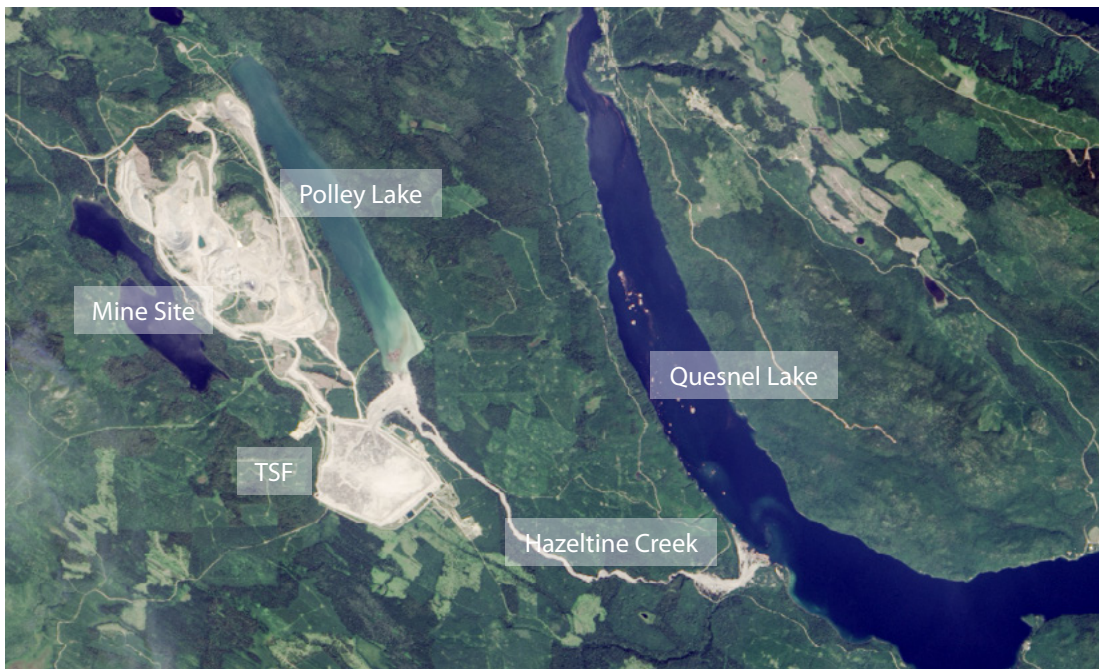
*Figure 1.1 Immediate Aftermath of Breach on Hazeltine Creek, Quesnel Lake, Polley Lake
NASA high-altitude imagery (August 5, 2014)*

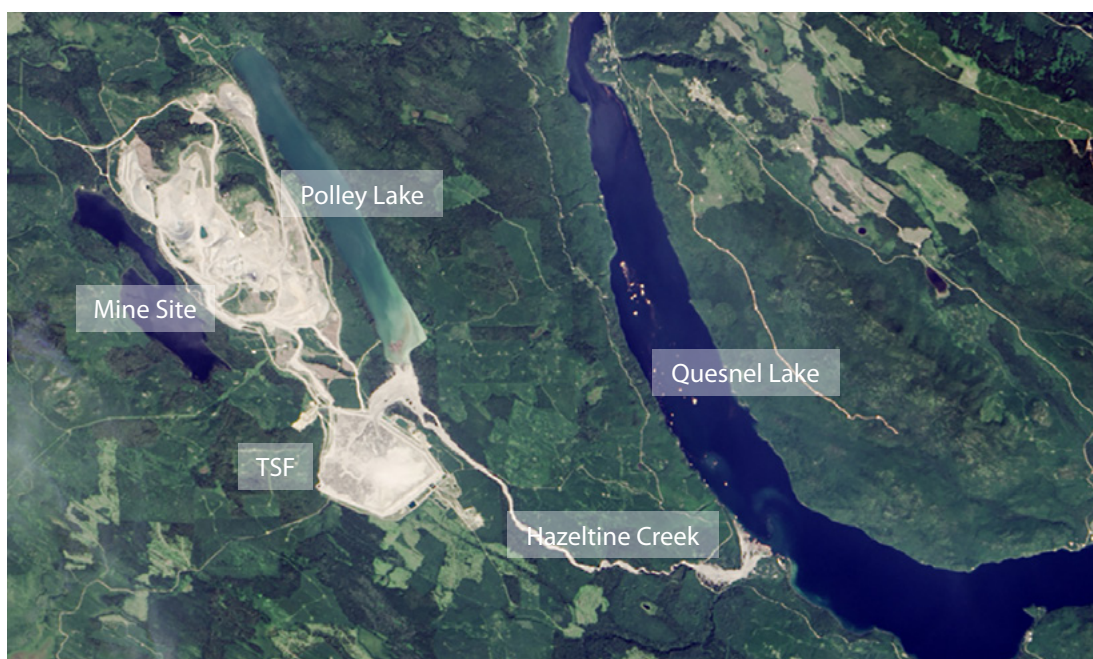
Figure 2.1 Immediate Aftermath of Breach on Hazeltine Creek, Quesnel Lake, Polley Lake
NASA high-altitude imagery (August 5, 2014)

The failure of the dam took place suddenly, without any warning signs. The failure of the embankment led to a breach of the dam, which became uncontrollable in less than two hours. In the ensuing days and weeks, as the mine ceased operations and began the challenge of stabilizing the immediate surroundings and assessing the environmental damage, the full scope of the event began to take shape. Imperial Metals Corporation, the owner of Mount Polley Mining Corporation (MPMC), estimates that between 21 and 25 million m³ of discharge was released in the breach, including 10 million m³ of process water stored in the tailings storage facility (TSF). Both Polley Lake (upstream from the dam breach) and Quesnel Lake were impacted by the debris flow; tailings and debris were introduced into recreational and drinking waters; and the public's confidence in the industry and government oversight were shaken severely.

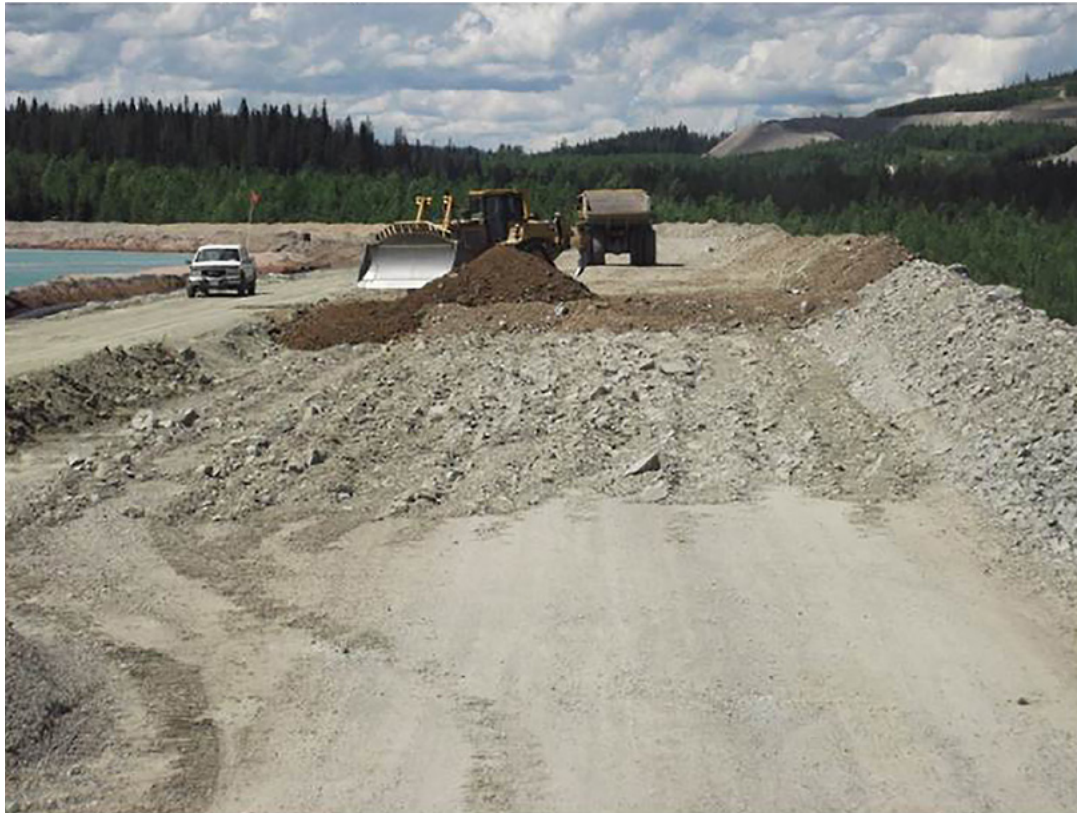
Figure 4.3 Placement of Zone C Rock near the area of the breach, June 26, 2014, Mount Poilley Mining Corporation (2014c)

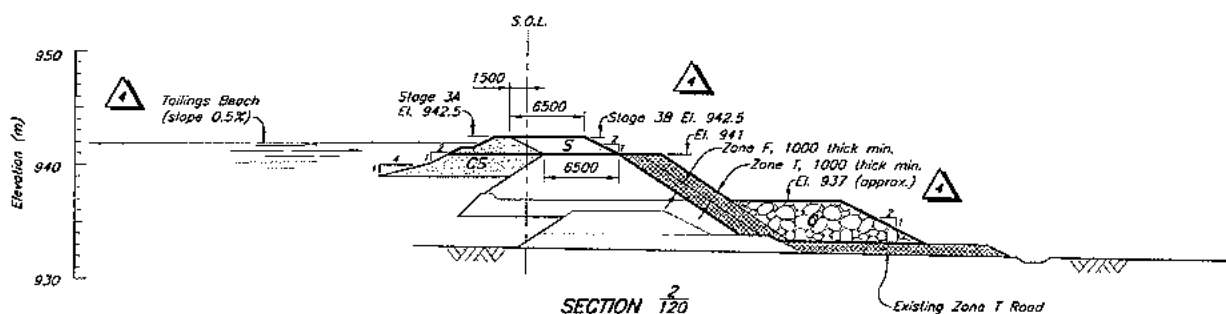
Figure 6.5 Typical As-Built PE Section
Knight Piésold (2001) Dwg. 11162-13-125

No section drawings of the Stage 3 as-built PE were made at the critical section (the location of the breach). Figure 6.5 depicts a section of the PE to the southeast of the breach area, similar to the area of interest, though somewhat lower in overall height. Documentation presented an embankment built in general accordance with the approved design.

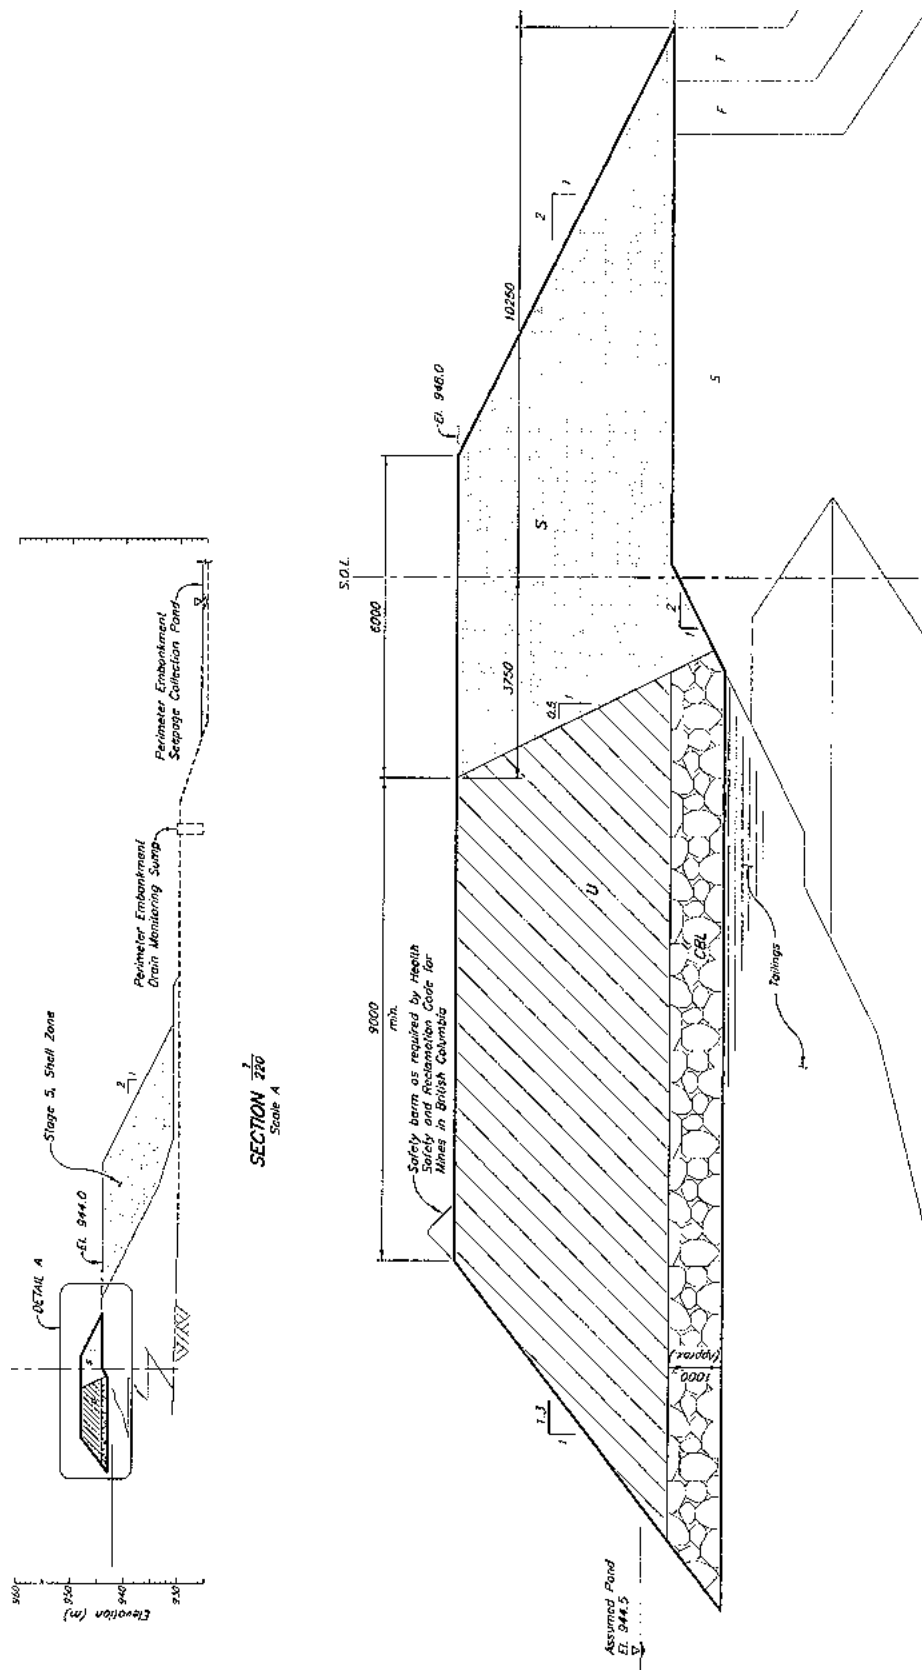
The Stage 4 construction program involving a 4 m cap raise using a modified centerline design commenced in May 2005 and was completed the first week of October 2006, with placement of the Zone C downstream shell planned for April 2006.⁵³ However, no Zone C shell rock was placed during Stage 4 (see Figure 6.6); expansion of Zone C was delayed until Stage 5 instead.

Figure 6.6 Stage 4 PE Section, As-Built
Knight Piésold (2007a) Dwg. 10-225 Rev. 1

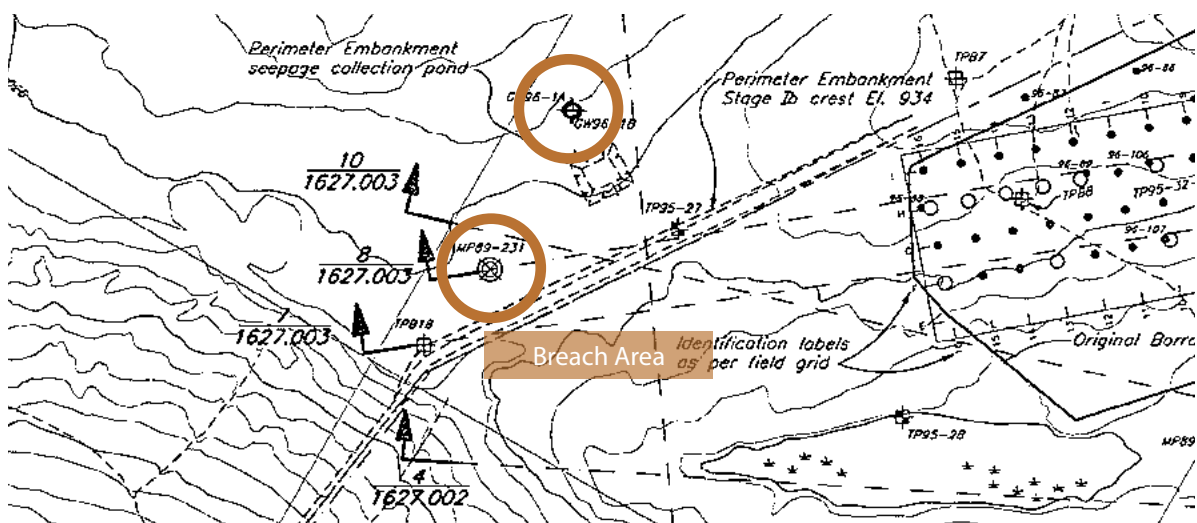
As part of the Stage 4 *Mines Act* permit amendment review, review of the 2005 KP report *Design of the TSF to Ultimate Elevation*, Senior Geotechnical Engineer Chris CARR raised a concern with borehole GW96-1A, located downstream of the breach location. He referred the following question through MPMC to KP: "Glaciolacustrine deposit is noted in GW96-1A on cross-sections 9 and 10 [in *Dwg. 1627.011*]. The material is described as firm. What are the characteristics and extent of this deposit and could it have an influence on dam stability locally?" The concern was discounted by KP as not being applicable to the dam footprint.⁵⁸

The test holes located in the vicinity of the area of the breach included: MP89-231 (condemnation drill hole), and GW96-1A (groundwater monitoring well), which are shown in plan on Fig. 6.7 and in section on Fig. 6.8. The highlighted section represents a lower-strength clay unit.

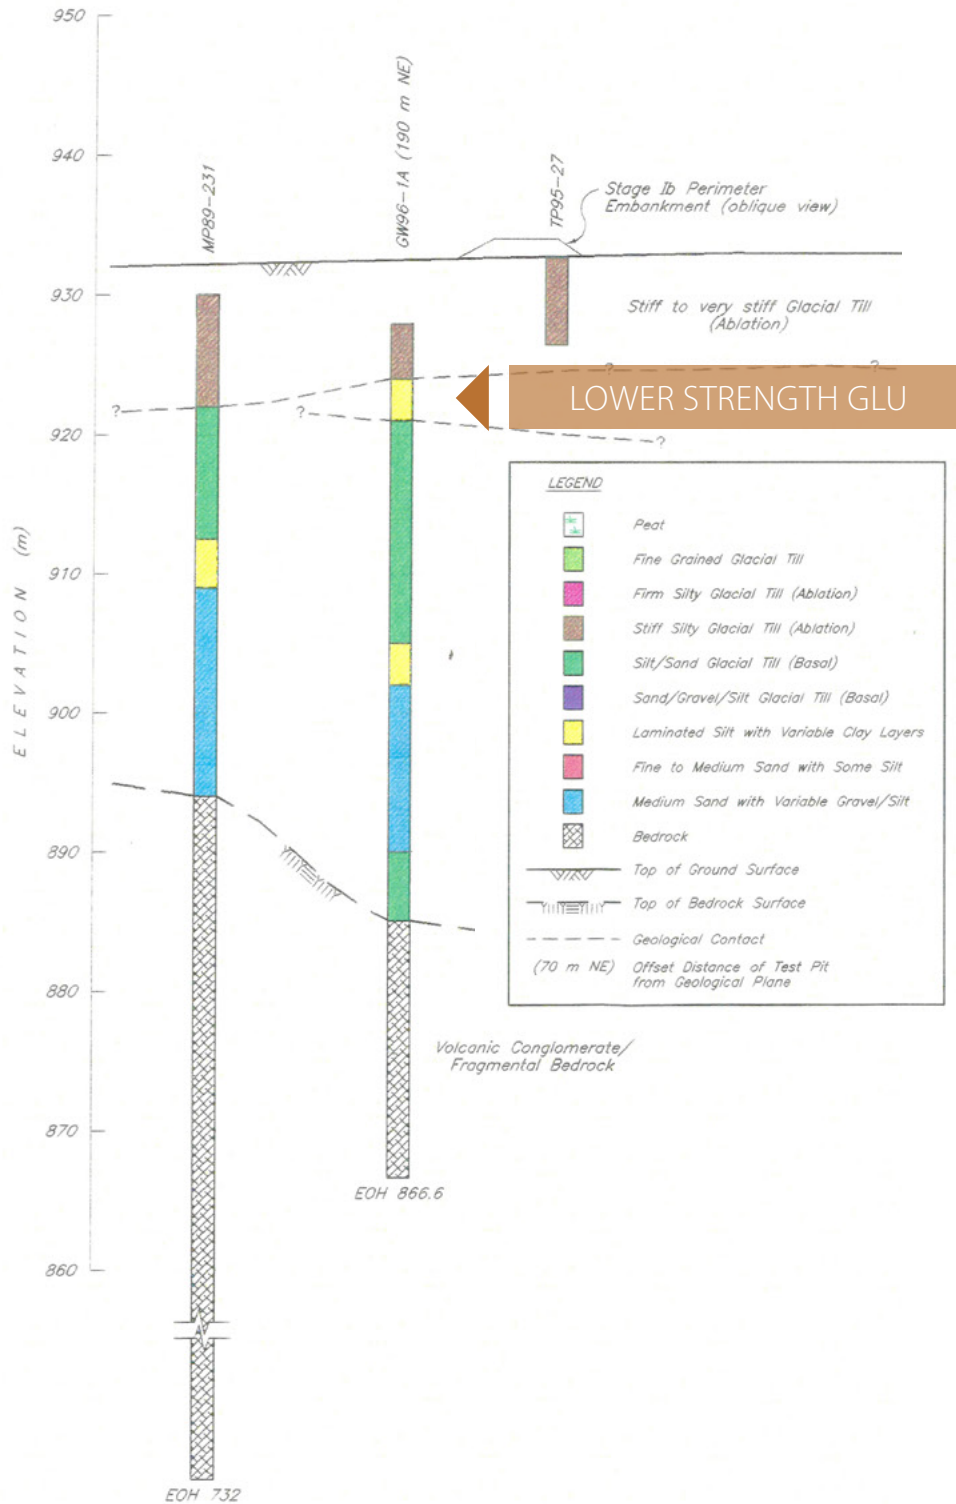
Figure 6.8 Profile of Drillholes MP89-231 and GW96-1A
Knight Piésold (1997d) Dwg 1627.011

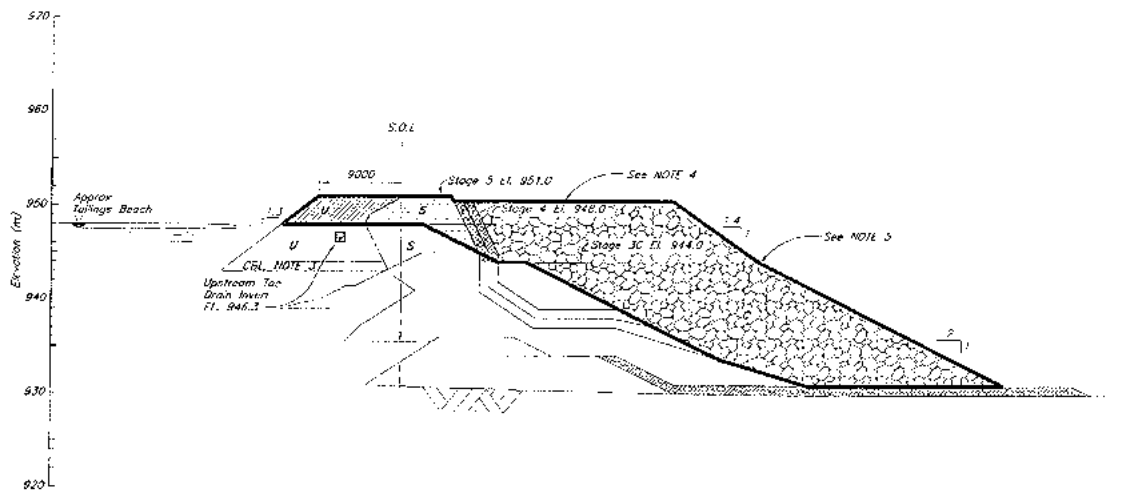
The as-built report (shown in Figure 6.10) indicates that the upper portion of the slope was an interim slope and the lower slope was 2H:1V.⁷¹

Figure 6.10 Stage 5 PE Section, As-Built, with Interim Slope
Knight Piésold (2008a) Dwg. 225

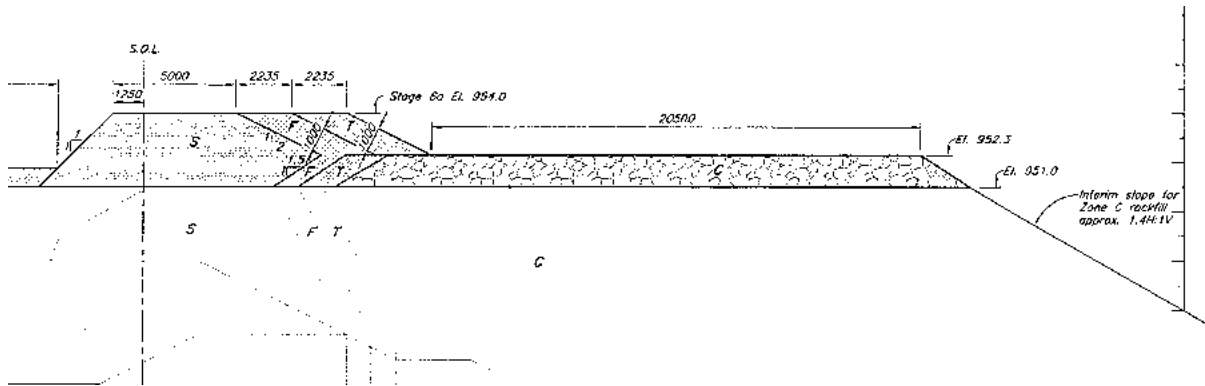
*Figure 6.12 Stage 6A PE Section, As-Built: Detail Reflecting an Interim Slope of 1.4H:1V
Knight Piésold (2009b) Dwg. 225*

Construction to an elevation of 954 m was completed in October 2008. Five new piezometers⁷⁸ were installed, for a total of 68 – 12 of which were foundation piezometers. Zones F, T, and C used screened, crushed waste rock from mine operations. At the request of MPMC, the design specifications for the slope of Zones S, F, and T were flattened to “facilitate the placement of the filter materials.”⁷⁹ As in the previous stage the upper portion of the embankment slope was 1.4H:1V and the lower portion was 2.0H:1V (see Figure 6.12; the full embankment section is shown in Figure 6.13).

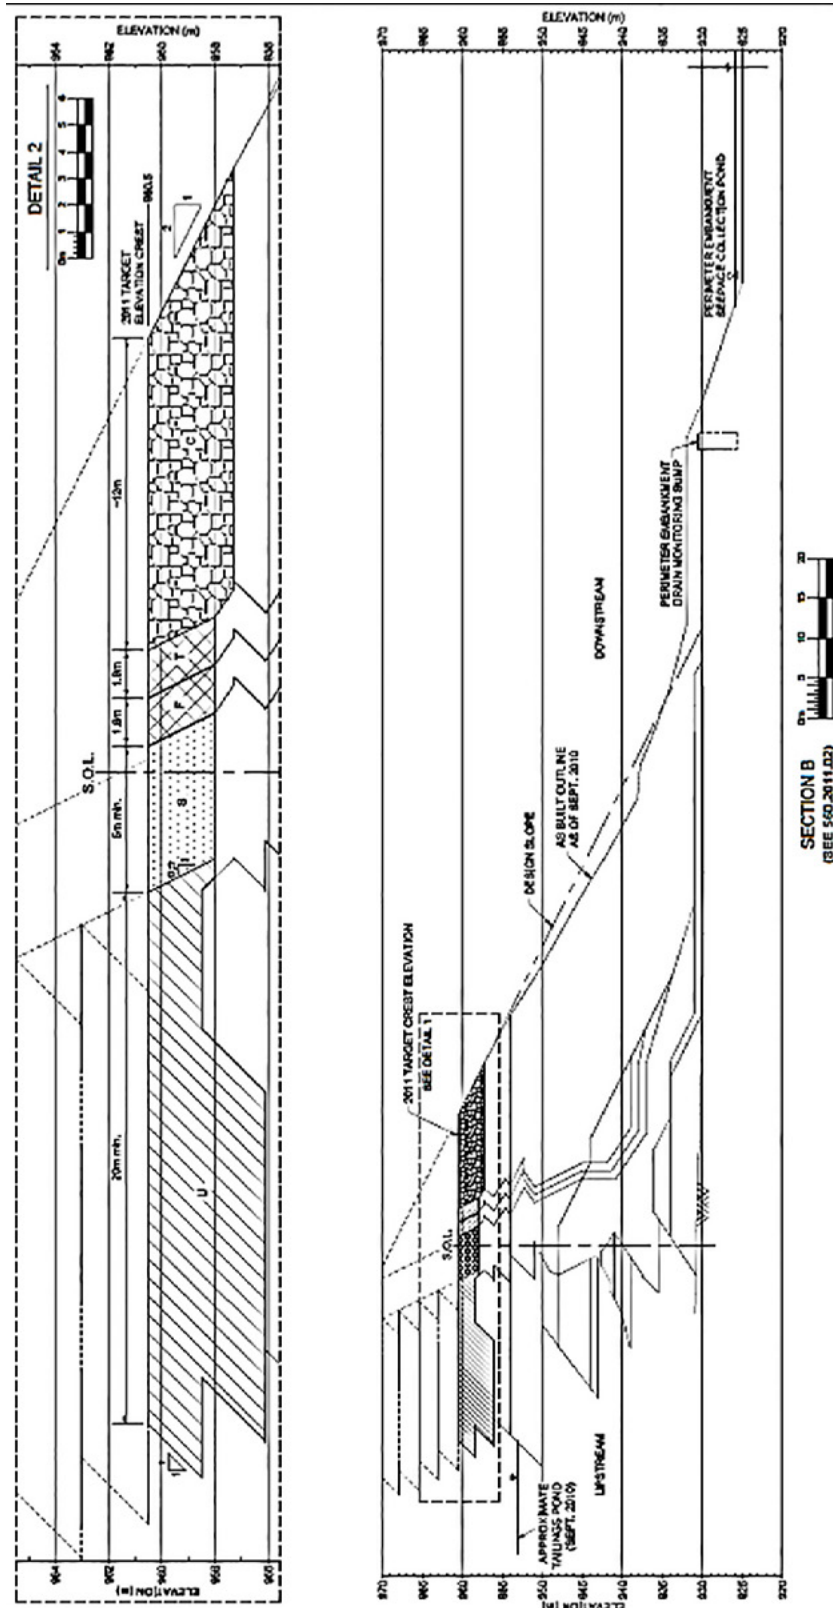
Figure 6.15 Stage 7 PE Section Plan, Reflecting a Downstream Slope of 2H:1V
AMEC Earth & Environmental (2011a) Fig. 560.2011.05

AMEC maintained the steeper “interim slope” of the PE downstream shell as KP, its predecessor EoR, had initiated; however, AMEC changed the nomenclature of the slope in its as-built drawings to show an as-built slope of 1.3H:1V, and a dotted line for an “ultimate design slope” of 2H:1V (see Figure 6.15).

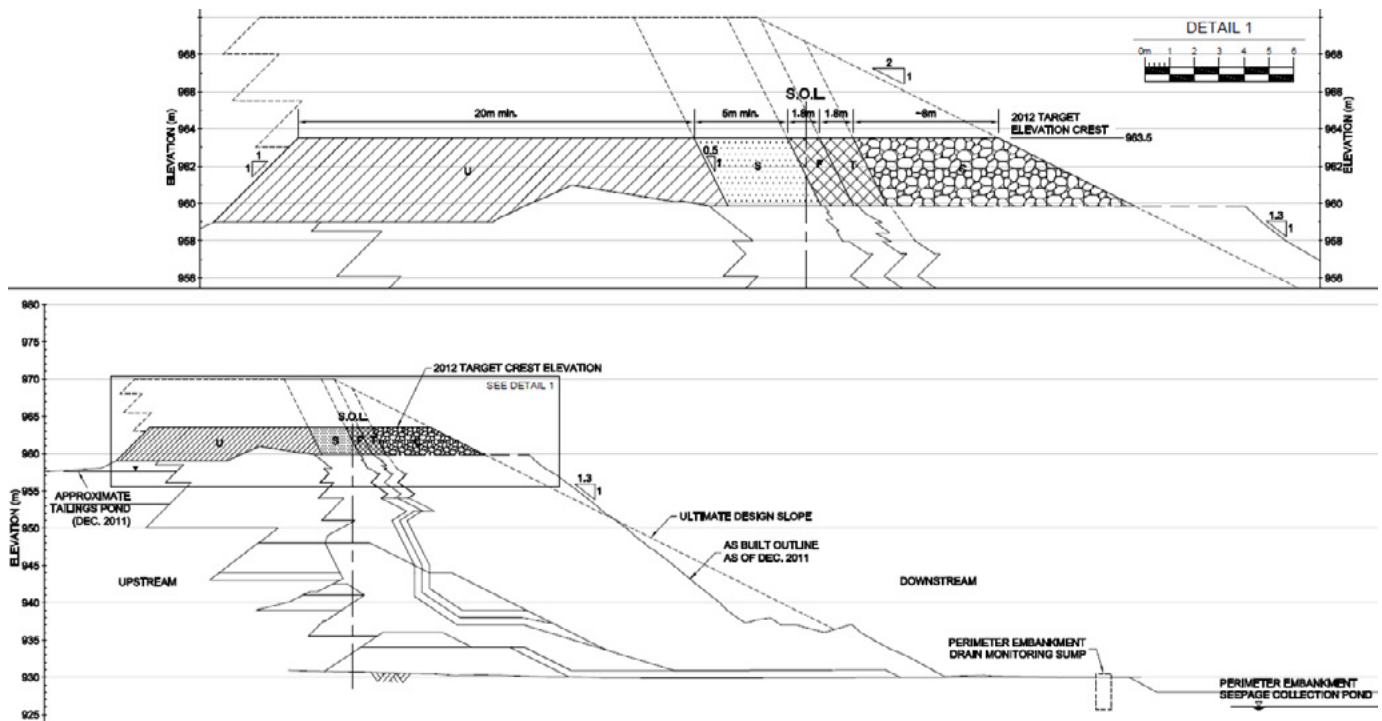
Figure 6.17 Stage 8 PE Section, Planned, Reflecting an Initial Slope of 1.3H:1V
AMEC Environment and Infrastructure (2012a) Fig. 2012.05)

Design of Stage 8 generally continued the design from Stage 7, with a raise of 3.0 to 3.4m following the modified centerline method, resulting in a narrowing of the dam crest. The PE downstream slope was again acknowledged at 1.3H:1V, with an “ultimate design slope” of 2H:1V (see Figure 6.17).

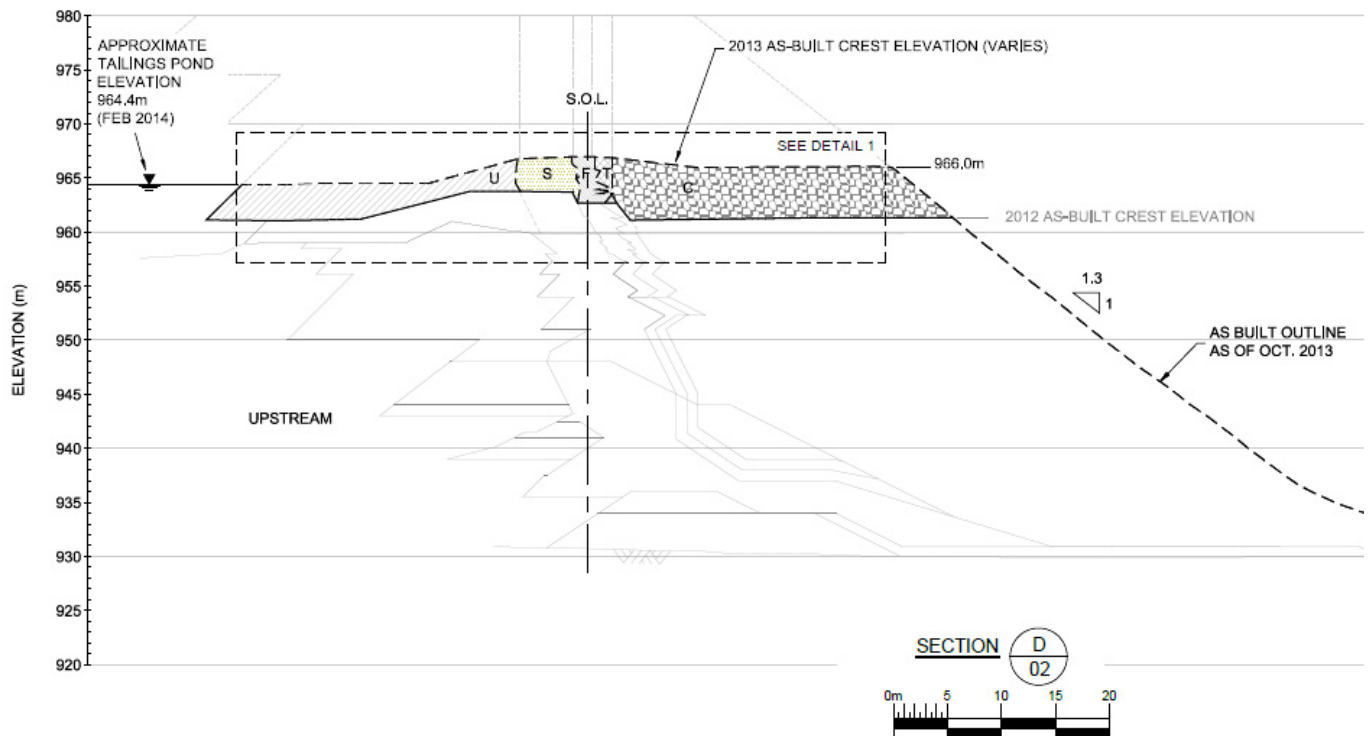
Figure 6.22 October 2013 PE Section, As-built, with Slope of 1.3H:1V
AMEC Environment and Infrastructure (2014a) Fig. 2013.AB04

At the end of the 2013 construction season, the PE was raised to 966 m (with a core elevation of approximately 966.5 m). The downstream slope of the PE remained at 1.3H:1V, and the maximum elevation of the dam was sketched in at 980 m (see Figure 6.22).

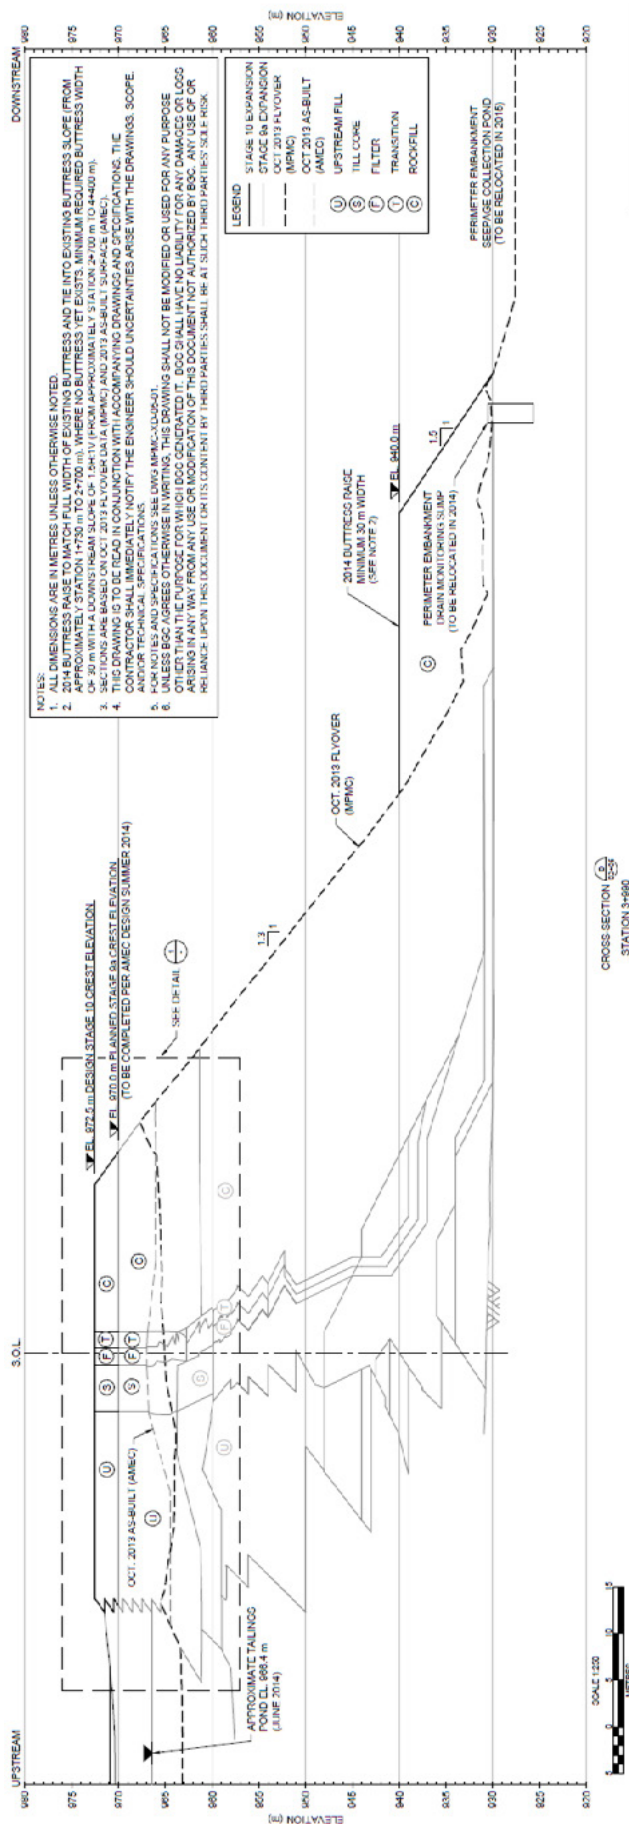
Figure 6.26 Stage 10 PE Section Plan BGC Engineering Inc. (2014) Dwg. MPMC-XD-03-02

The crest raise to 972 m “is expected to provide sufficient tailings, water storage, and flood storage freeboard until the end of September, 2015.”¹⁵⁰ Figure 6.26 shows both the construction lift at the dam crest and the development of a buttress to increase stability.

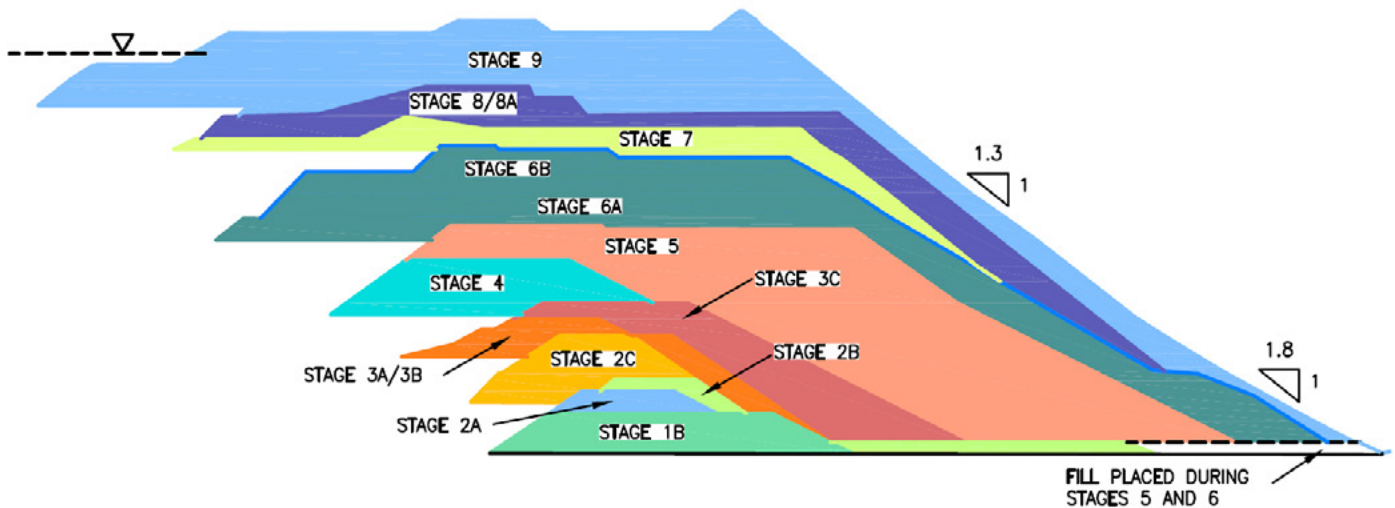
Figure 6.27 Embankment Stages Appendix 3, Fig. 2.6

The design profile of the PE at the close of Stage 9 (at the time of the failure) is shown in Figure 6.27. The elevation of the crest is 970 m; the height of the embankment at its highest point (where the breach occurred) is approximately 40 m, and the downstream slope is at 1.3H:1.0V.

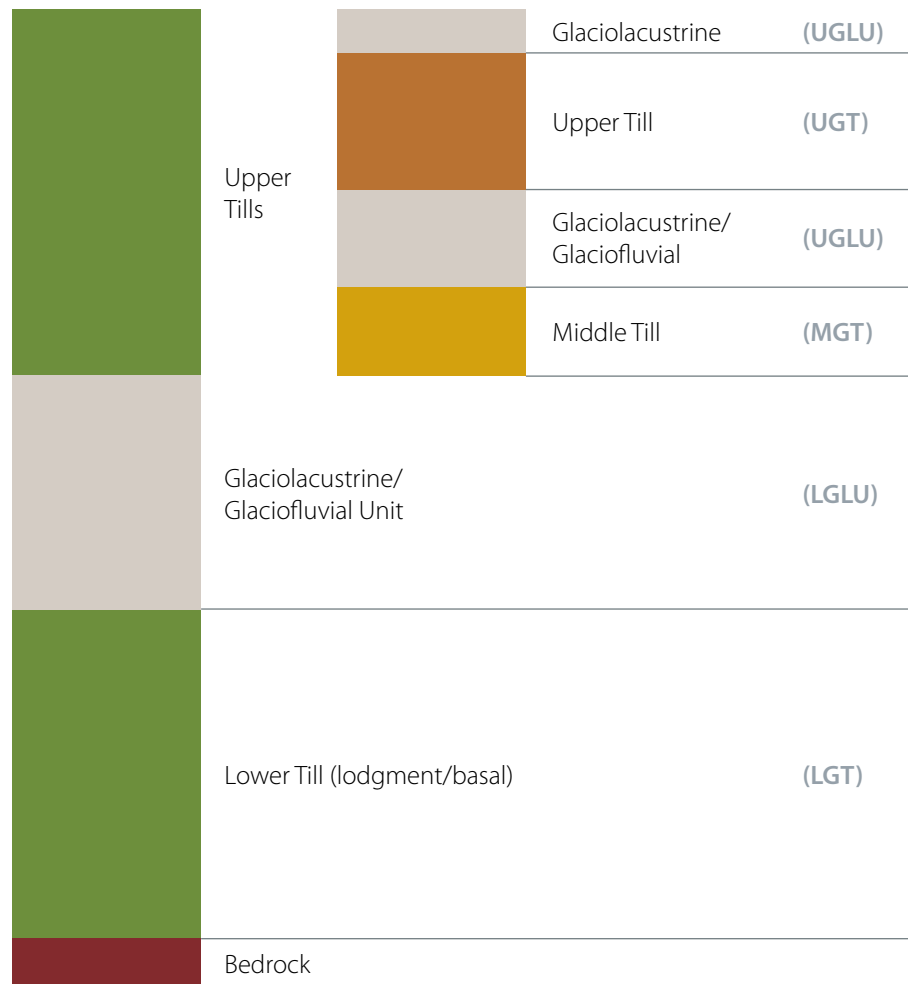
Figure 7.1 Schematic of Generalized Soil Units Appendix 3, p. 79

A simplified schematic illustrating the generalized soils units is presented in Figure 7.1. The left soil profile is the generalized summary of the foundation soils as known prior to the breach; the right side shows the additional detail gained from investigations following the breach.

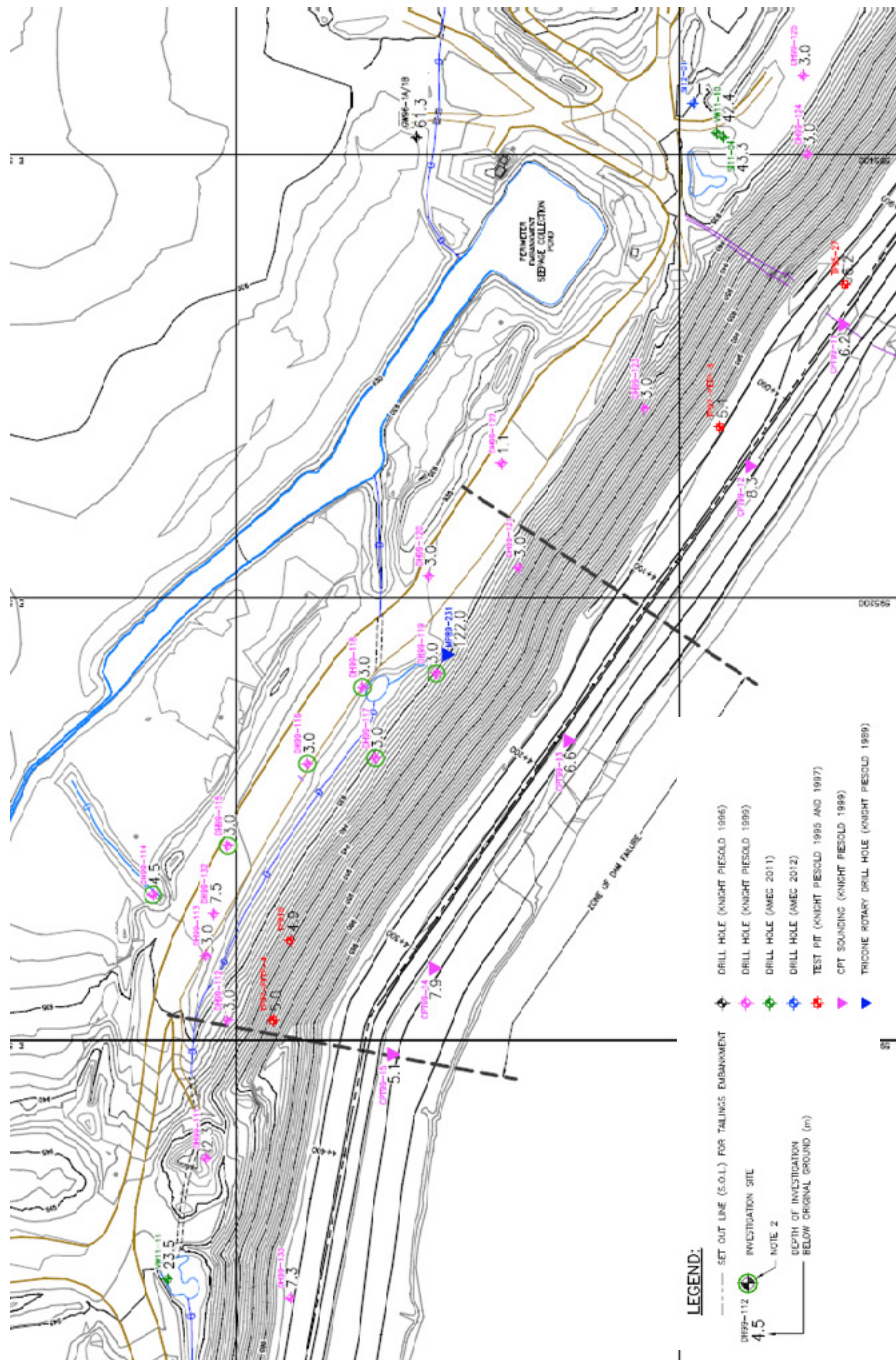
Figure 7.2 Site Investigations Near the Breach Appendix 2, Fig 2.9

Various site investigations were conducted from 1989 to 2012 at the TSF. Figure 7.2 presents the plan of pre-failure site investigations conducted at or near the failed embankment. The deep condemnation drillhole, MP89-231, is indicated with the arrow.

- From 1995 and 1999, a total of 4 test pits and 17 drill holes were completed in the vicinity, with 2 test pits and 11 drill holes below the failed embankment. These investigations were restricted to 5 m depth, except for DH99-132 which was 7.5 m deep. A clay layer, up to 2 m thickness, was encountered near the surface overlying stiff to very stiff glacial till. The areal extent of this layer was confined to the center of the failed embankment area, at DH99-114 to DH99-119 as shown in Appendix 2, Figure 2.9. This correlates with the shallow clay deposit excavated during the foundation preparation.

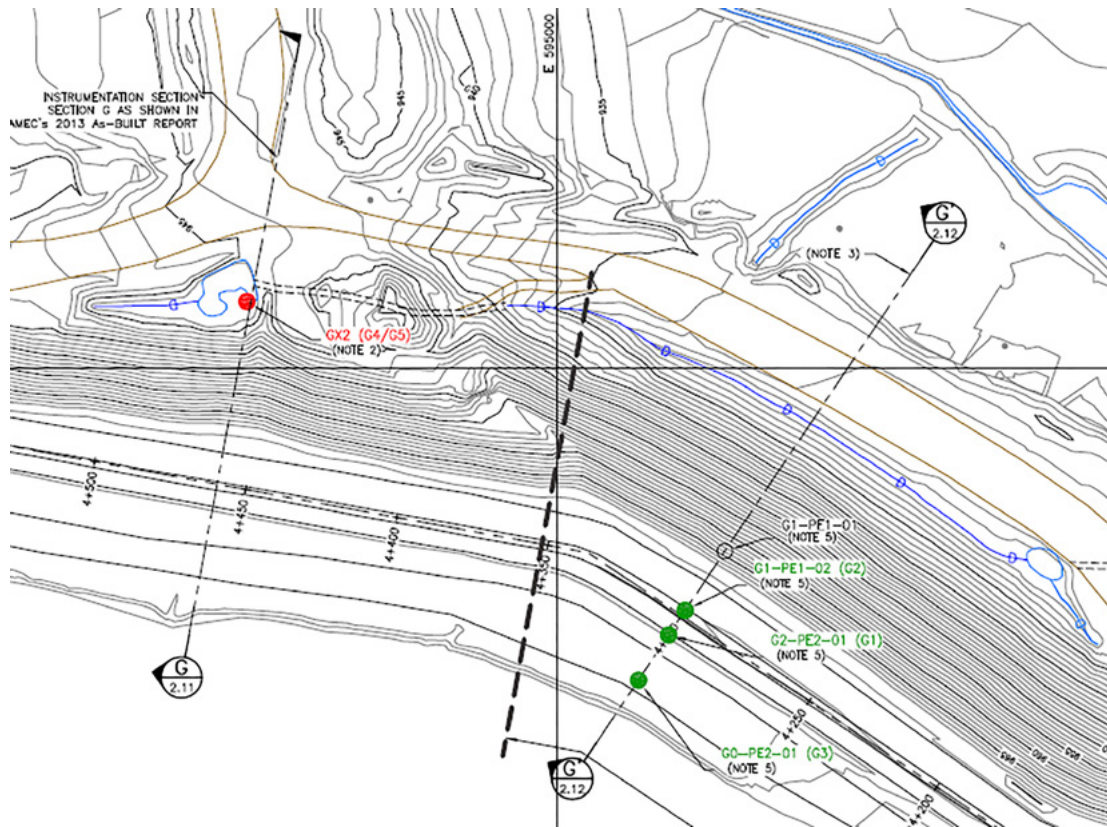
*Figure 7.3 Instrumentation Plan at Section G and G' at Breach Site
Appendix 2, Fig 2.10*

Figure 7.3 presents the pre-failure instrumentation plan at Corner 1 of the PE. Instrumentation includes: 17 vibrating wire piezometers, 2 slope inclinometers and flow measurements from the upstream toe drain. Reference information for the instrumentation is included in the *Failure Assessment*, Appendix 2.

Monitoring frequency varied throughout the operation of the TSF. Frequency was initially every two weeks for inclinometers and piezometers, and was reduced to once a month after 2012.⁴ Seepage measurements from the upstream toe drain were typically recorded 3 to 8 times per year starting in 2007.

The piezometers were either installed during construction within the tailings impoundment and fill materials, or installed in foundation soils during site investigations. In the area of the breach, piezometers were installed in the dam structure, but not in the foundation. 12 of the 17 vibrating wire piezometers at the PE were functioning in 2014. The functioning piezometers are located along three sections (2 are shown in Fig. 7.2; Section D is shown in Appendix 2, Figure 2.10:

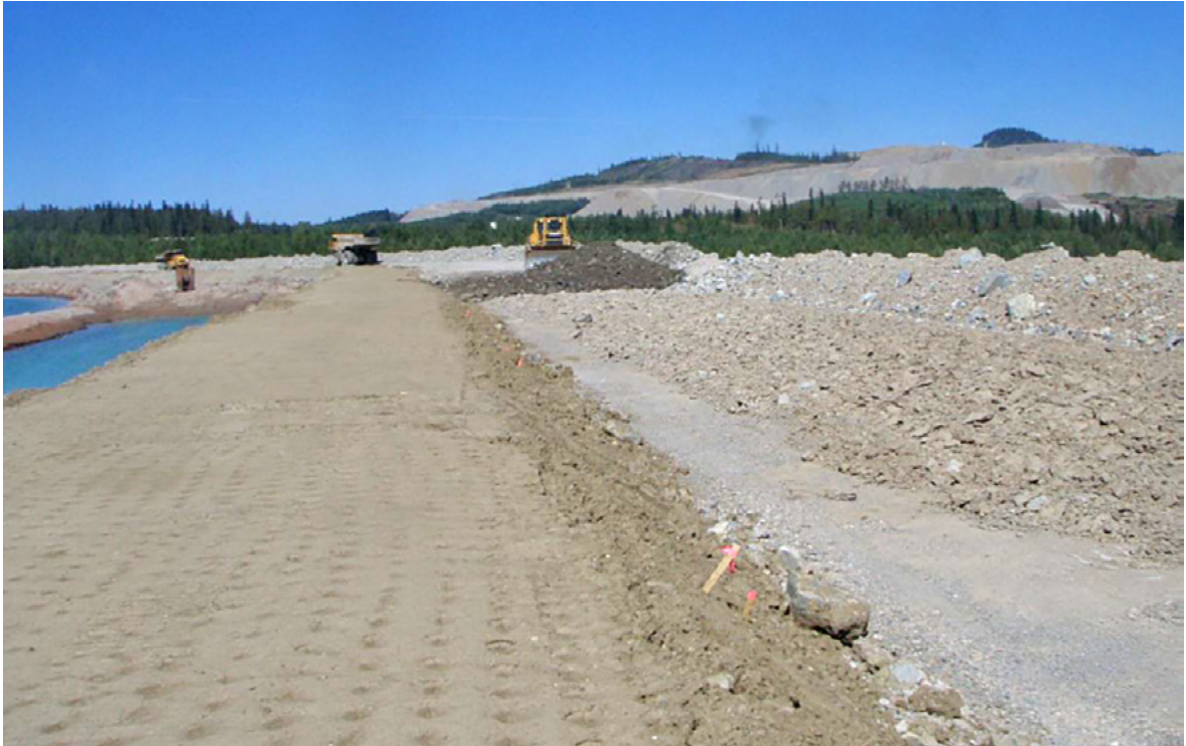
Figure 8.2 Placement of Zone C Rock on PE, July 28, 2014
AMEC Environment and Infrastructure (2014e)

Construction activities on the TSF continued up to the time of the breach. Figure 8.2 shows placement of Zone C rockfill on the PE a week before the failure. The night of the event, sand cell construction was under way until the breach was in full progress.

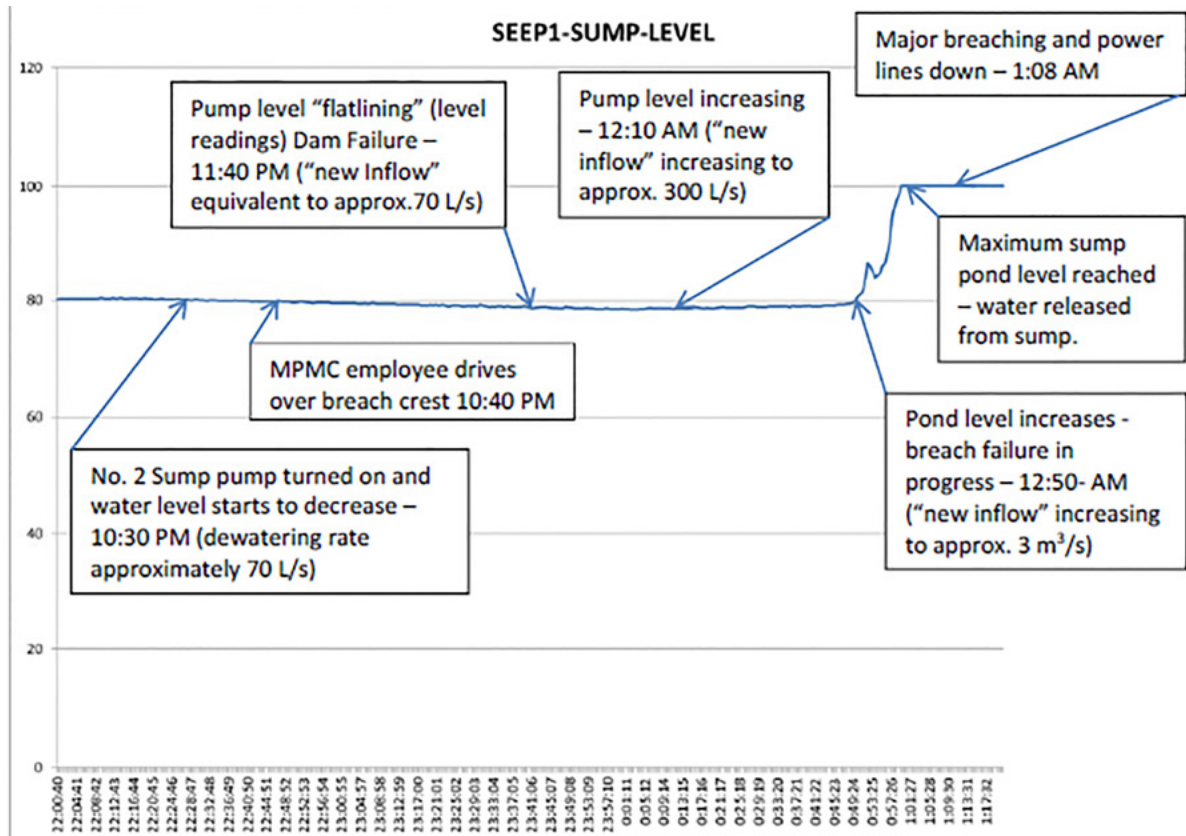
Figure 9.3 Perimeter Sump Volumes Appendix 3, Fig. 5-1

Following the structural failure of the dam, the breach increased progressively. While it is difficult to assign specific durations to each element of this sequence, flow records from the pump at the Perimeter Sump indicate the volume of water overtopping the dam at the times noted in Figure 9.3.

Overtopping flow rates began to increase at approximately 10:30 pm, and by 11:40 pm the rate was 70 L/s. By 12:10 am, the rate had increased to approximately 300 L/s. As the breach was in progress by 12:50 am, the flow level increased to 3 m³/s (or 3,000 L/s). The breach increased with sufficient flows to take down the power lines below the dam by 1:08 am.

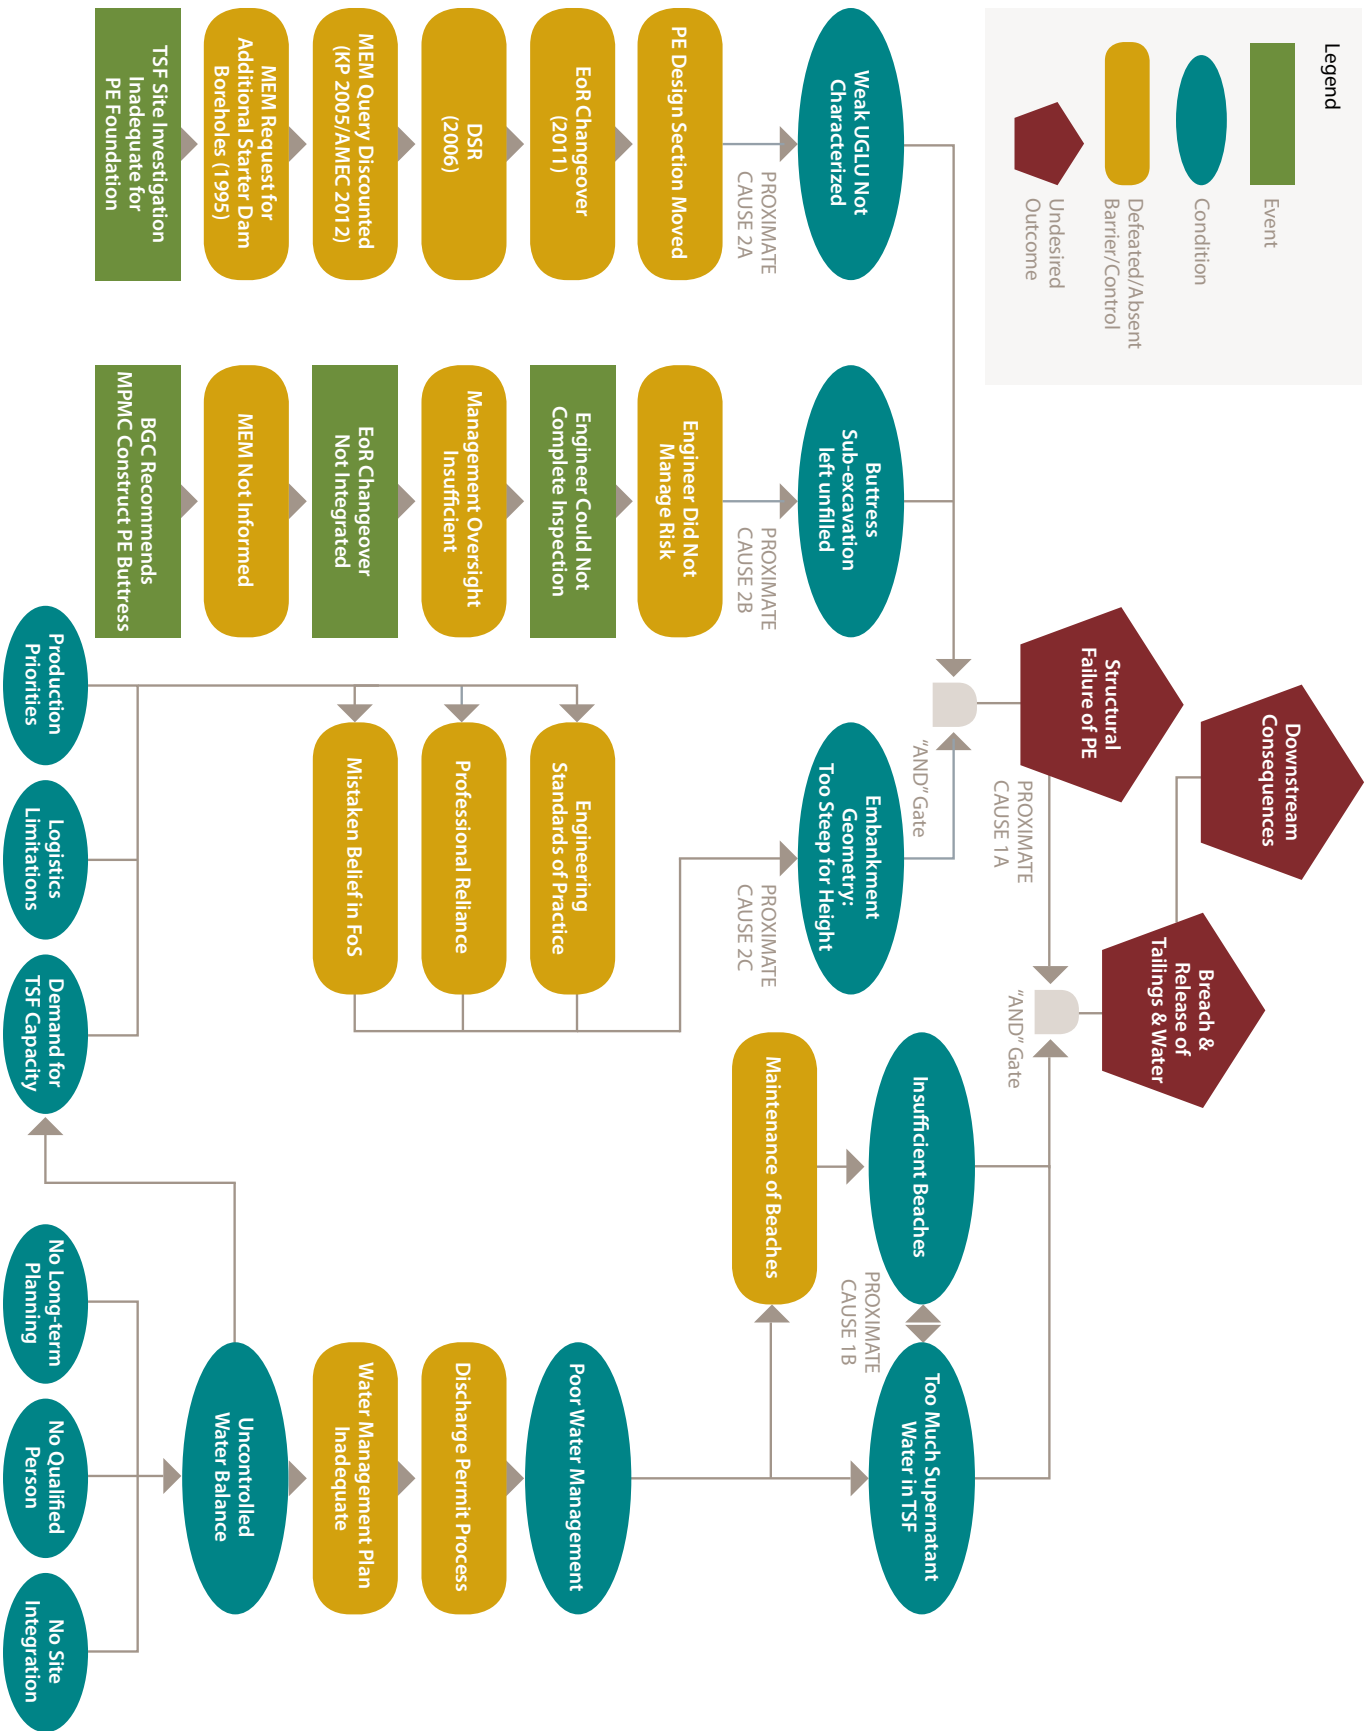
Figure 10.1 RCA Event and Causal Factor Tree - Summary Ministry of Energy and Mines (2015b)

Three proximate causes are associated with the structural failure of the PE: geometry of the embankment, an uncharacterized foundation glaciolacustrine unit, and an open sub-excavation at the embankment toe. The proximate causes are linked with an "and" gate, indicating that each of the three causes was necessary to produce the structural failure.

The event at Mount Polley unfolded in a sequence of events, each of which played a causal role in the next. This section describes the logic of each step in the RCAT process, working down through the ECFT shown in Figure 10.1, and backwards through time to arrive at the root causes of each branch of the diagram. The ultimate undesired outcomes of the event are labelled Downstream Consequences in the ECFT, encompassing the effects of the dam breach on the environment downstream of the embankment and ultimately far beyond the mine's boundaries. These downstream consequences are discussed in Section 10.7.
