MOUNT POLLEY MINE TAILINGS STORAGE FACILITY BREACH

August 4, 2014

Investigation Report
of the Chief Inspector of Mines

November 30, 2015

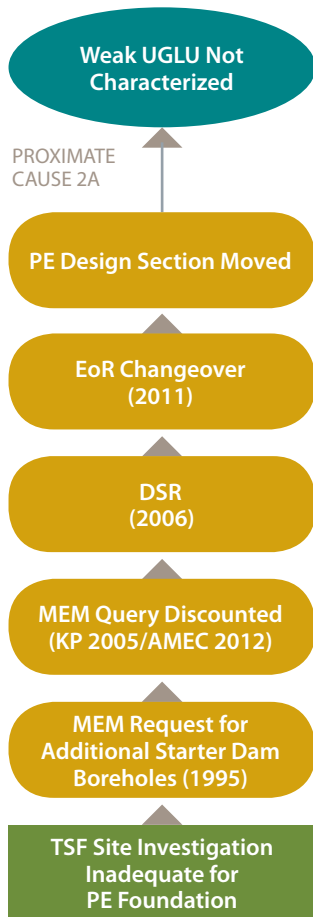
WEAK UGLU NOT CHARACTERIZED

- The glacial history of the dam foundation was not adequately understood.
- There was a disconnect between the level of understanding and an appreciation of uncertainty with respect to that understanding. The risk associated with the potential for weak UGLU was not appreciated, and never taken into account with stability analyses. There was limited effort to either conduct more soil exploration or to anticipate potentially unknown soils with a more conservative design. Either approach would have, in all likelihood, avoided the failure.

- Site investigations appeared to be focused on the initial starter dam (which was limited to the ME) or at most, the first two stages. Subsequent construction stages seemed to operate on the assumption that all necessary foundation studies had been completed during the initial design phase, and that test holes were mainly for installation of monitoring instrumentation.

the root cause associated with Proximate Cause 2A is that the site investigation conducted for the Perimeter Embankment was inadequate

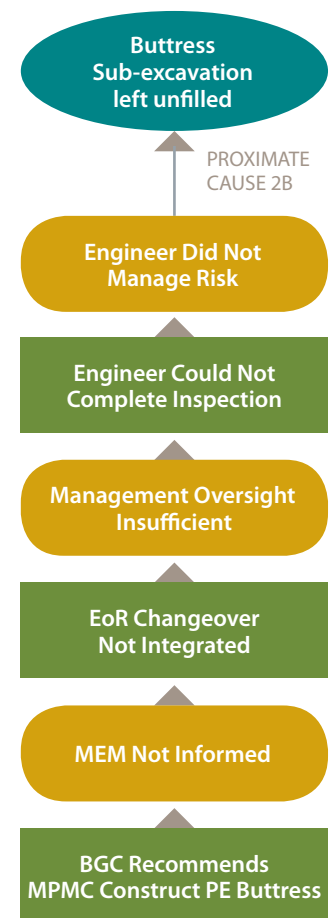
BUTTRESS SUB EXCAVATION LEFT UNFILLED

The design for the PE buttress, including detailed construction drawings, was submitted to MEM as part of the Stage 10 *Mines Act* permit amendment application prepared by BGC Engineering, and received by MEM on July 25, 2014 — 10 days before the breach event.

The root cause associated with Proximate Cause 2B is that an unapproved buttress subexcavation reduced the PE Factor of Safety

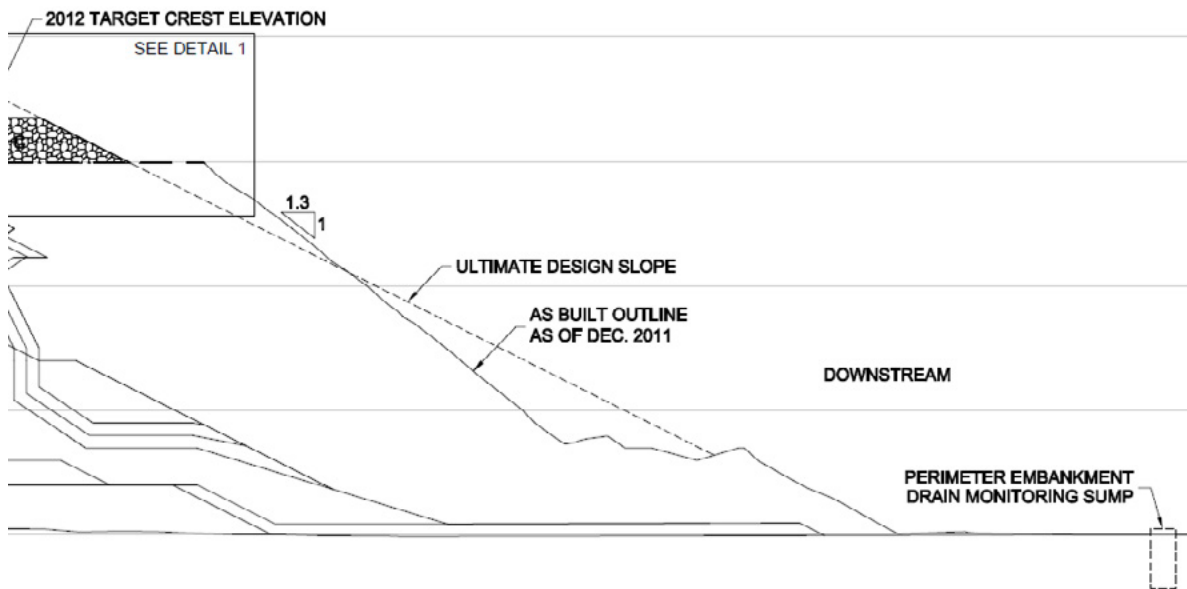
Figure 10.4 PE Downstream Slopes. AMEC Environment and Infrastructure (2012c)
Dwg 2012.05

The final proximate cause of the structural failure of the PE is embankment geometry: both steepness of the downstream slope and the height of the embankment (see Figure 10.4). A downstream rockfill shell with adequate slope represents a conventional engineered barrier: it is a completely passive, effective defense against failure of an embankment.

Mirroring the Stage 7 as-built report, the *Stage 8 (2012) Construction Manual* acknowledged an as-built slope of 1.3H:1V, with the drawing (see Figure 10.4) noting a 2H:1V slope as the “ultimate design slope,”⁴⁴ the slope that would remain after closure. Language referring to an “interim slope” no longer appeared in design documentation. The *Stage 8 As-Built and Annual Review Report* documented a 1.3H:1V slope as of October 2013 without comment on the as-built drawings.⁴⁵ The slope became accepted in Stage 9: the *Stage 9 Construction Manual* specified a 1.3H:1V downstream slope without comment.⁴⁶

The steepness of the downstream slope contributed to the initiation of the failure of the PE on August 4, 2014. The over-steepened slope and increased height of the dam led to stress concentration below the downstream slope of the dam within the UGLU, which ultimately induced undrained strength behavior, leading to progressive failure of the dam.

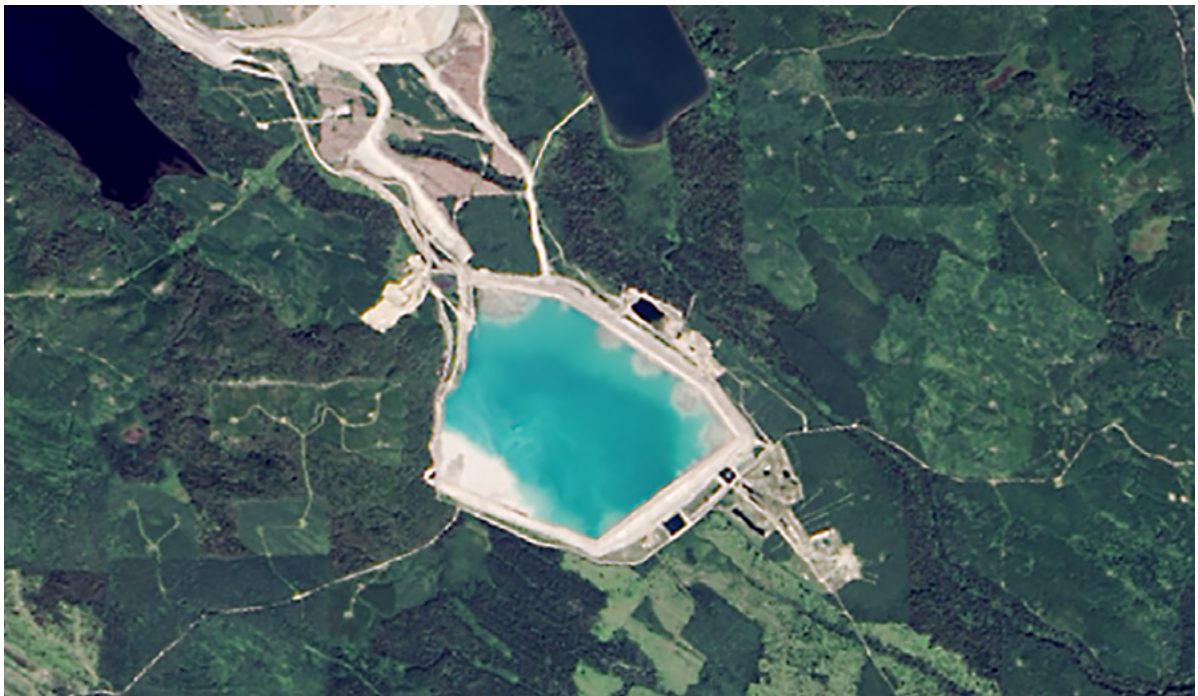
Figure 10.5 NASA High Altitude imagery, July 29, 2014

Despite these efforts, as Figure 10.5 shows, very limited beaches were established at the site of the embankment failure only days prior to the event (July 29, 2014).

Defeated Control: Maintenance of Beaches. Although it is impossible to accurately predict what the impact of sufficient beaches would have been at the time of the embankment failure, the lack of beaches represents a barrier that, had it been present, would have mitigated or prevented the structural failure of the PE from becoming a breach.

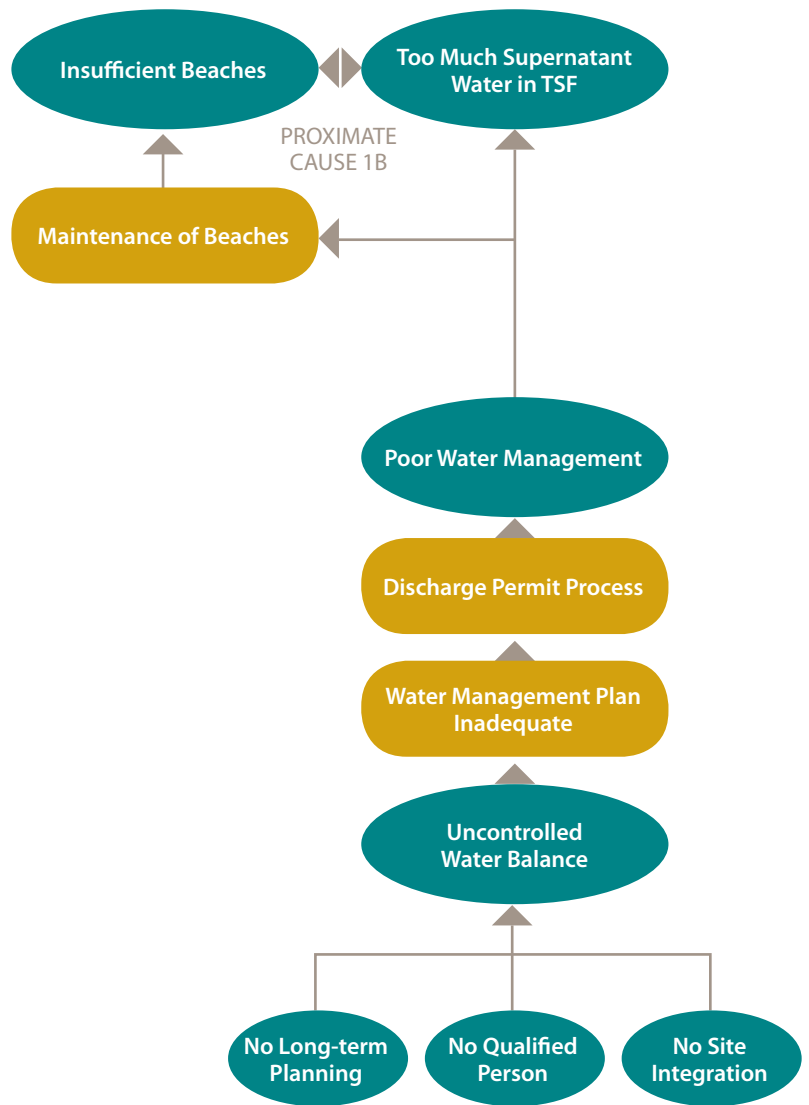
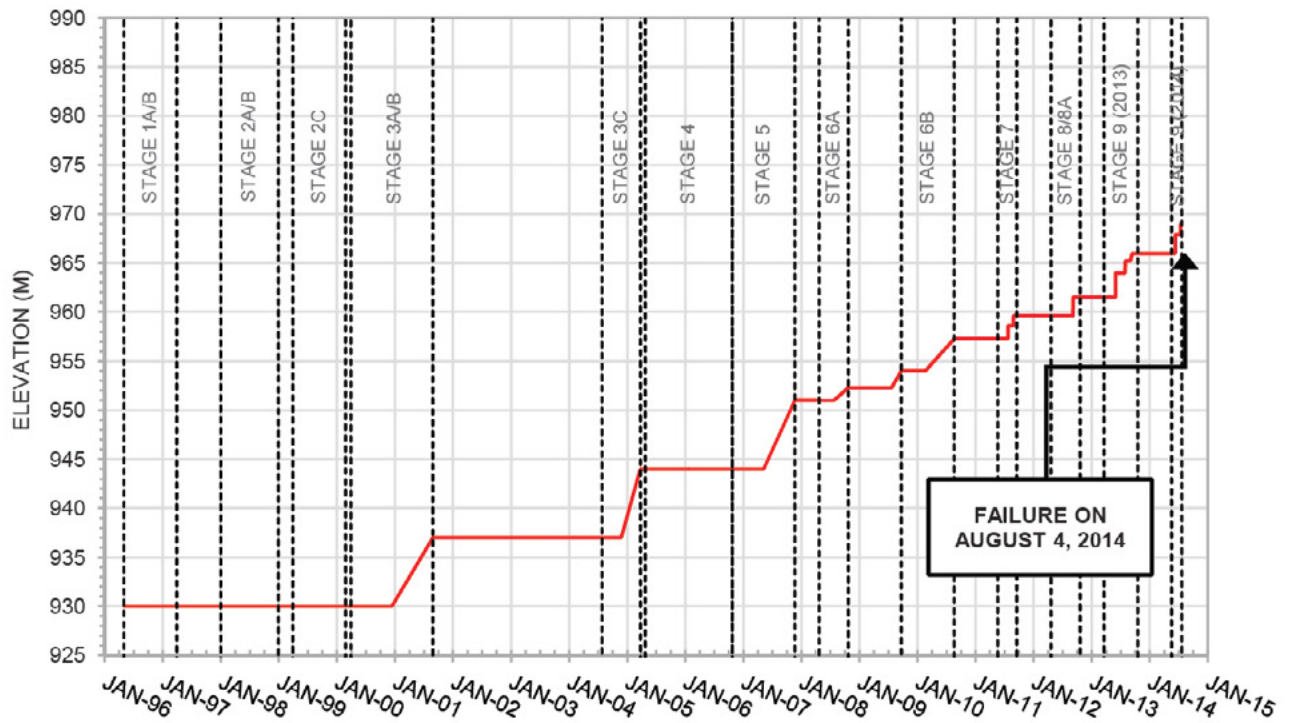
Figure 10.6 Embankment Zone C Elevation Over Time
Independent Expert Engineering Investigation and Review Panel (2015), p. 5-5

Water Levels. Both a tailings deposition model and an effective water balance are needed to assess if the tailings beach can be maintained throughout the operation of the TSF. Historical pond elevation and tailings beach levels are shown in Figure 10.6 below. The pond elevation immediately prior to failure was 966.8 m (freeboard was reported to be between 2.7 and 3.0 m) as reported in AMEC’s daily report dated August 3, 2014. The beach elevation in the area of the breach at that time was estimated to be 966.3 m as inferred from the post-failure tailings contours outside the breach area, the observed submergence of the tailings beach and photographic records from August 2014.⁵⁴
